185 FIFTEENTH AVENUE, WEST HOXTON

Geotechnical Investigation for Commercial Precinct

Report Number. 147622023_005_R_Rev0

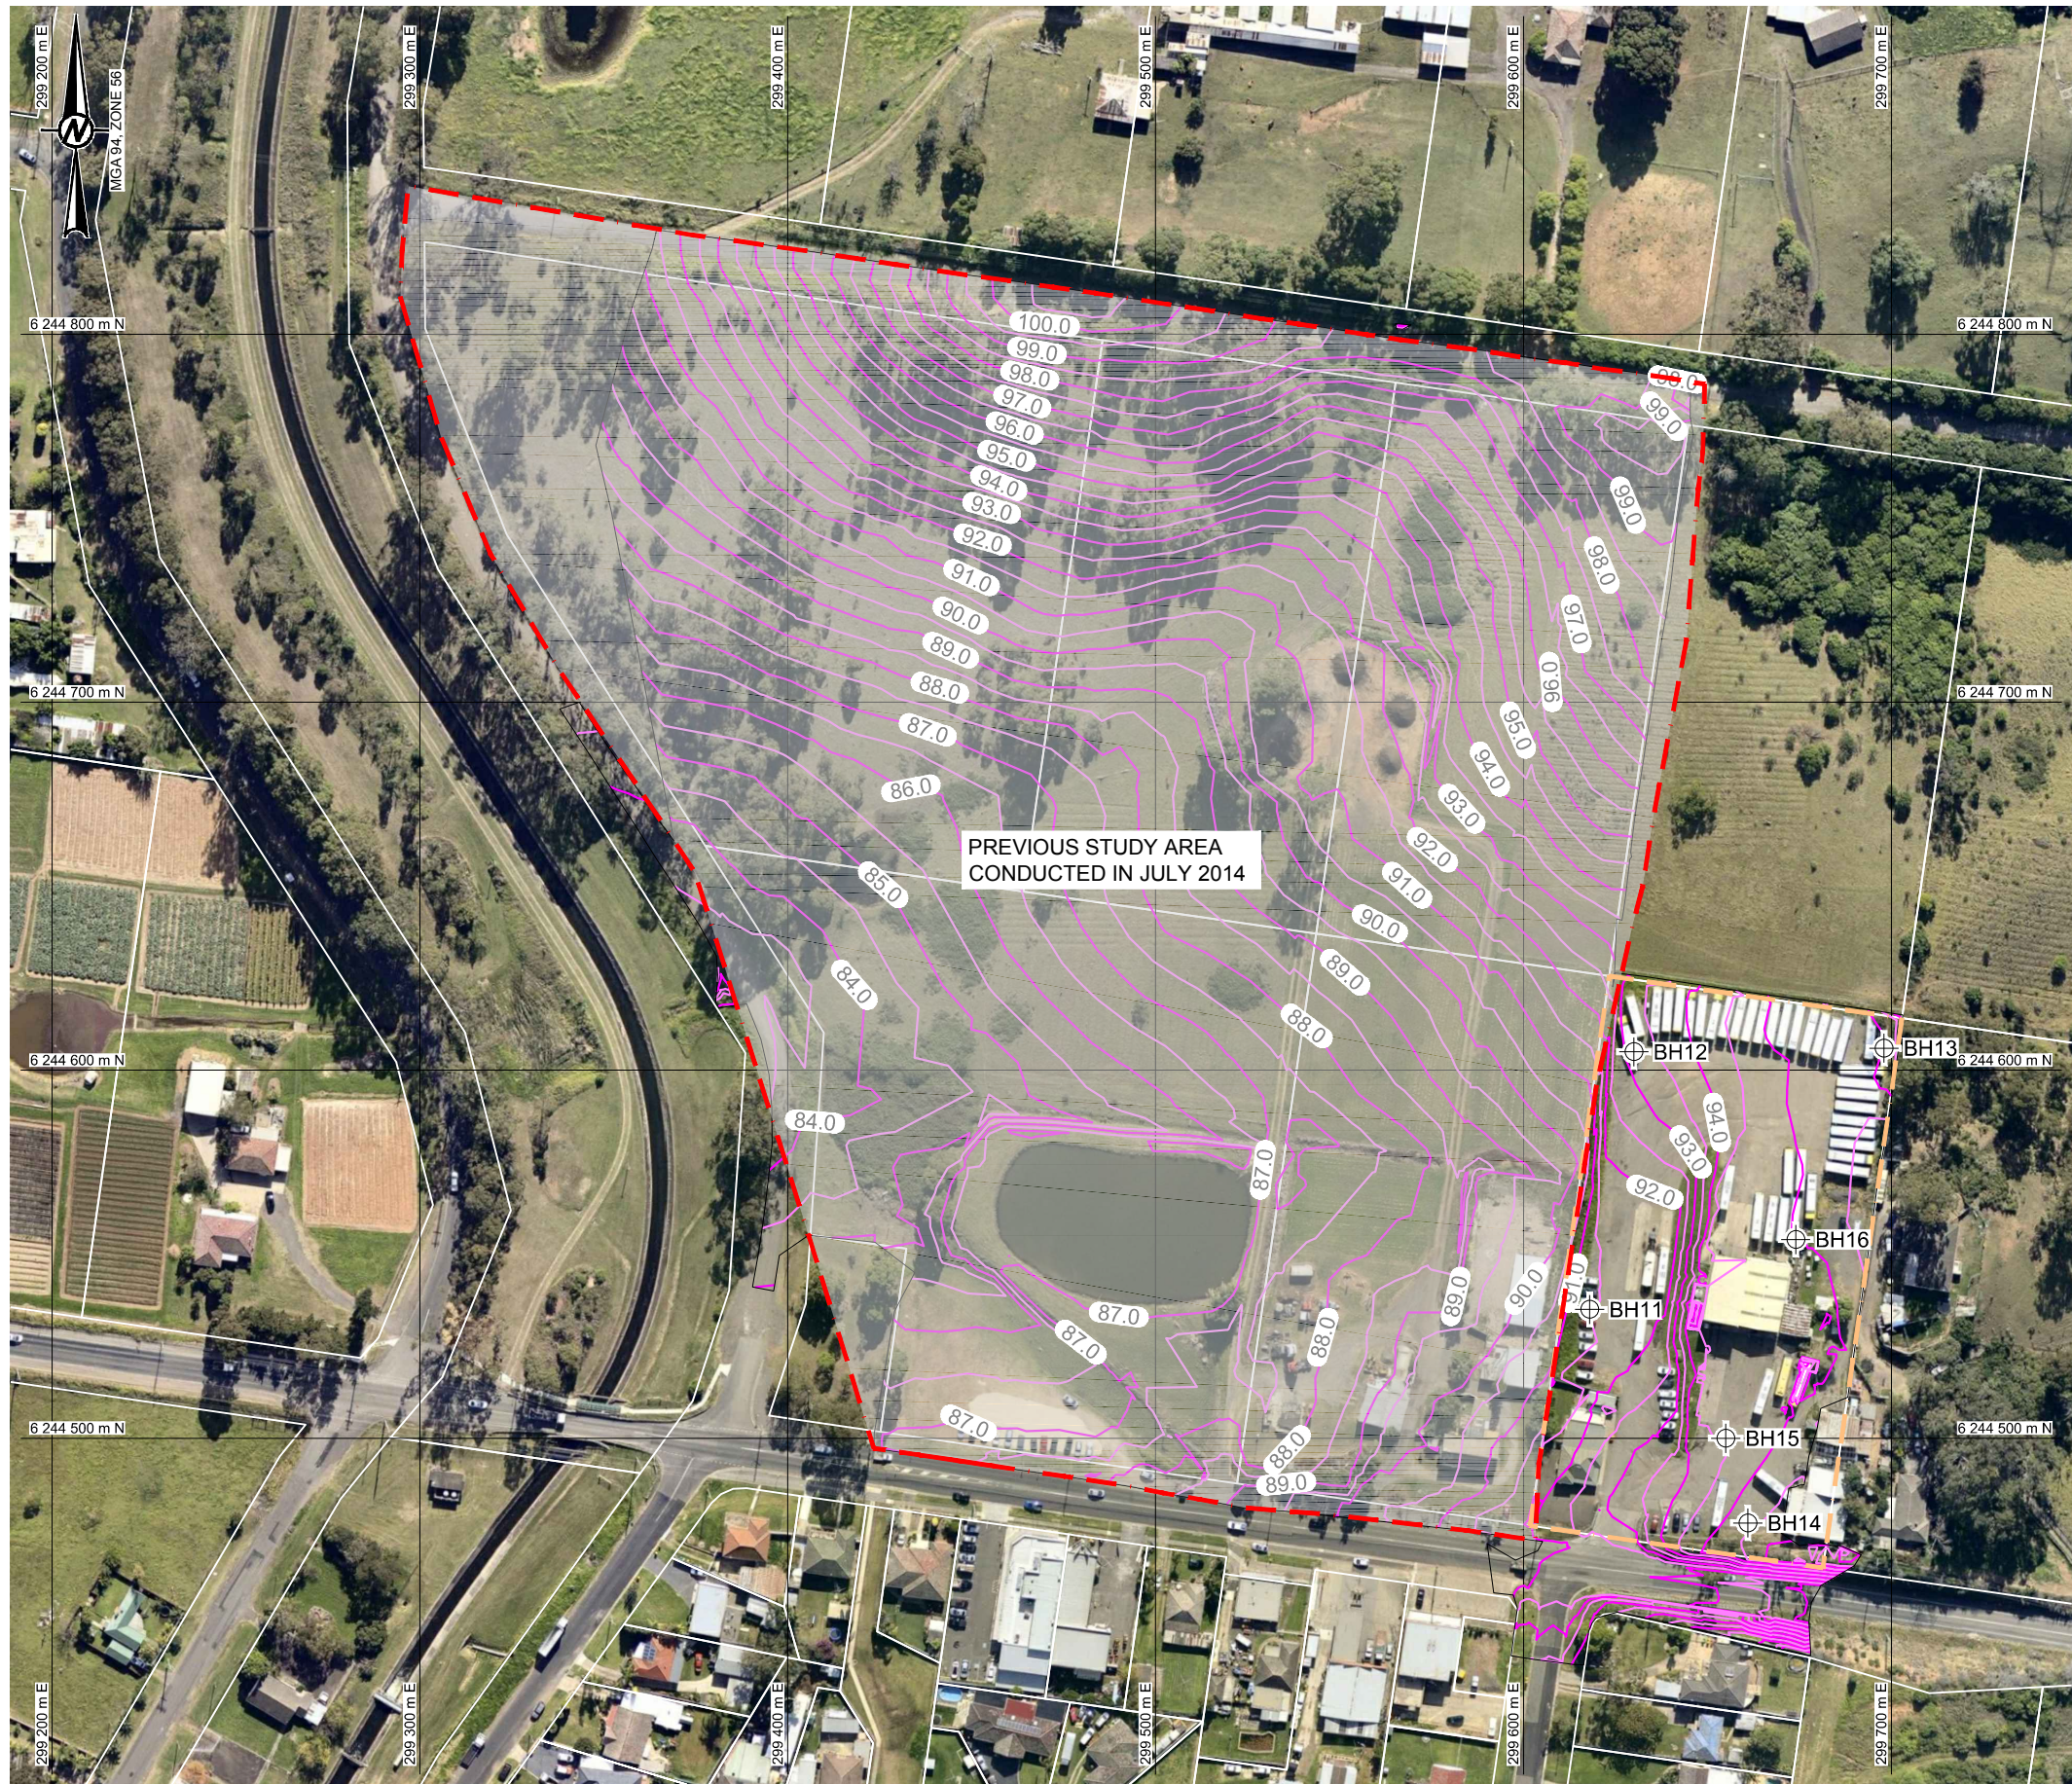
FIGURE
FIGURE 1

This report describes a preliminary geotechnical investigation of 185 Fifteenth Avenue (Lot 345 DP 2475), herein referred to as 'the *Site*', which forms the eastern portion of the commercial precinct. The location of the *Site* in relation to the surrounding area is shown on the site location plan, included as Figure 1.

Each test location was positioned using a hand held GPS accurate to about ± 5 m horizontally and levels were inferred from the contour plans provided. The investigation locations are shown on Figure 001 and a summary of the locations and details of the testing are provided in Table 1. The soil and rock units encountered in the boreholes are described below in Section 3.1 and summarised in Table 2.
