195 FIFTEENTH AVENUE, WEST HOXTON

Preliminary Environmental Site Assessment for Commercial Precinct

147622023_001_R_Rev2

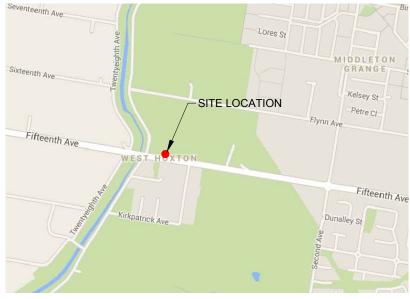
PROJECT No. 147622023 FIGURE 1 001 - R

195 FIFTEENTH AVENUE, WEST HOXTON INVESTIGATION LOCATIONS

The location of the study area in relation to the surrounding area is shown on Figure 1. A sketch of the proposed development of the site (Ref: 2014-4330 -u/c, dated 04/02/15) provided by WSPT and is included as Figure 2.

A Site location plan is presented in Figure 1 attached. Study area details are summarised below provided in Table 1.

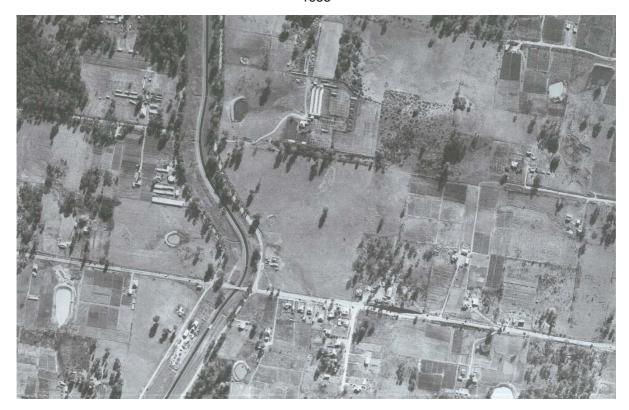
1961		Study area	The study area was similar in appearance to that shown in the 1955 aerial photograph.
		Surrounding area	The surrounding area was generally similar in appearance to that shown in the 1955 aerial photograph. An increased number of buses were observed on the Bus Depot site to the east. The number of residential type structures on the southern side of Fifteenth Avenue opposite the study area had increased, as had the extent of land in the vicinity of the study area that appeared to be under cultivation for market gardens. Additional sheds had been constructed on the assumed poultry
