Site Audit Report

185 & 195 Fifteenth Avenue
West Hoxton NSW

14 July 2016

51767-104548 (Rev 0)

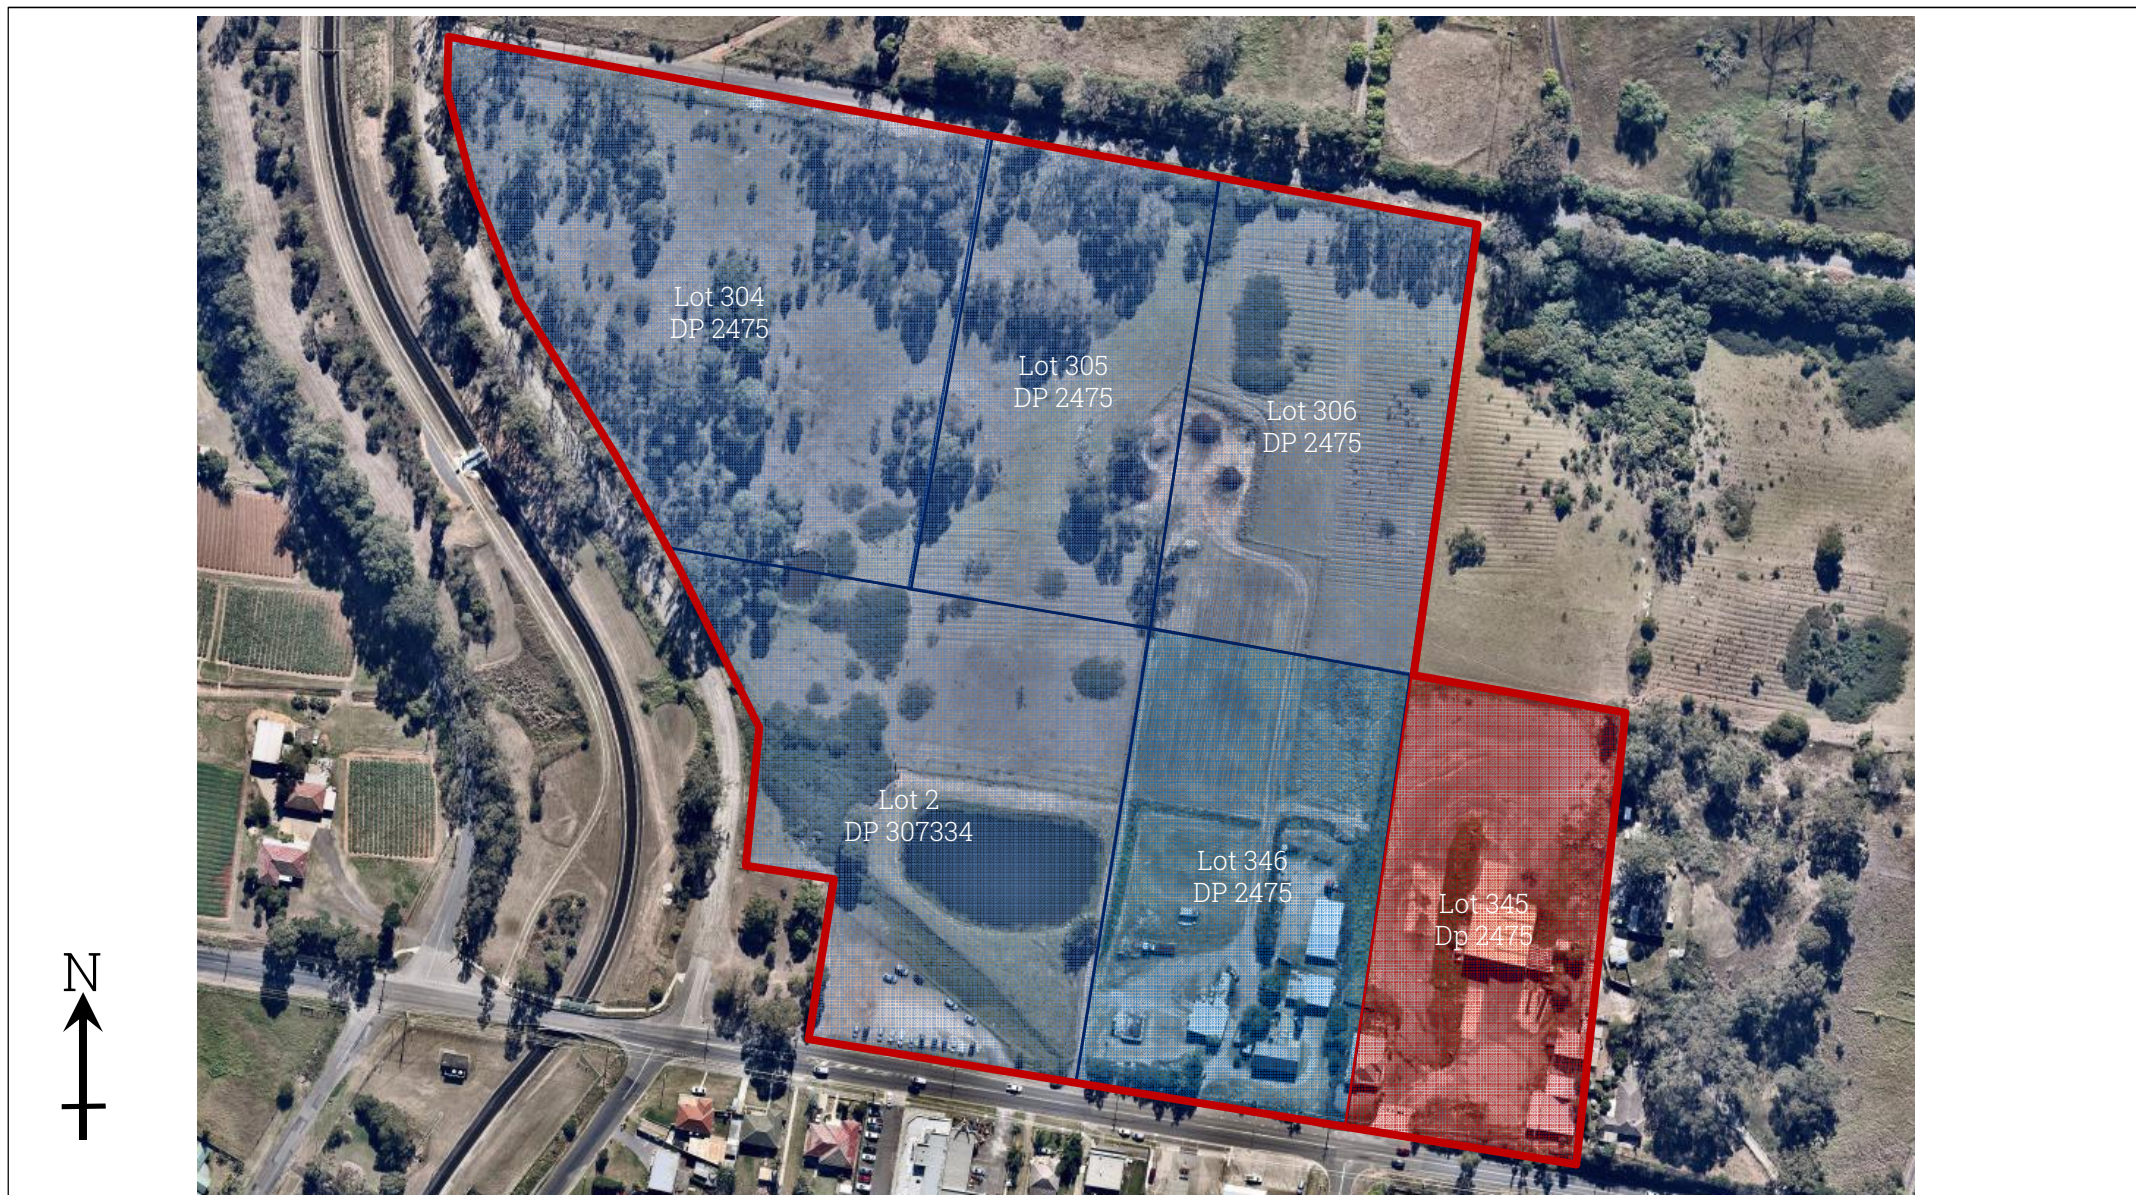
185-195 Fifteenth Avenue, West Hoxton NSW

- Site Boundary
- Zoic 2016 Area (195 Fifteenth Ave)
- DP 2015 Area (185 Fifteenth Ave)

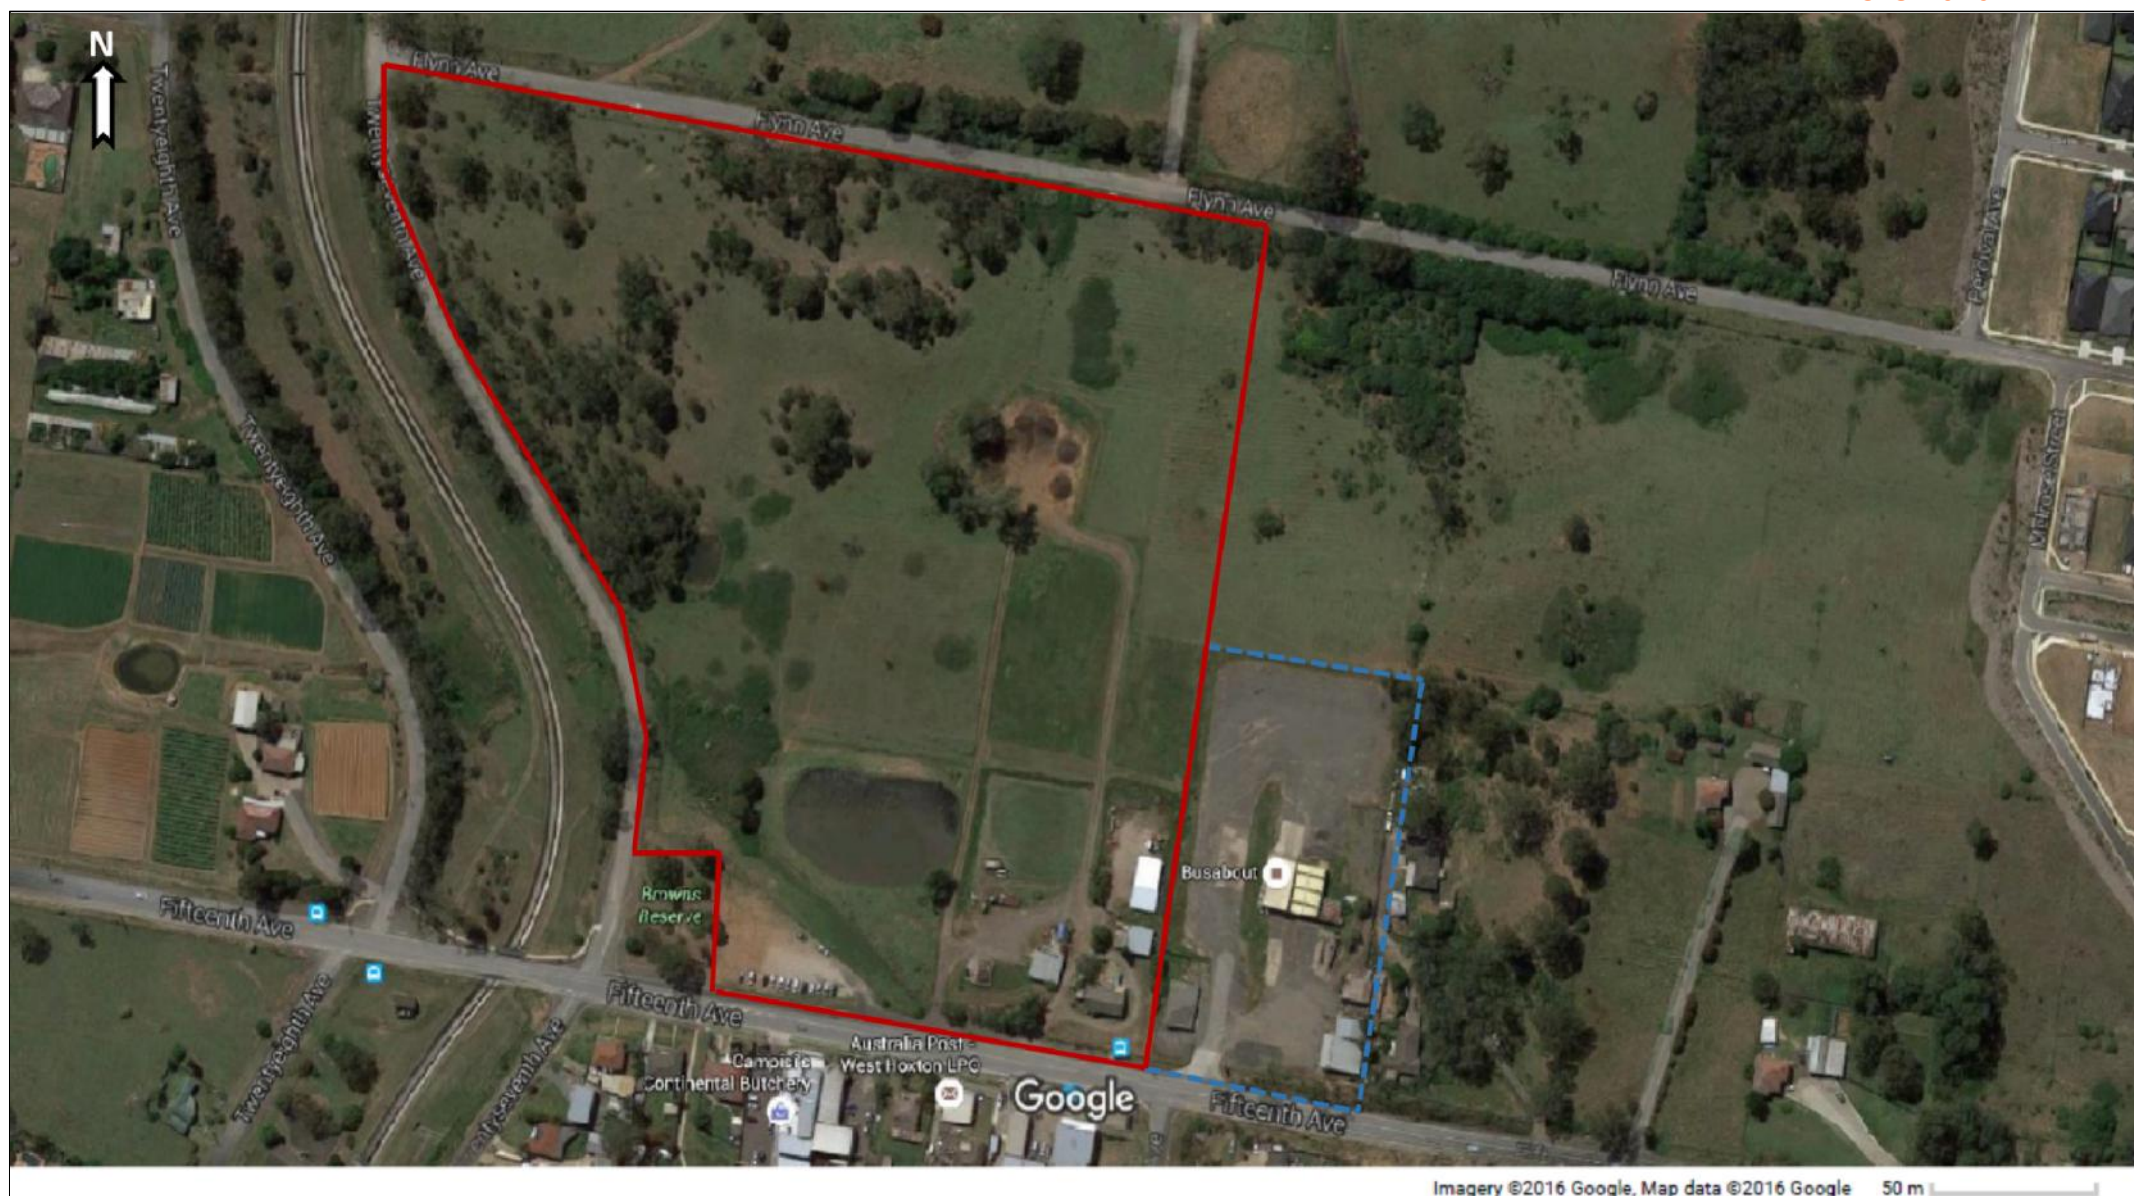
- 195 Fifteenth Avenue (current site)
- 185 Fifteenth Avenue
- Fifteenth Avenue Business Park
