## Heritage Impact Statement

### SSD 6533-2014 Remediation Development Application

#### EPA Declaration Area 21122

### Block 5, Barangaroo Central

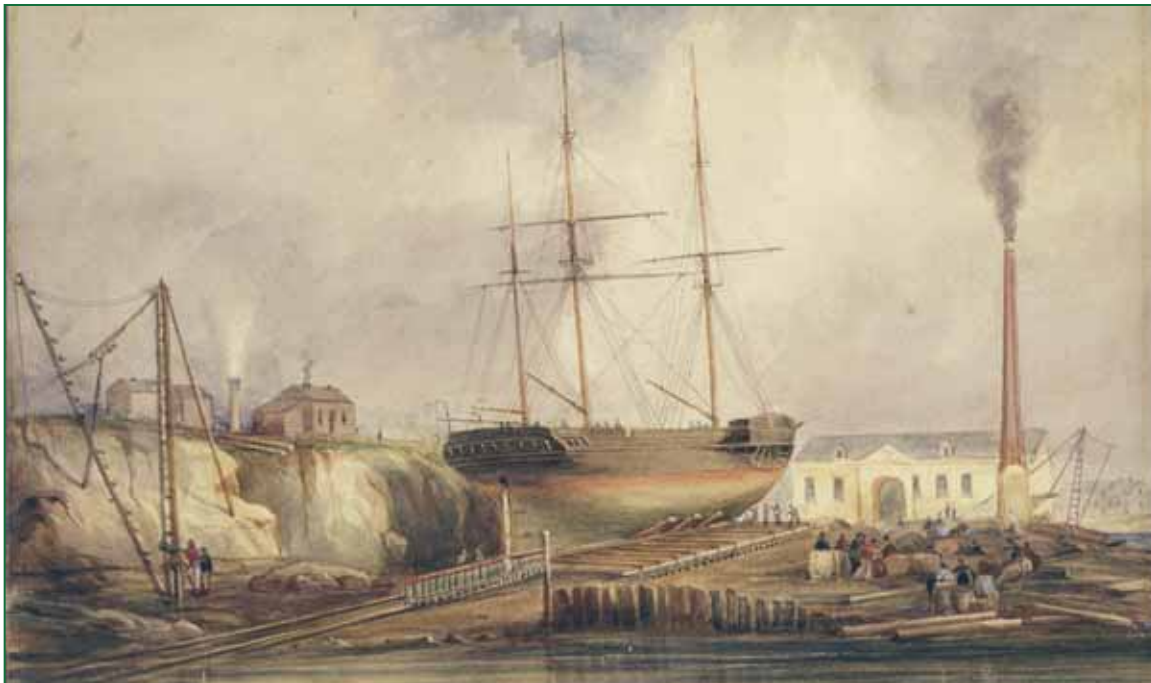
Boatyard with gasworks to the south, Block 5 is in the area of the boatyard.  
*Patent Slip belonging to the Australian Steam Navigation Co., Frederick Garling, c.1855.*

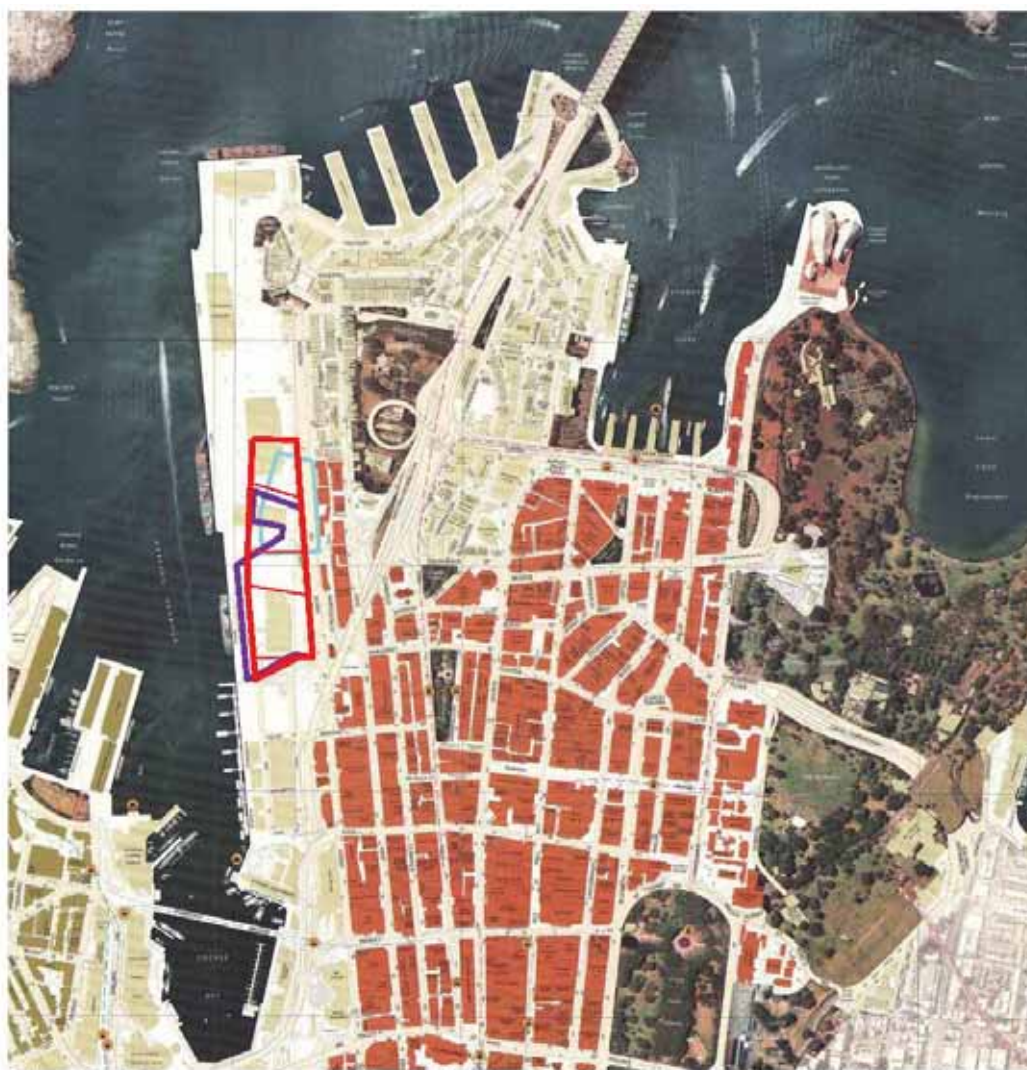
Figure 1.1: The EPA Declaration Area is the blue outline on the plan. Barangaroo, Historical Atlas of Sydney, City of Sydney Archives

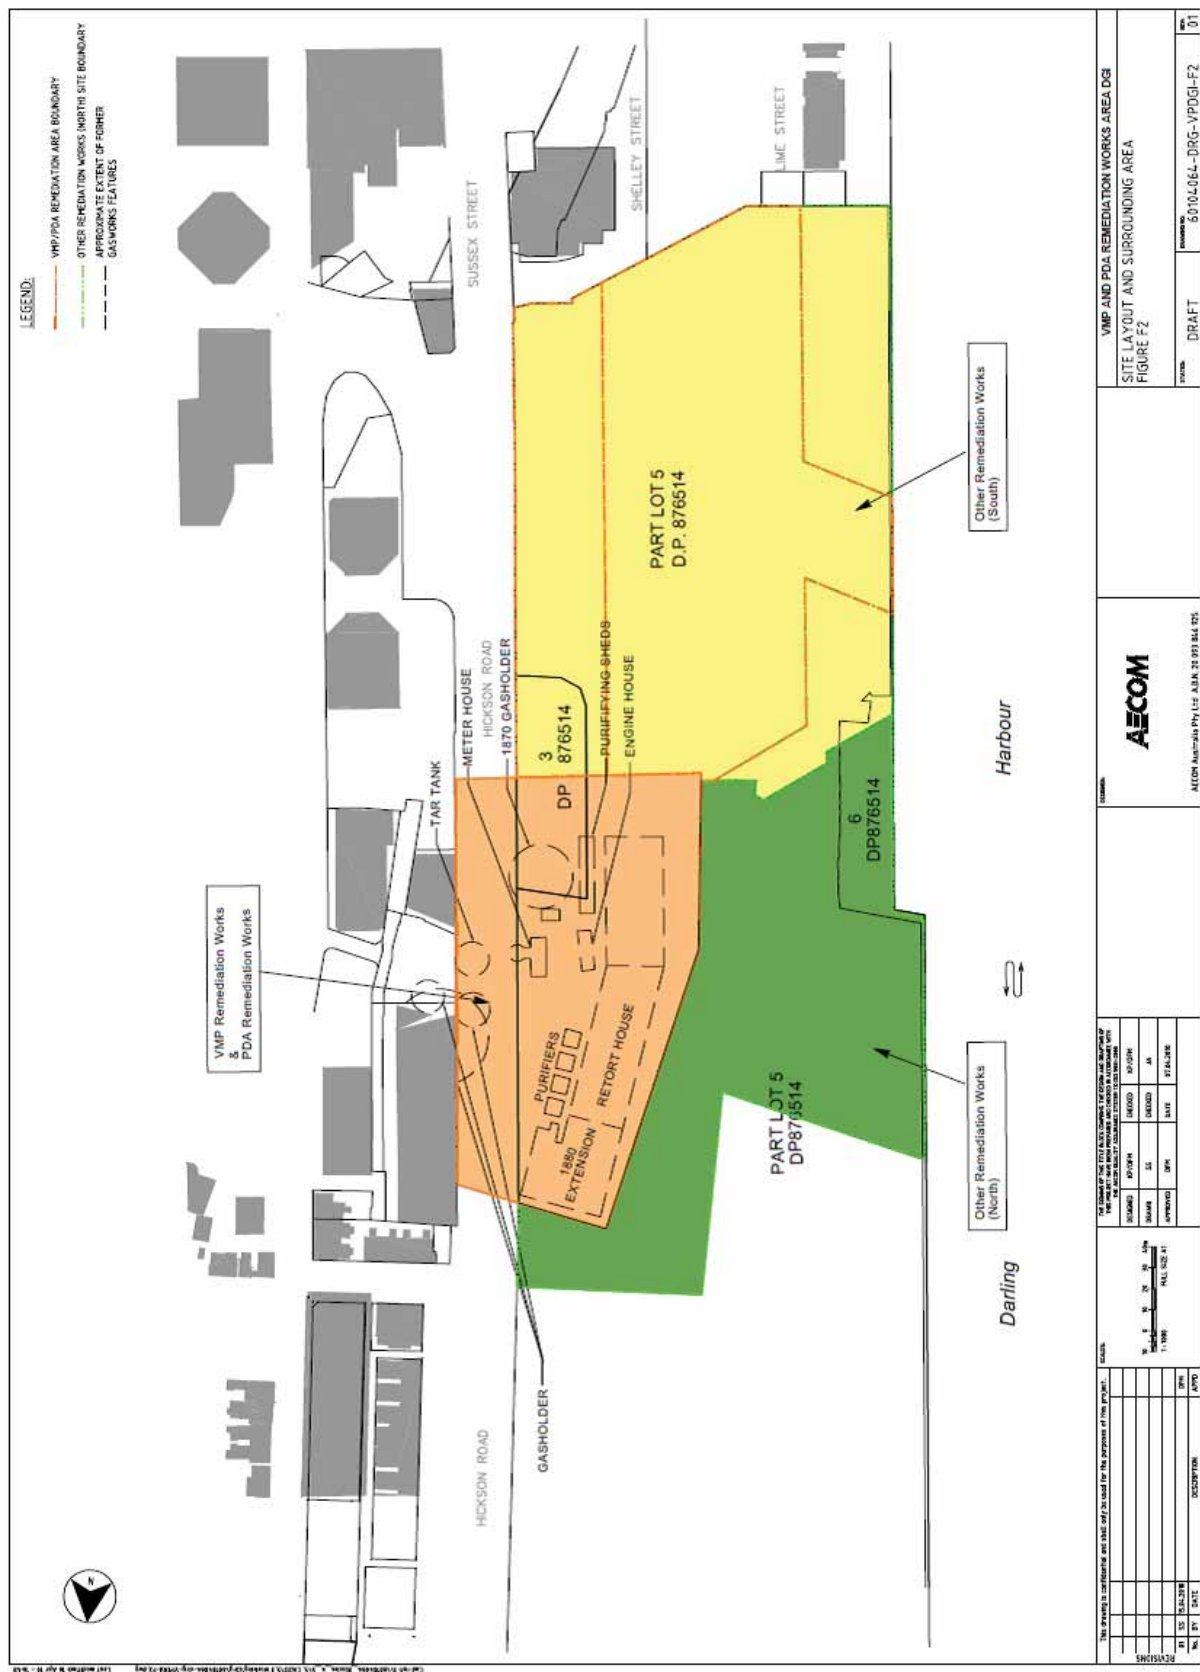
**Figure 1.5: Remediation and land forming works, Block 5 recent site survey.**

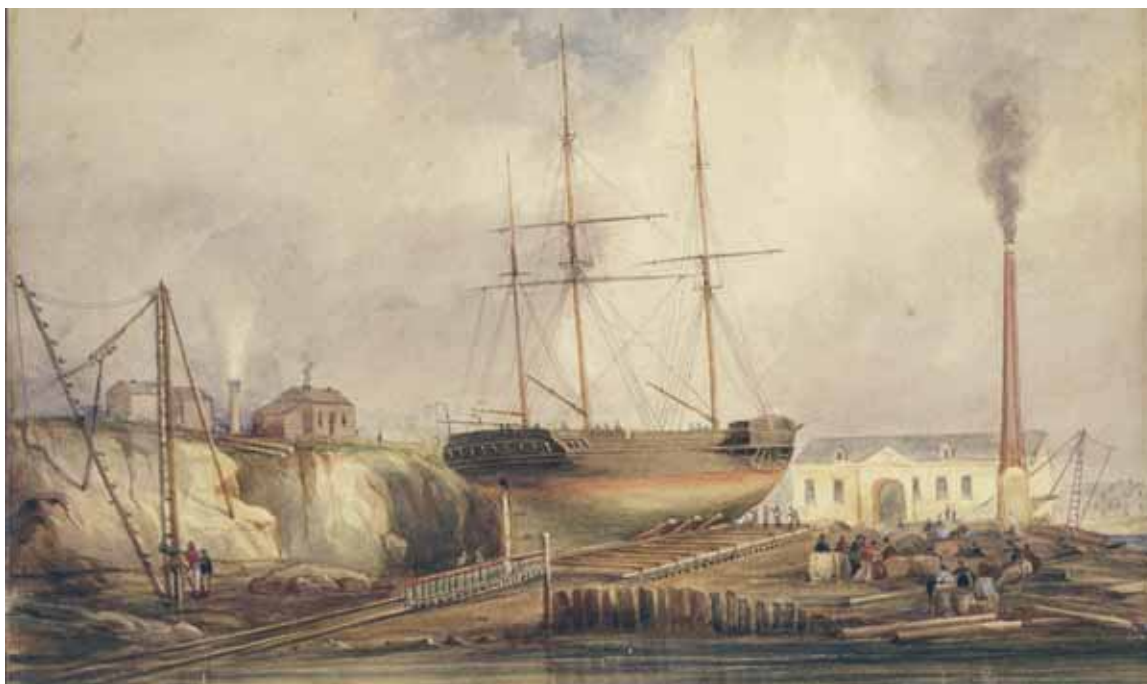
Figure 3.8: View of Block 5 with a gasworks building behind. Initial reclamation of Block 5 was reclaimed by 1855. The high rocky area is probably the area of the Gasworks above Hickson Road and west of modern Kent Street. *Patent Slip* belonging to the Australian Steam Navigation Co., Frederick Garling, c.1855, ML, SLNSW, DGD3

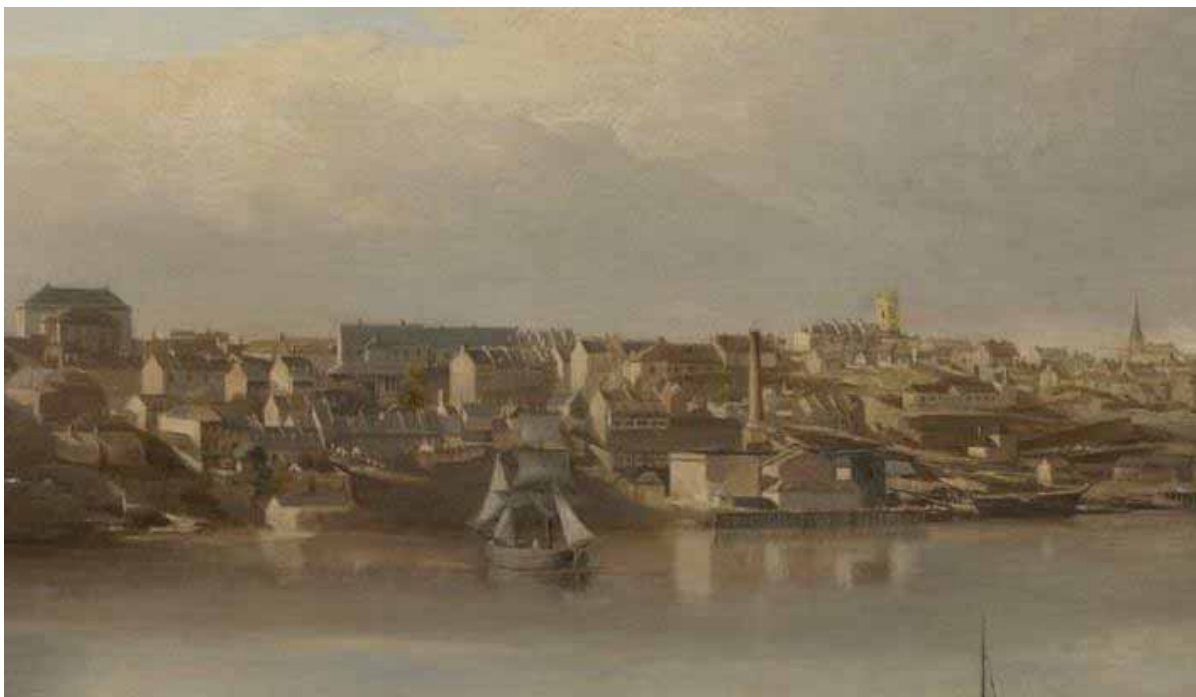
**Figure 3.9: AGL gasworks and the adjacent shipyard to the north in Block 5. View of Miller's Point and Darling Harbour, c.1870 [artist unknown], ML, SLNSW, DG 392.**

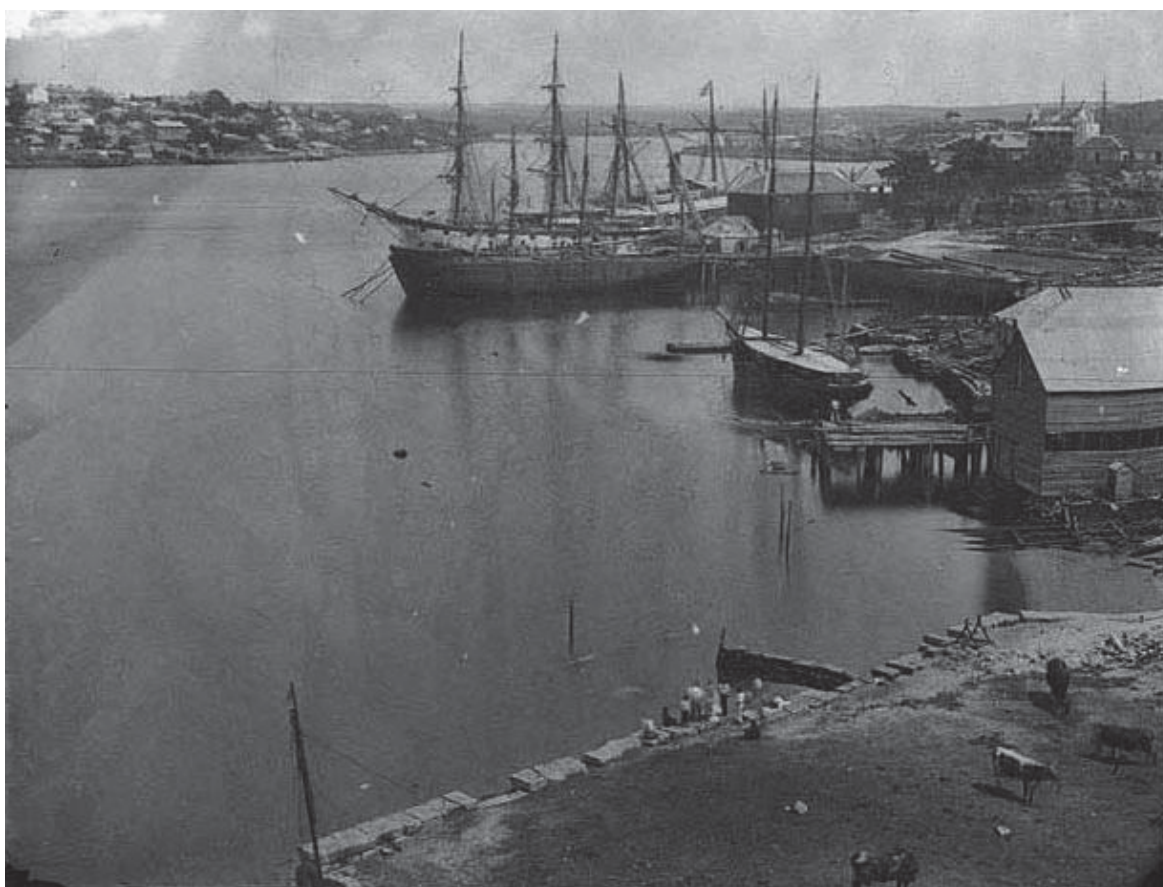
**Figure 3.10: View to northwest from area of gasworks across Cuthbert's shipyard, 1873. The northern edge of the stone seawall of the gasworks wharf is in the foreground. Holterman Collection, SPF, ML, SLNSW**

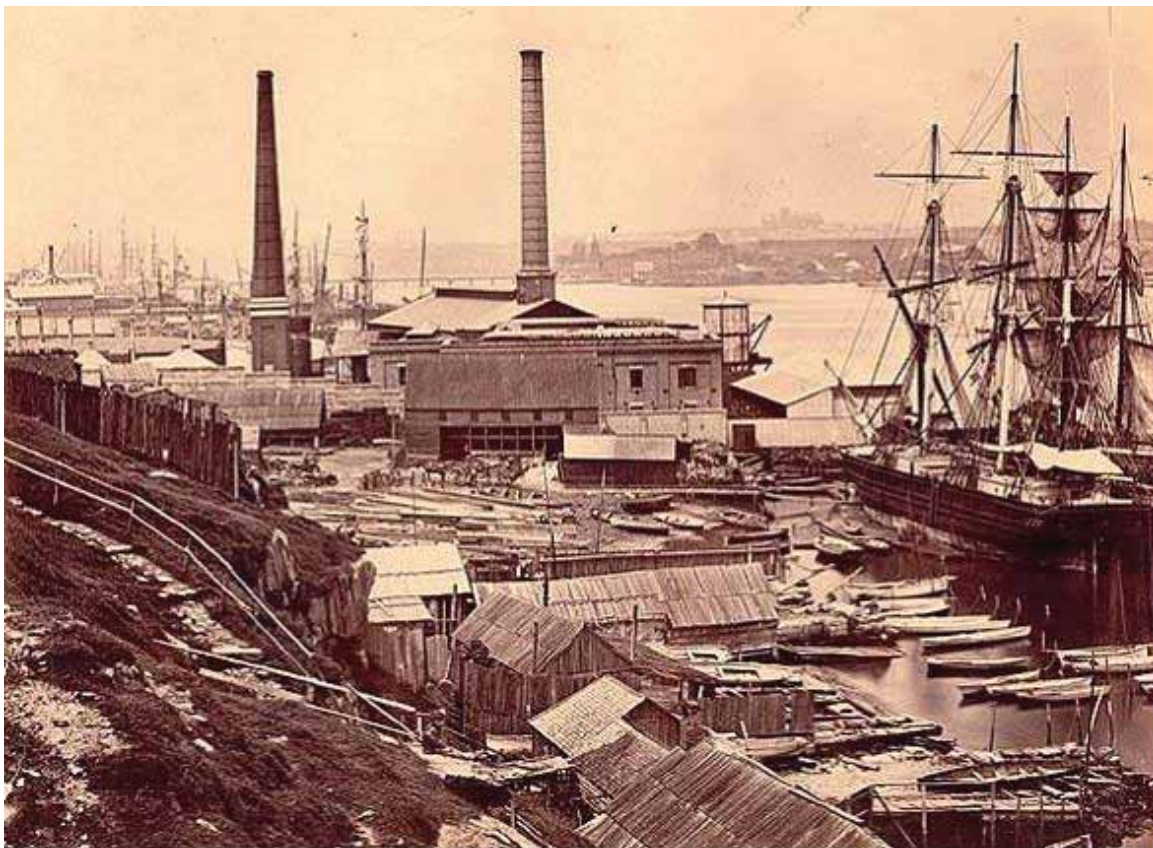
Figure 3.13: Gasworks from the north showing the new retort house (1880) and stack on the southern side of the old carbonising plant with the Rowntree shipyard in middleground. Dates prior to the purchase of the northern block by the gasworks in 1880, probably c.1880. SPF, ML SLNSW

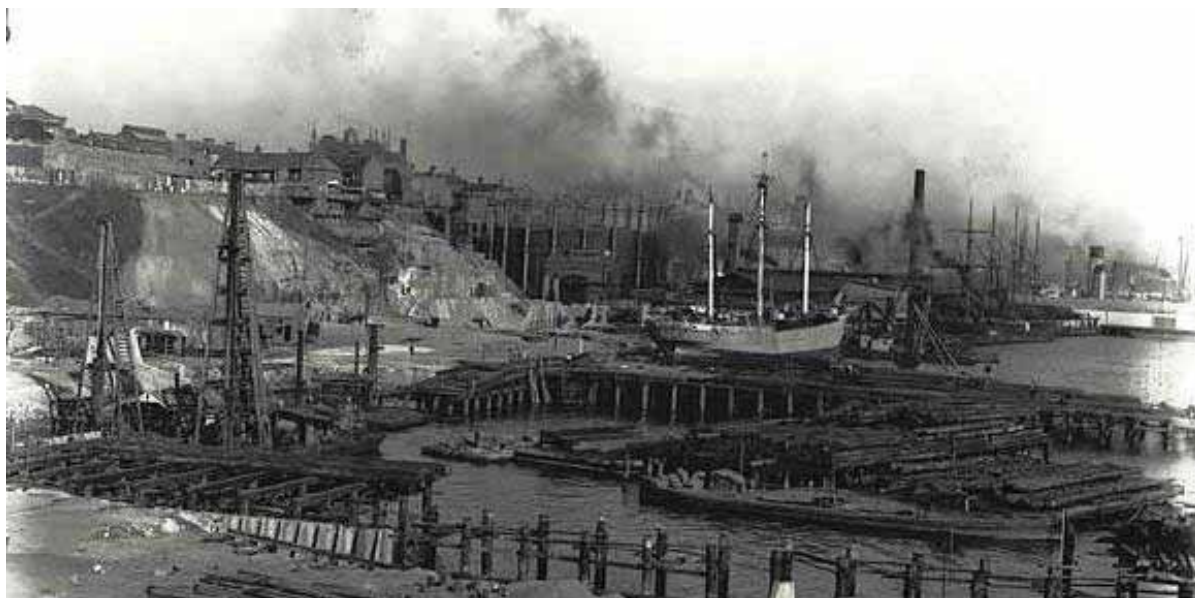
**Figure 3.15:** View to the southeast showing the large gasholder on Block 4 and the southern part of Hickson Road. The rocky face to the north of the gasholder was cut back when Hickson Road was built in the early twentieth century. View of the reconstruction of Darling Harbour from Millers Point showing Dalgetys Wharf No.1 partly completed, 1/1/1909, State Records 9856\_ao17\_AO17000007.

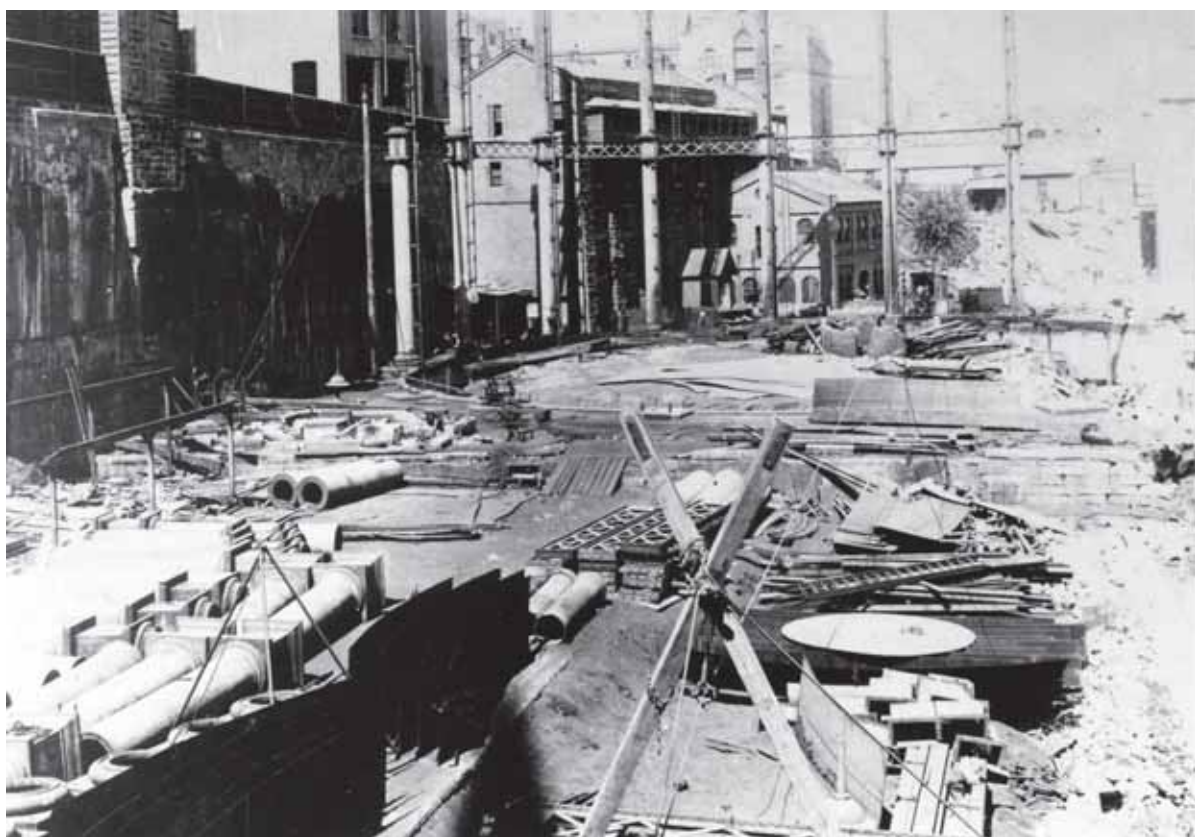
**Figure 3.16:** AGL site during demolition, c. 1922, shows the northern side of the five-storey sandstone office and store with the balcony on the western side and the brick building in front of it. The telescopic holder in the middle ground was being dismantled. The cutting for the holder, excavated deep into the bedrock, was recorded during the construction works for the Bond in 2002 (Archaeology & Heritage 2004). AGL Archives, from Broomham 2007:43

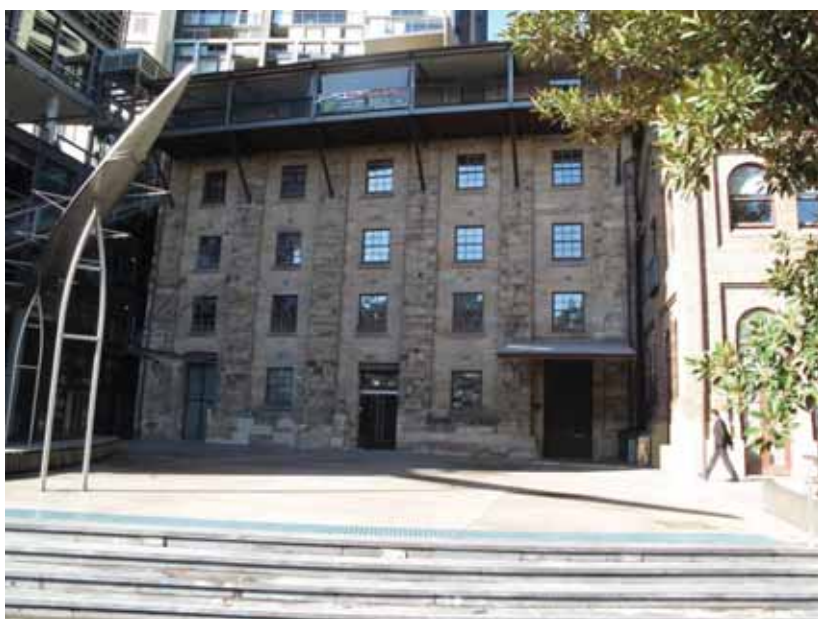
**Figure 3.17: Former gasworks building at 34 Hickson Road.**

It is noted that while the archaeological resources have been removed to the east of Hickson Road under 30 Hickson Road, some should still survive within Hickson Road. Also a number of gasworks buildings survive at 34-36 Hickson Road and 2-4 Jenkins Street (Figs 3.17, 3.18, 3.19).

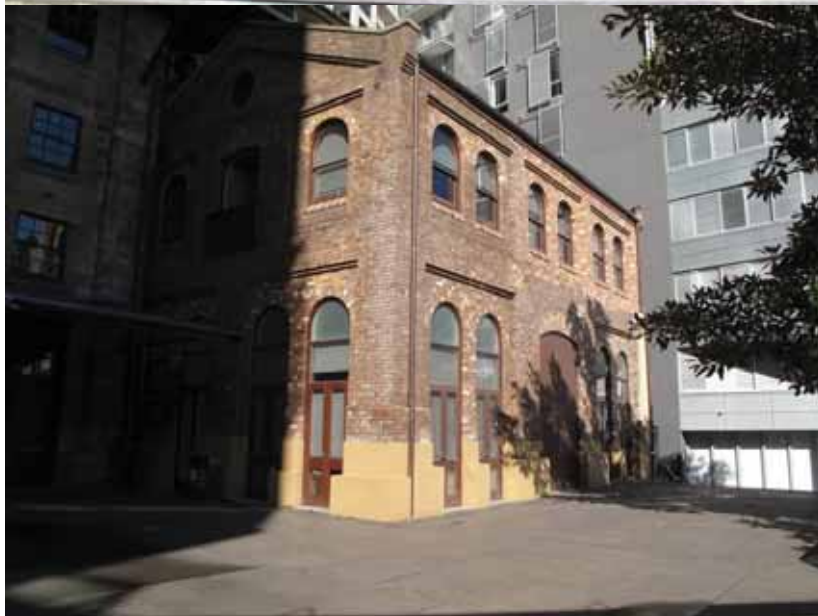
**Figure 3.18: Former gasworks building at 36 Hickson Road.**

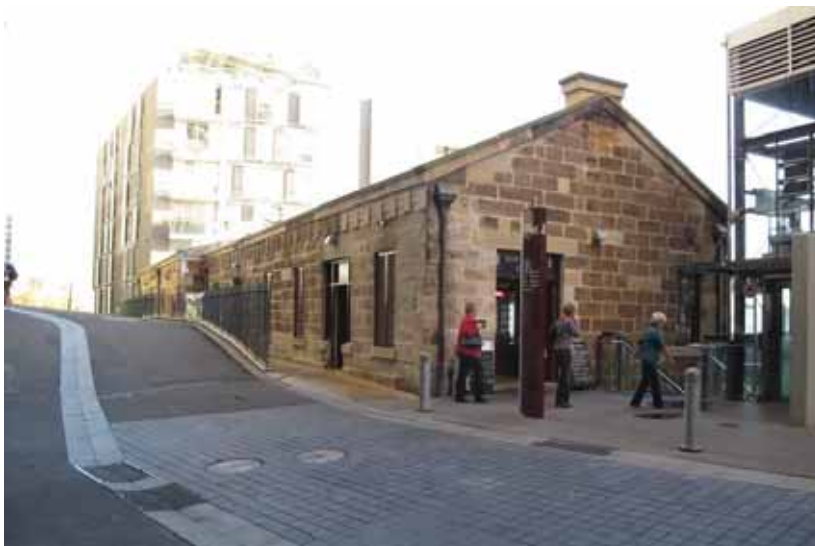
Figure 3.19: Former gasworks building, Jenkins Street above the Hickson Road buildings.

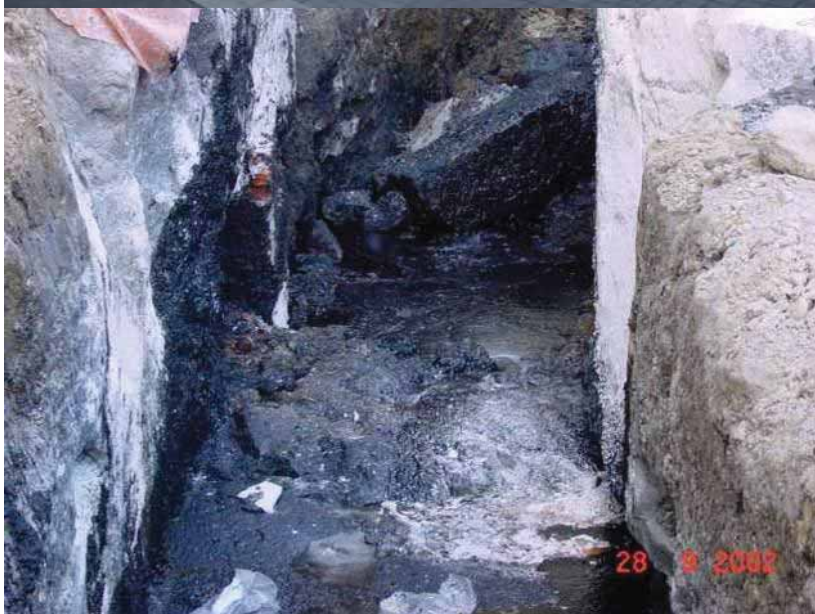
Figure 3.20: Tar contamination apparently uncovered during construction works in September 2002. Mark Burns, Lend Lease (Millers Point)

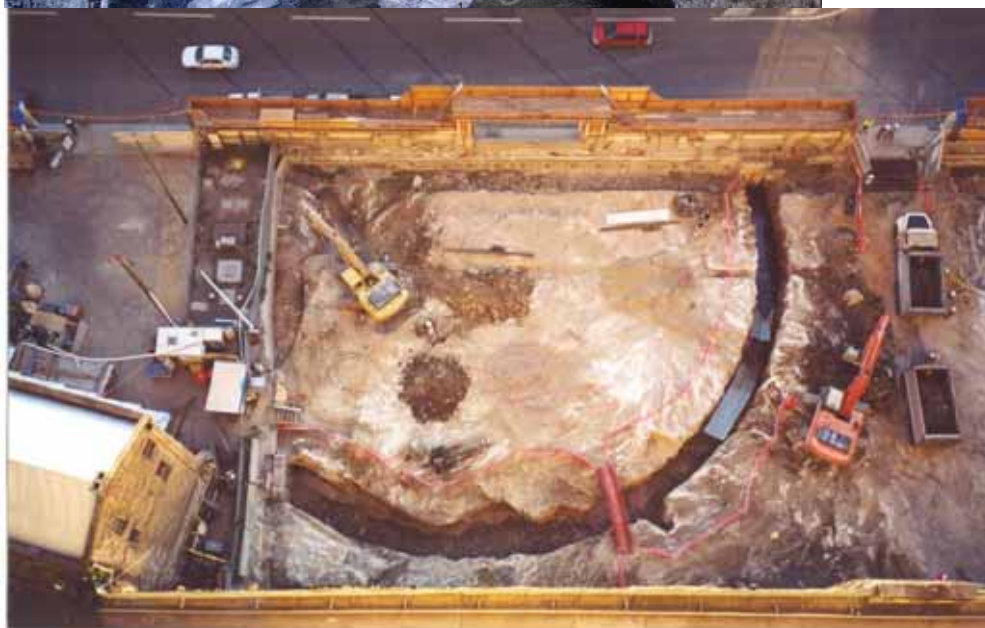
Figure 3.21: View of the the eastern part of the annulus, cut into bedrock, found beneath the bond during works in 2002. Bedrocks is quite high in this area. Mark Burns, Lend Lease.
