Report on
Preliminary Site Investigation (Contamination)

Proposed Residential Development
Site 68, Sydney Olympic Park

Project 73942
September 2014

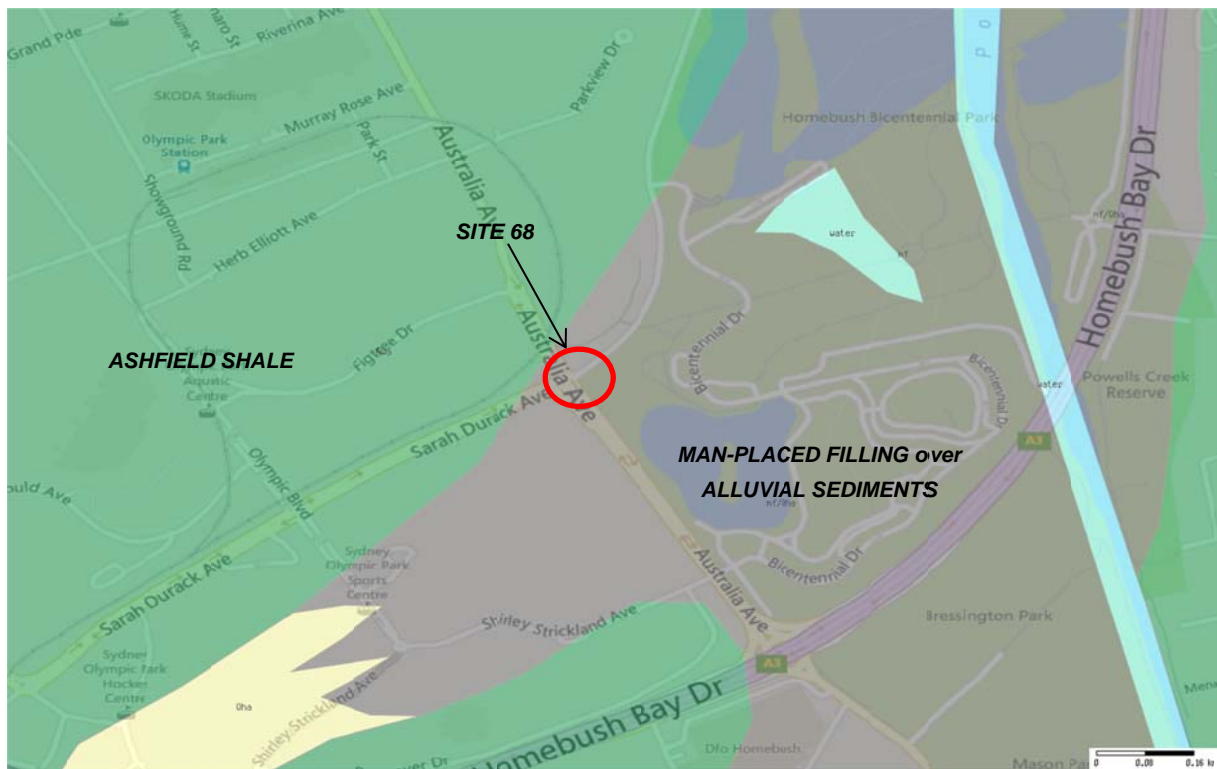
Figure 1: Extract from geological map

The *Sydney 1:100 000 Geological Series Sheet* shows that the site is close to a boundary between man-placed filling over alluvial and estuarine sediments, and Ashfield Shale. Ashfield Shale typically comprises black to dark grey shale and laminite, and weathers to form clayey soils of high plasticity. An extract from the geological map is shown in Figure 1.

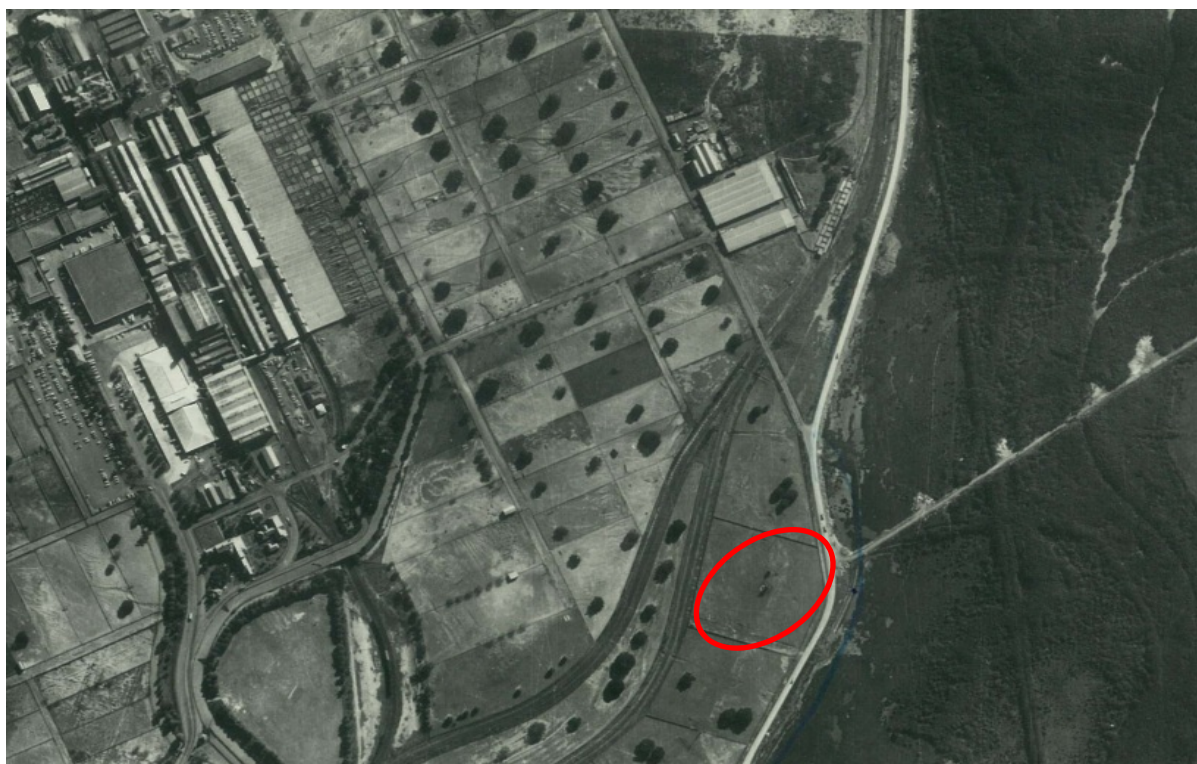
Photo 2: Aerial photo from 1961

The 1961 and 1970 photographs show similar site conditions as the earlier photograph. Reclamation of Homebush Bay has been undertaken and some earthworks activities, presumably associated with landfilling on the eastern side of Bennelong Parkway, are evident.

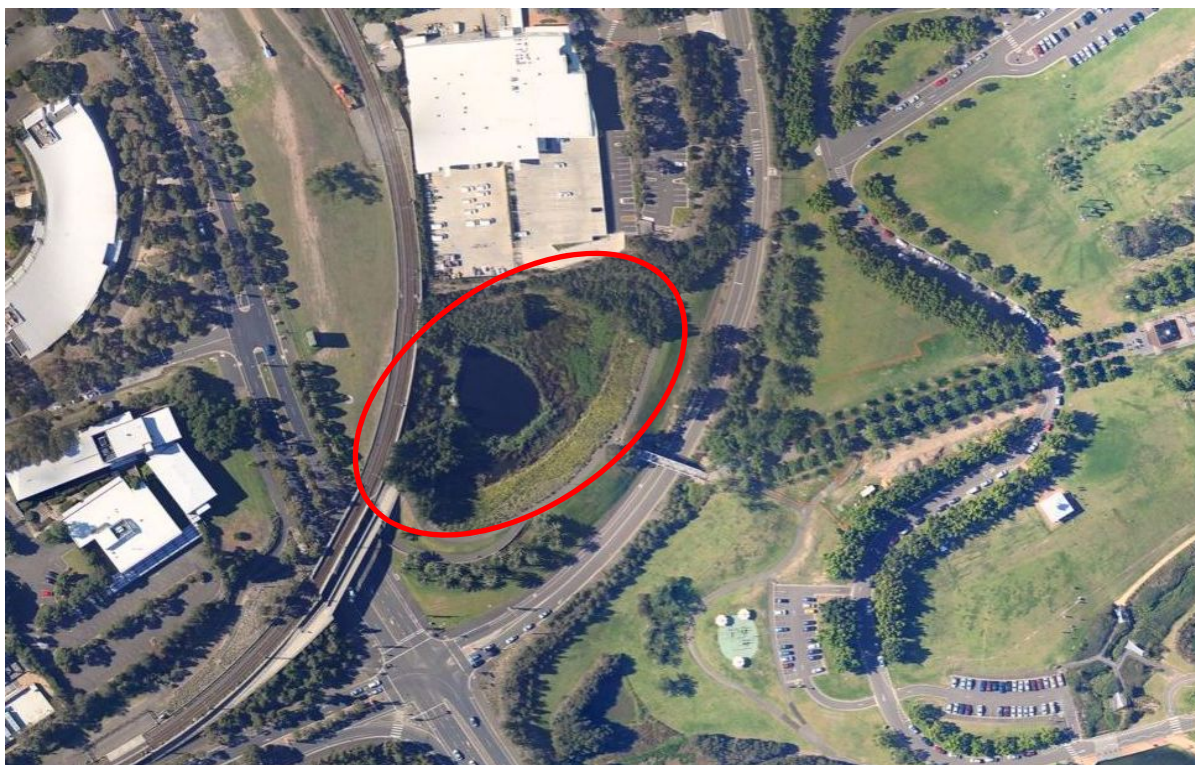
Photo 7: Aerial photo from 2009

The 2009 and 2014 photographs show the site in its current condition. The most recent photograph shows development works on the western side of the railway loop (residential buildings) and in the south-western corner of Bicentennial Park (electricity substation).
