Report on  
Supplementary Geotechnical Investigation

Proposed Residential Development  
Site 68, Sydney Olympic Park

Prepared for  
Ecove Group Pty Ltd

Project 73942  
September 2014

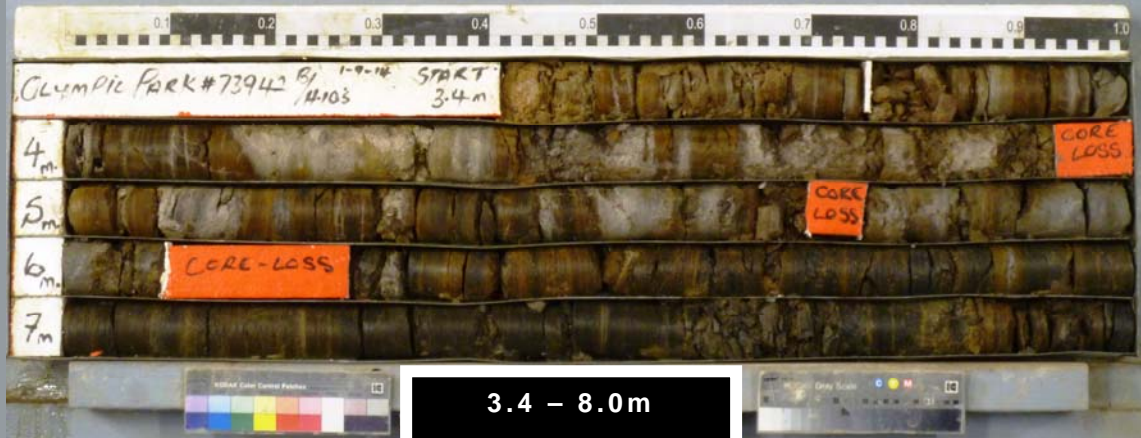
DOUGLAS PARTNERS PTY LTD  
SITE 68 GEOTECHNICAL INVESTIGATION – SYDNEY OLYMPIC PARK  
BORE 103 PROJECT 73942 SEPT 2014

3.4 – 8.0m
