# **Cockle Bay Marine Structures Redevelopment Addendum**

## **Heritage Impact Statement**

Cockle Bay  
Sydney  
NSW

**October 2017**

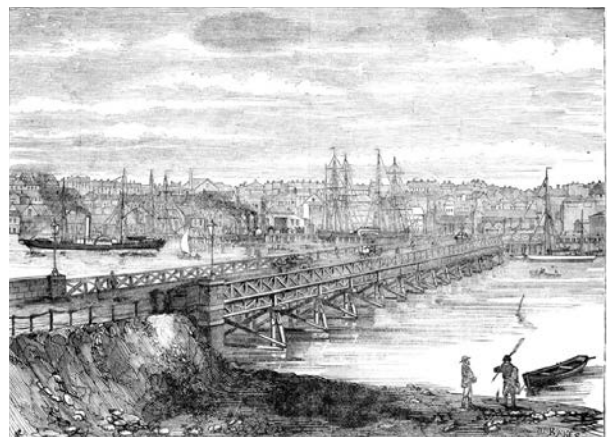
**Figure 6: Pyrmont Bridge, 1871, wood engraving, facing north-east towards Sydney.**<sup>14</sup>

The construction of the bridge was carried out by contractor Mr. T. Alston, under the supervision of engineer E. O. Moriarty, with the iron swing span fabricated by the Australasian Steam Navigation Company. The first pile was driven on 16<sup>th</sup> of October, 1856, and the completed Pyrmont Bridge was opened with great ceremony on the 17<sup>th</sup> of March 1858 (Figure 5 to Figure 10).<sup>12</sup>

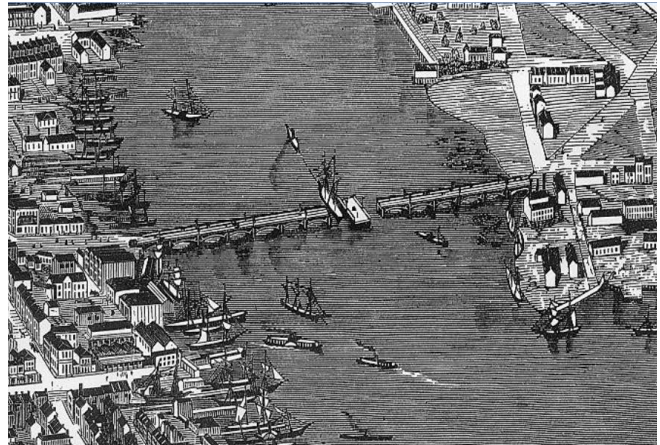
**Figure 8: Pyrmont Bridge, 1879 bird's eye view sketch showing swing span open.**<sup>16</sup>

The central swing span consisted of a large iron swivel, surmounted by three wrought iron lattice beams, mounted in their centre on cast-iron conical rollers and wheels working on a circular rail; the whole of which was supported by a cluster of 54 iron-bark piles. The swing span was operated manually and once in the open position, provided a passage of 56 feet (17 metres) in width for vessels on each side of the span. Several buoys attached to large anchors were laid down in the harbour by the Pyrmont Bridge Company to enable vessels to tie off whilst waiting for the bridge to open; a steamer was also constantly kept in readiness to tow vessels through the bridge if required.

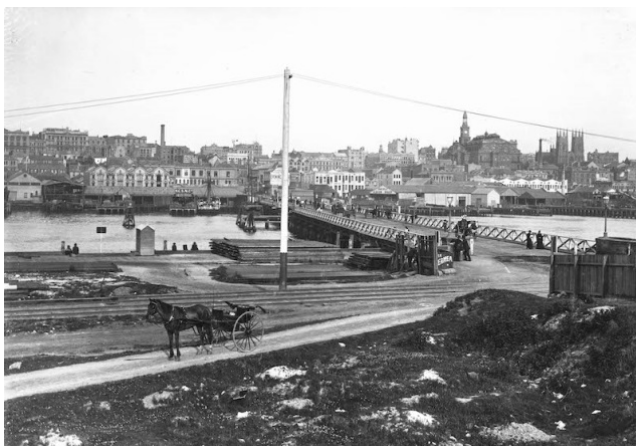
**Figure 9: Pyrmont Bridge, ca.1880-1890, facing south-east towards Sydney.**<sup>17</sup>

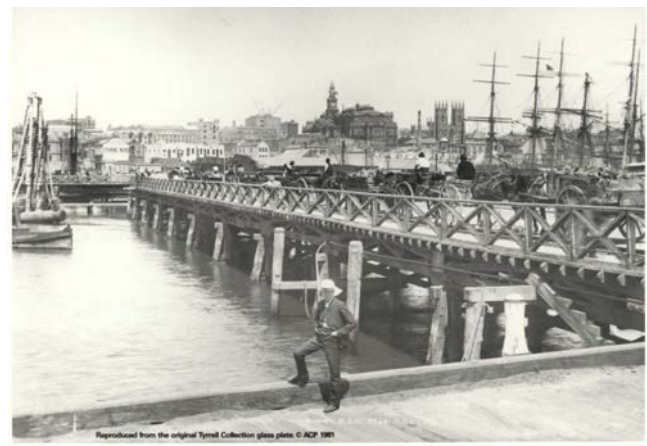
**Figure 10: Pyrmont Bridge, ca.1880, facing south-east towards Sydney showing swing span open.**<sup>18</sup>

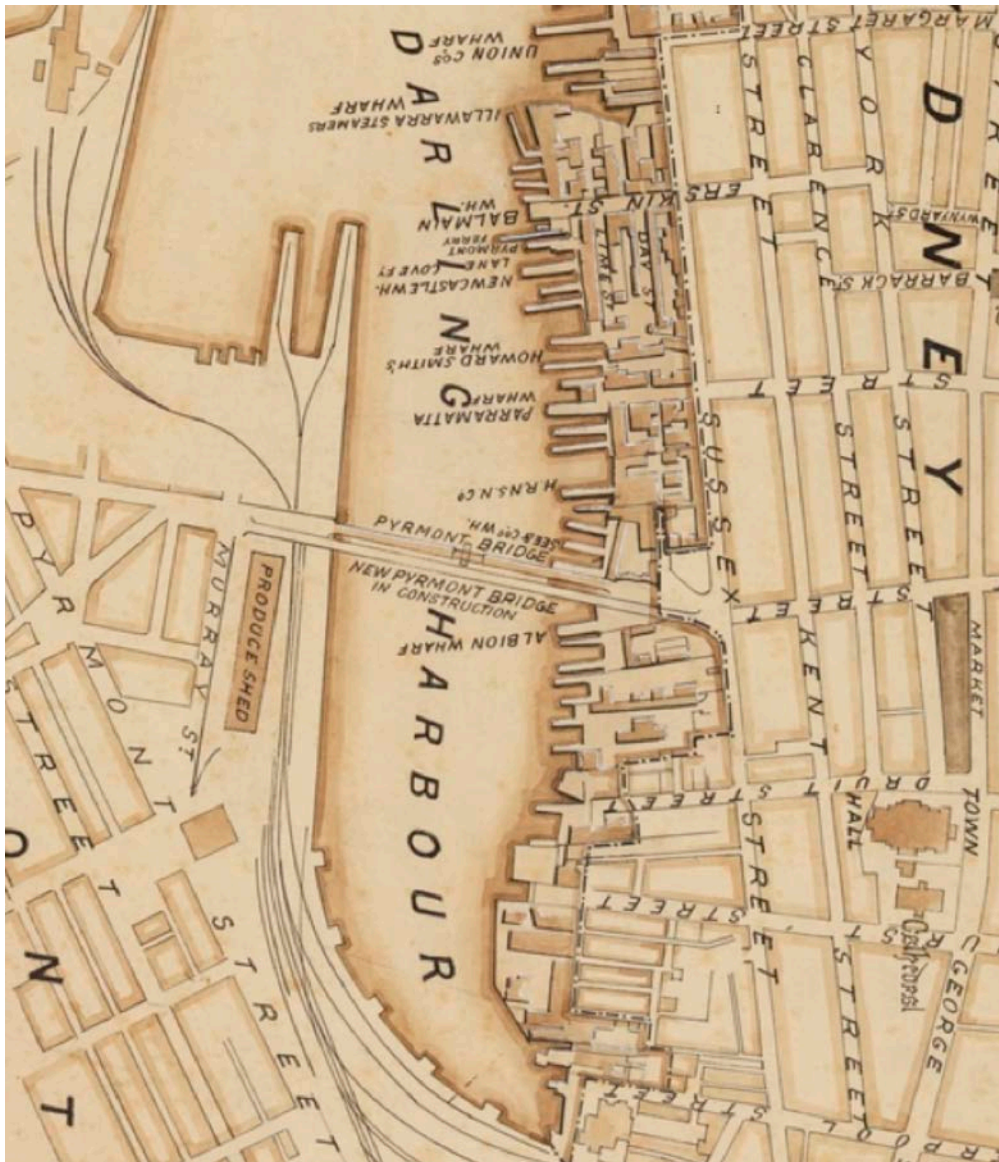
**Figure 11: 1900 plan of Darling Harbour, depicting the second Pymont Bridge, then in construction, and the first Pymont Bridge still standing to the north.**<sup>21</sup>

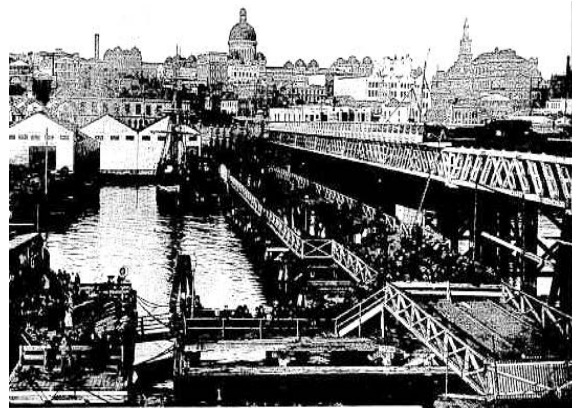
**Figure 13: The second Pyrmont Bridge nearing completion, 1902, facing east towards Sydney, showing the first bridge on the left.<sup>23</sup>**

including a number submitted as part of a public competition. After prolonged inquiry, a design prepared by the Public Works Department – specifically Robert Hickson, Engineer-in-Chief and Percy Allan, Engineer-in-Charge of Bridge Design – for a higher level, timber and steel, swing span bridge was selected. The new bridge was to be sited to the southern side of the existing Pymont Bridge, necessitating a slight realignment of both Market Street and Union Street approaches (Figure 11). Construction commenced in 1899 and the new Pymont Bridge was opened to traffic with great celebration on 28<sup>th</sup> of June 1902. The first Pymont Bridge was subsequently demolished throughout late 1902 to 1903 (Figure 12 to Figure 15).<sup>20</sup>

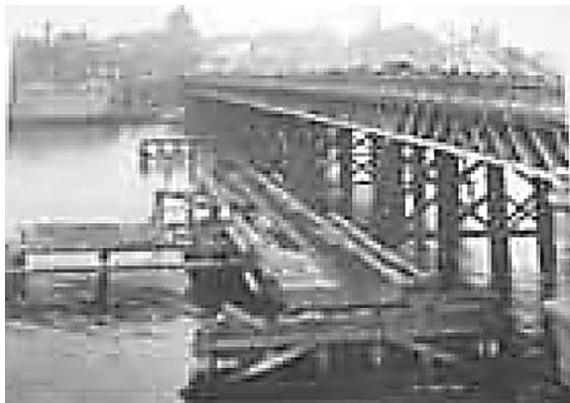
**Figure 14: The first Pyrmont Bridge being dismantled, 1903, facing east towards Sydney, showing the second bridge on the right.<sup>24</sup>**

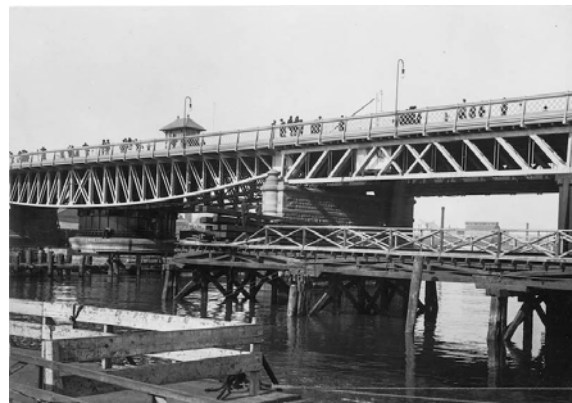
**Figure 15: The first Pyrmont Bridge being dismantled, 1903, facing south-east towards Sydney, showing the second bridge in the background.<sup>25</sup>**

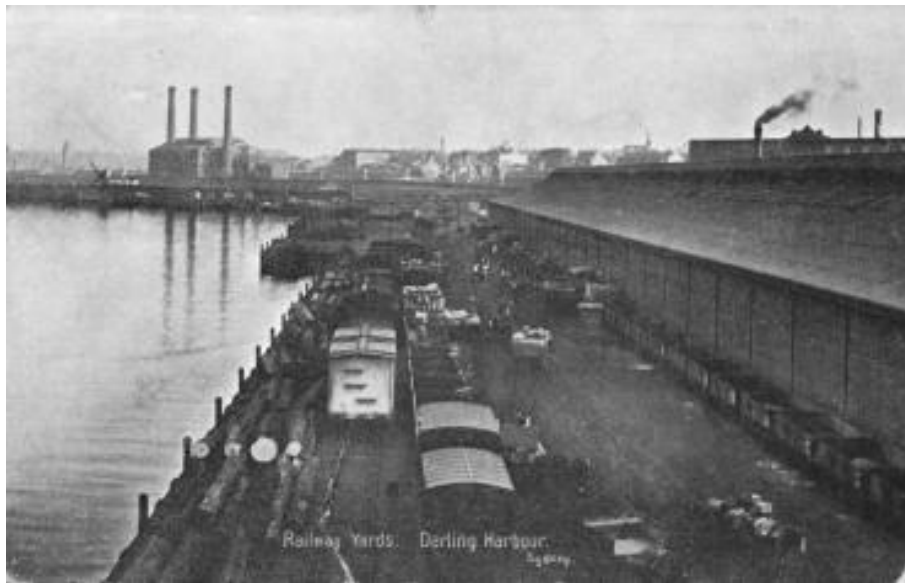
**Figure 16: Darling Harbour railway goods yard, ca.1905, showing a section of Wharf 49 in left foreground.** <sup>26</sup>

Wharf 49 was constructed in the early 1890s as part of the extension of the Darling Harbour railway to the new Government wharves in Pyrmont Bay and the associated expansion of the Darling Harbour railway goods yard (Figure 16). Wharf 49 was a long open wharf, constructed of timber piles and decking, built parallel to the shoreline on the frontage of ca.1870s reclamation. The wharf was widened with the northern end tapered towards shore in ca.1908-1911 as part of the Sydney Harbour Trust improvements to Darling Harbour. By the late 1920s, the southern portion of Wharf 49 was buried in the Railway Departments reclamation of the head of Darling Harbour, however, the northern portion remained in operation. Wharf 49 was demolished in the mid-1980s during the redevelopment of Cockle Bay by the Darling Harbour Authority, with the southern portion largely buried in reclamation.

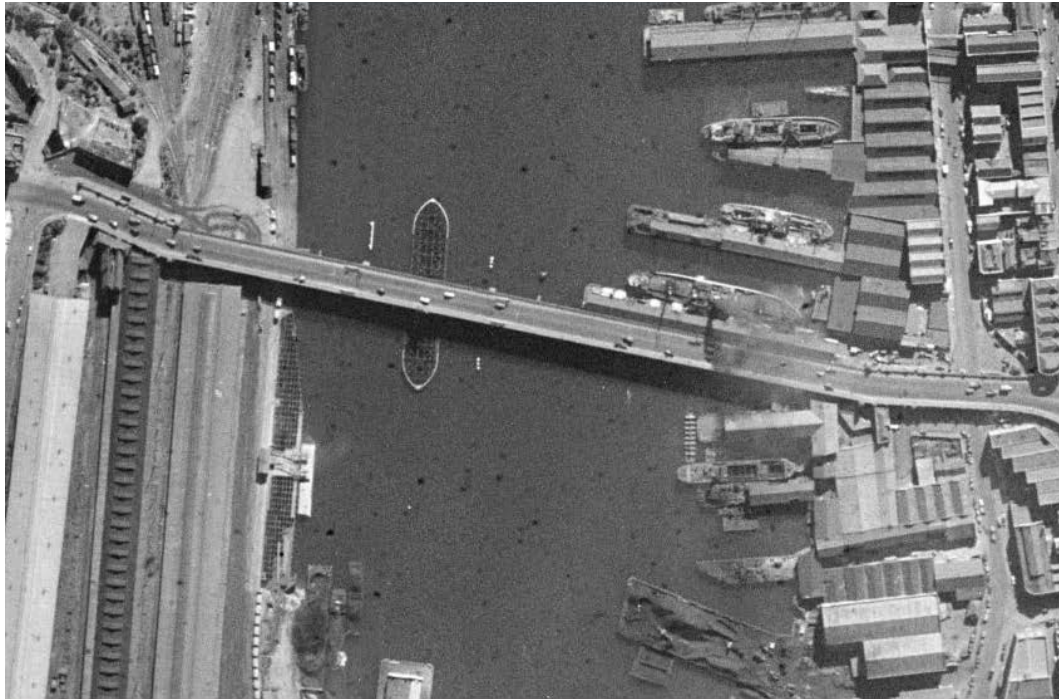
**Figure 18: 1943 aerial view of Darling Harbour, showing Wharf 49 being re-decked.<sup>28</sup>**
