Landscape & Visual Impact Assessment

PROPOSED MARTINS CREEK QUARRY EXPANSION

Prepared for: **DARACON**

Project No: **1149**

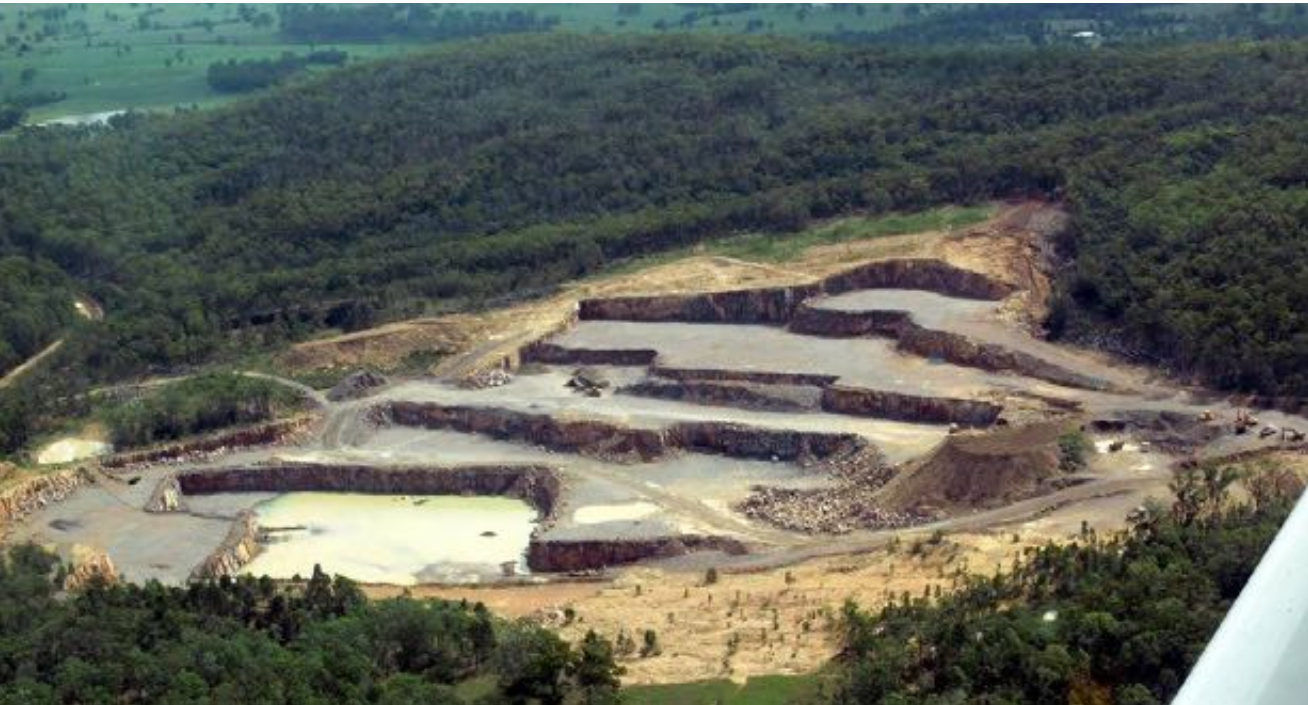
Previous extraction undertaken on the Site has created two exposed pit sites, one to the east of Station Street (as shown in the birds eye image below), and one to the north west of Station Street. The remaining land on the site is densely vegetated.

Birds eye view of Martins Creek Quarry
(Source: <http://www.theherald.com.au/story/2435373/daracon-expected-to-submit-da-for-martins-creek-quarry/>)

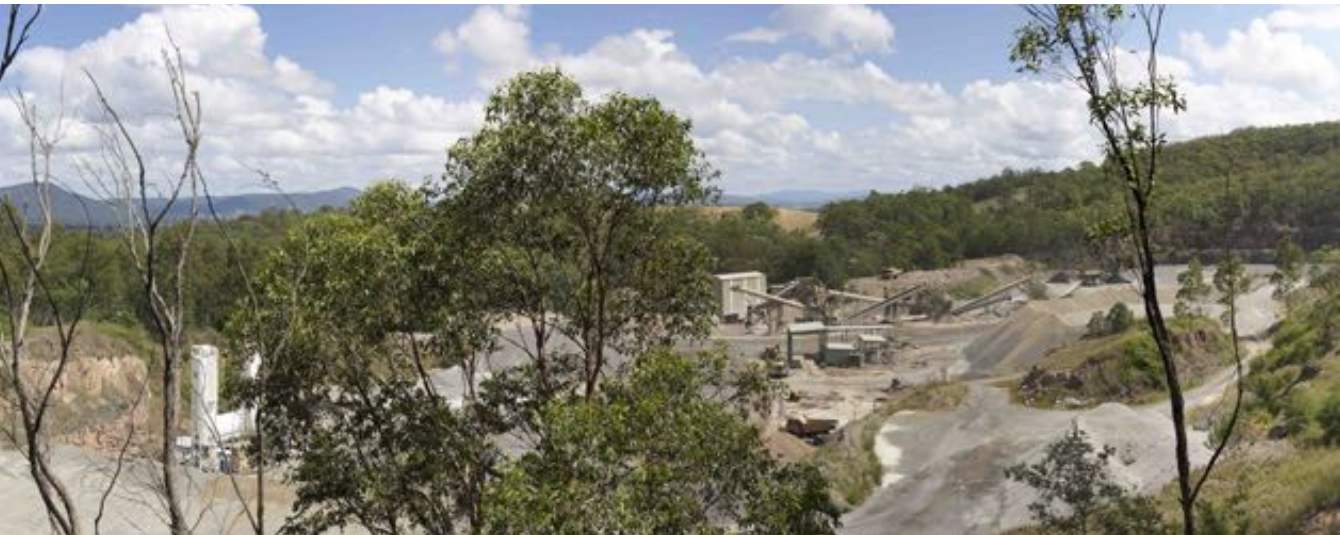
Martins Creek Quarry - Viewed from Vogeles Road

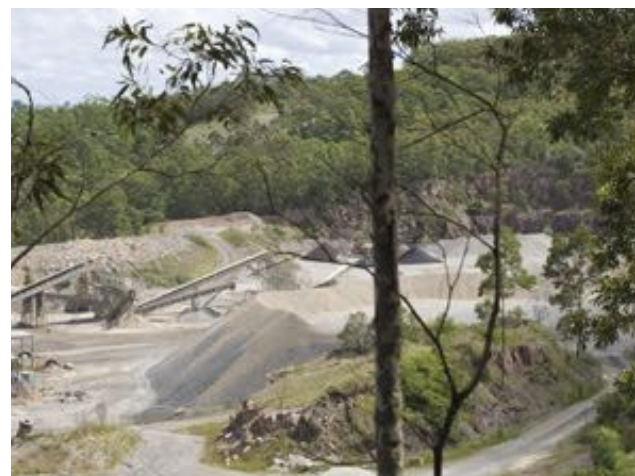
Martins Creek Quarry - viewed from southern site boundary along Vogeles Road.

Views within the LCU, are mostly contained by the dense vegetation and undulating topography associated with hills surrounding the Quarry. The existing quarry is largely screened from residences by vegetation. Dense vegetation associated with the LCU contributes to the character of the town.

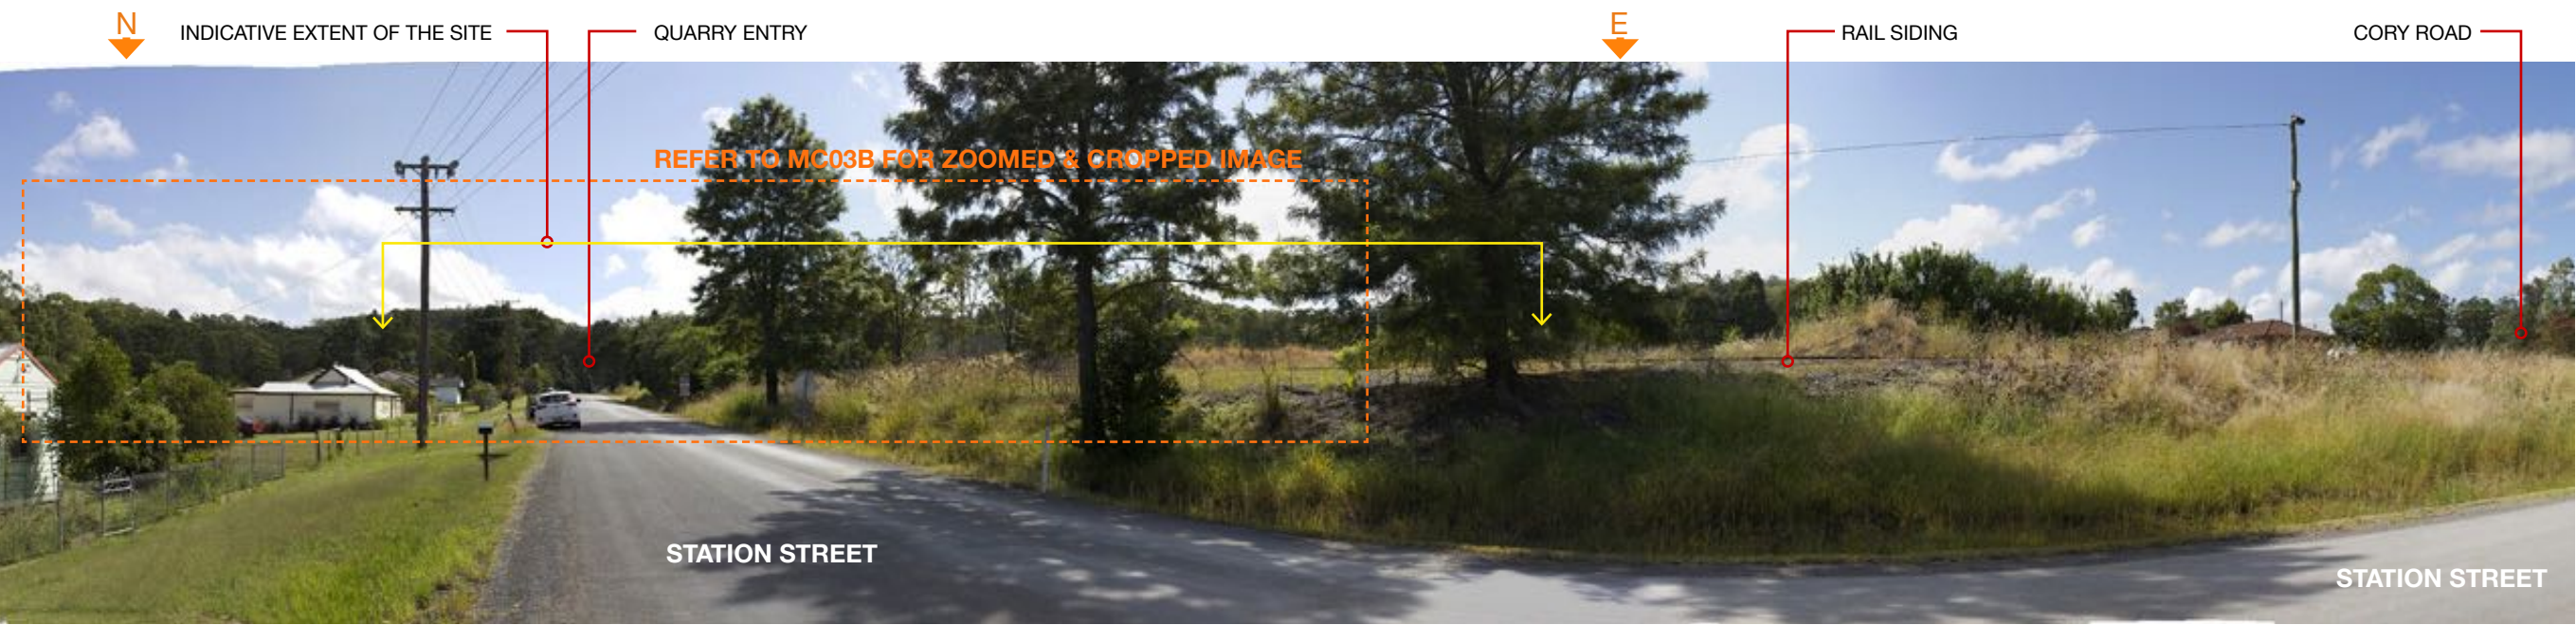
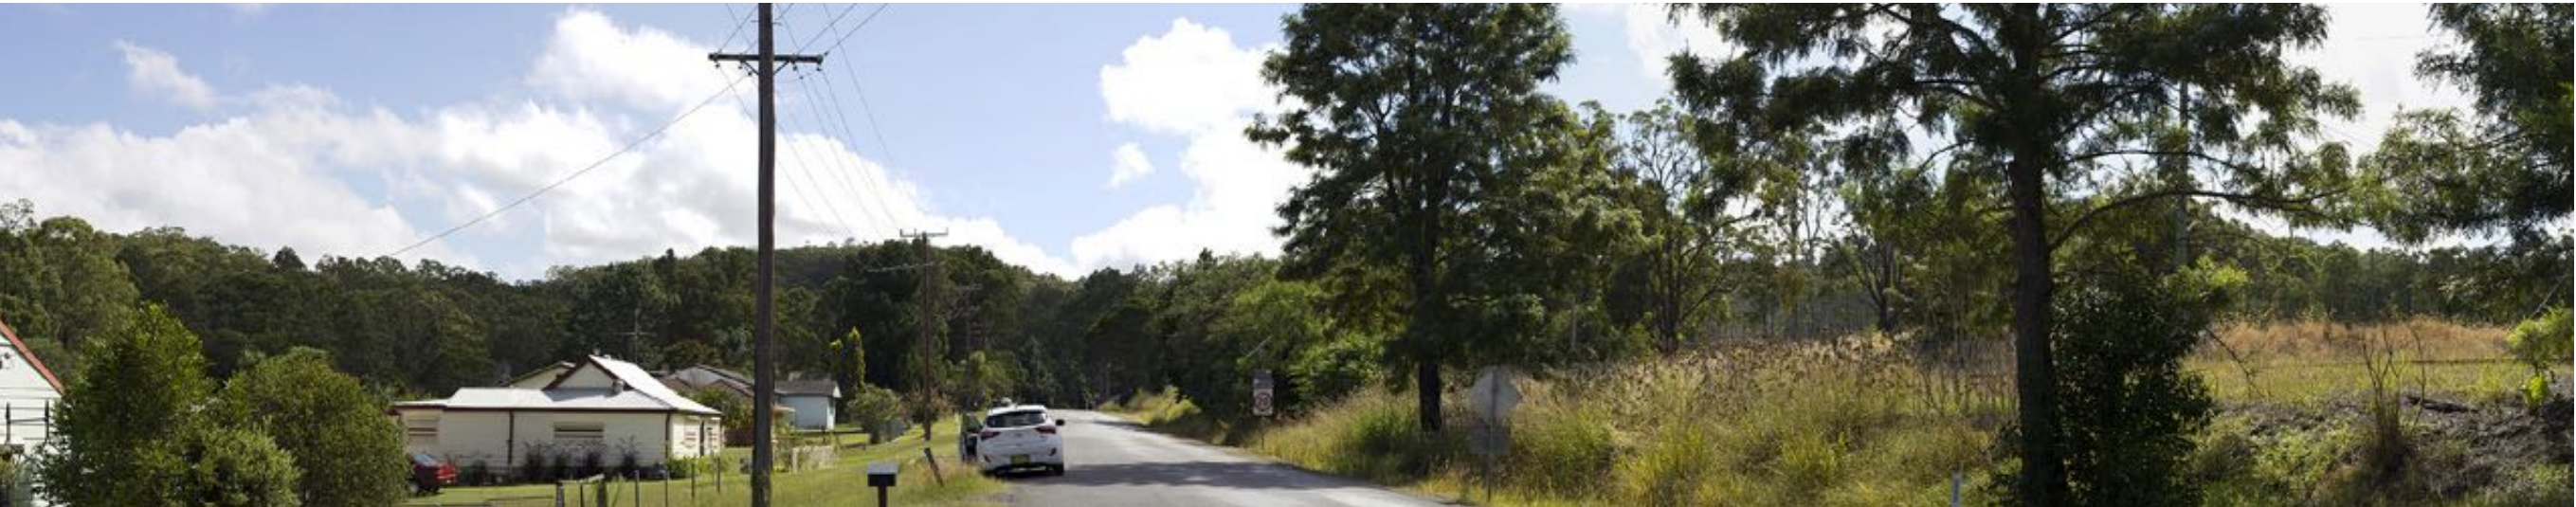
VIEWPOINT MC01A: Station Street

COORDINATES	S 32° 33.404' E 151° 37.117'		
ELEVATION	27m		
VIEWING DIRECTION	North East		
DISTANCE TO SITE	15m (to nearest boundary)		
LCU	Martins Creek		
VISUAL EFFECT	Moderate		
VISUAL IMPACT	High

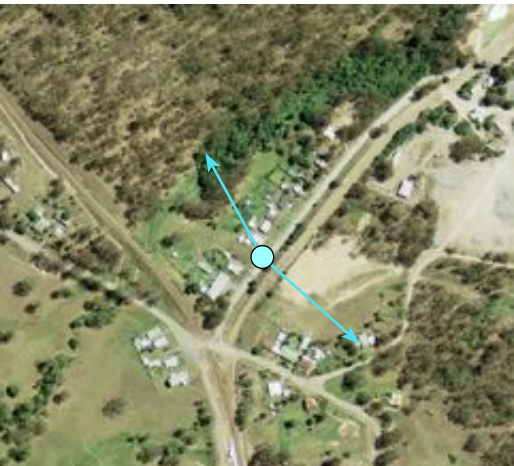
MC01 Viewpoint Location

VIEWPOINT MC01			
SUMMARY OF VIEWPOINT		VIEWPOINT DESCRIPTION	POTENTIAL VISUAL IMPACT
LOCATION	Station Street, Martins Creek	View looking north east along Station Street towards the proposed expansion of the site. Single storey residential dwellings typical of Martins Creek are evident along Station Street with little vegetation within residential lots. A small rise in topography is associated with the rail siding which runs parallel to Station Street into the site. The visual sensitivity of this viewpoint has been rated as high due to the close proximity of the site to surrounding residential dwellings.	From this viewpoint some glimpse views of change to distant tree canopies associated with the proposal may be evident as the topography rises towards the Station Street quarry entry. The proposed acoustic wall along the existing railway line will be visible along the top of the embankment on the eastern side of Station Street. The visual effect has been assessed as moderate resulting in a visual impact of high from this location. Landscaping to the front of the proposed wall would significantly reduce the visual impact overtime. Refer to Photomontage 01.

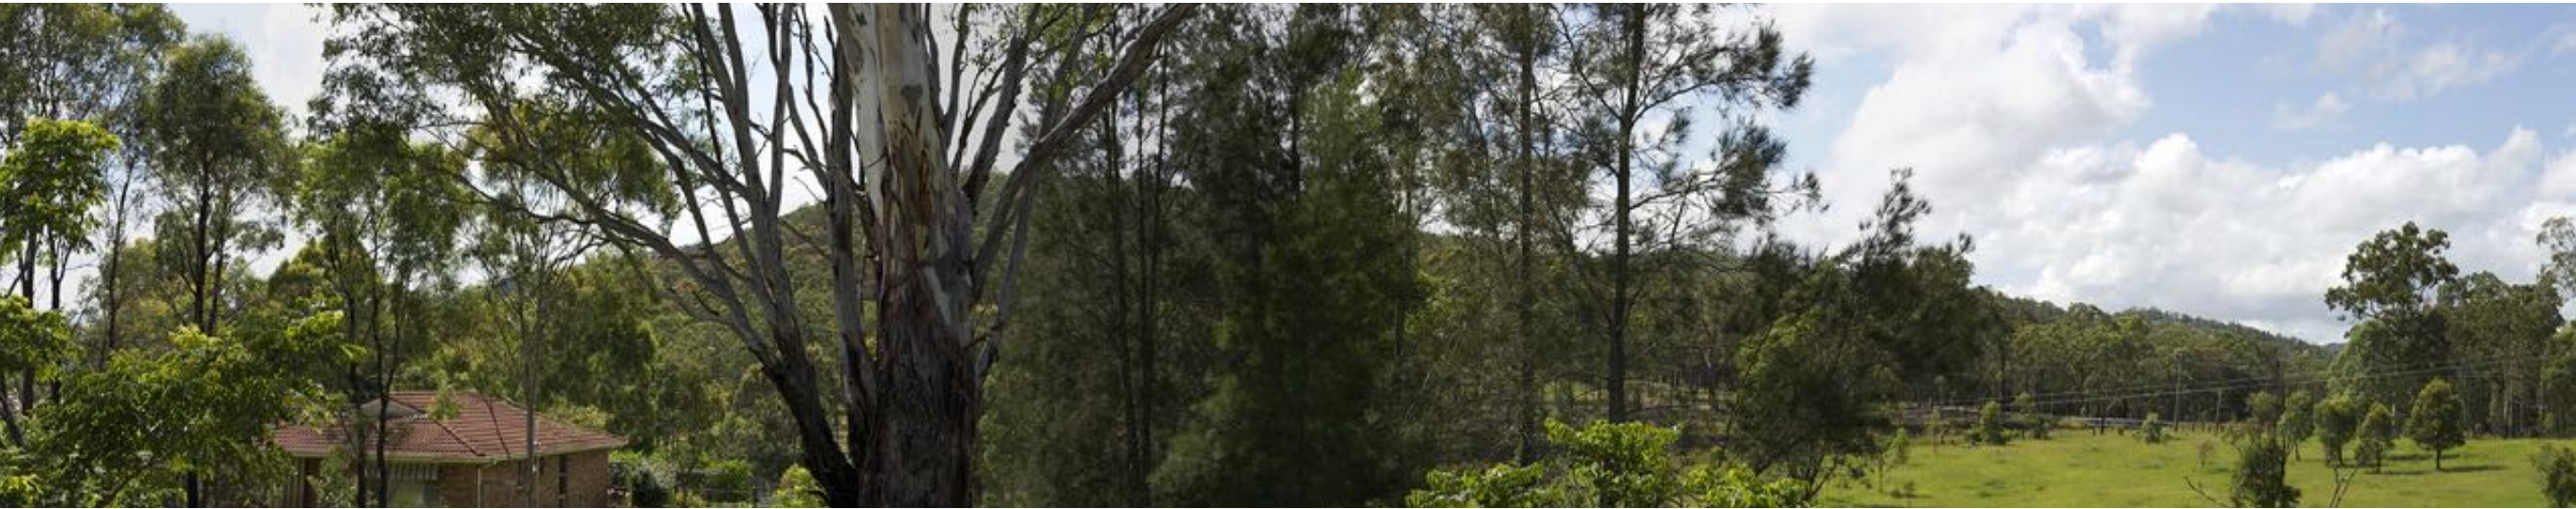
VIEWPOINT MC02A: View Street

VIEWPOINT MC02		
SUMMARY OF VIEWPOINT		VIEWPOINT DESCRIPTION
LOCATION	View Street, Vacy	View from minor local road, View Street with surrounding rural residential properties. Topography in this area is generally cleared and slightly sloping with vegetation clusters surrounding residential dwellings. The open low rise areas are viewed against a backdrop of densely vegetated hilltops. The visual sensitivity of this viewpoint has been rated as high due to the close proximity to the site and surrounding residential dwellings.
COORDINATES	S 32° 32.410' E 151° 36.645'	
ELEVATION	14m	
VIEWING DIRECTION	South East	
DISTANCE TO SITE	650m (to nearest boundary)	
LCU	Horns Crossing	
VISUAL EFFECT	Nil	
VISUAL IMPACT	Nil	POTENTIAL VISUAL IMPACT
		Vegetation associated with Horns Crossing Road screens views towards the south from this viewpoint. It is likely some clearing of vegetation associated with the proposed excavation would be noticeable. However in the context of the surrounding vegetation the visual effect would not be discernible.

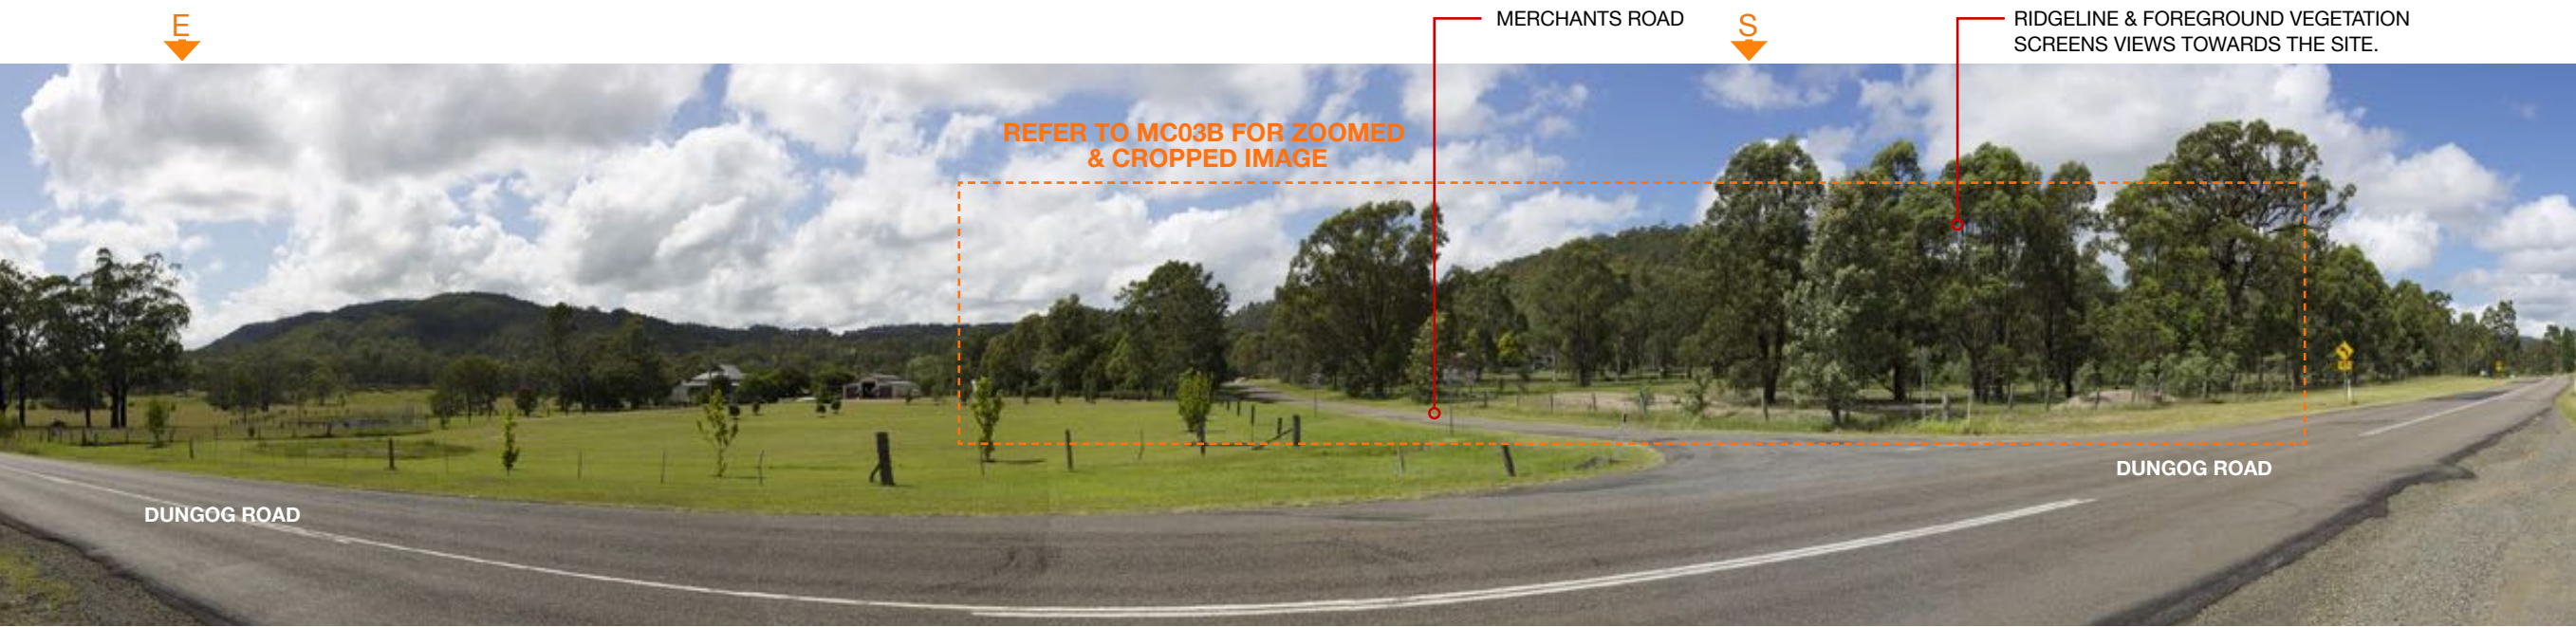
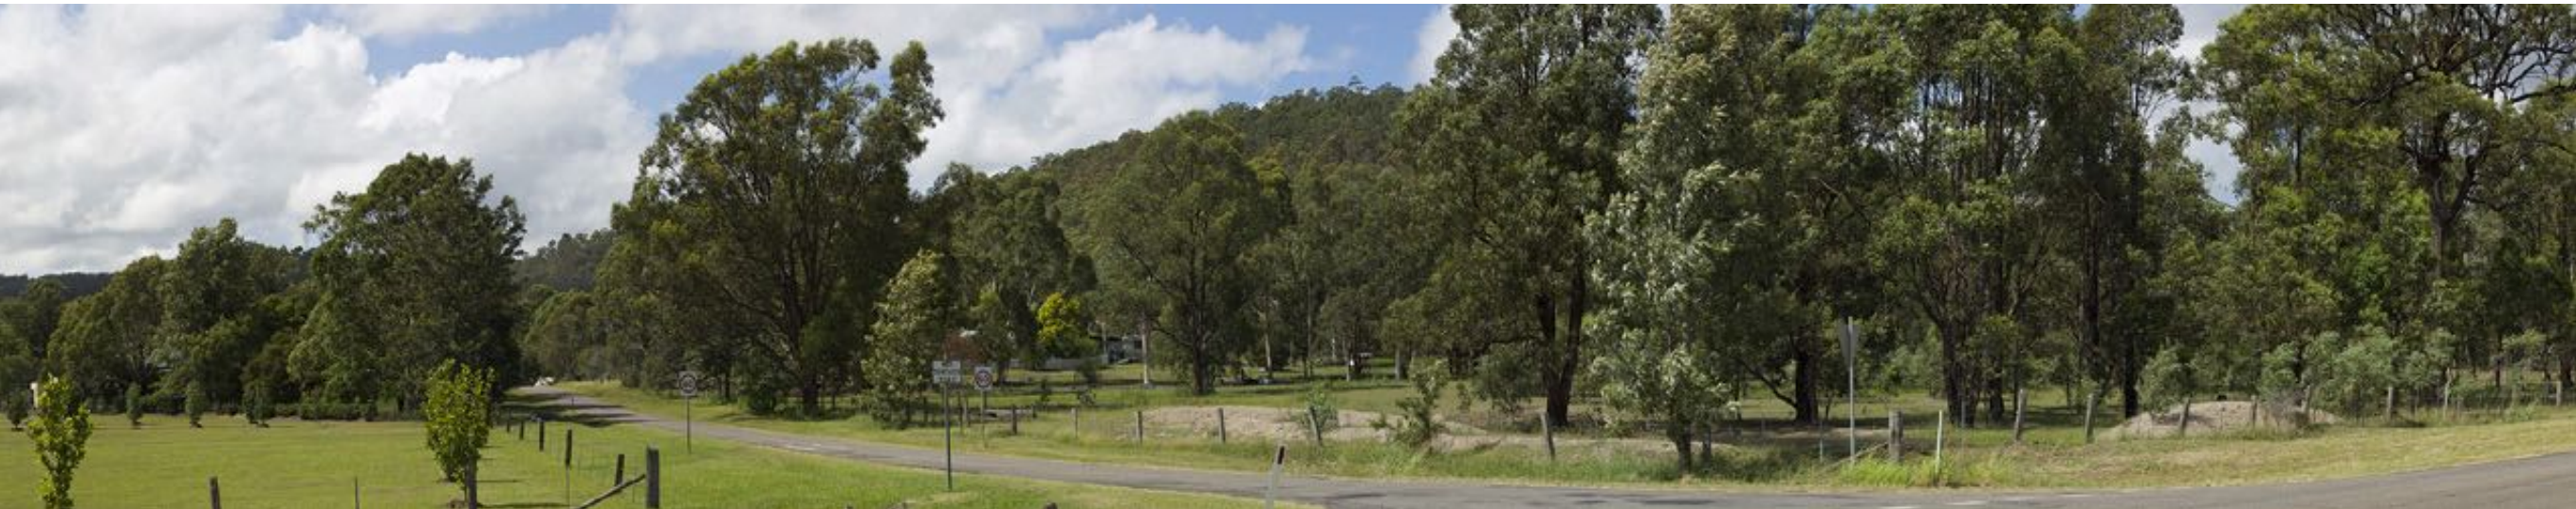
VIEWPOINT MC03A: Dungog Road

COORDINATES	S 32° 32.094' E 151° 37.072'		
ELEVATION	12m		
VIEWING DIRECTION	Generally South East		
DISTANCE TO SITE	1.04km		
LCU	N/A		
VISUAL EFFECT	Nil		
VISUAL IMPACT	Nil

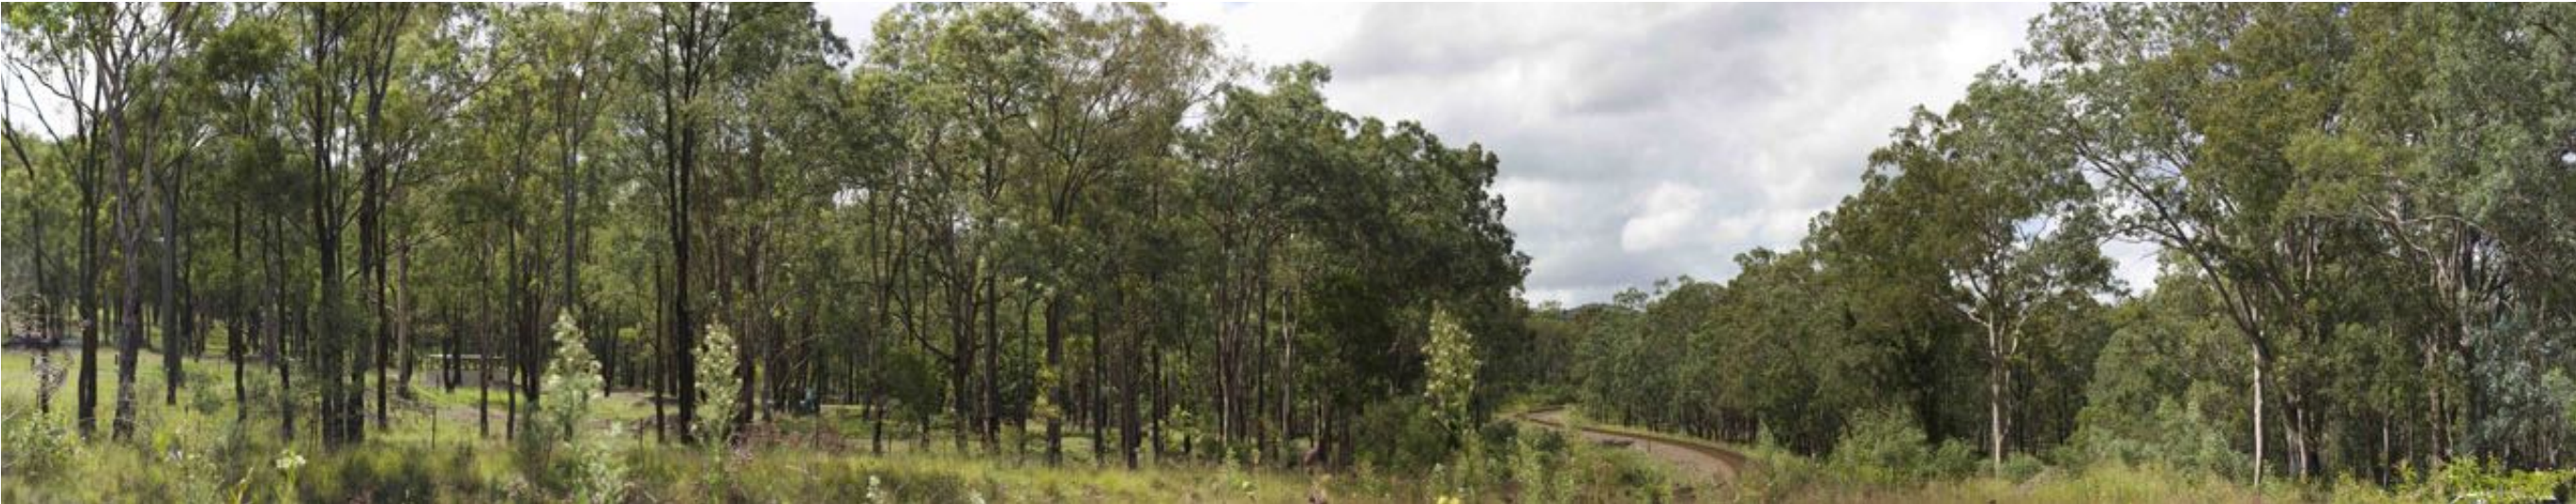
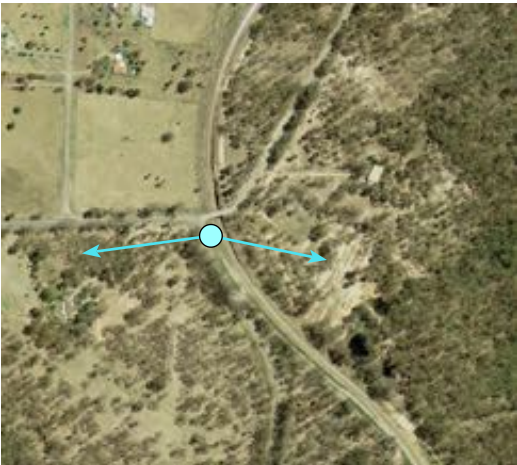
VIEWPOINT MC04A: Corner of Dungog & Horns Crossing Roads

VIEWPOINT MC04B: Corner of Dungog & Horns Crossing Roads cropped from MC04A

VIEWPOINT MC04			
SUMMARY OF VIEWPOINT		VIEWPOINT DESCRIPTION	POTENTIAL VISUAL IMPACT
LOCATION	Corner Dungog & Horns Crossing Road	View from the corner of Dungog Road and Horns Crossing Road, directly adjacent to the railway corridor, looking generally south towards the site. Land in this area is generally characterised by the railway and road intersection with dense surrounding vegetation. The topography surrounding is low rise with disturbance from the railway corridor. The visual sensitivity of this viewpoint is moderate due to the land use and close proximity to the site boundary.	The dense vegetation adjacent to the railway corridor screens views from this viewpoint towards the proposal. The proposal would not be visible from this viewpoint.
COORDINATES	S 32° 32.506’ E 151° 36.743’		
ELEVATION	32m		
VIEWING DIRECTION	Generally South		
DISTANCE TO SITE	420m		
LCU	Martins Creek		
VISUAL EFFECT	Nil

VISUAL IMPACT	Nil

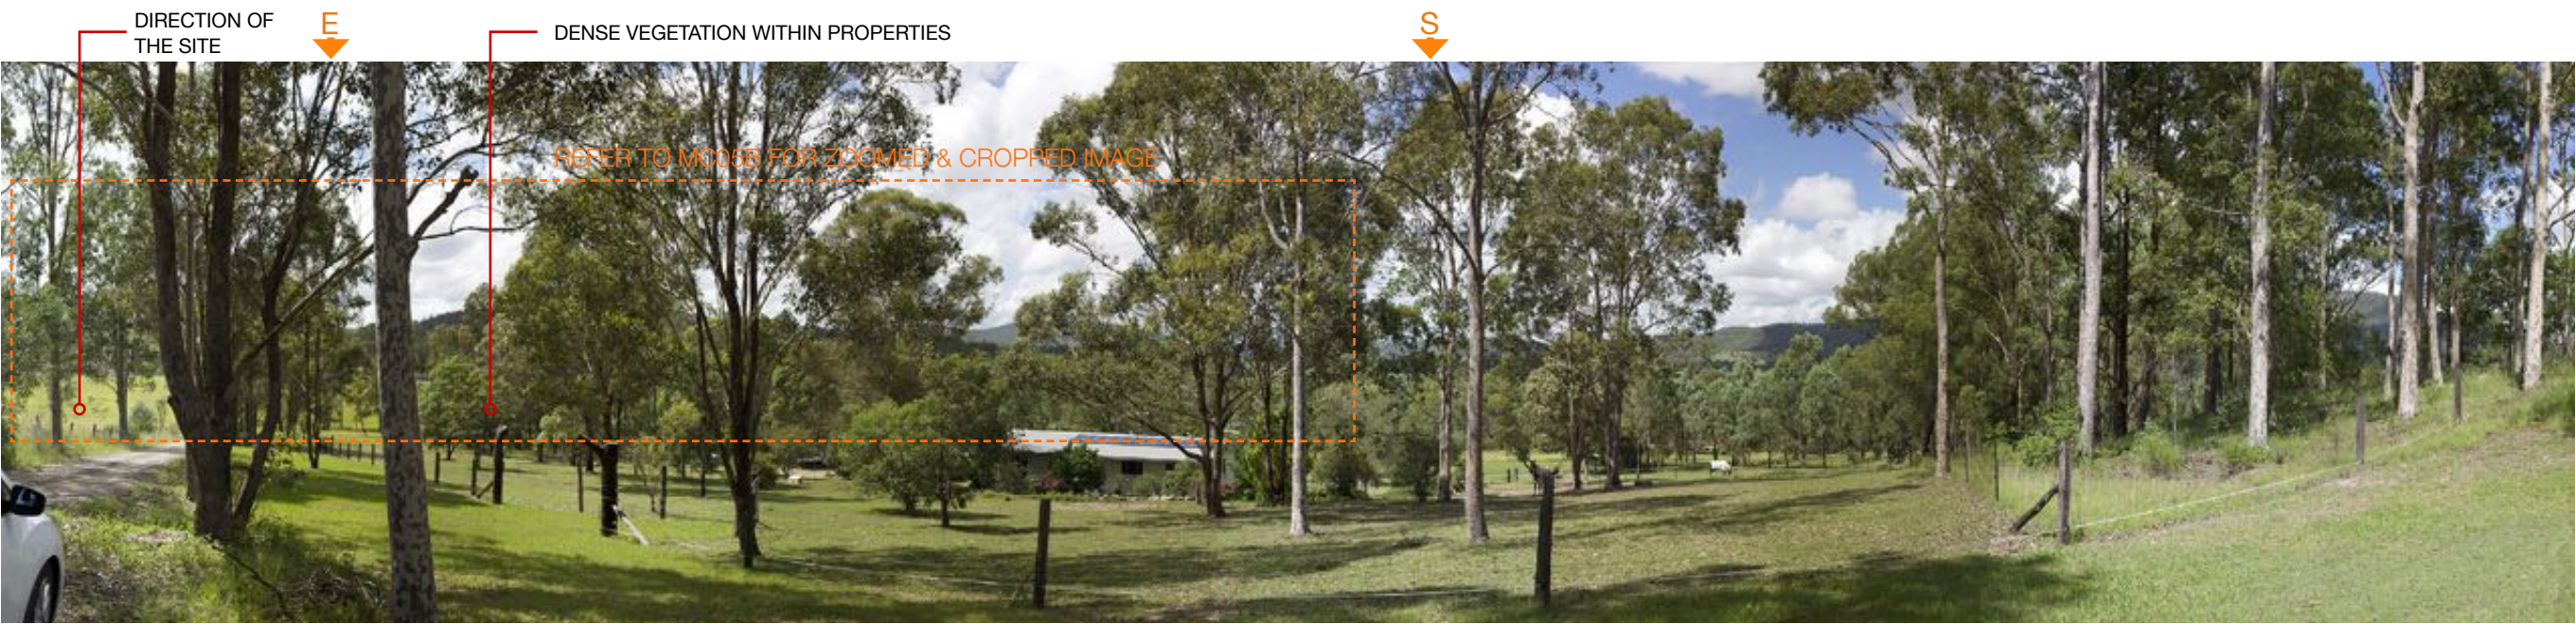
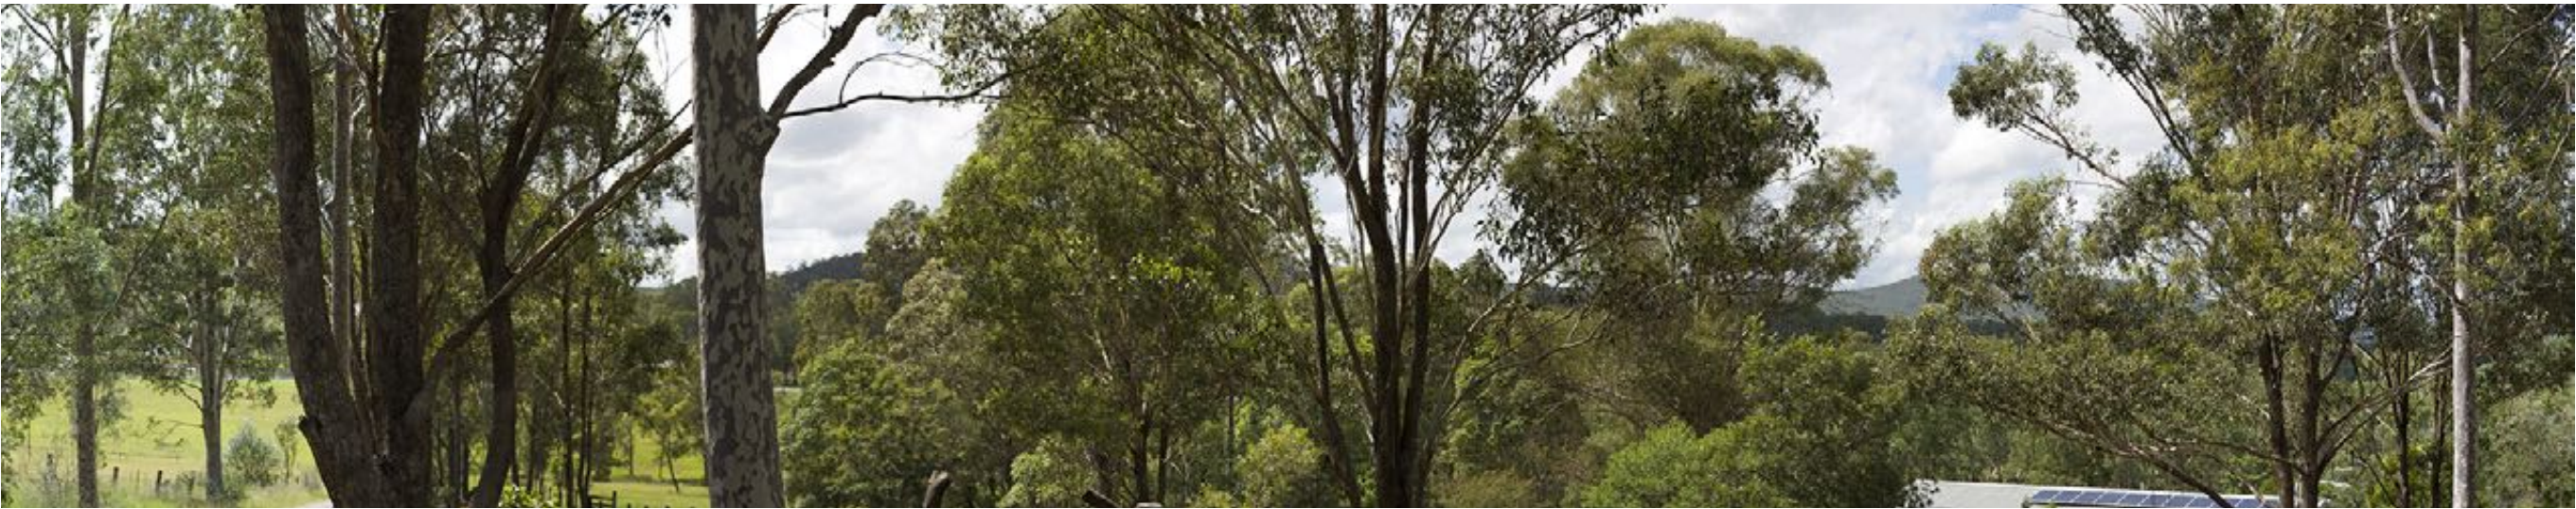
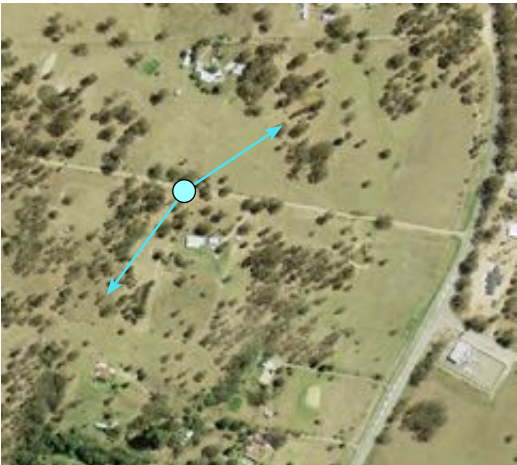
VIEWPOINT MC05A: Lane off Dungog Road

VIEWPOINT MC05B: Lane off Dungog Road zoomed and cropped from MC05A

VIEWPOINT MC05			
SUMMARY OF VIEWPOINT		VIEWPOINT DESCRIPTION	POTENTIAL VISUAL IMPACT
LOCATION	Lane off Dungog Road	This photograph was taken in a generally south east direction from the highpoint of an unsealed road off Dungog Road. The road links to surrounding rural residential properties of undulating topography. Views from this location are contained by fragmented vegetation within rural properties and undulating, densely vegetated topography in the backdrop. The visual sensitivity of this viewpoint has been rated as high due to the close proximity of the site and surrounding residential land use.	From this viewpoint it is likely the proposal would be screened by vegetation associated with surrounding properties. The proposal would not be visible from this viewpoint. This viewpoint has been included to illustrate the character of the areas.
COORDINATES	S 32° 33.199' E 151° 36.569'		
ELEVATION	30m

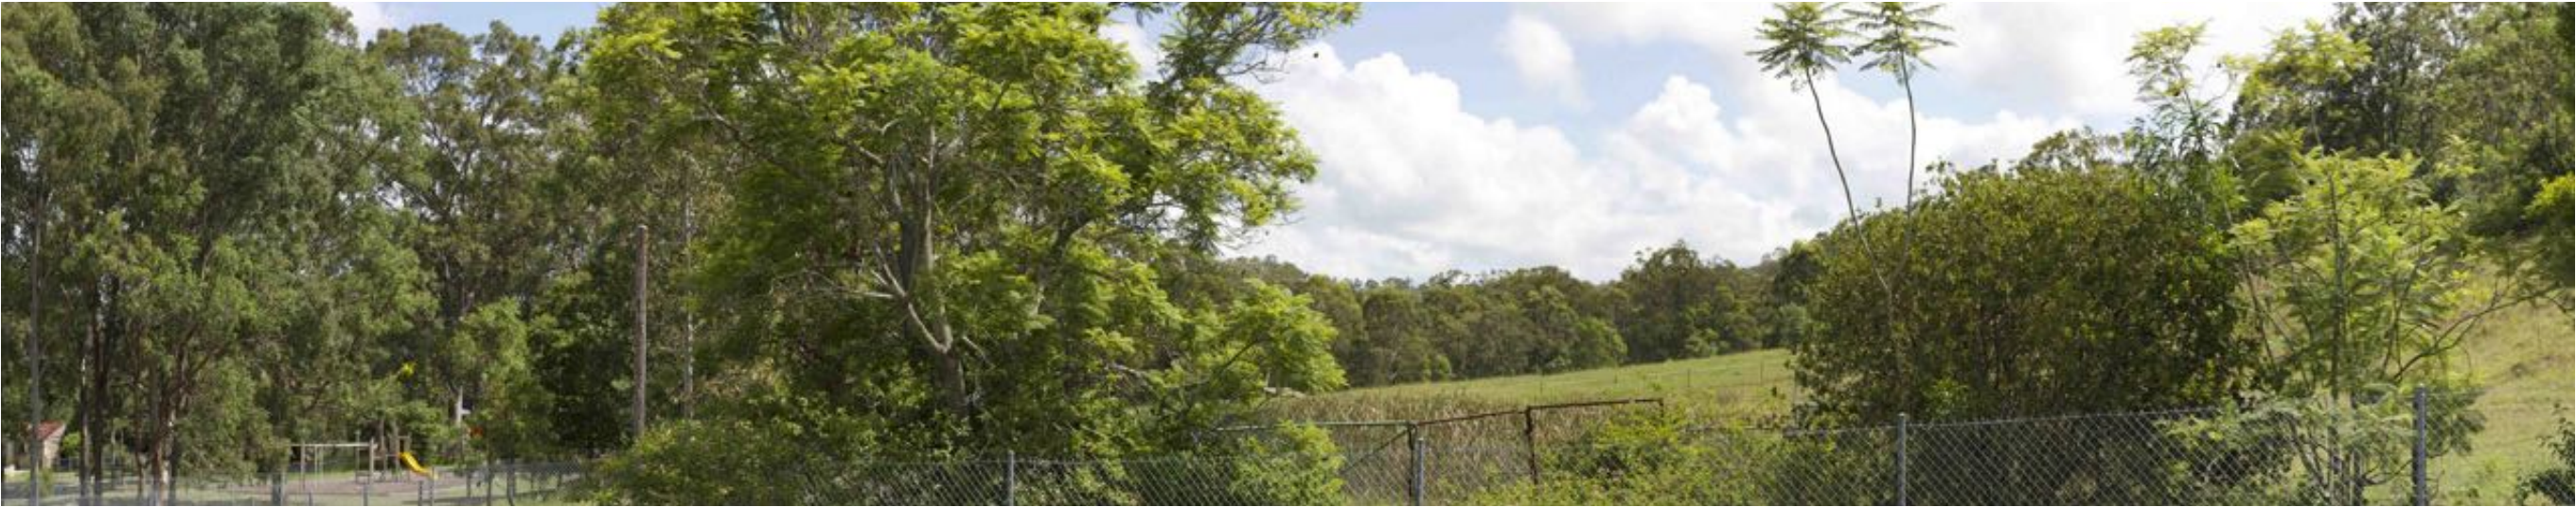
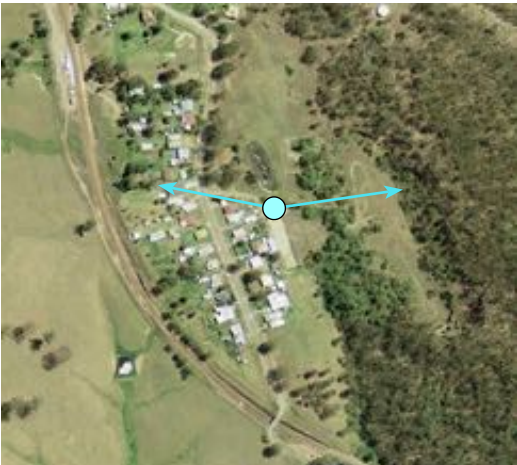
VIEWPOINT MC06A: Martins Creek Tennis Court

VIEWPOINT MC06B: Martins Creek zoomed and cropped from MC06A

VIEWPOINT MC06		
SUMMARY OF VIEWPOINT		POTENTIAL VISUAL IMPACT
LOCATION	Martins Creek Tennis Court	From this viewpoint some glimpse views of change to distant tree canopies may be evident. It is unlikely the proposal would be noticeable, resulting in minimal visual effect as a result. There is likely to be no visual impact from this location.
COORDINATES	S 32° 33.620' E 151° 37.261'	
ELEVATION	38m	
VIEWING DIRECTION	North	
DISTANCE TO SITE	375m	
LCU	Martins Creek	
VISUAL EFFECT	Nil	
VISUAL IMPACT	Nil	
VIEWPOINT DESCRIPTION		
View north towards the proposal from the Martins Creek tennis courts, adjacent to single storey residential dwellings associated with Cory Street. Views are contained due to gently sloping topography and dense vegetation both in the foreground and backdrop. Tree canopies within the proposal are visible on a slightly raised portion of land in the distance to the north. Visual sensitivity of this viewpoint has been rated as high due to the close proximity to surrounding residential dwellings.

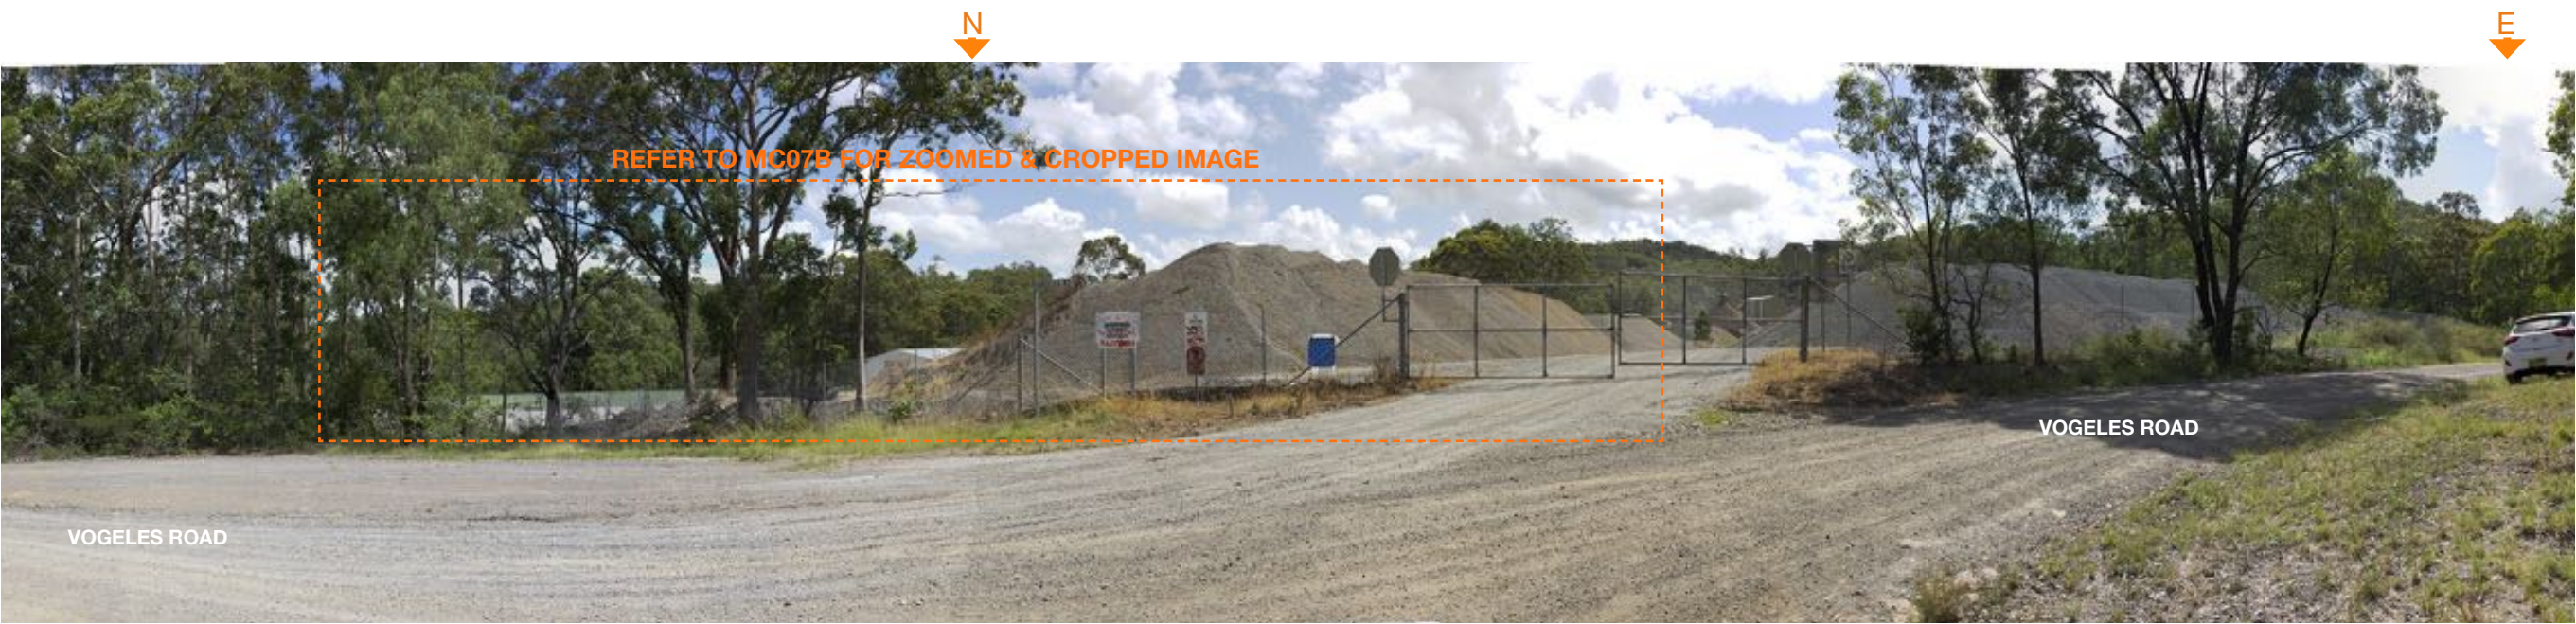
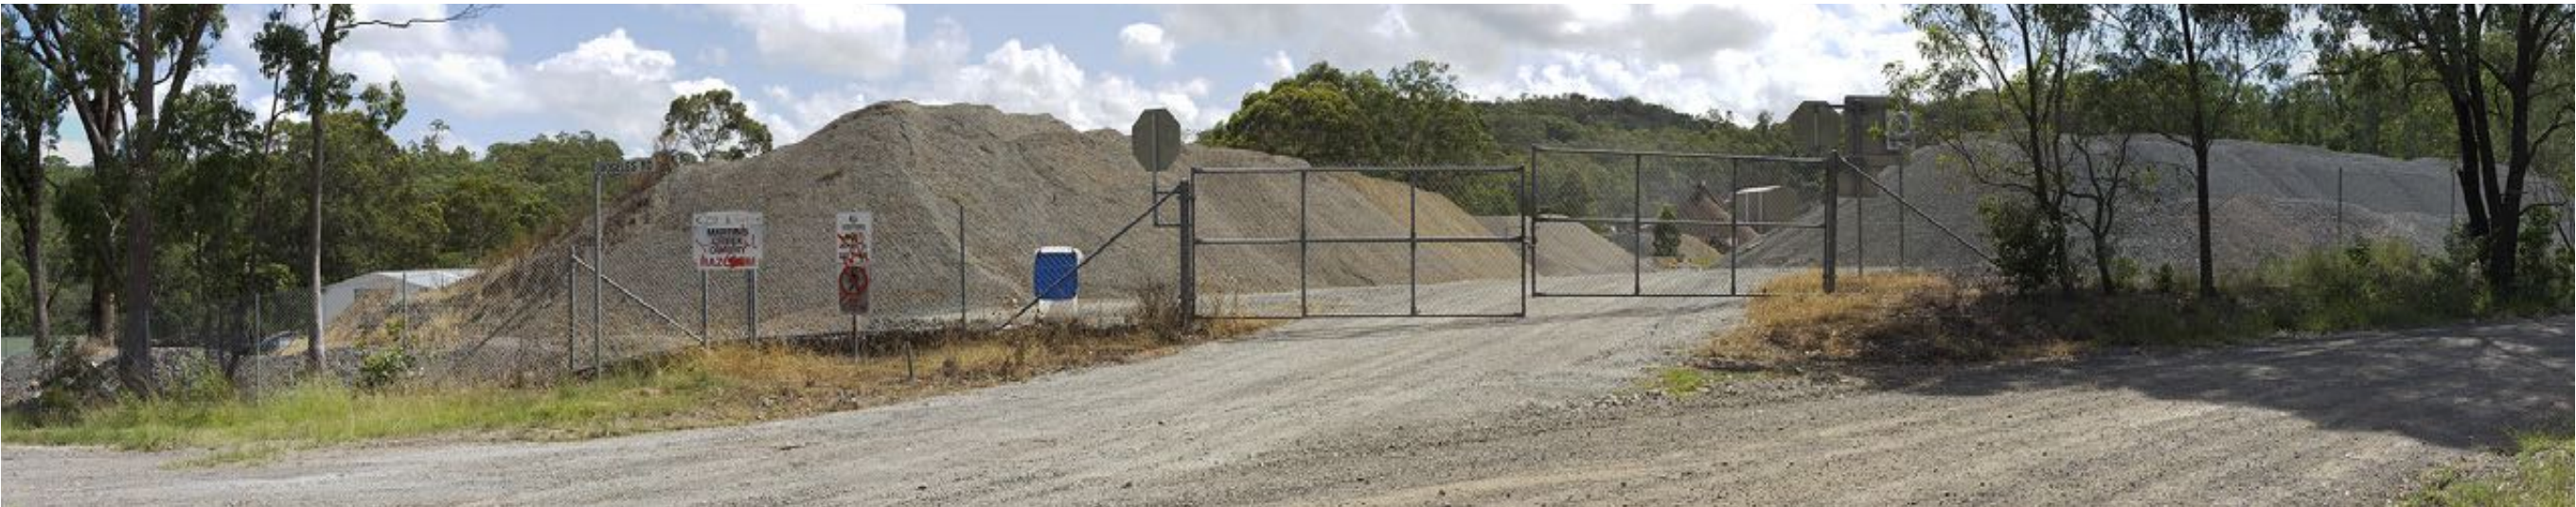
VIEWPOINT MC07A: Vogeles Road

COORDINATES	S 32° 33.388' E 151° 37.263'		
ELEVATION	47m		
VIEWING DIRECTION	North		
DISTANCE TO SITE	10m		
LCU	Martins Creek		
VISUAL EFFECT	Moderate		
VISUAL IMPACT	Moderate

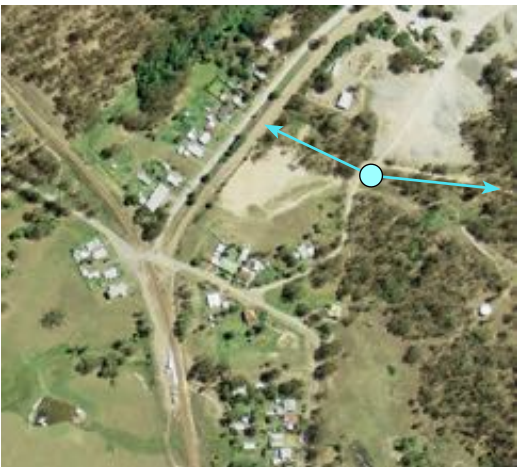
MC07 Viewpoint Location

VIEWPOINT MC07B: Vogeles Road zoomed and cropped from MC07A

VIEWPOINT MC07			
SUMMARY OF VIEWPOINT		VIEWPOINT DESCRIPTION	POTENTIAL VISUAL IMPACT
LOCATION	Vogeles Road, Martins Creek	This photograph was taken from a dominant bend in Vogeles Road, looking north directly into the site. Vogeles Road is a minor local road of low frequency use, increasing in elevation towards the east. The road provides access to a few rural residential properties east of the site. The unseal road is characterised by unscreened views of the quarry and dense vegetation on the opposite side of the road. The topography is generally low rise with disturbance visible due to the close proximity to the site. The visual sensitivity of this viewpoint is moderate due to the direct proximity to the site and minor local road.	From this viewpoint it is likely the removal of vegetation associated with the proposed expansion would be visible in the background where the topography rises. The visual effect from this viewpoint has been rated moderate and the resulting visual impact is rated as moderate impact.
