Landscape & Visual Impact Assessment

PROPOSED MARTINS CREEK QUARRY EXPANSION

Prepared for: **DARACON**

Project No: **1149**

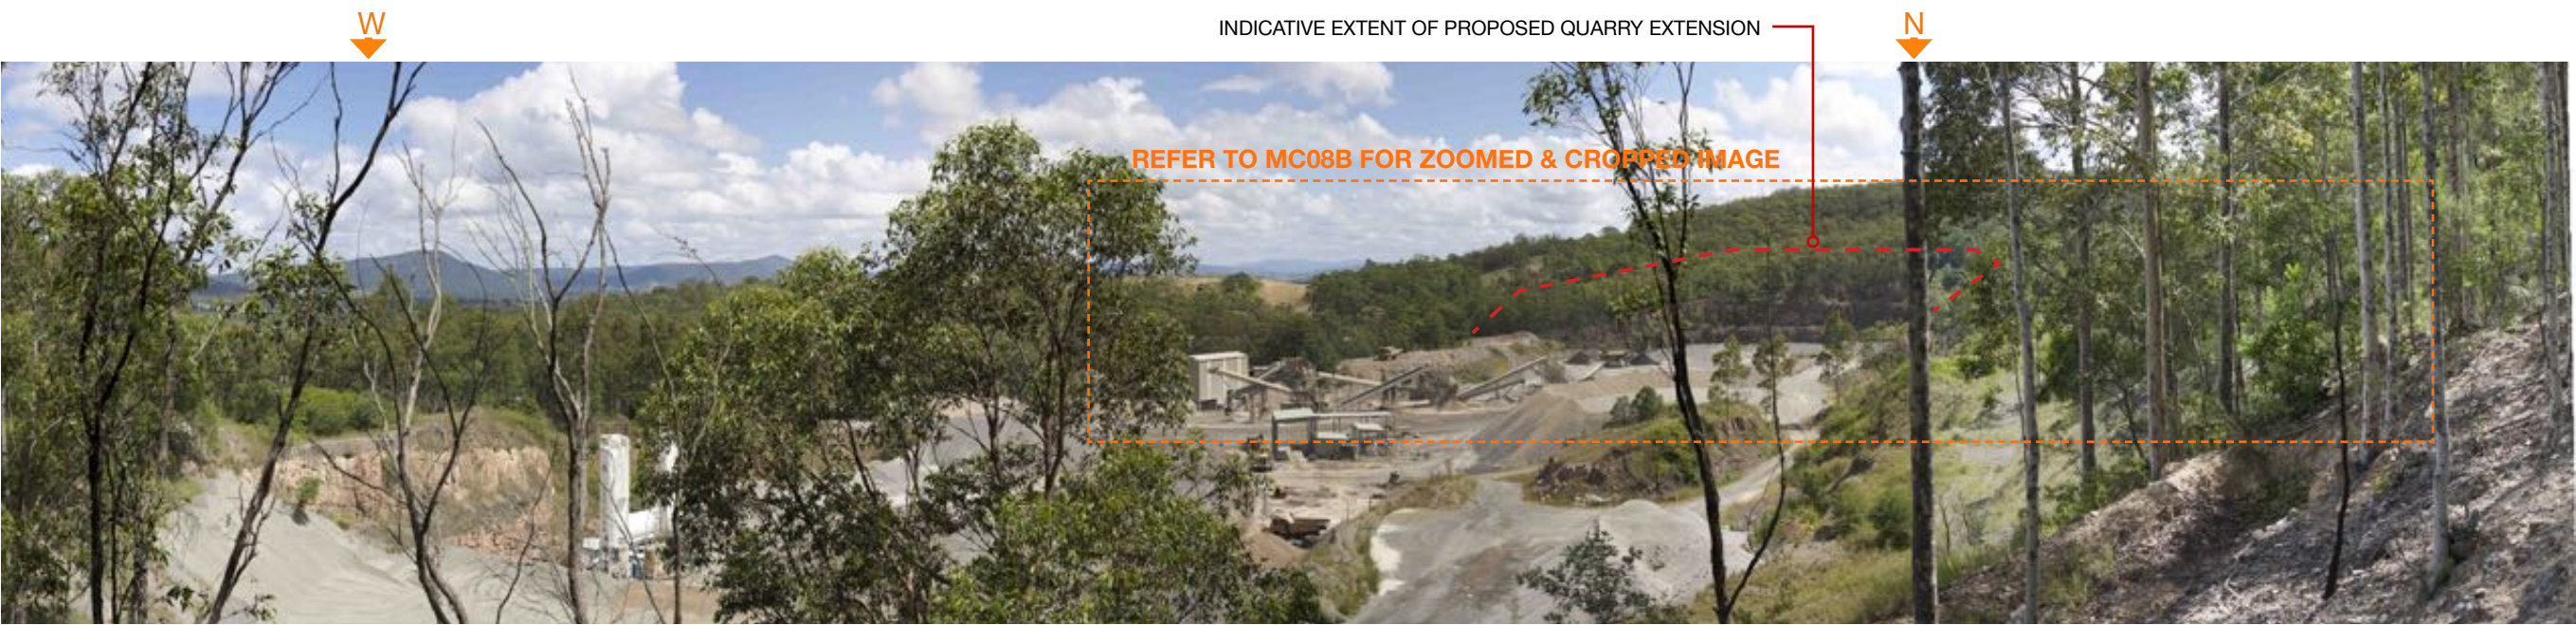
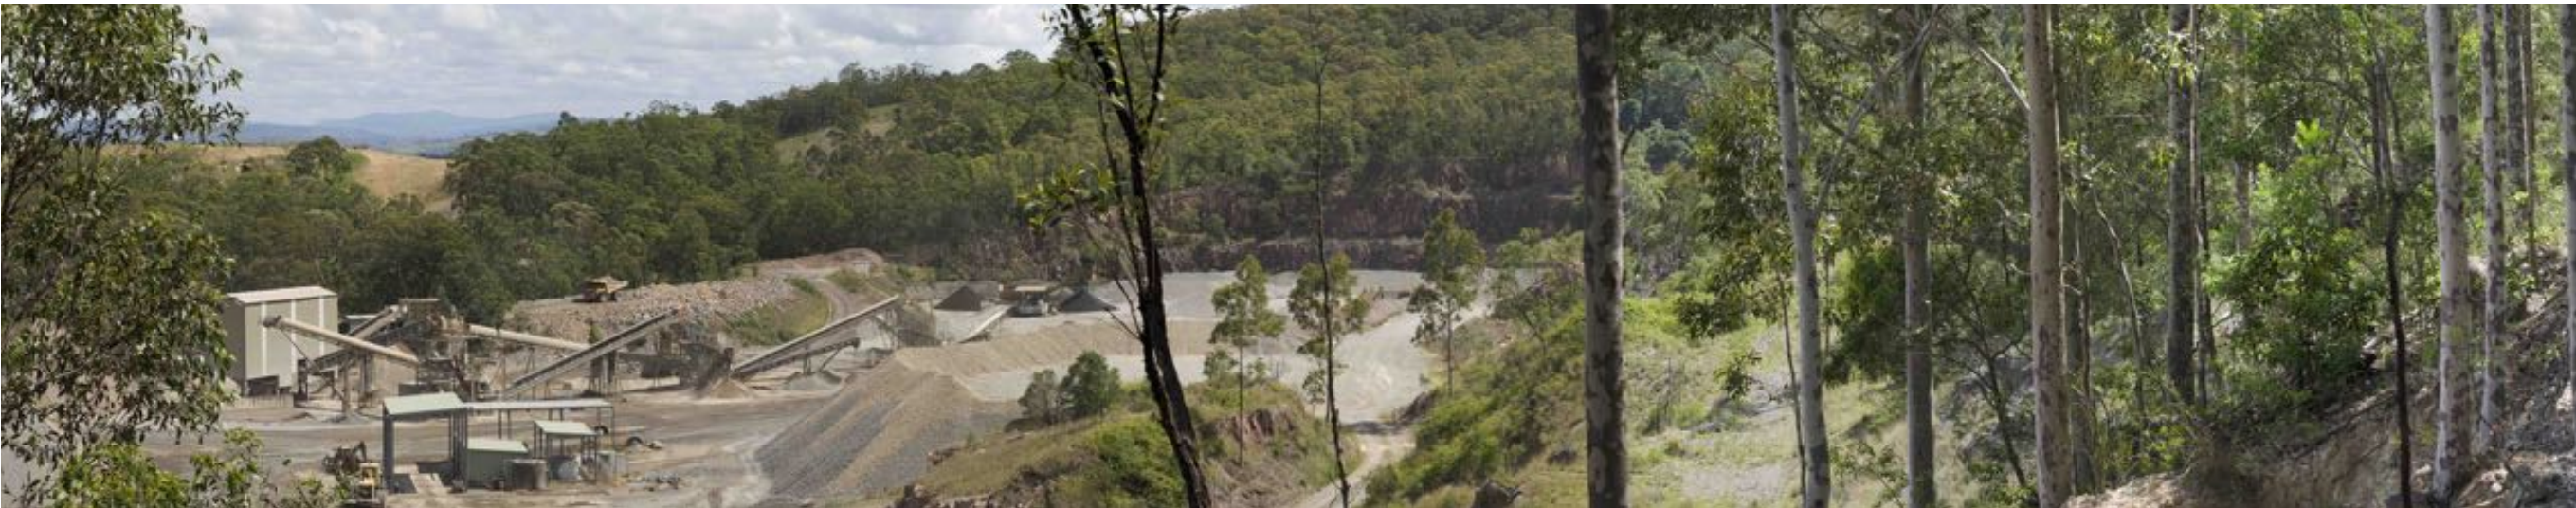
VIEWPOINT MC08A: Douglas Voge Road

VISUAL IMPACT	Moderate	
		POTENTIAL VISUAL IMPACT
		From this viewpoint change to vegetation and topography associated with the proposal is likely to be visible and unscreened. The proposed works would appear as an extension of the existing quarry. Due to the extent of existing disturbance to the natural topography the proposed quarry extension would have a low visual effect from this viewpoint. The resulting visual impact has been rated as moderate. Refer to photomontage 02.

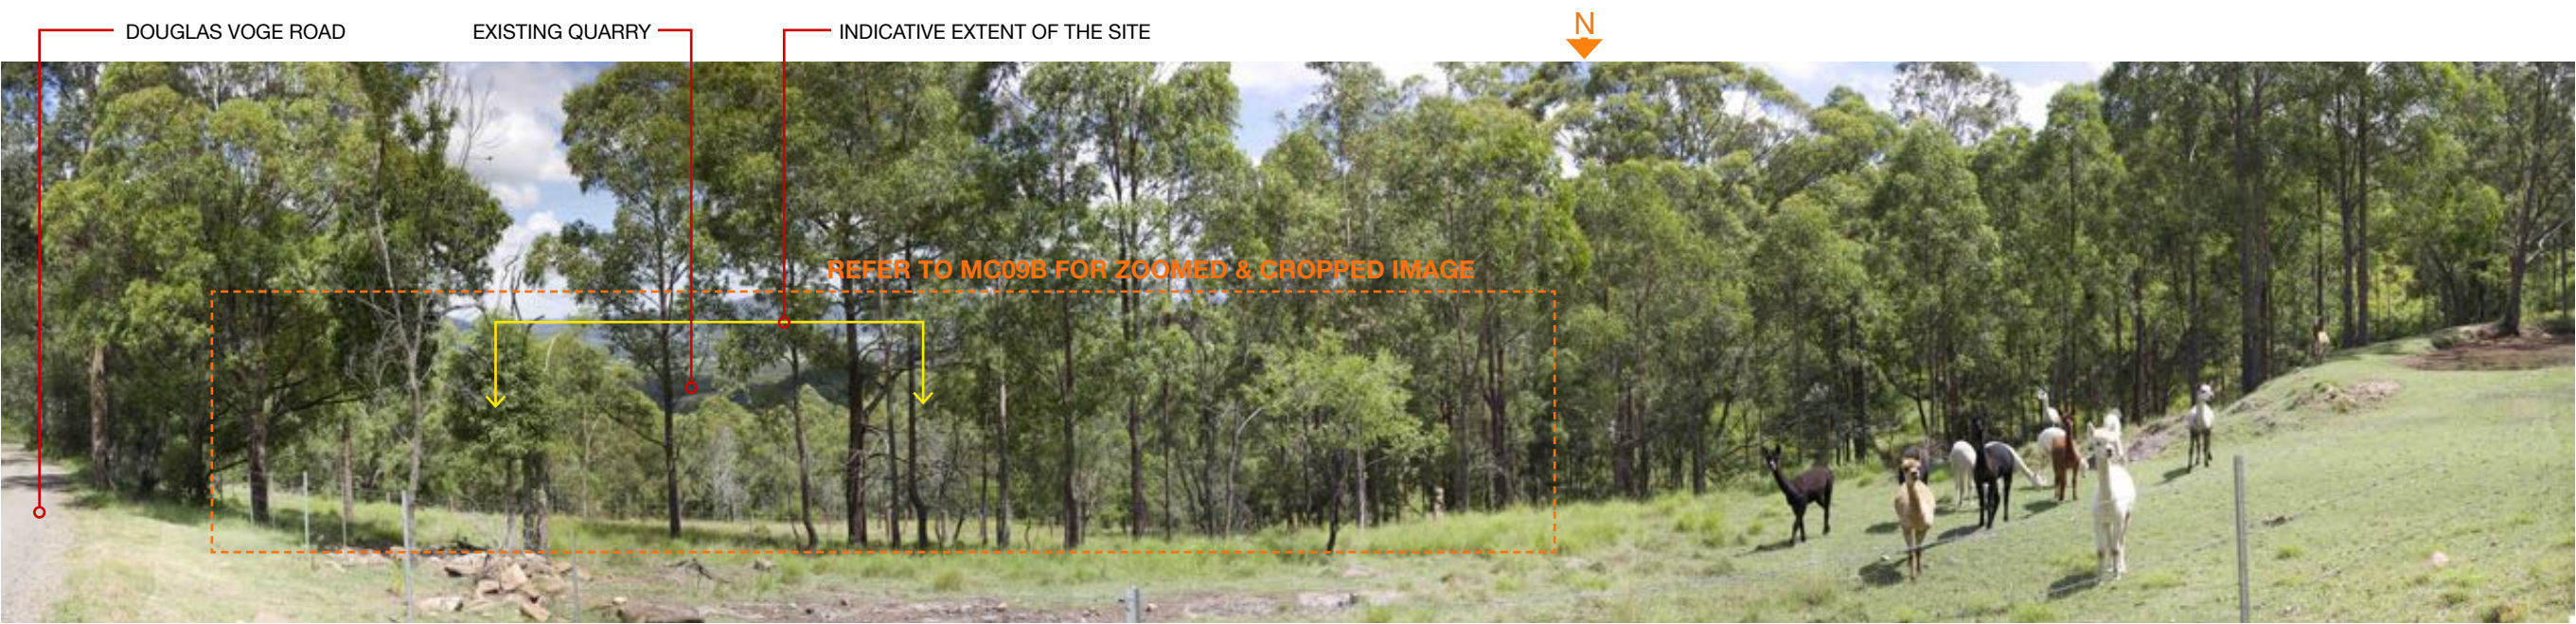
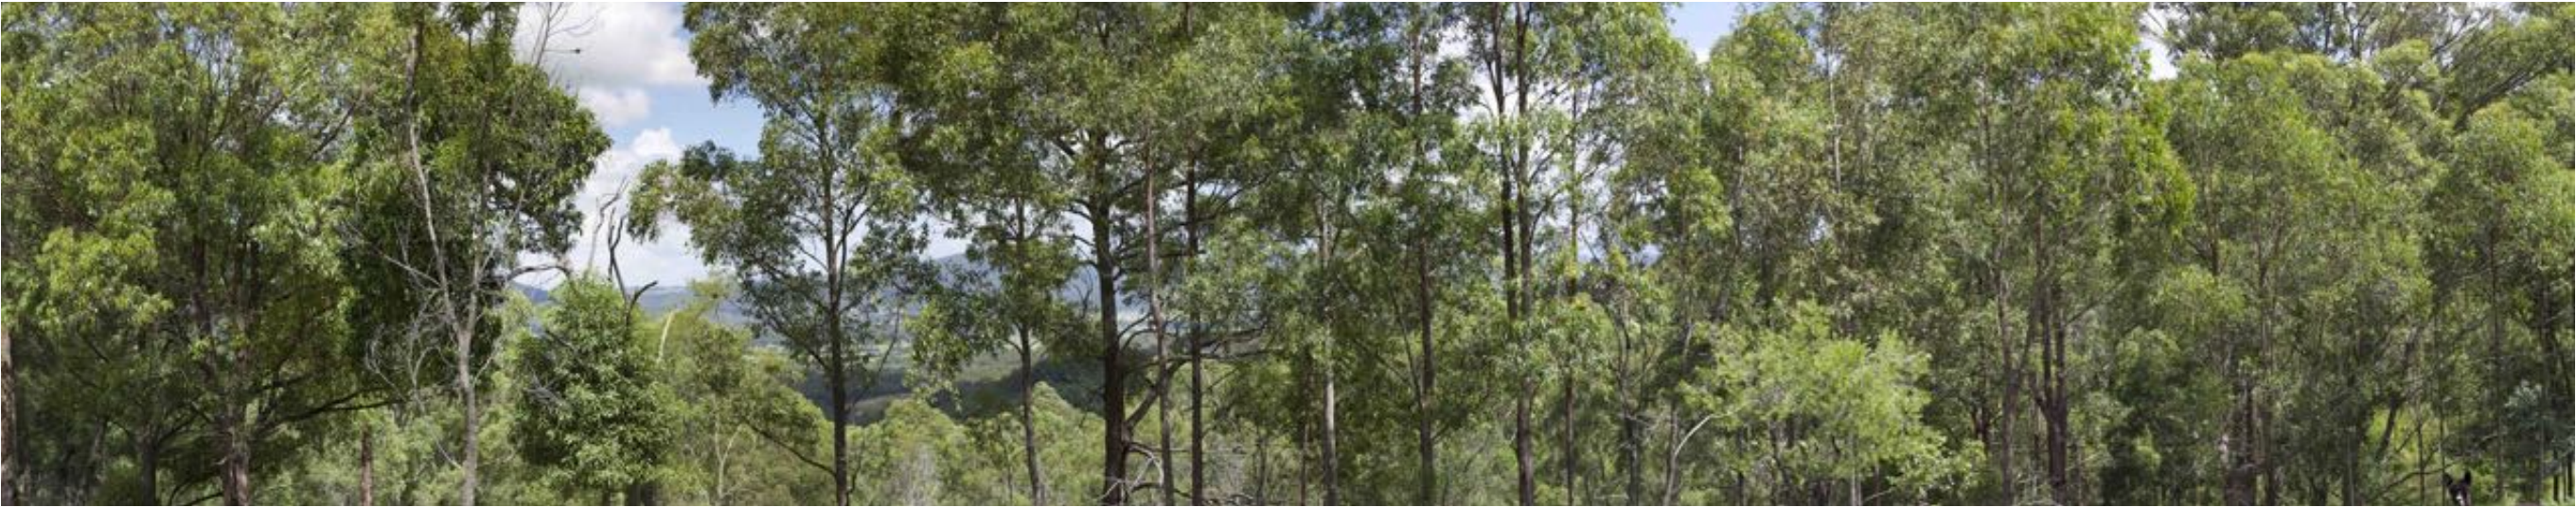
VIEWPOINT MC09A: Douglas Voge Road

COORDINATES	S 32° 33.134' E 151° 38.123'		
ELEVATION	200m		
VIEWING DIRECTION	North West		
DISTANCE TO SITE	650m (nearest boundary)		
LCU	Martins Creek Hills		
VISUAL EFFECT	Low		
VISUAL IMPACT	Low

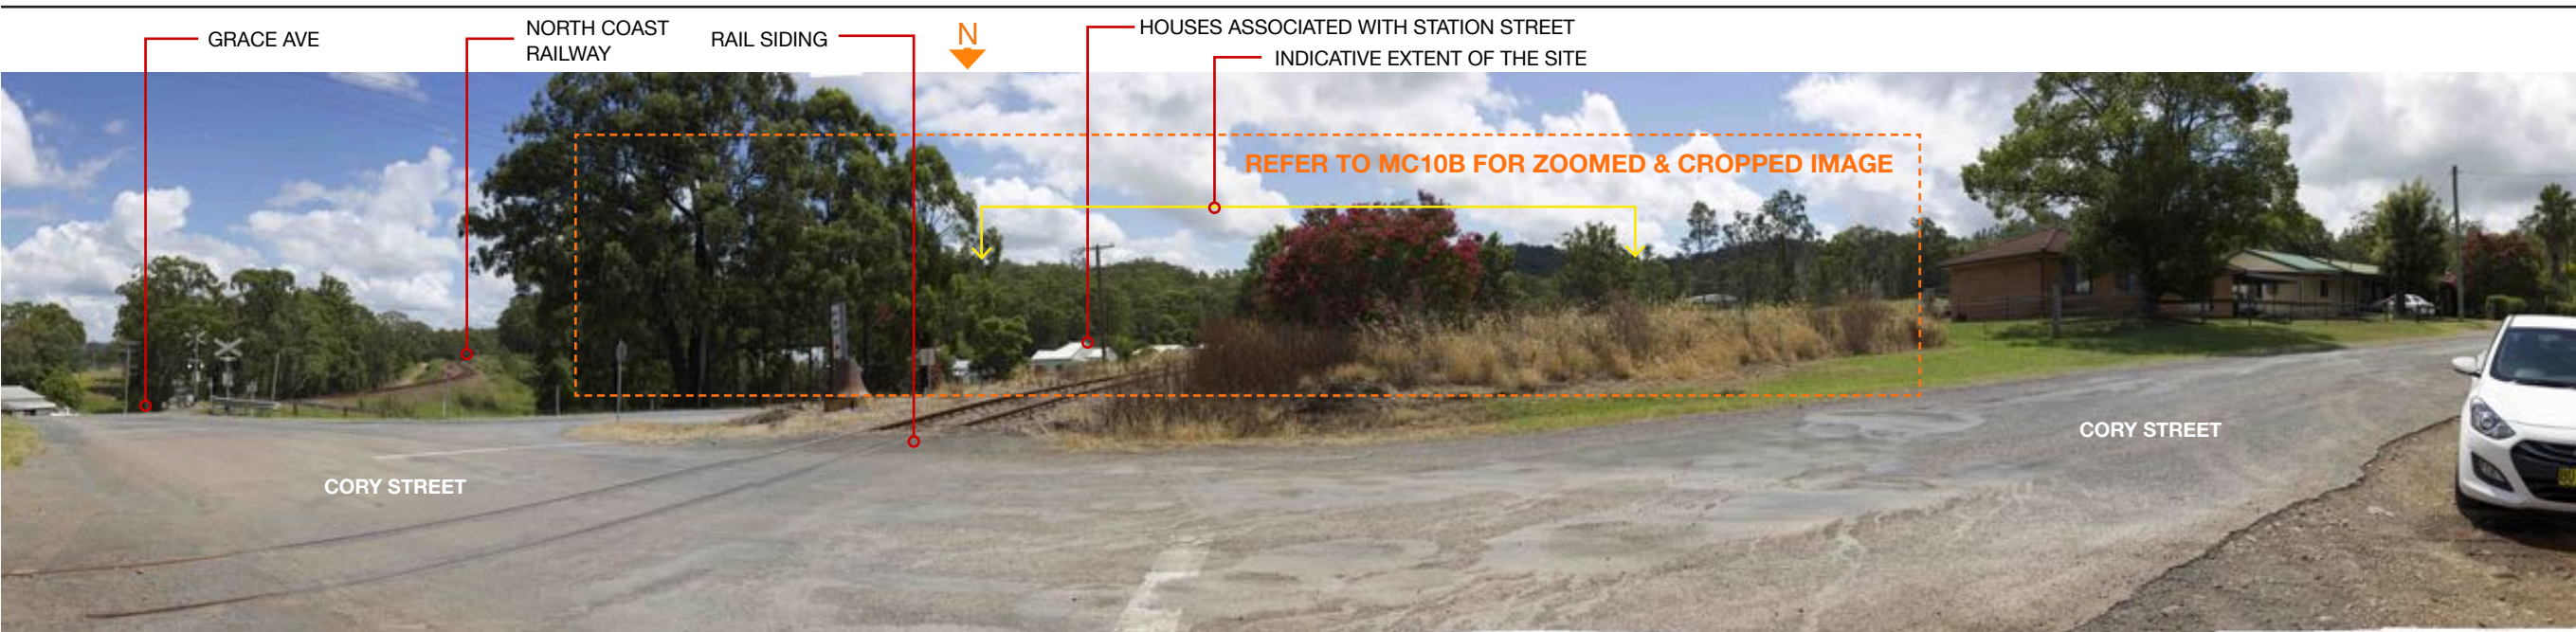
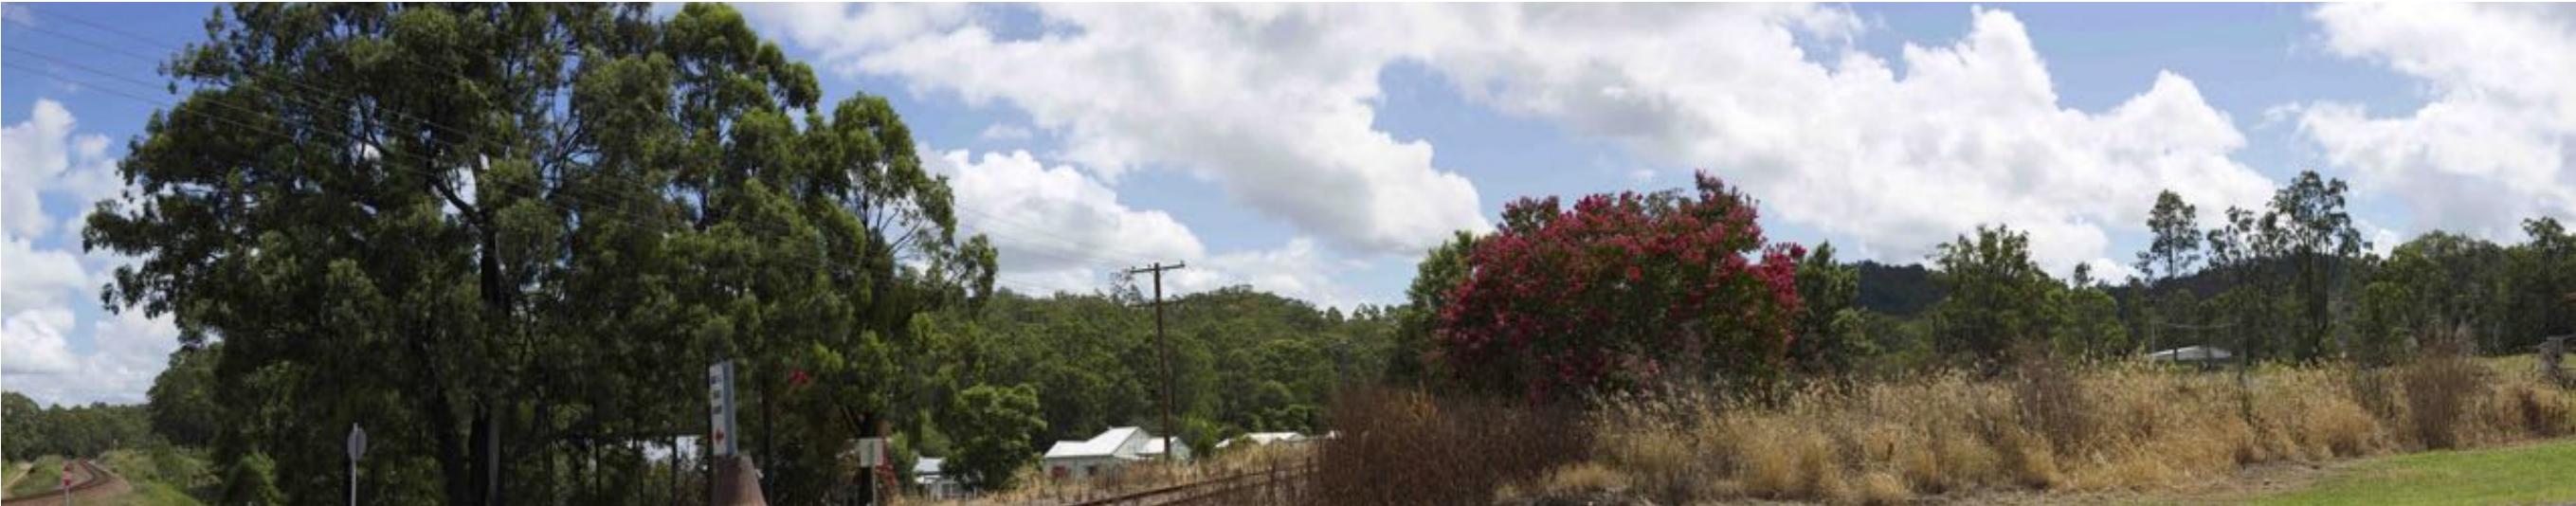
VIEWPOINT MC10A: Cory Street

COORDINATES	S 32° 33.455' E 151° 37.110'		
ELEVATION	46m		
VIEWING DIRECTION	North		
DISTANCE TO SITE	45m (nearest boundary)		
LCU	Martins Creek		
VISUAL EFFECT	Low		
VISUAL IMPACT	Moderate

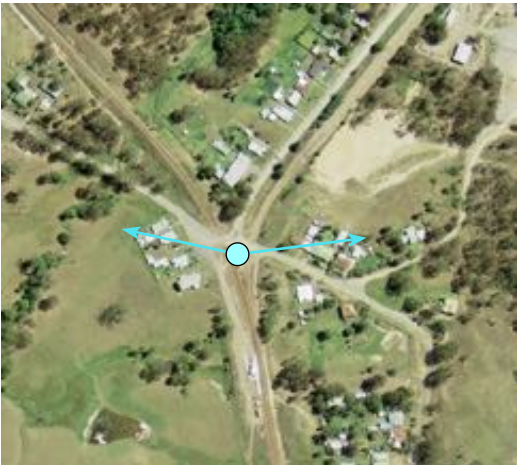
MC10 Viewpoint Location

VIEWPOINT MC10B: Cory Street zoomed and cropped from MC10A

VIEWPOINT MC10			
SUMMARY OF VIEWPOINT		VIEWPOINT DESCRIPTION	POTENTIAL VISUAL IMPACT
LOCATION	Cory Street	View looking north from Cory Street, adjacent to the rail siding within the town of Martins Creek. The landscape is slightly sloping, characterised by the dominant railway corridor, nearby station and intersection of Grace Avenue and Station Street. The main quarry entry is accessed via the intersection at Station Street, regularly utilised by vehicles associated with the quarry. Vegetation within surrounding residential properties and road verges is present and screens views towards the site. The visual sensitivity of this viewpoint is high due to surrounding residential dwellings and close proximity to the nearest site boundary.	From this viewpoint some glimpse views of change to distant tree canopy densities may be evident as the topography rises to the north. It is unlikely the proposal would be discernible, resulting in minimal visual effect. The proposed acoustic wall associated with the existing railway corridor will be visible from this location, resulting in a low visual effect. The visual impact has been assessed as moderate from this location.

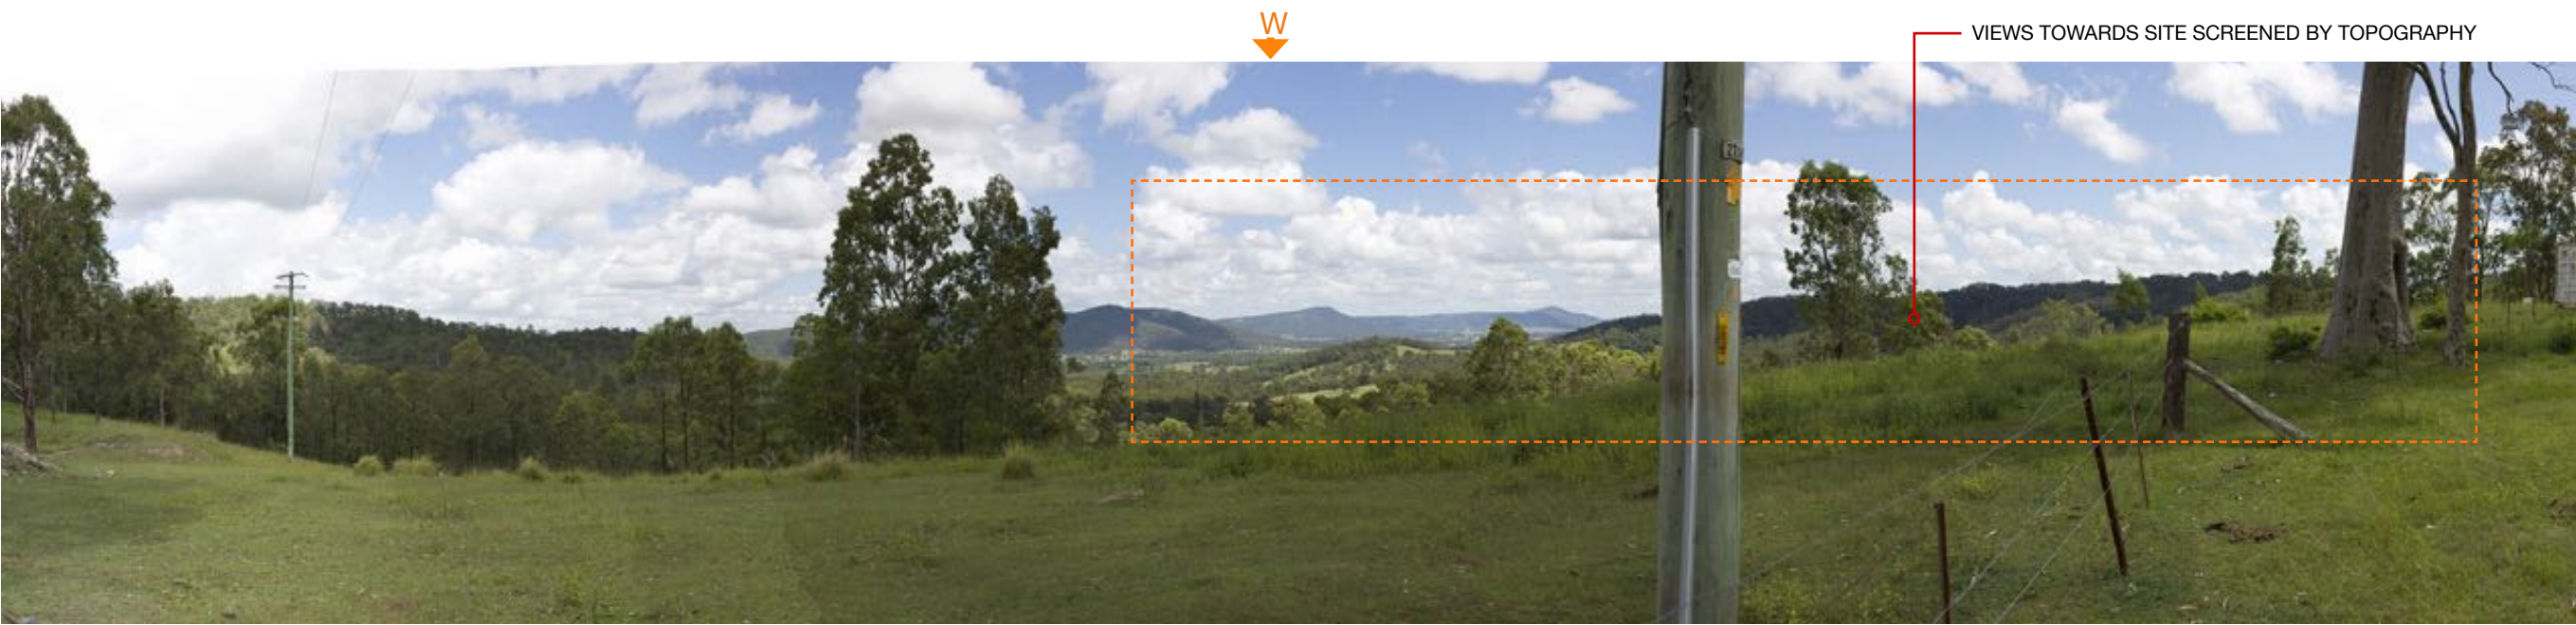
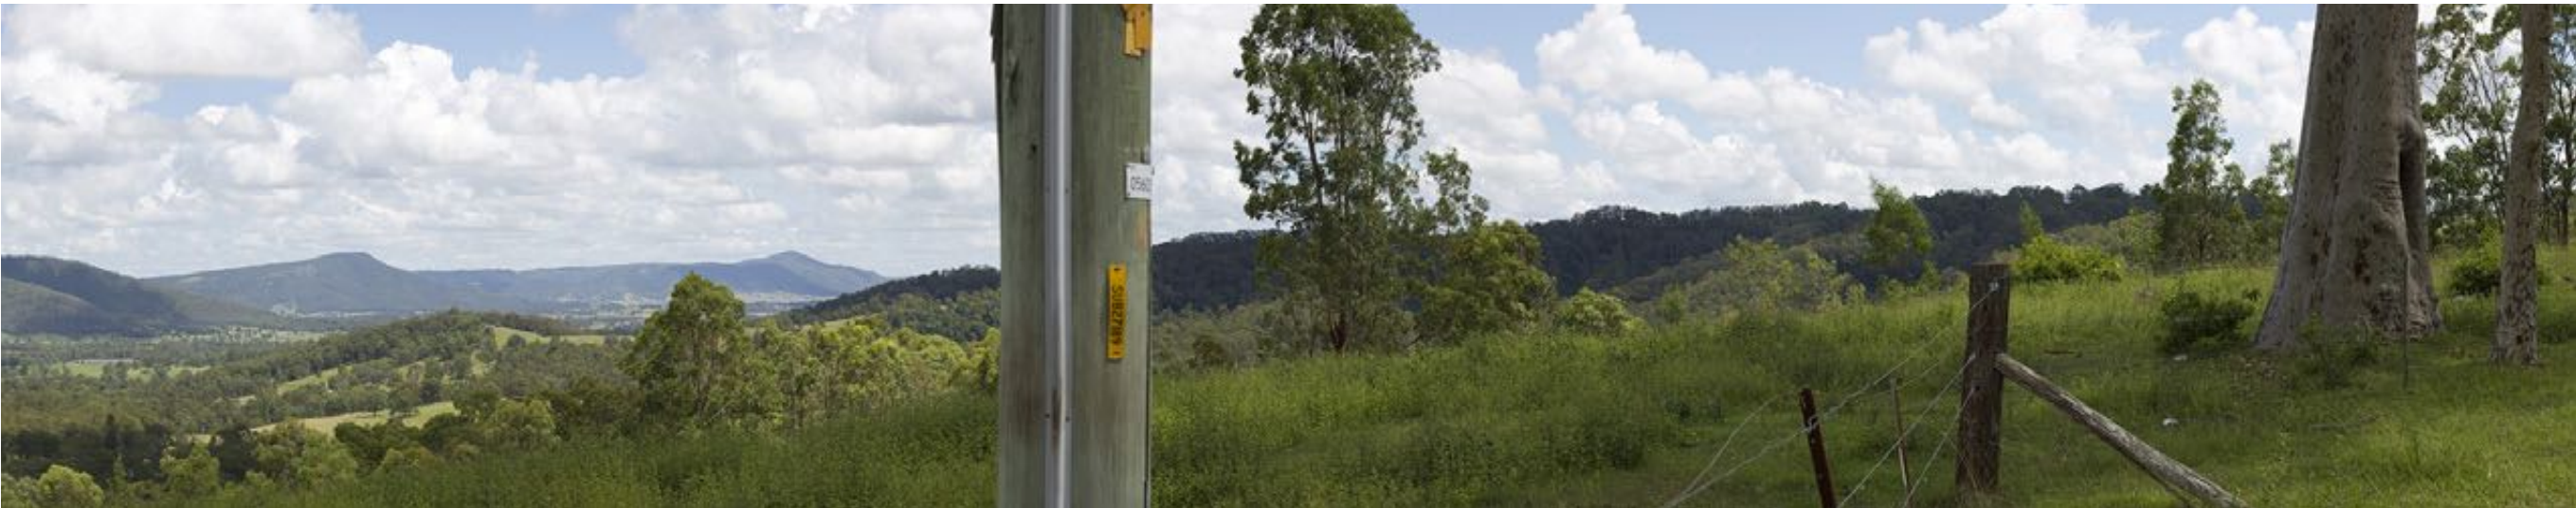
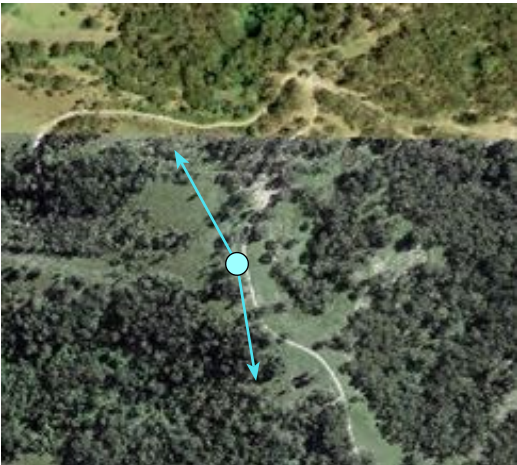
VIEWPOINT MC11A: Black Rock Road

VIEWPOINT MC11B: Black Rock Road zoomed and cropped from MC11A

VIEWPOINT MC11			
SUMMARY OF VIEWPOINT		VIEWPOINT DESCRIPTION	POTENTIAL VISUAL IMPACT
LOCATION	Black Rock Road	View looking in a generally west direction from a highpoint and clearing along the unsealed Black Rock Road. Black Rock Road climbs steeply in elevation, serving as an access road to various rural properties. The road follows the natural ridgeline, characterised by undulating topography and dense vegetation communities. Distant views are evident from high points in the topography to mountain ranges west of the viewpoint. The visual sensitivity of this viewpoint has been rated as low due to the distance from the site and land use.	The dominant mountain ridgeline in the backdrop screens all visibility to the site in the north west. Consequently, the proposal would not be visible from this viewpoint. This viewpoint has been included to illustrate the typical character of this area.
COORDINATES	S 32° 34.032' E 151° 38.984'

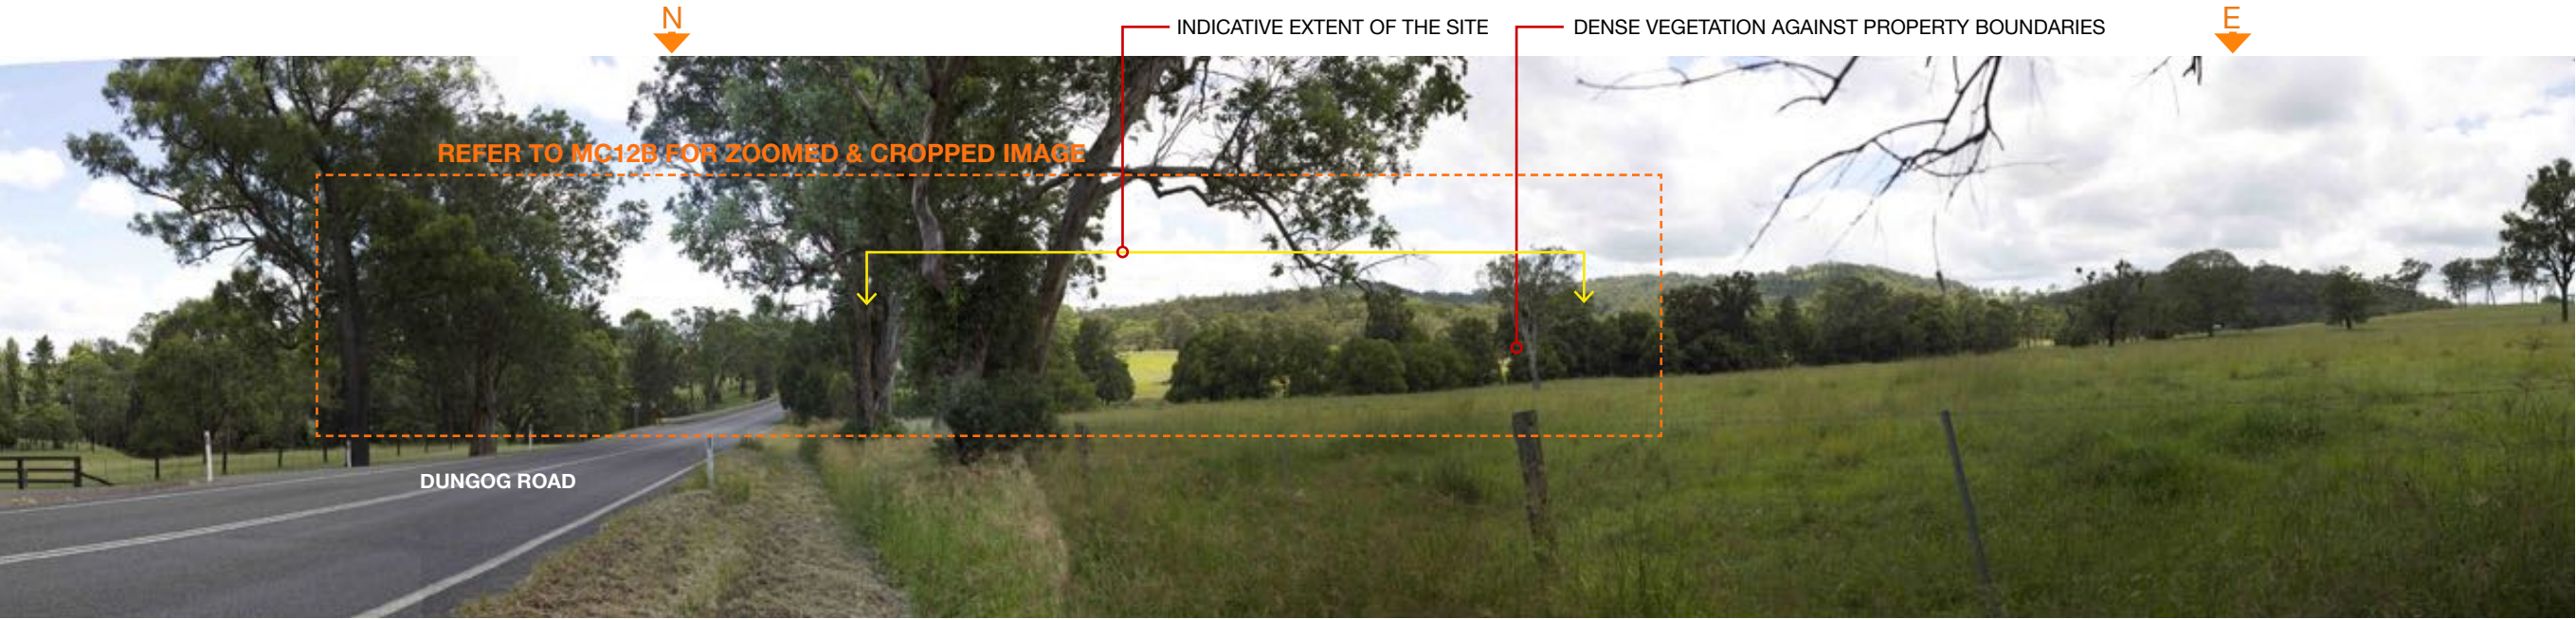
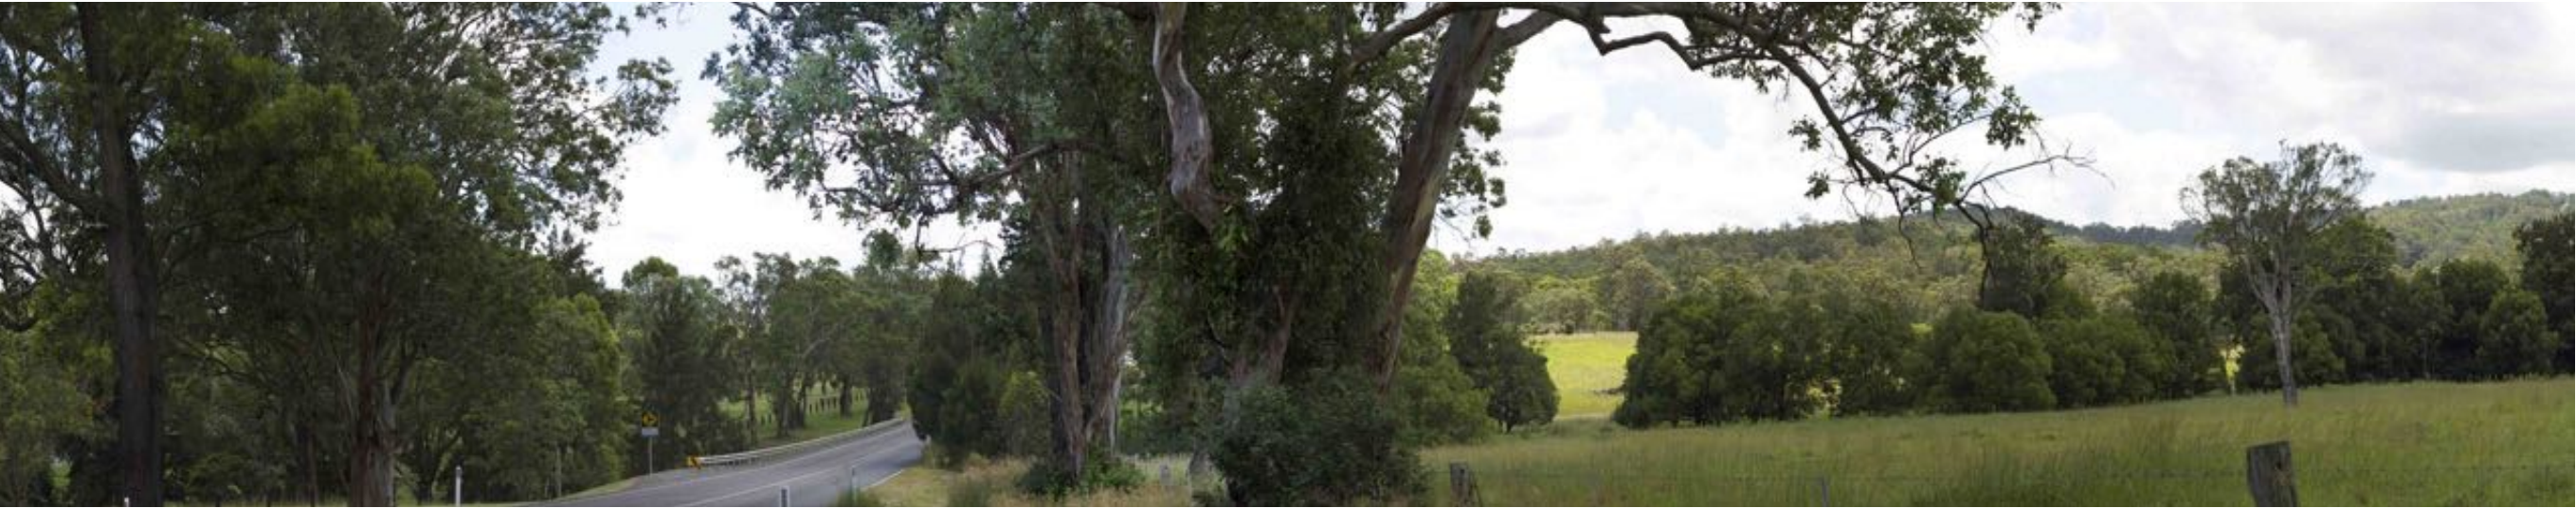
VIEWPOINT MC12A: Dungog Road

COORDINATES	S 32° 33.527' E 151° 36.652'		
ELEVATION	37m		
VIEWING DIRECTION	North East		
DISTANCE TO SITE	740m		
LCU	Martins Creek Rural		
VISUAL EFFECT	Moderate		
VISUAL IMPACT	Moderate

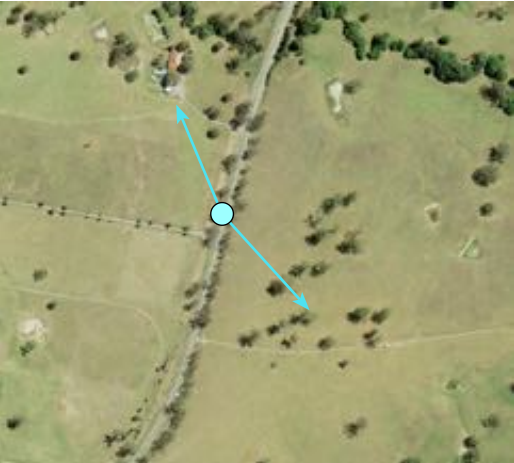
MC12 Viewpoint Location

VIEWPOINT MC12			
SUMMARY OF VIEWPOINT		VIEWPOINT DESCRIPTION	POTENTIAL VISUAL IMPACT
LOCATION	Dungog Road	This photograph was taken looking north east from Dungog Road approximately 500m south from the intersection with Grace Avenue. Dungog Road is a main travel corridor connecting Martins Creek with Vacy and Paterson. The surrounding landscape is characterised by undulating topography and cleared rural properties. Vegetation is generally associated with roads, drainage lines and properties. Tree canopies within the proposal form part of the distant high points in the backdrop to the north east. The visual sensitivity of this viewpoint has been rated as moderate as a result of the close proximity to the site.	From this viewpoint the removal of vegetation to accommodate the proposal is likely to be visible to the north east. The undulating topography and dense vegetation along property boundaries would help to fragment views of the vegetation clearing. Consequently, the visual effect of this viewpoint has been rated as moderate and the resulting visual impact has been rated as moderate. Refer to Photomontage 03.

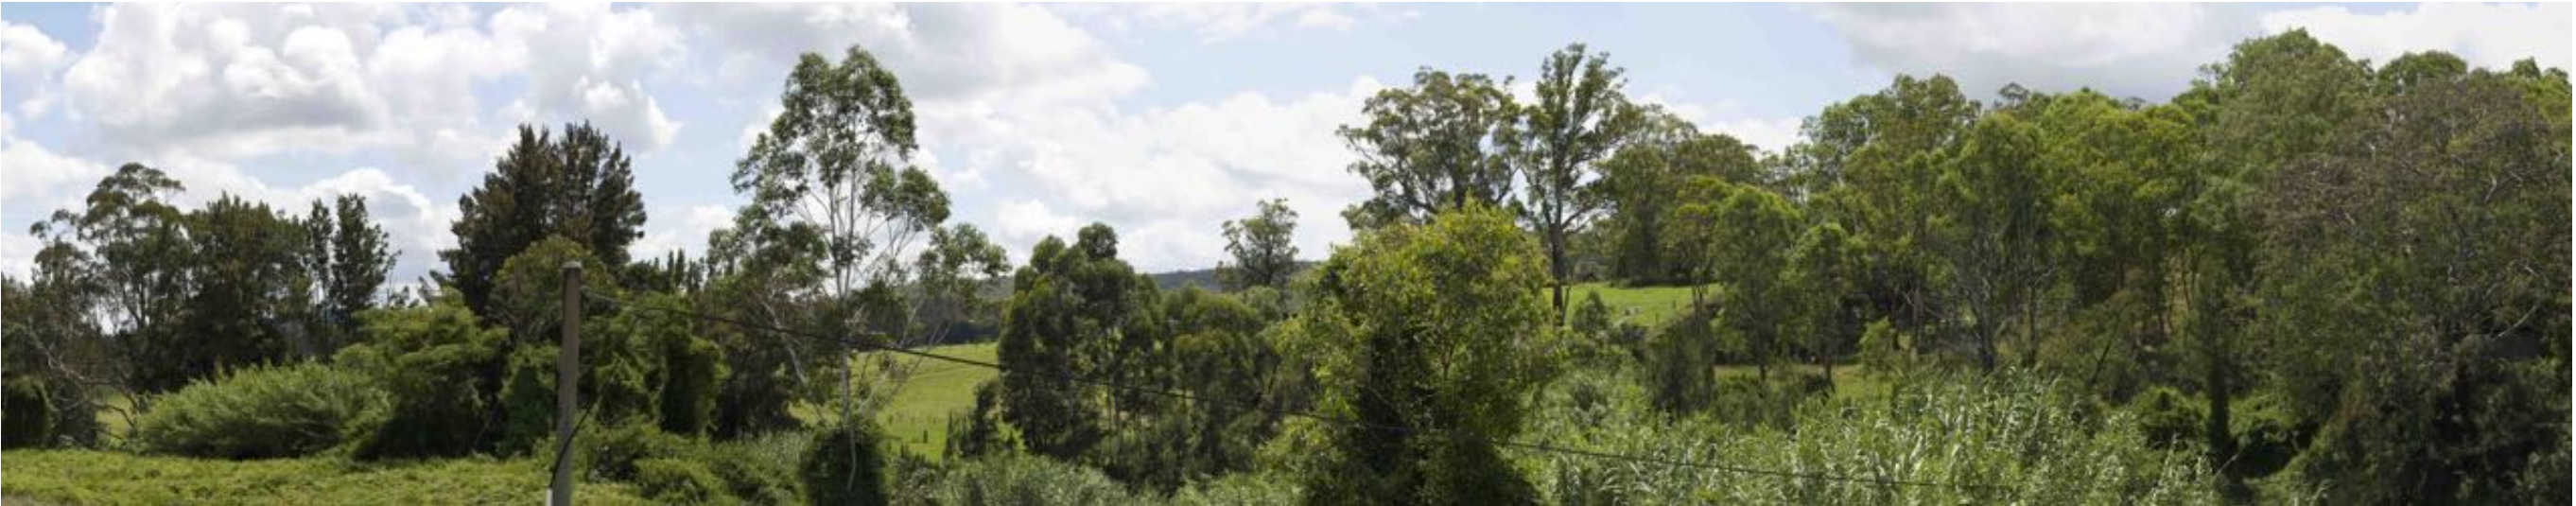
VIEWPOINT MC13A: Gostwych Bridge

COORDINATES	S 32° 33.896' E 151° 36.283'		
ELEVATION	31m		
VIEWING DIRECTION	North East		
DISTANCE TO SITE	1.55km		
LCU	Martins Creek Rural		
VISUAL EFFECT	Low		
VISUAL IMPACT	Low

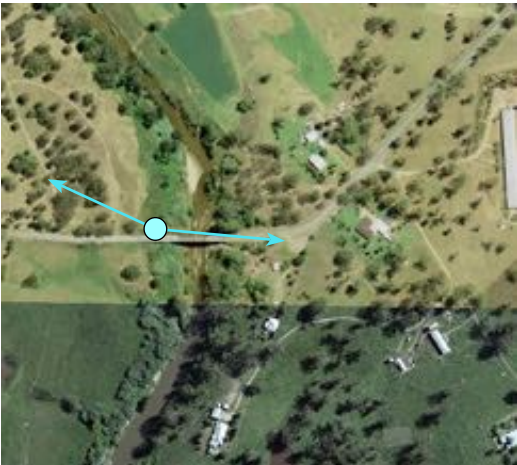
MC13 Viewpoint Location

VIEWPOINT MC13			
SUMMARY OF VIEWPOINT		VIEWPOINT DESCRIPTION	POTENTIAL VISUAL IMPACT
LOCATION	Gostwych Bridge	View looking north east from Gostwych Bridge at the Paterson River crossing of Dungog Road. The surrounding landscape is characterised by the main travel corridor and bridge of Dungog Road, connecting Martins Creek with the intersection of Gresford Road approximately 700m west. Surrounding rural properties are mostly open with scattered vegetation along the road corridor. The Paterson River and associated steep banks form a dominant feature as well as the dense riparian vegetation that screens surrounding views at road level. The visual sensitivity of this viewpoint is rated as moderate due to the land use as a main travel corridor and close proximity to the site.	Tree canopies visible on the distant hills from this viewpoint are likely to change as a result of trees being removed to accommodate the proposed works. It is likely views towards the change in vegetation would be fragmented by existing vegetation and unlikely to be discernible by motorists travelling along Dungog Road. The visual effect of this viewpoint has been rated as low and the resulting visual impact as low.

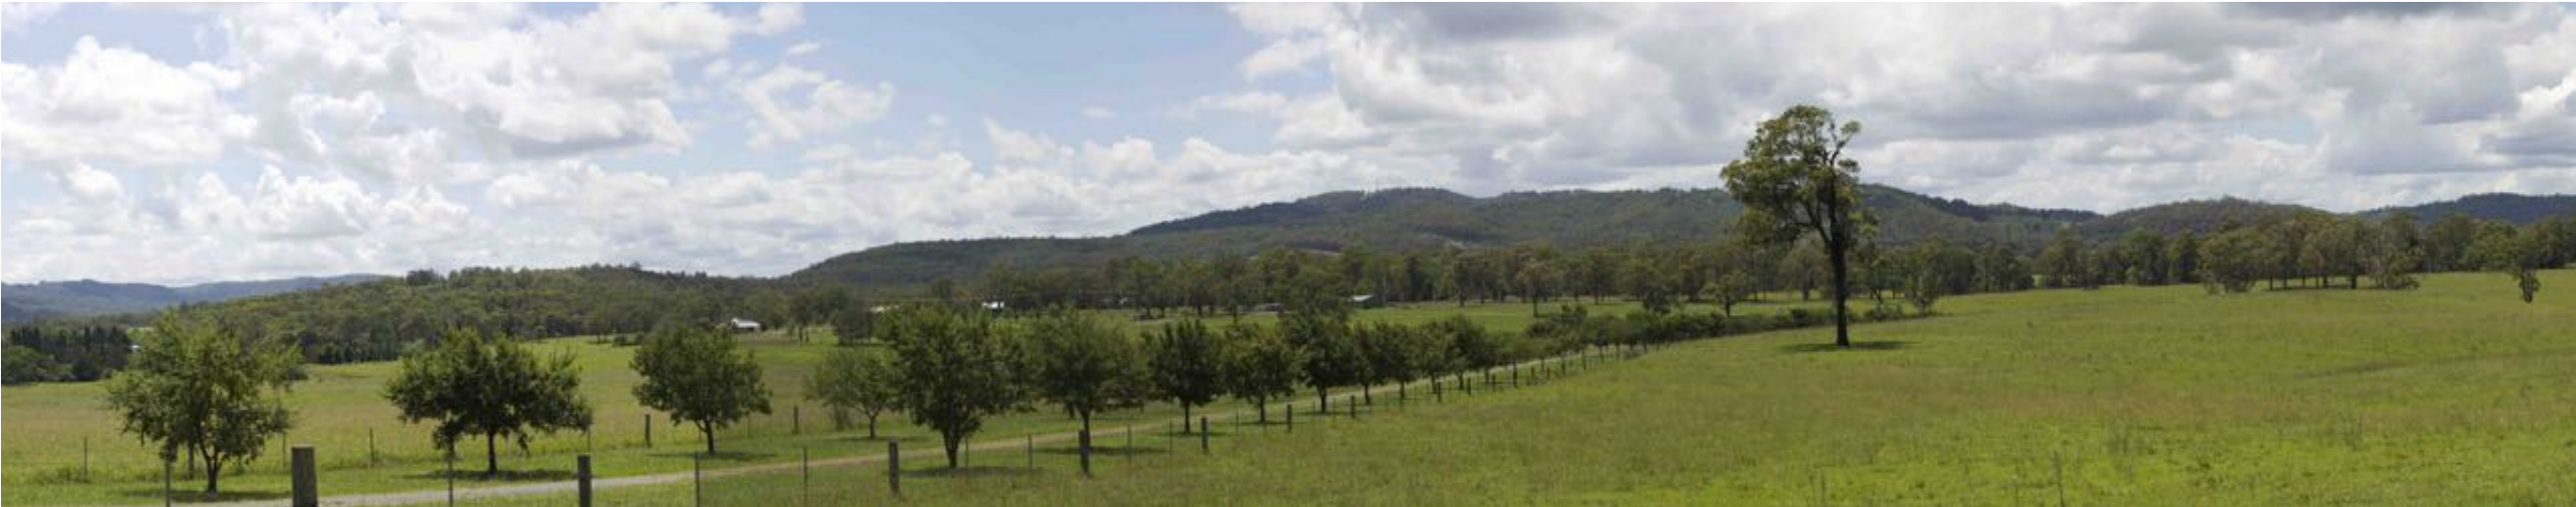
VIEWPOINT MC14B: Gresford Road zoomed and cropped from MC14A

VIEWPOINT MC14			
SUMMARY OF VIEWPOINT		VIEWPOINT DESCRIPTION	POTENTIAL VISUAL IMPACT
LOCATION	Gresford Road	View looking north east from Gresford Road, approximately 1km north from the intersection of Dungog Road. The surrounding landscape is characterised by the dominant vegetated mountain ranges to the north east, and open low lying rural properties with fragmented vegetation clusters. From this viewpoint the existing quarry excavation is evident to the north east within the mountain ranges. The visual sensitivity of this viewpoint is rated as moderate due to the land use and distance to the proposal.	From this viewpoint change to distant vegetation canopies and earthworks associated with the proposal is likely to be visible on the dominant mountain backdrop. The limited vegetation screening and surrounding properties results in a moderate visual effect and moderate visual impact.
COORDINATES	S 32° 33.503' E 151° 35.485'

ELEVATION	41m		
VIEWING DIRECTION	North East		
DISTANCE TO SITE	2.34km		
LCU	Mount Johnson		
VISUAL EFFECT	Moderate		
VISUAL IMPACT	Moderate

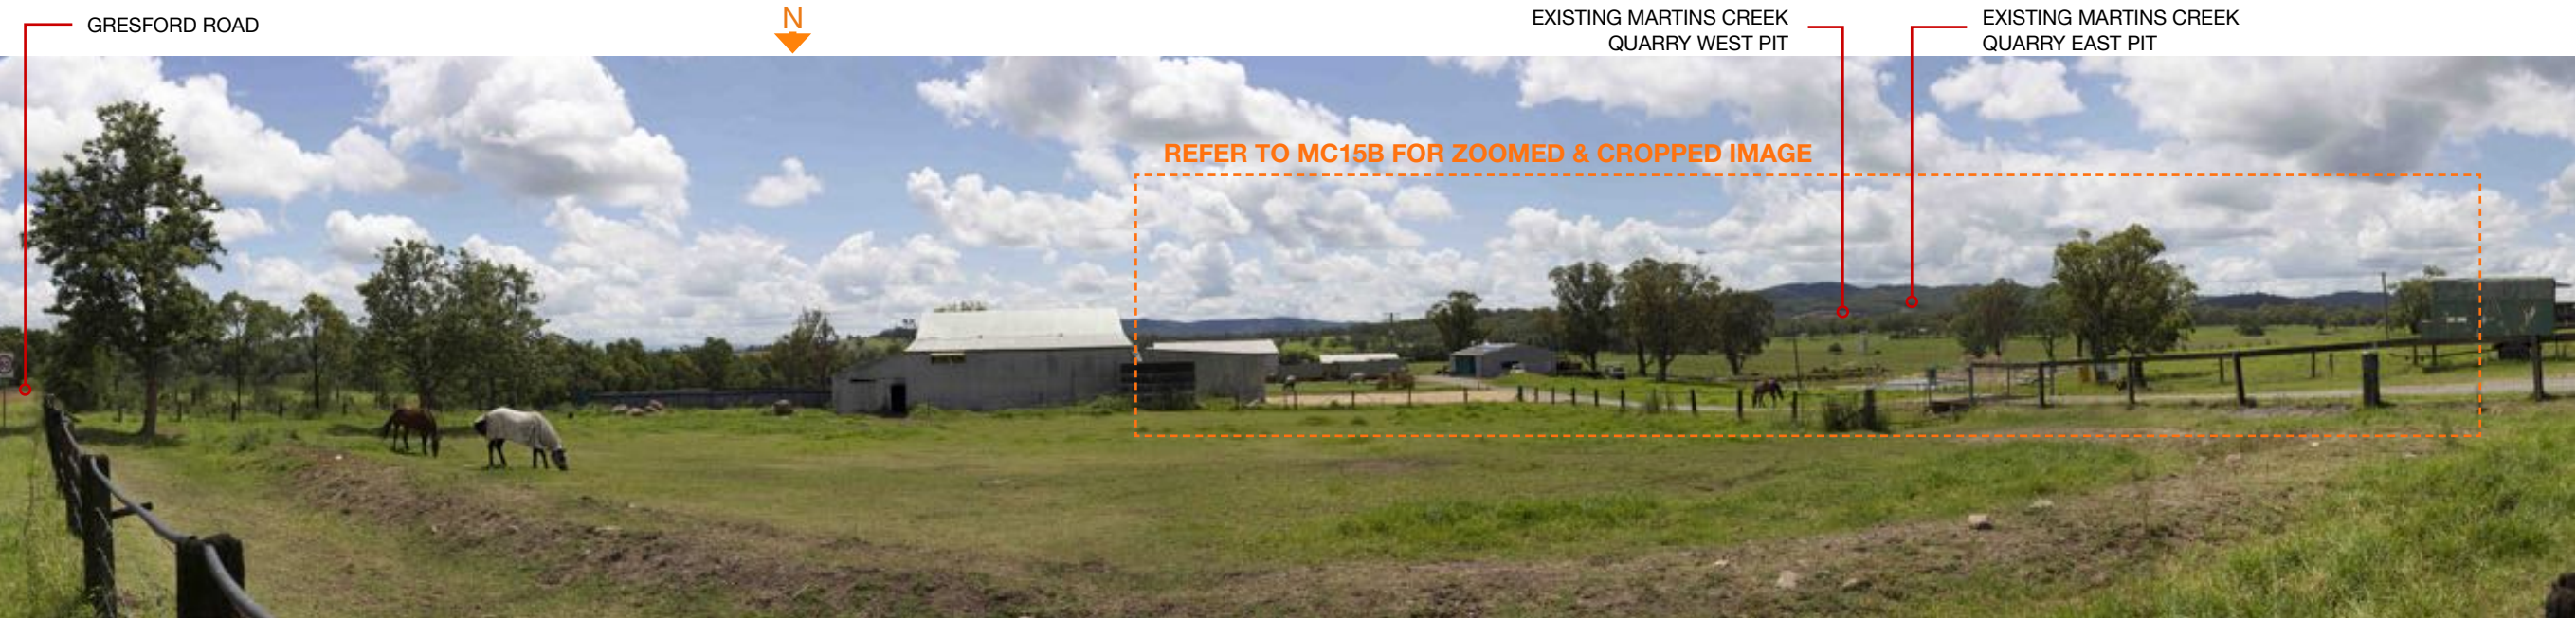
VIEWPOINT MC15A: Gresford Road

VIEWPOINT MC15			
SUMMARY OF VIEWPOINT		VIEWPOINT DESCRIPTION	POTENTIAL VISUAL IMPACT
LOCATION	Gresford Road	View north east from Gresford Road, near the entry to number 598. The surrounding landscape is predominantly cleared agricultural land with fragmented vegetation along boundaries. The distant mountains to the north east are a dominant characteristic of the landscape. The visual sensitivity of this viewpoint is moderate.	As a result of the existing quarry excavation being clearly visible, it is likely the proposal will change the natural ridgeline in the backdrop. The associated proposal is likely to change visible tree canopies and the natural topography. As a result of the proposed expansion the visual effect is likely to be moderate, resulting in a moderate visual impact. Refer to Photomontage 04.
COORDINATES	S 32° 33.327' E 151° 35.324'		
ELEVATION	39m		
VIEWING DIRECTION	North East

DISTANCE TO SITE	2.52km		
LCU	Paterson Rural		
VISUAL EFFECT	Moderate		
VISUAL IMPACT	Moderate
