Landscape & Visual Impact Assessment

PROPOSED MARTINS CREEK QUARRY EXPANSION

Prepared for: **DARACON**

Project No: **1149**

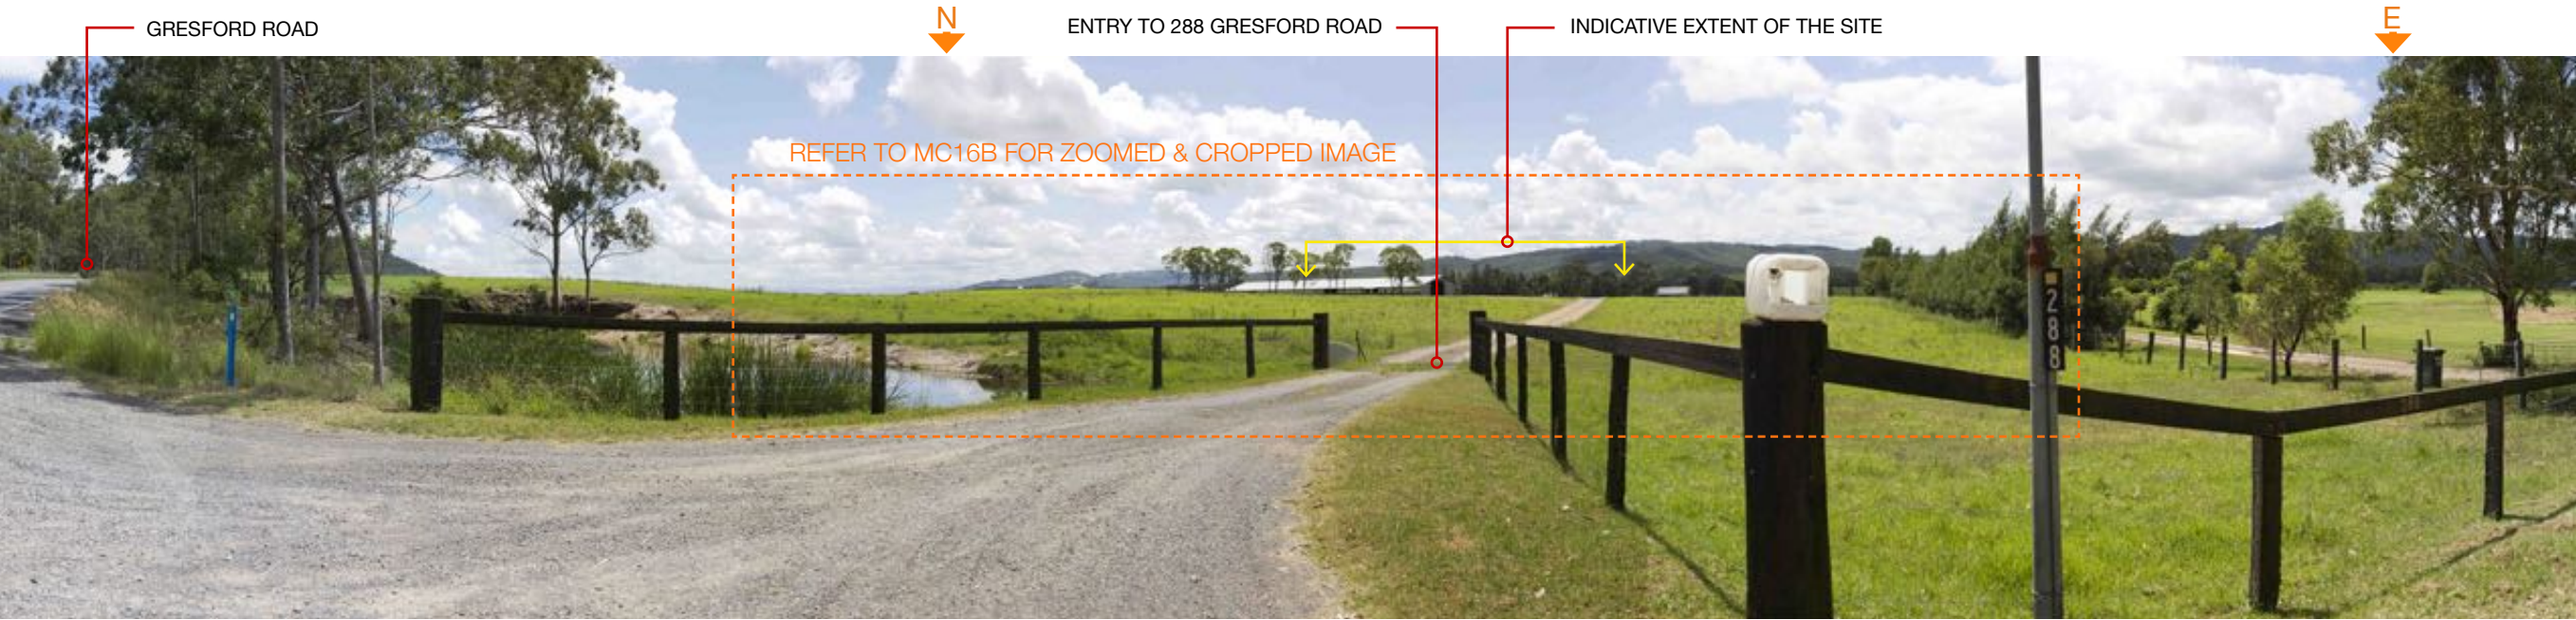
VIEWPOINT MC16A: Gresford Road

VIEWPOINT MC16			
SUMMARY OF VIEWPOINT		VIEWPOINT DESCRIPTION	POTENTIAL VISUAL IMPACT
LOCATION	Gresford Road	View north east towards the site from the entry to 288 Dungog Road, approximately 3.2km north west of Paterson town centre. The surrounding landscape is slightly undulating between rural residential properties with mostly open agricultural land, dense boundary vegetation and dominant views to the vegetated mountain backdrop beyond. The land use and distance to the site results in a moderate visual sensitivity.	The loss of vegetation associated with the proposal is likely to be visible to the north east. Vegetation and structures associated with the property will assist in screening views to the proposal. The visual effect of this viewpoint is rated as moderate and the resulting visual impact as moderate.
COORDINATES	S 32° 34.801' E 151° 36.121'		
ELEVATION	39m		
VIEWING DIRECTION	Generally North East

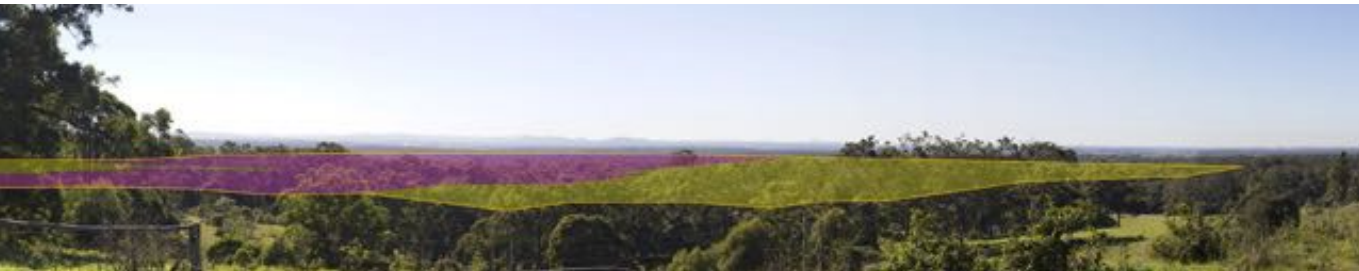
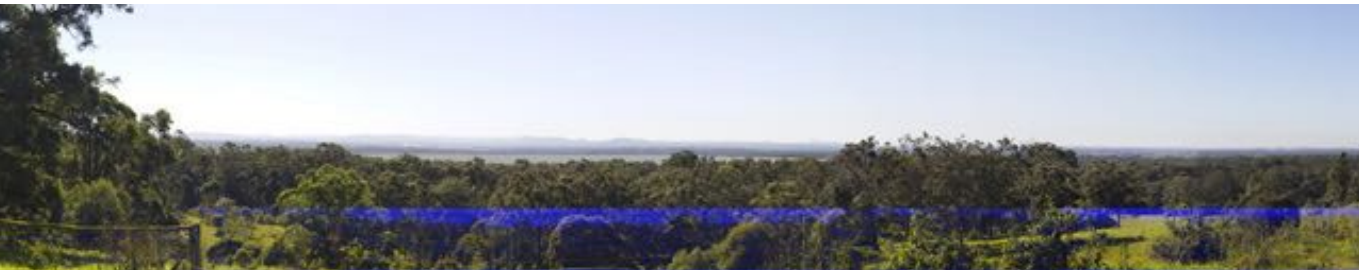
FIGURE 8: Photomontage development process (Moir LA, 2013)

Scaled perspective view of Digital Terrain Model placed over photograph of the existing landscape showing the extent of The Site.

Photomontage developed using a light grey colour to depict clearing of land zoned for industrial use (taking into account retained trees).

The photo simulations based on photography from typical sensitive viewpoints are included within the following analysis section. The images that the photo simulations have been based on have been were captured with a Canon EOS 50D Mark III Full Frame Digital SLR through a 50mm fixed focal lens which closely represent the central field of vision of the human eye. The process for photomontage development is demonstrated in the following example:

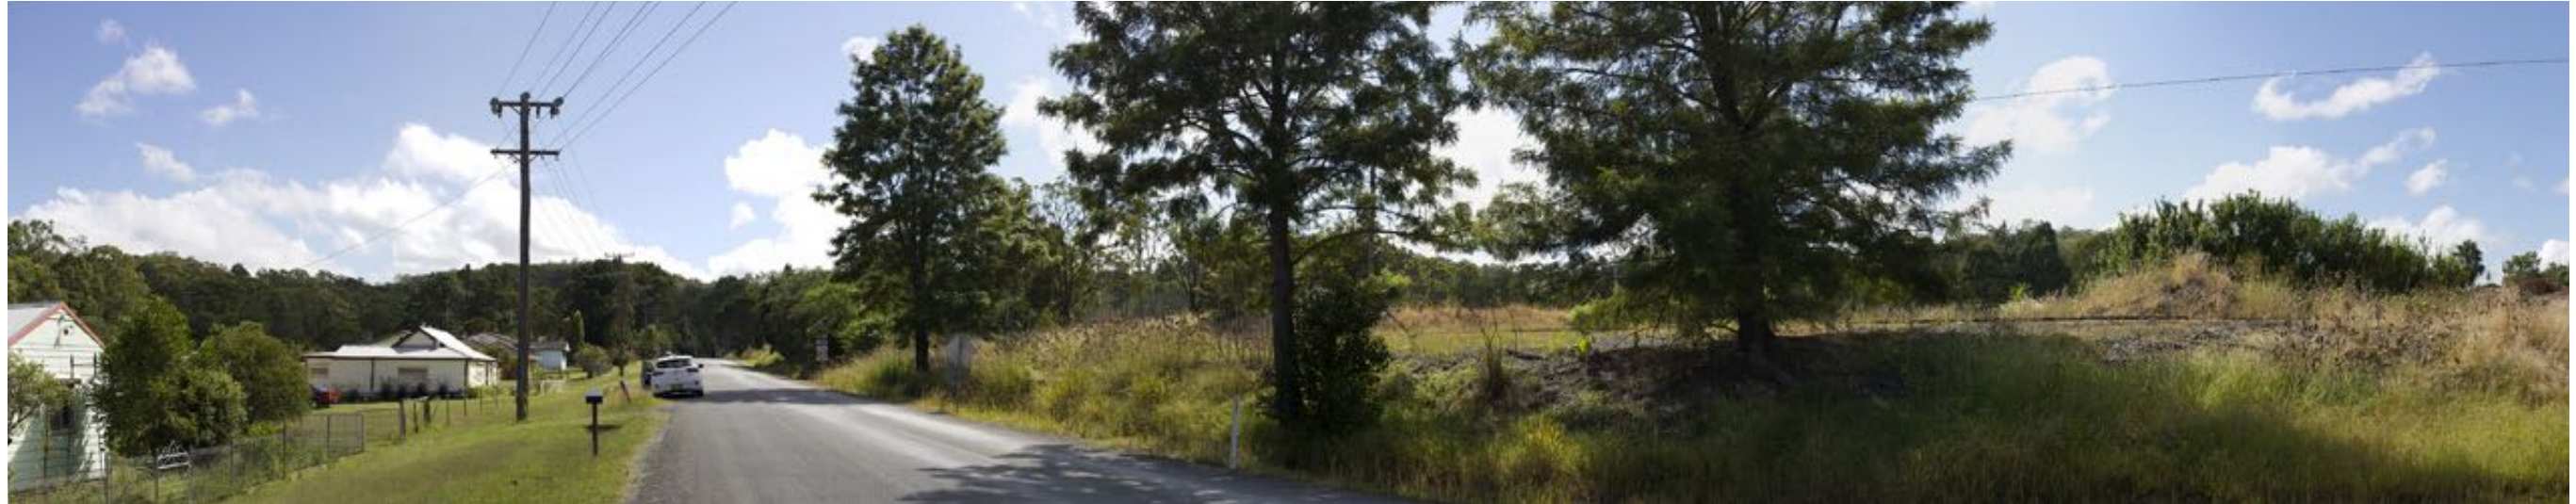
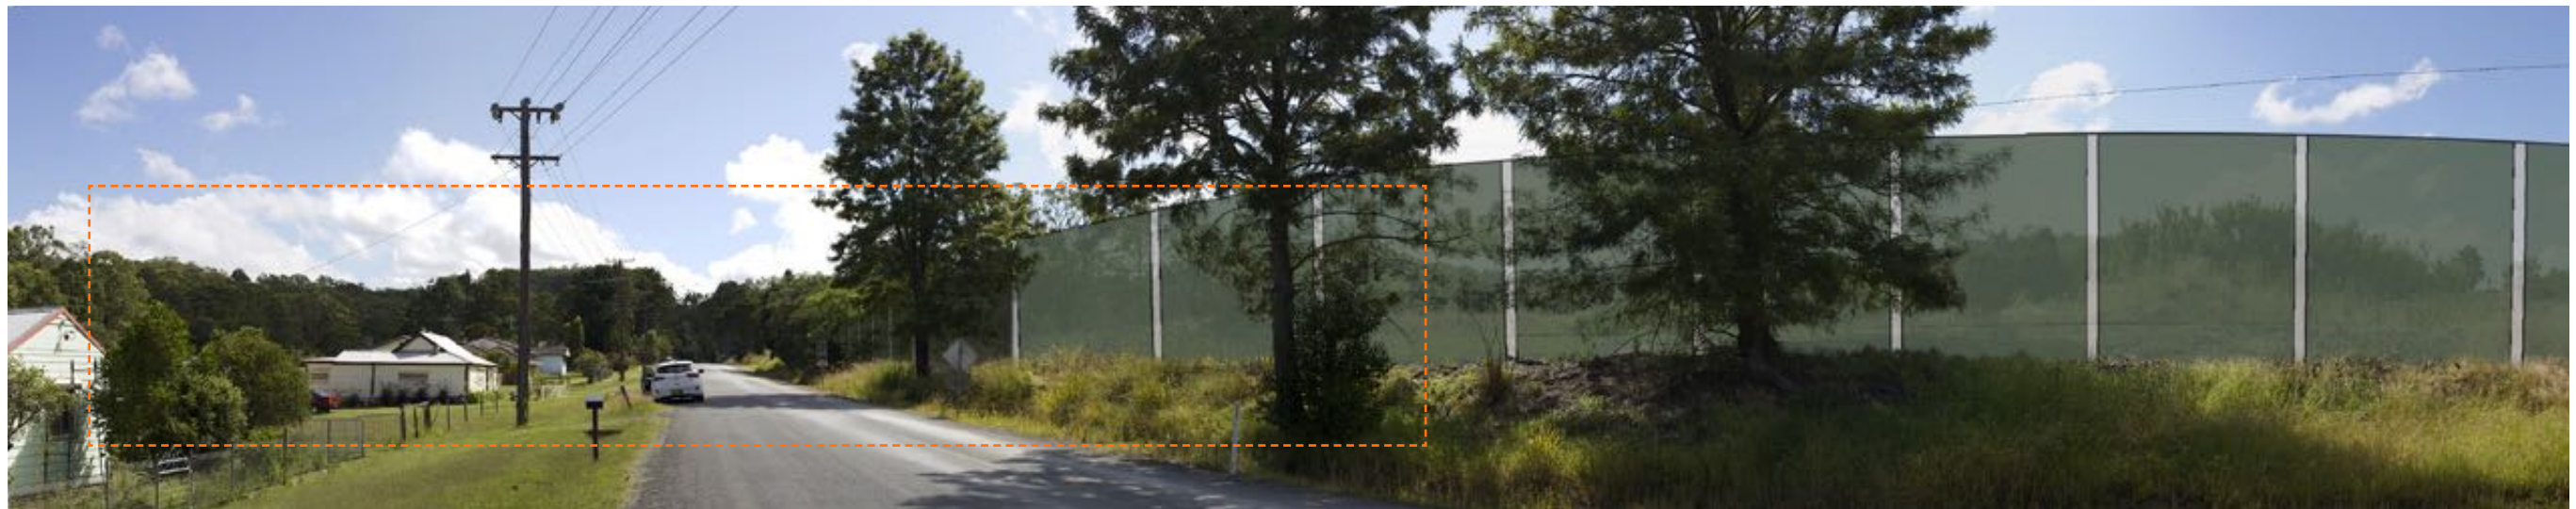
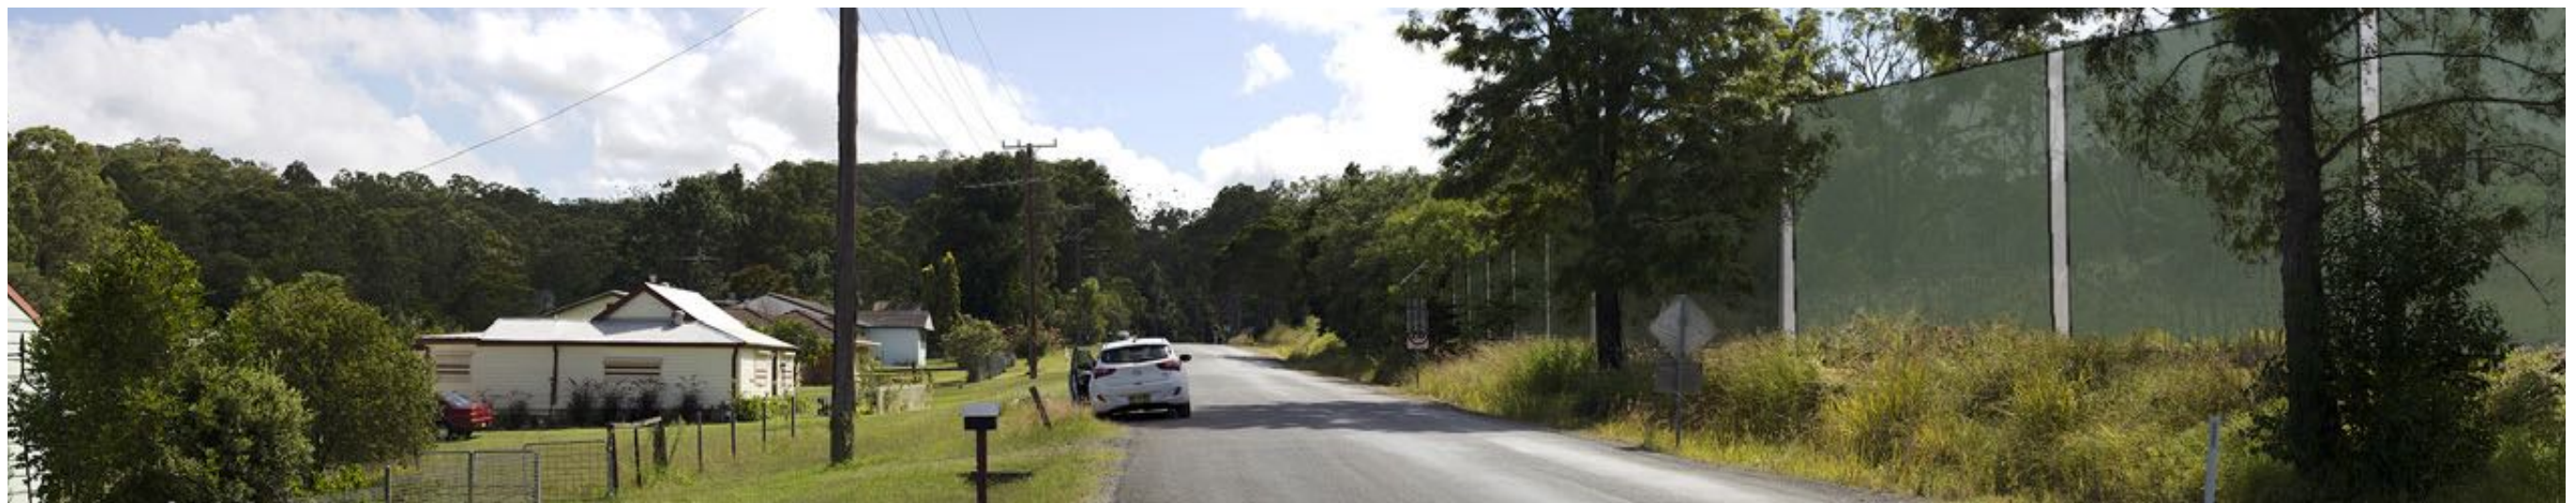
PHOTOMONTAGE 01A: Existing view from Station Street (Viewpoint MC01)

PHOTOMONTAGE 01B: Proposed view from Station Street (Viewpoint MC01)

PHOTOMONTAGE 01C: Image Zoomed and Cropped from PM01B.

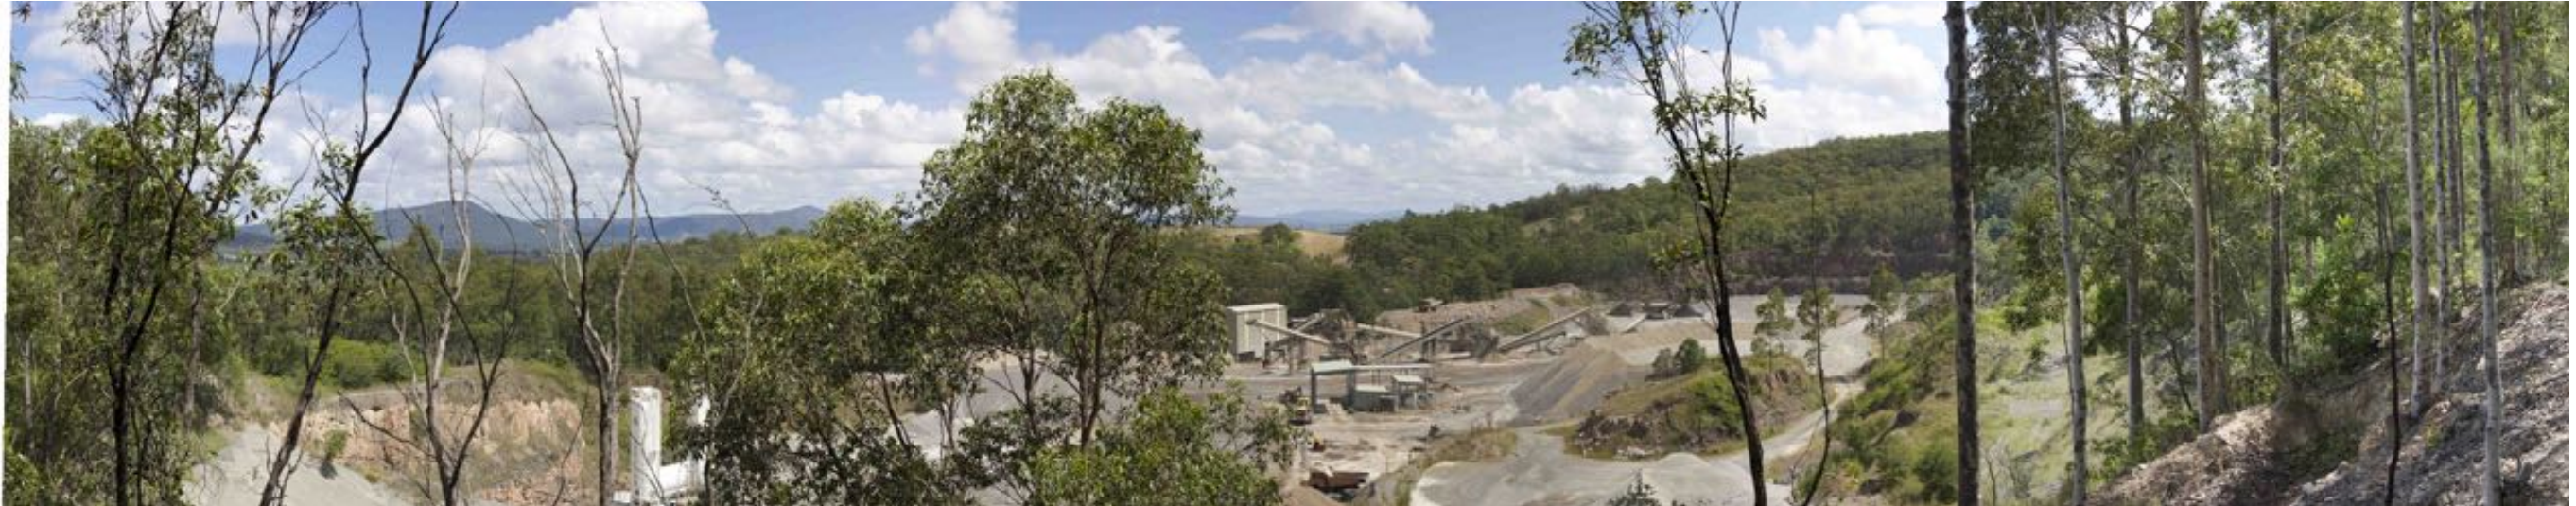
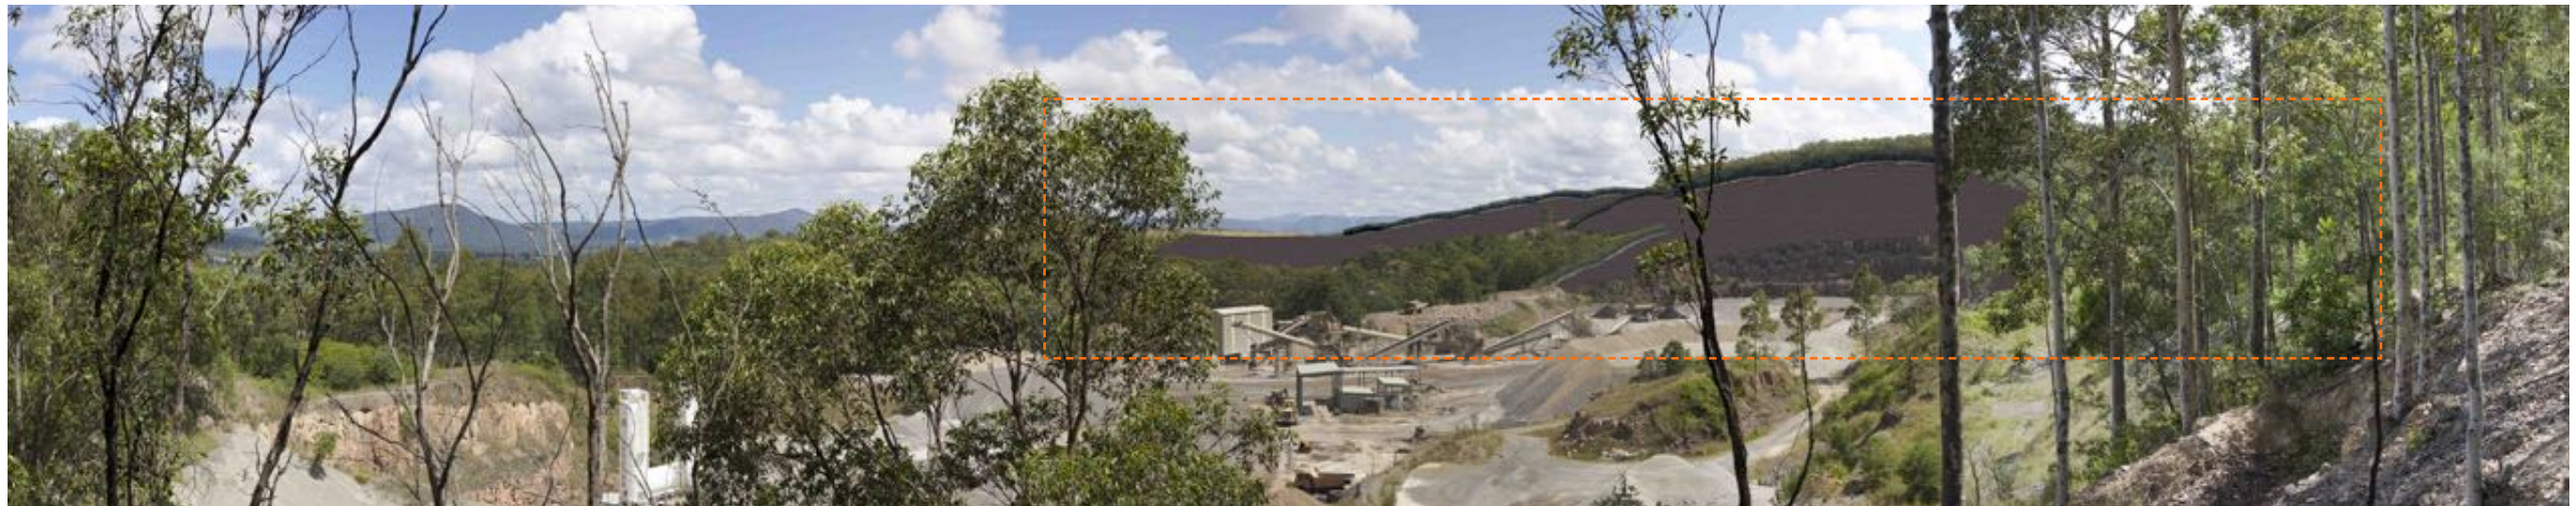
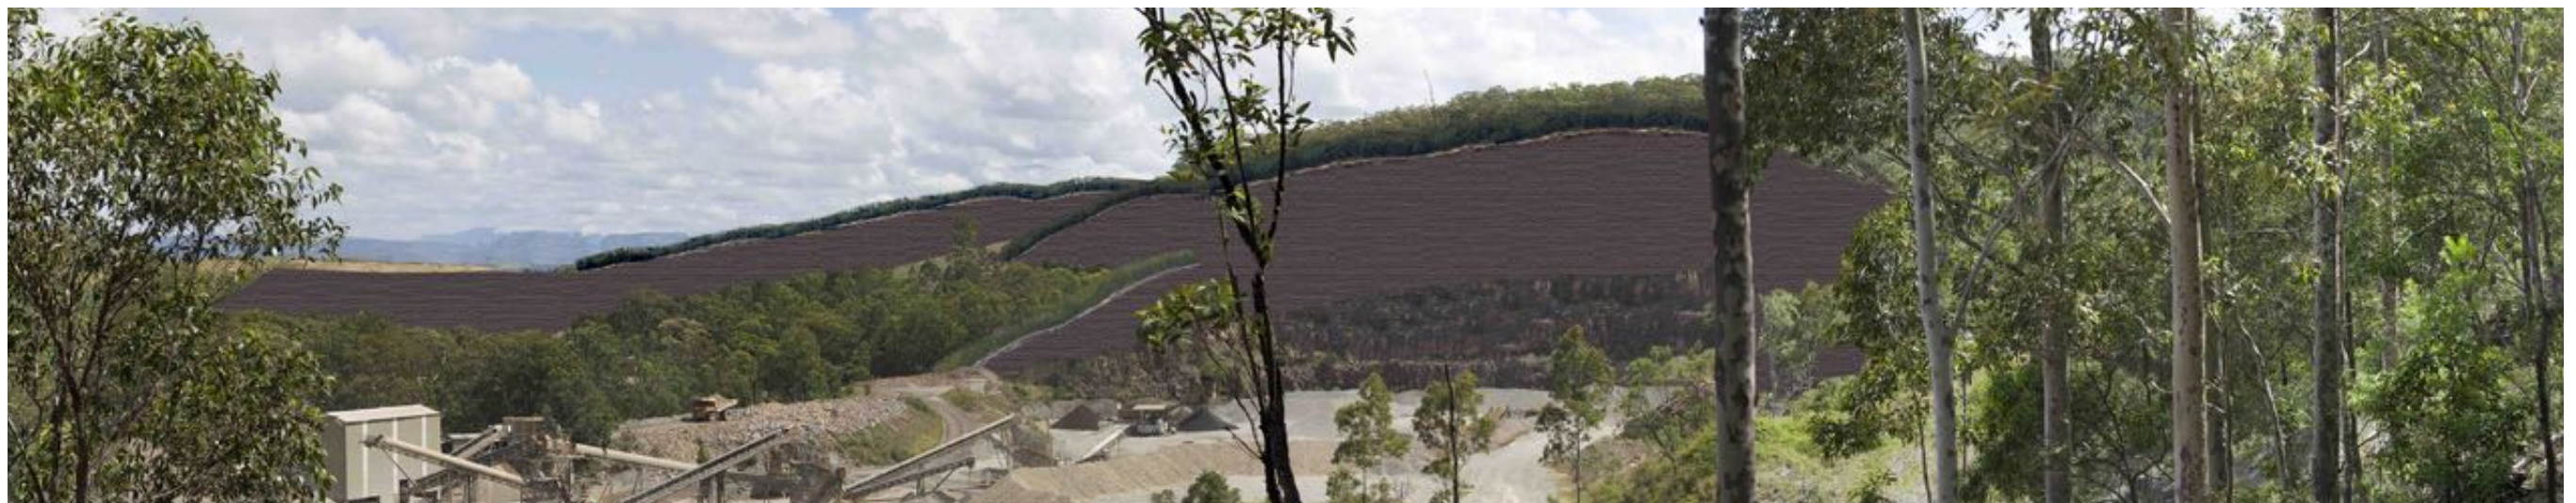
PHOTOMONTAGE 02A: Existing view from Douglas Voge Road (Viewpoint MC08)

PHOTOMONTAGE 02B: Proposed view from Douglas Voge Road (Viewpoint MC08)

PHOTOMONTAGE 02C: Image Zoomed and Cropped from PM02B.

VISUAL IMPACT	Moderate	
		POTENTIAL VISUAL IMPACT
		From this viewpoint change to vegetation and topography associated with the proposal is likely to be visible and unscreened. The proposed works would appear as an extension of the existing quarry. Due to the extent of existing disturbance to the natural topography the proposed quarry extension would have a low visual effect from this viewpoint. The resulting visual impact has been rated as moderate. Refer to photomontage 02.

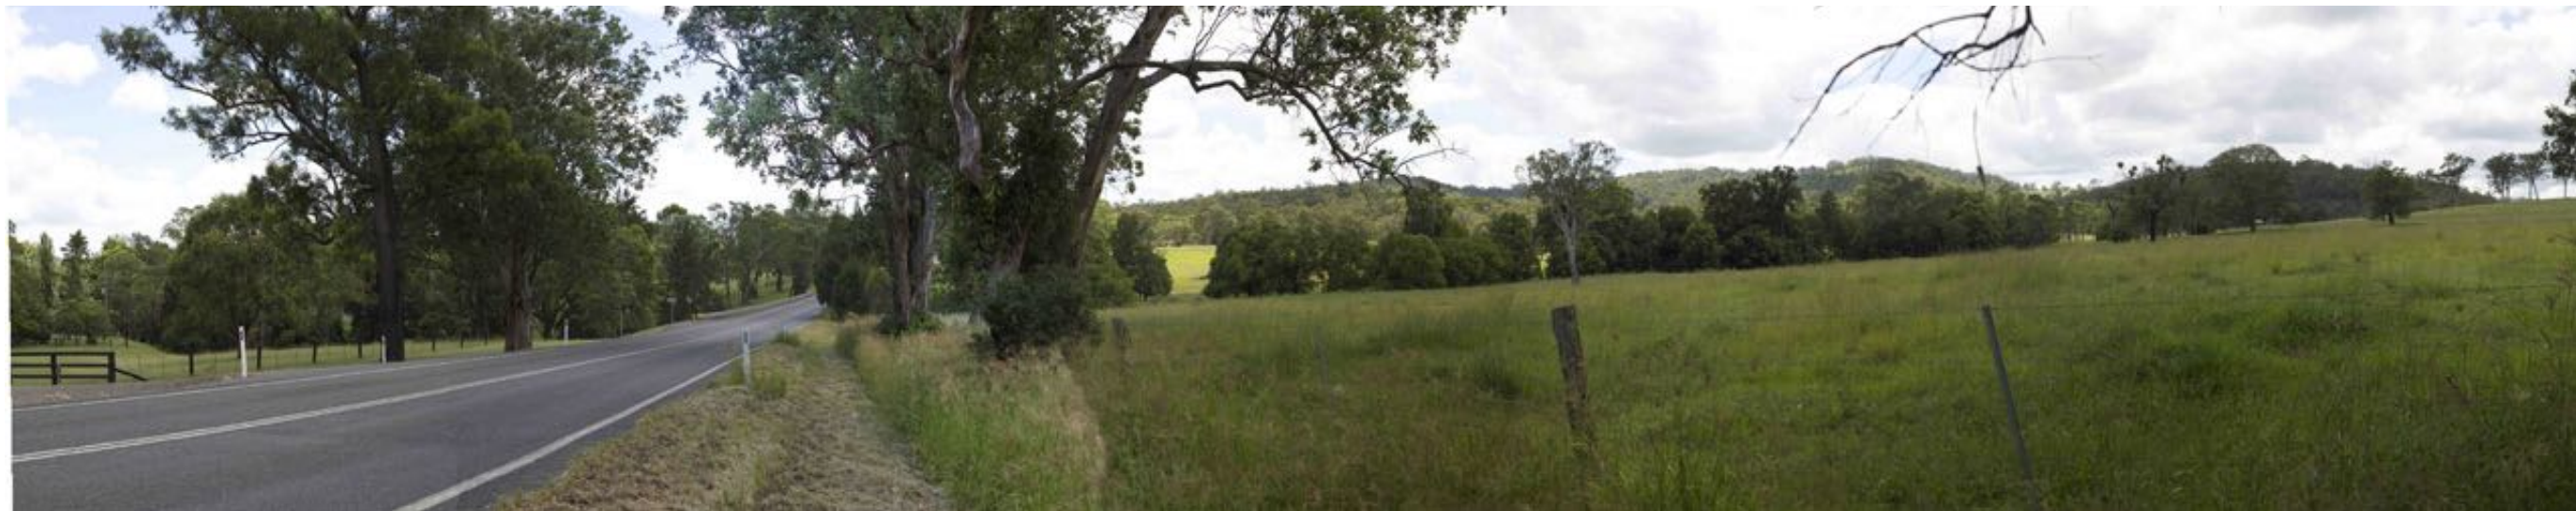
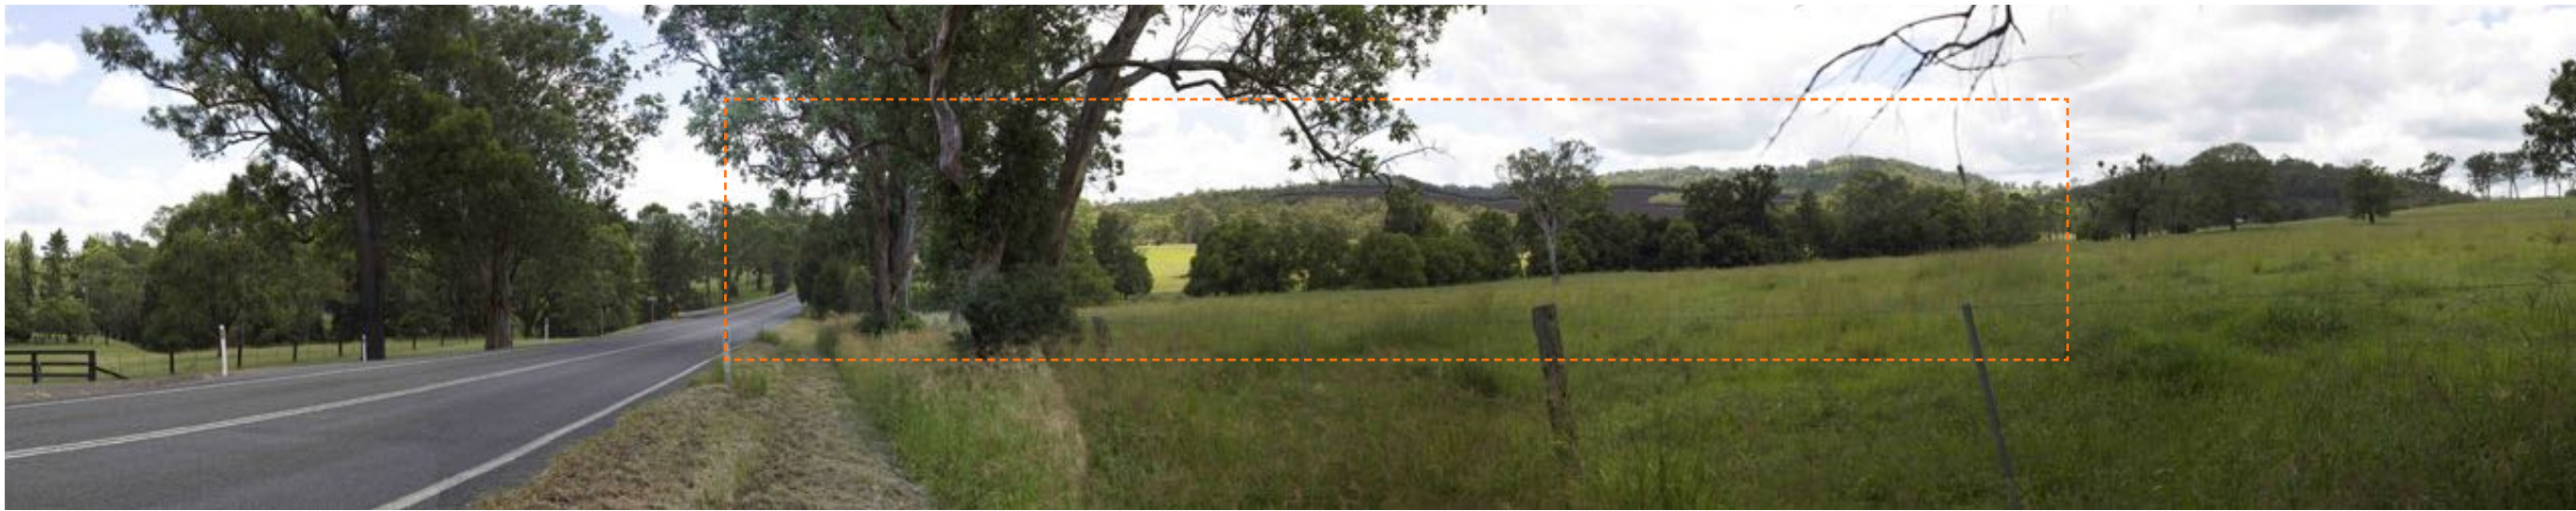
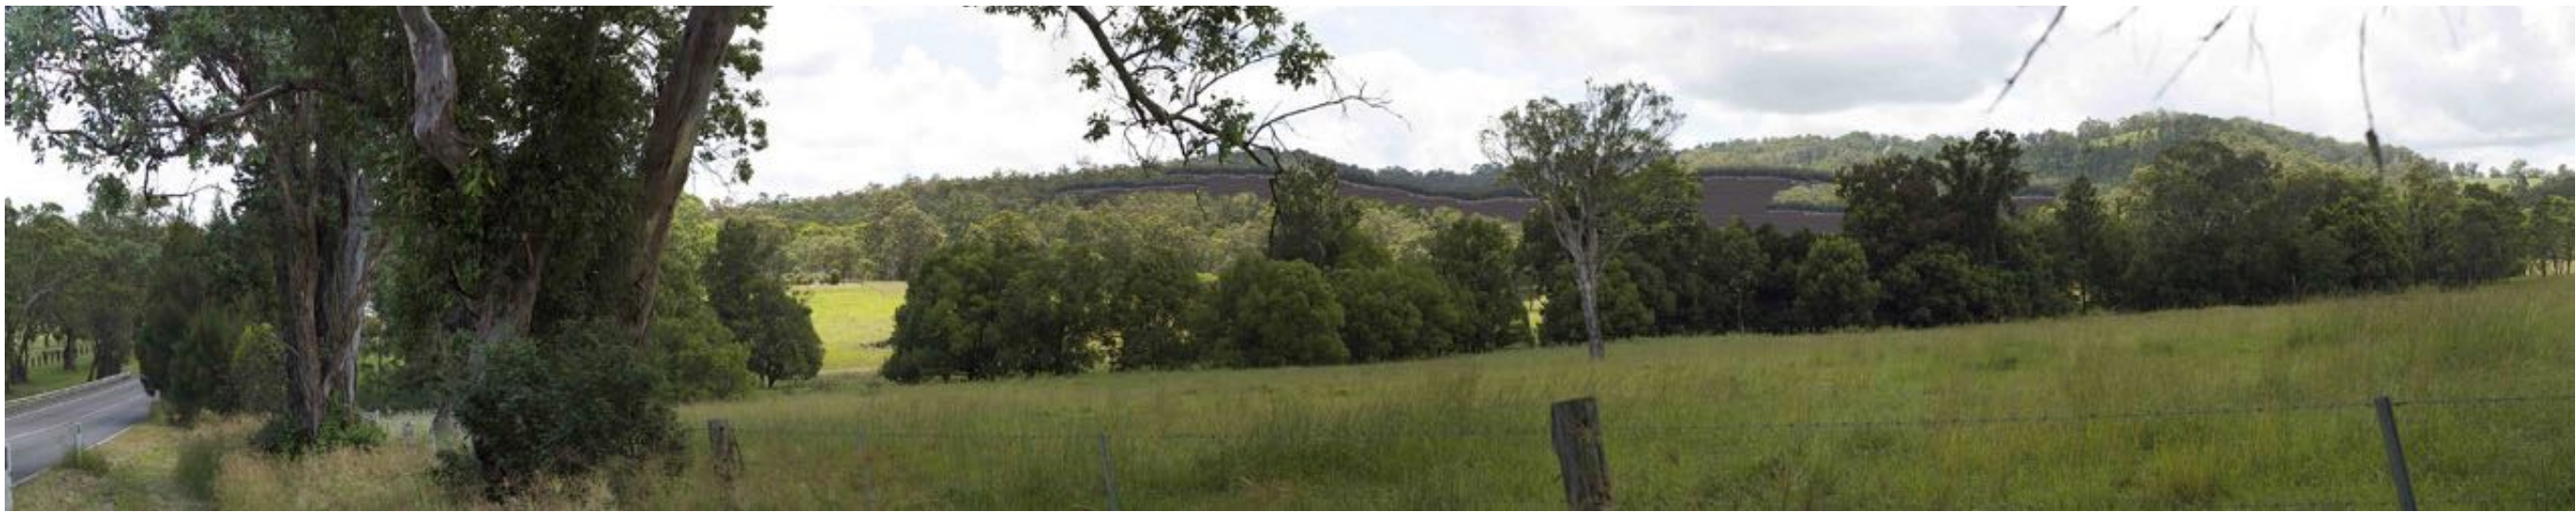
PHOTOMONTAGE 03A: Existing view from Dungog Road (Viewpoint MC12)

PHOTOMONTAGE 03B: Proposed view from Dungog Road (Viewpoint MC12)

PHOTOMONTAGE 03C: Image Zoomed and Cropped from PM03B.

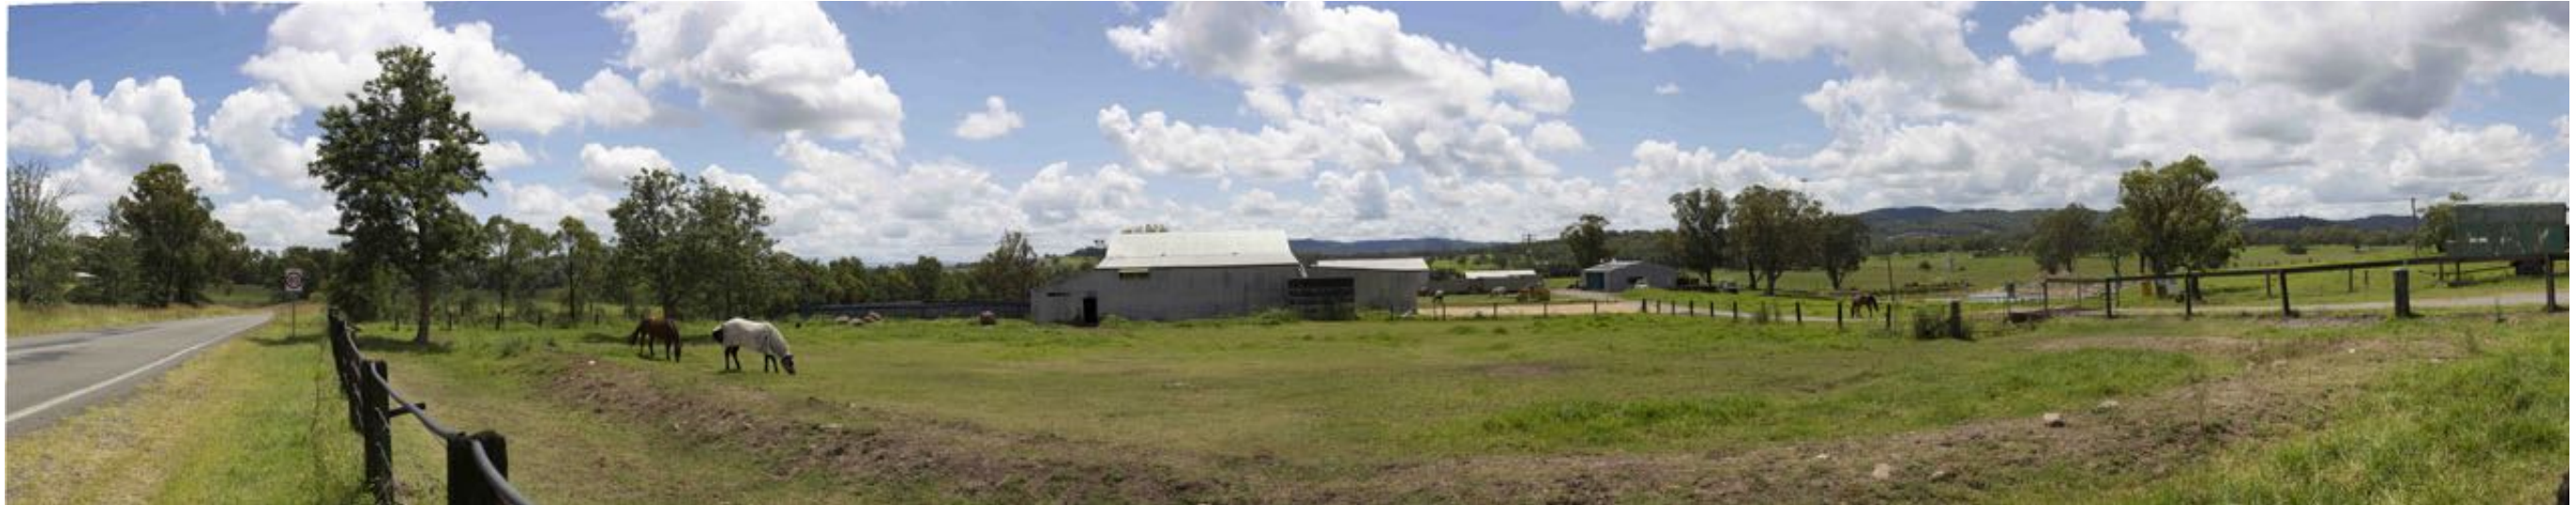
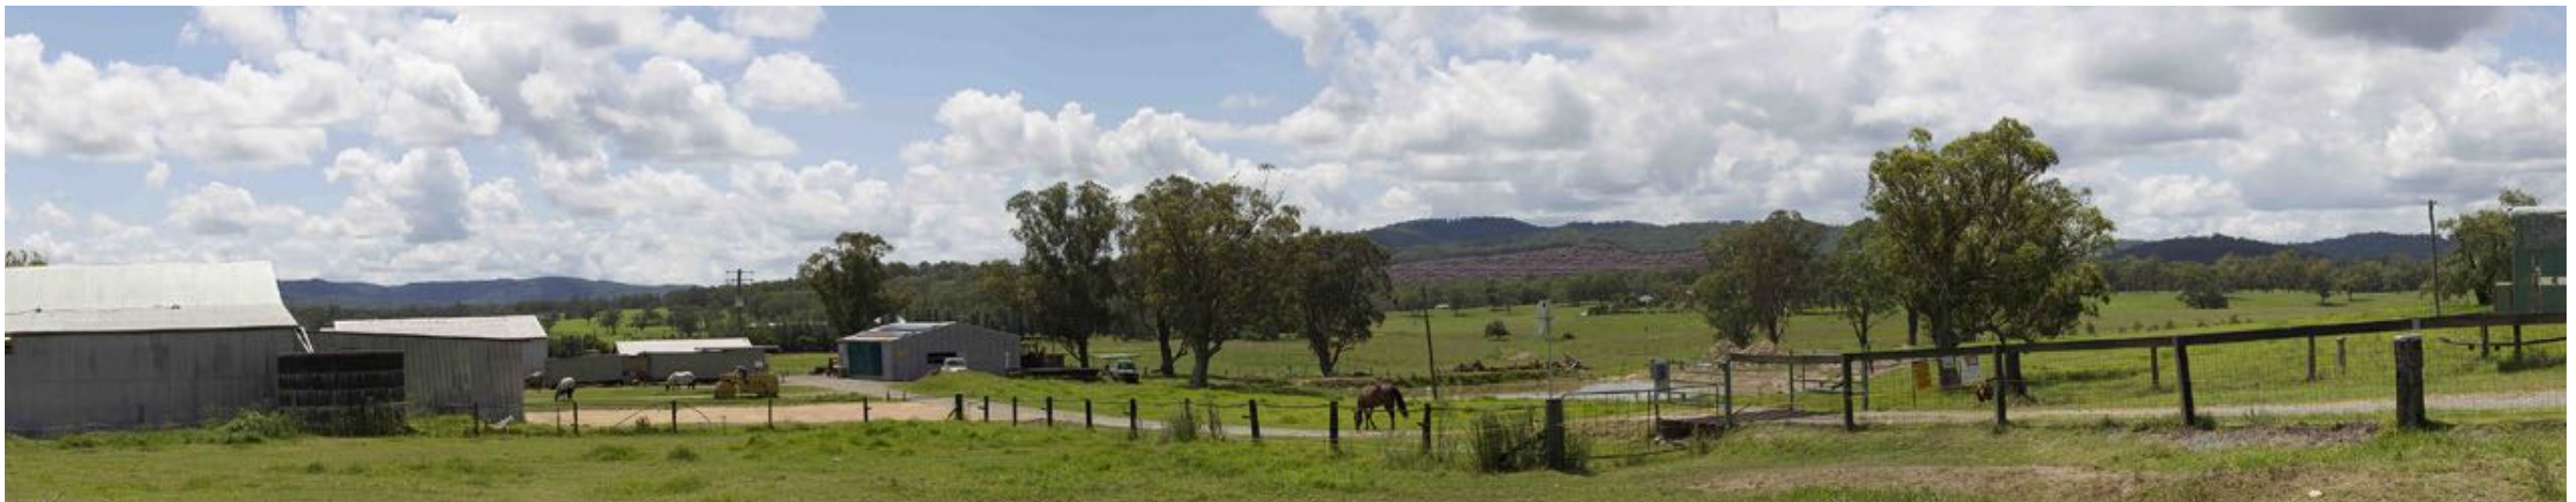
PHOTOMONTAGE 04A: Existing view from Gresford Road (Viewpoint MC15)

PHOTOMONTAGE 04B: Proposed view from Gresford Road (Viewpoint MC15)

PHOTOMONTAGE 04C: Image Zoomed and Cropped from PM04B.
