Enirgi Power Storage Recycling Consolidation Project
Environmental Impact Statement
Appendix M - O

Appendix M – Contaminated Site Assessment

Enirgi Power Storage Recycling Consolidation Project EIS Contaminated Site Assessment

July 2018

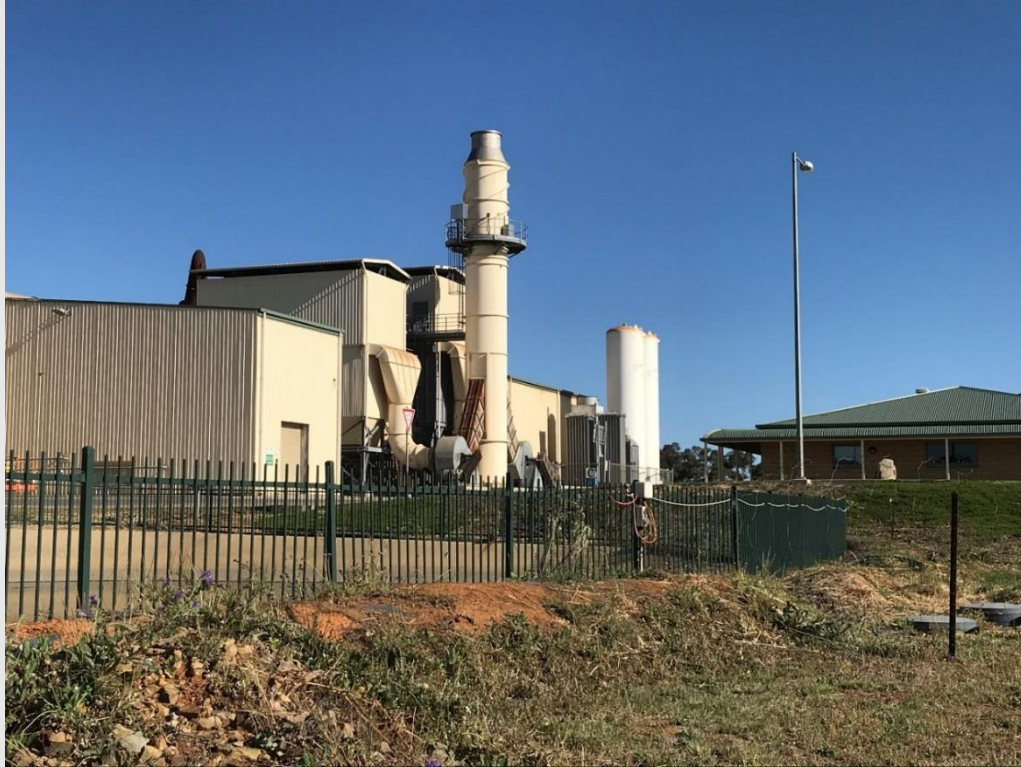
Plate 1 – Processing sheds and stacks. Photograph taken facing south-east. (19 July 2017)

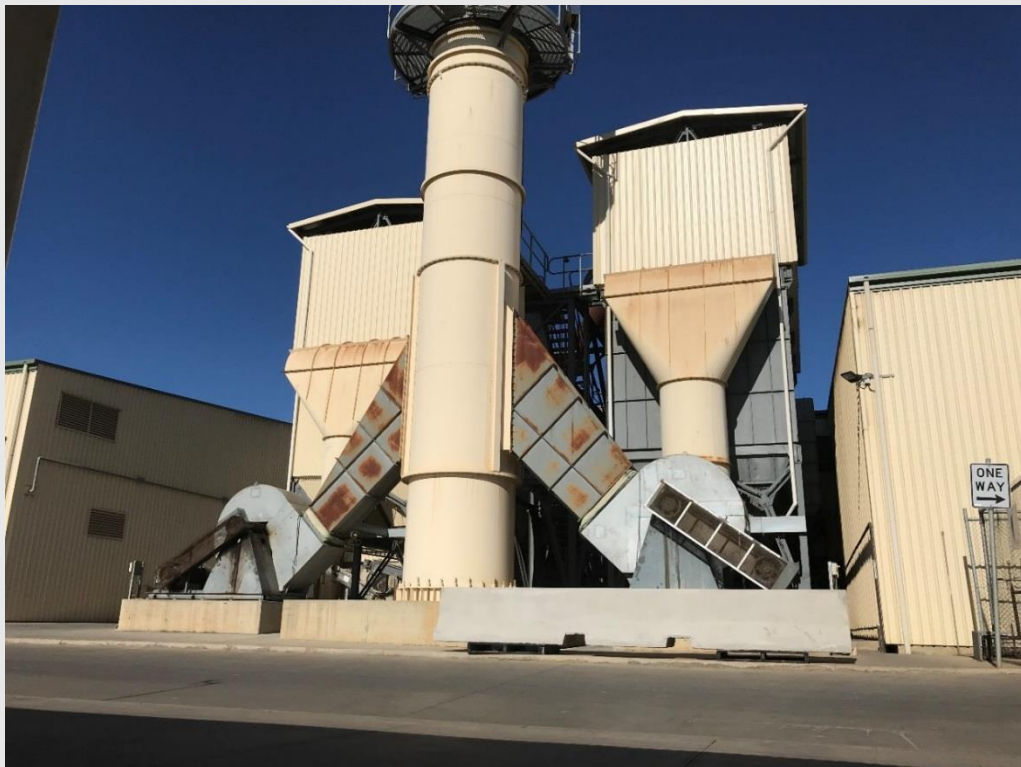
Plate 2 – processing infrastructure and heavy vehicle hardstand observed to be in good condition. Photograph taken facing east. (19 July 2017)

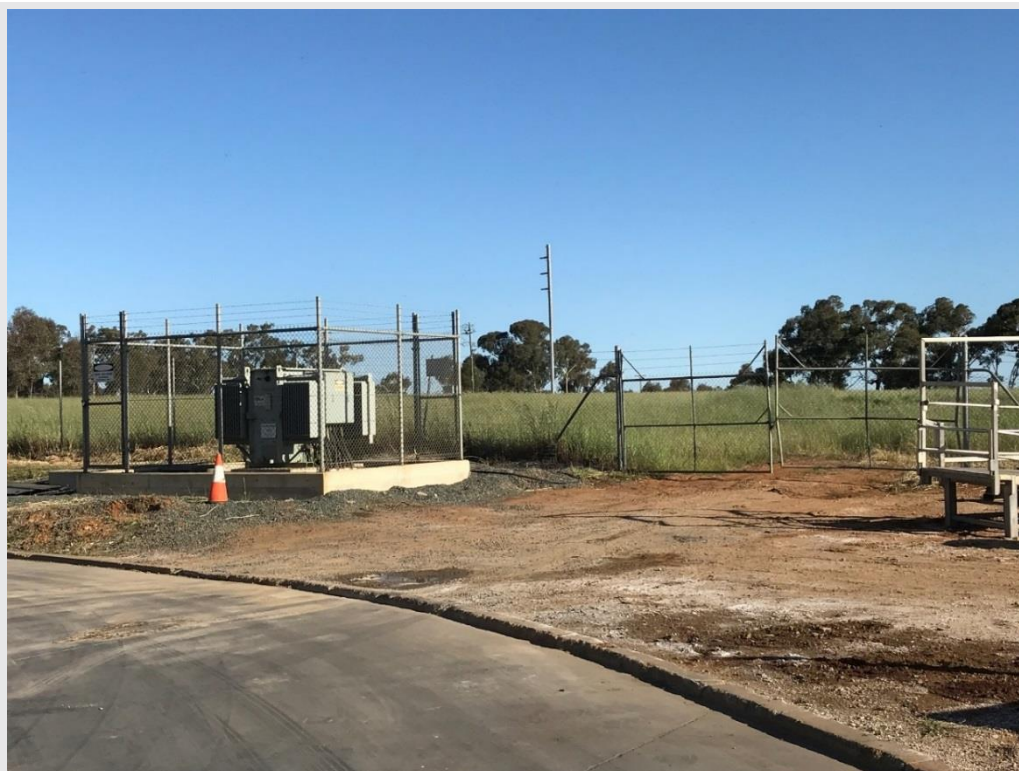
Plate 3 – Existing operational transformer on site. Photograph taken facing south-east. (19 July 2017)

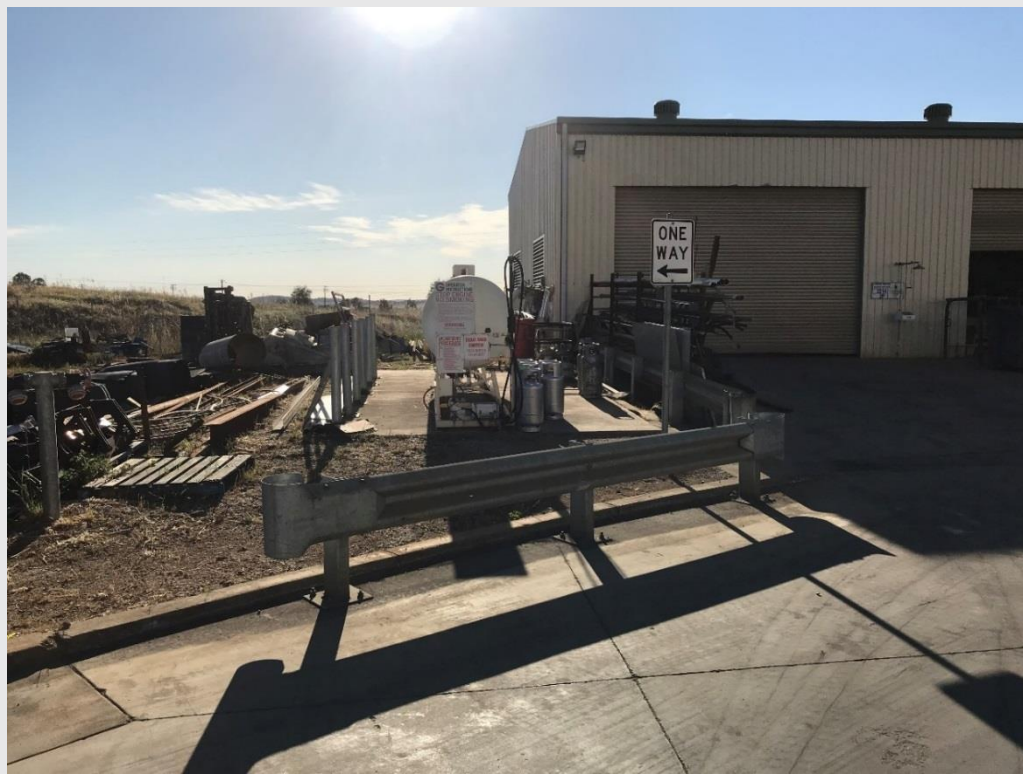
Plate 5 – Operational LPG AST on concrete hardstand. Photograph taken facing east. (19 July 2017)

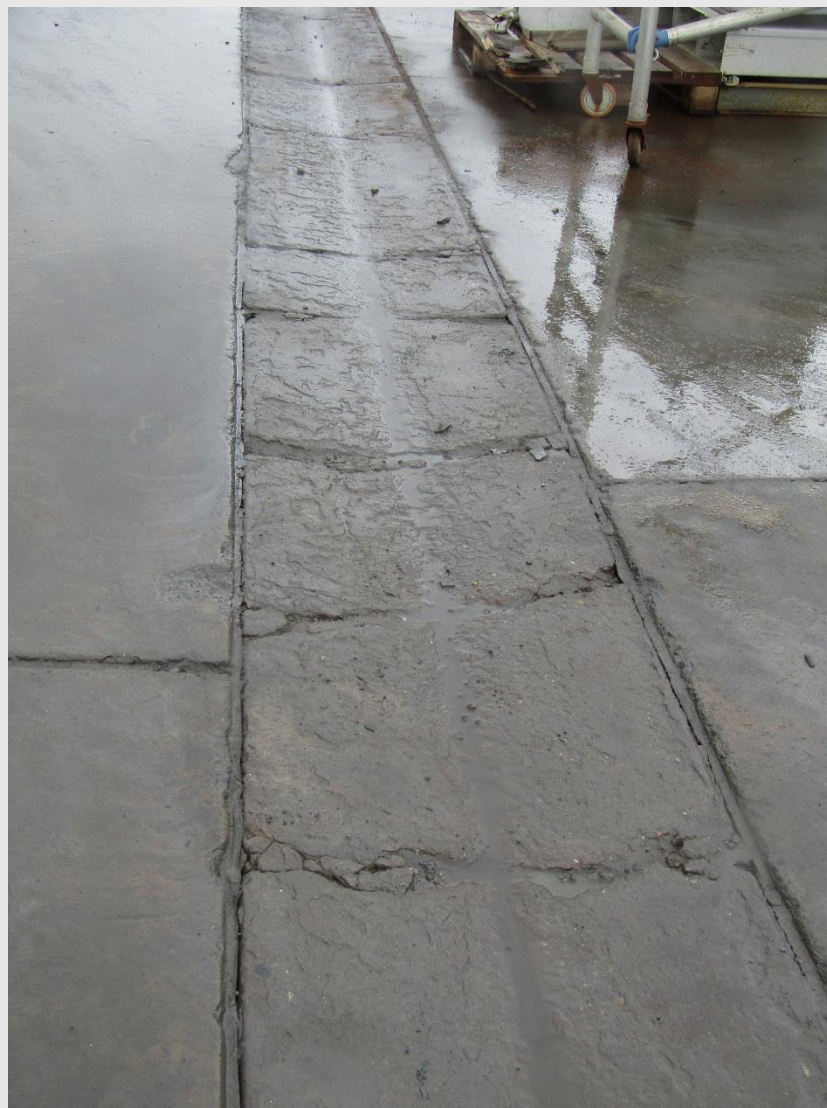
Plate 6 – Damaged concrete stormwater drainage line observed running adjacent to the heavy vehicle ring road. (19 July 2017)

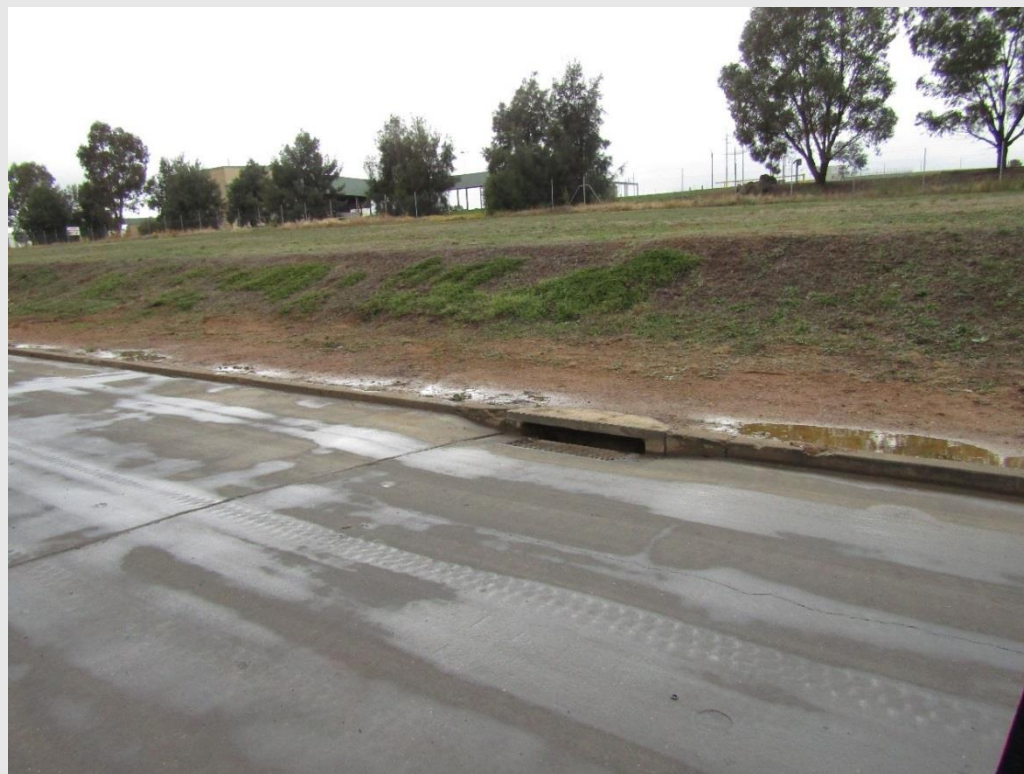
Plate 7 – Stormwater drain adjacent to the heavy vehicle ring road. Photo taken facing north-east. (19 July 2017)

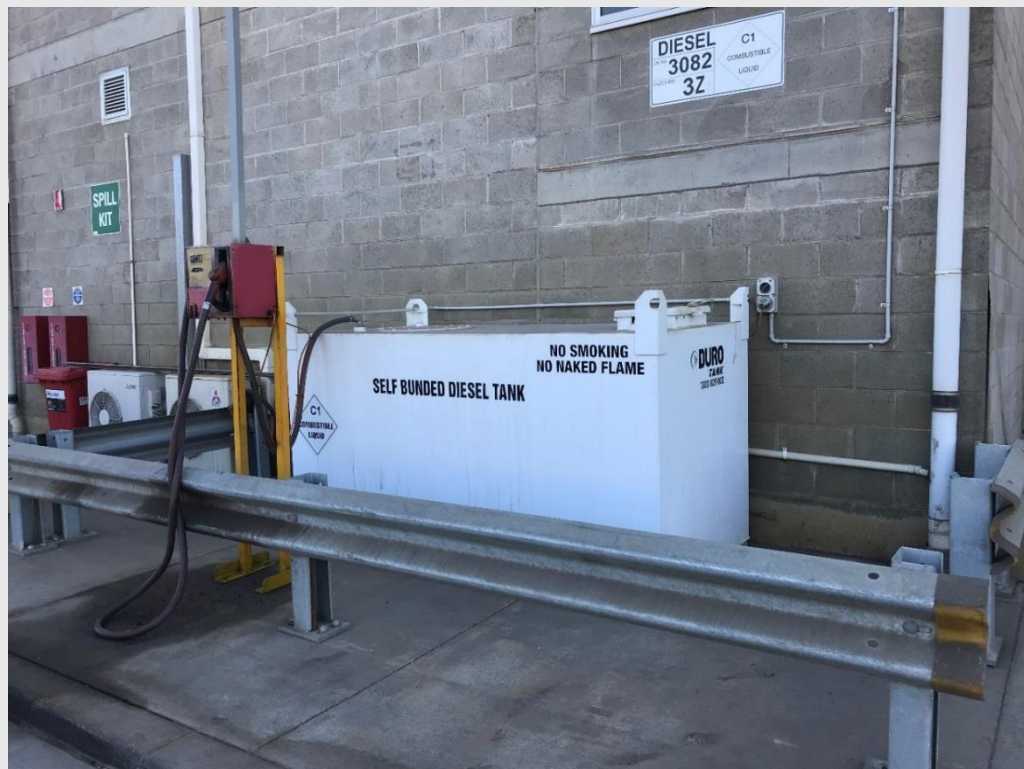
Plate 8 – Operational diesel AST adjacent to the heavy vehicle ring road. Photo taken facing north-west. (19 July 2017)

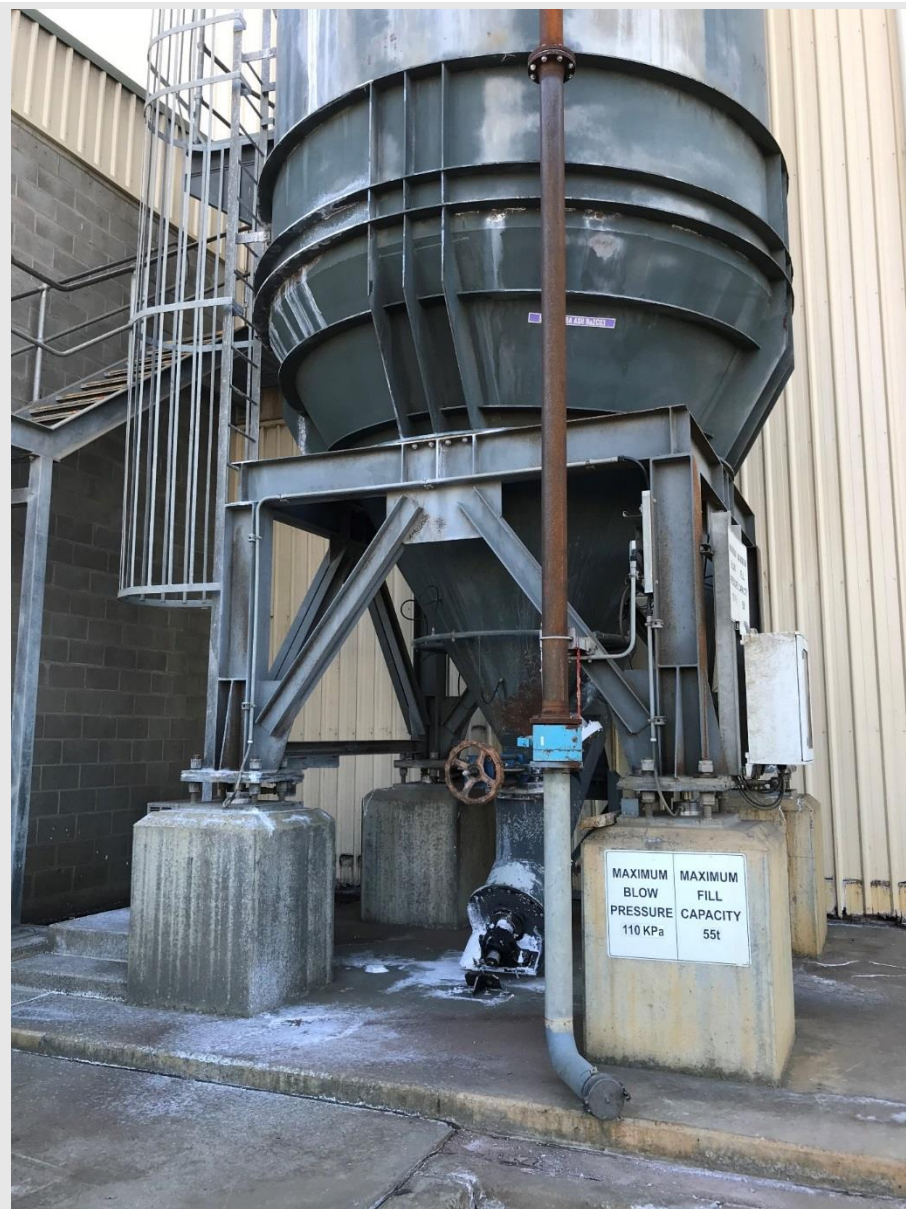
Plate 9 – Operational processes storage silo. (19 July 2017)

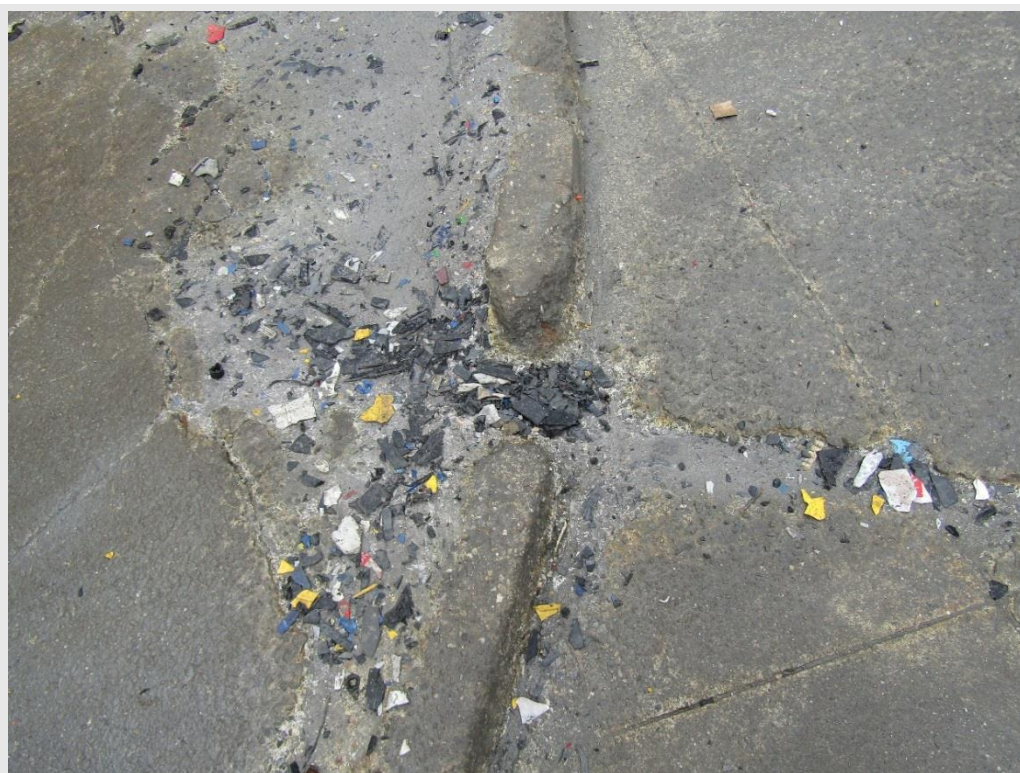
Potentially contamination activities	<p><i>Refuse:</i></p> <p>The open grassed surfaces of the site was generally observed to be free of litter and debris. Waste and recycling skip bins were noted across the hardstand areas of the site. General litter (plastics and paper waste) was noted</p>

Plate 10 – Example of general plastic refuse. Photo taken within process infrastructure hardstand area at centre of the site. (19 July 2017)

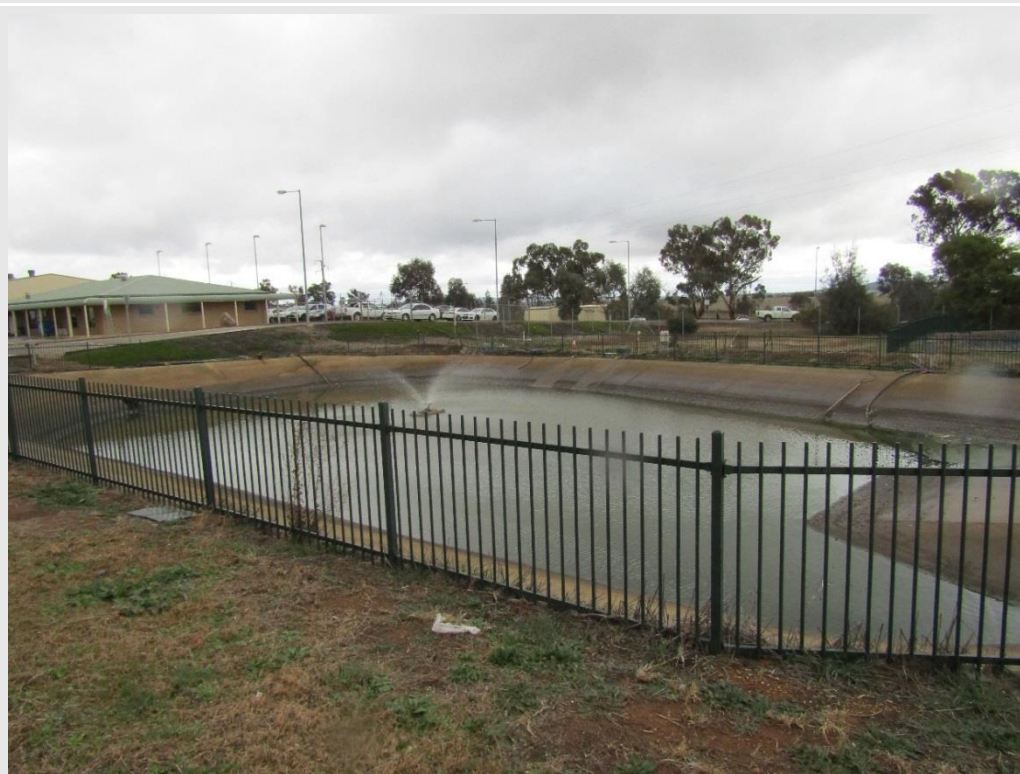
Plate 11 – Main stormwater retention basin in foreground. Site administrative building and carpark observed in the distance. Photo taken facing south-west. (19 July 2017)

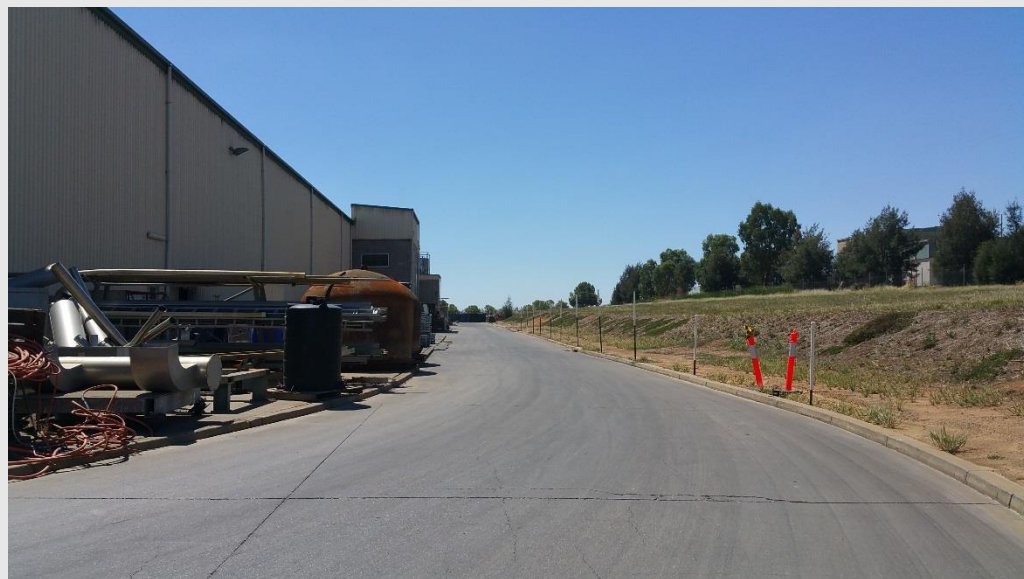
Plate 13 – The internal ring road. Embankment to the east is shown on the right hand side and the main warehouse is shown on the left hand side. (1 March 2018).

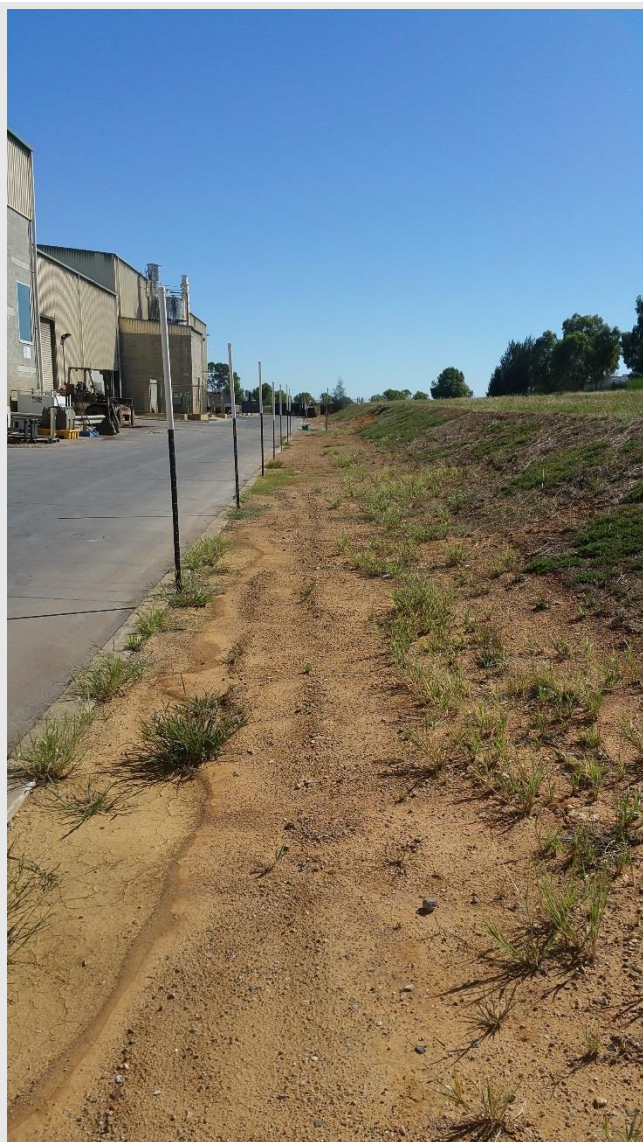
- The ground surface of this strip of soils was noted to be largely bare, with minimal vegetation. The side slope and top of the embankment (BH103) was vegetated by grass which appeared to be in good condition.
- At BH105, which was located immediately east of the main warehouse building, the ground surface comprised a layer of ballast. The ballast was underlain by fill materials of similar appearance to other investigation locations near the ring road.
- In the open paddock irrigation area (BH111 and BH112), the ground surface was vegetated. No obvious sign of vegetation distress was observed.

Plate 14 – Bare strip of soils between the ring road and the embankment. (1 March 2018)

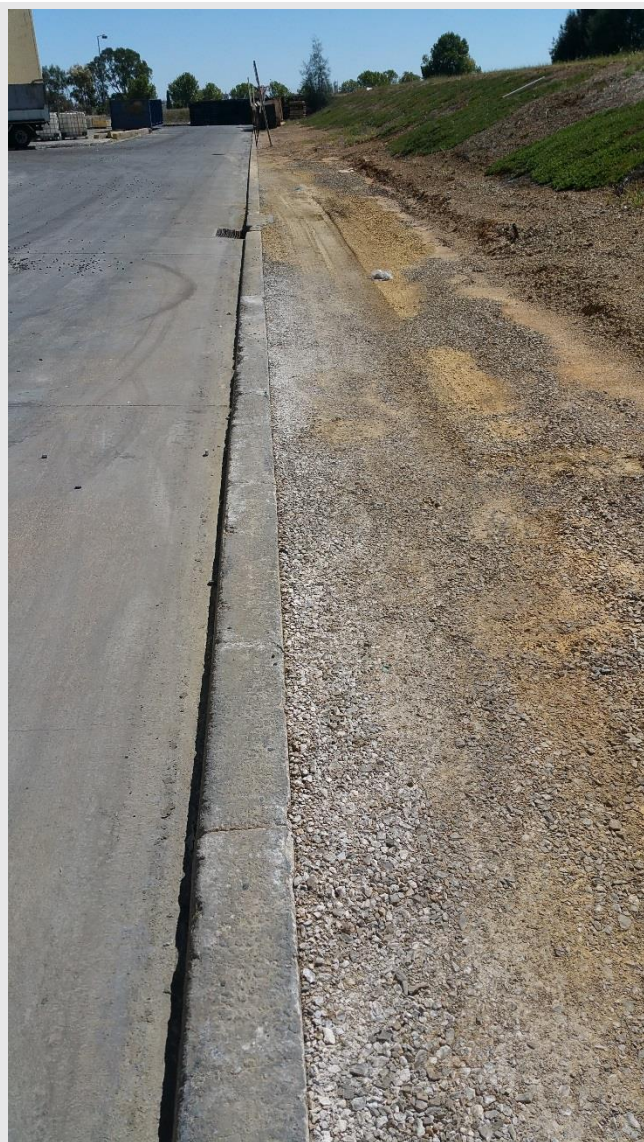
- Consistent with EMM's observations in 2017 (EMM, 2017), white crust was observed at surface at some locations within this strip of soils. EMM considered this white crust was lead sulfate which was related to the production activities of the facility.

Plate 15 – White crust observed at surface next to the ring road. (1 March 2018)

- Further characterisation of the identified lead impact near the internal ring road prior to development works as a condition of consent for the DA. Such works should aim to delineate the lateral and vertical extent of the impact and identify potential contamination source(s), in order to inform subsequent management and remediation activities, as well as to improve future site practices. The characterisation works should address other data gaps in the existing CSM, including potential contaminants of concern that have not been assessed to date.

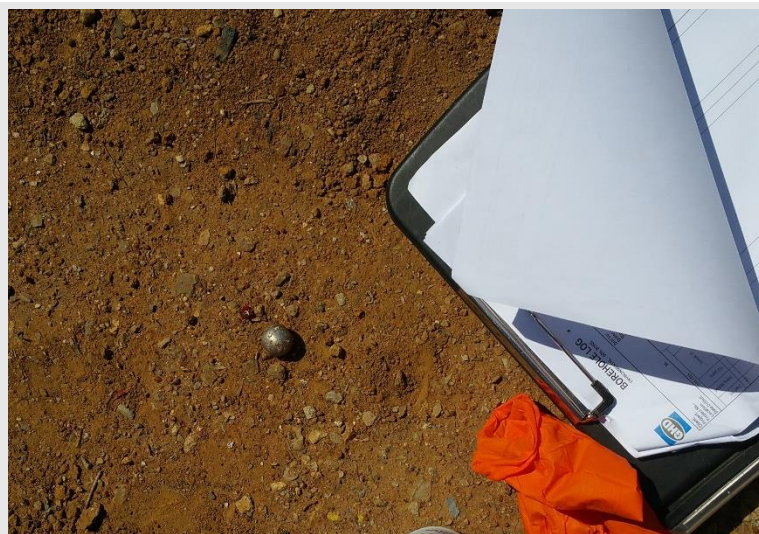
- Presence of spherical metal objects (up to approximately 20 mm in diameter) was observed at the ground surface in the area. It remains unknown if such spherical objects are related to the production activities of the facility. A photo of such object is included in Plate 16, Appendix A.

Plate 16 – Spherical metal object observed at surface next to the ring road. (1 March 2018)
