REPORT on REMEDIAL ACTION PLAN

UTS BLACKFRIARS CAMPUS CHIPPENDALE

Prepared for HUTCHINSON BUILDERS PTY LTD

Project 45996.02 March 2008

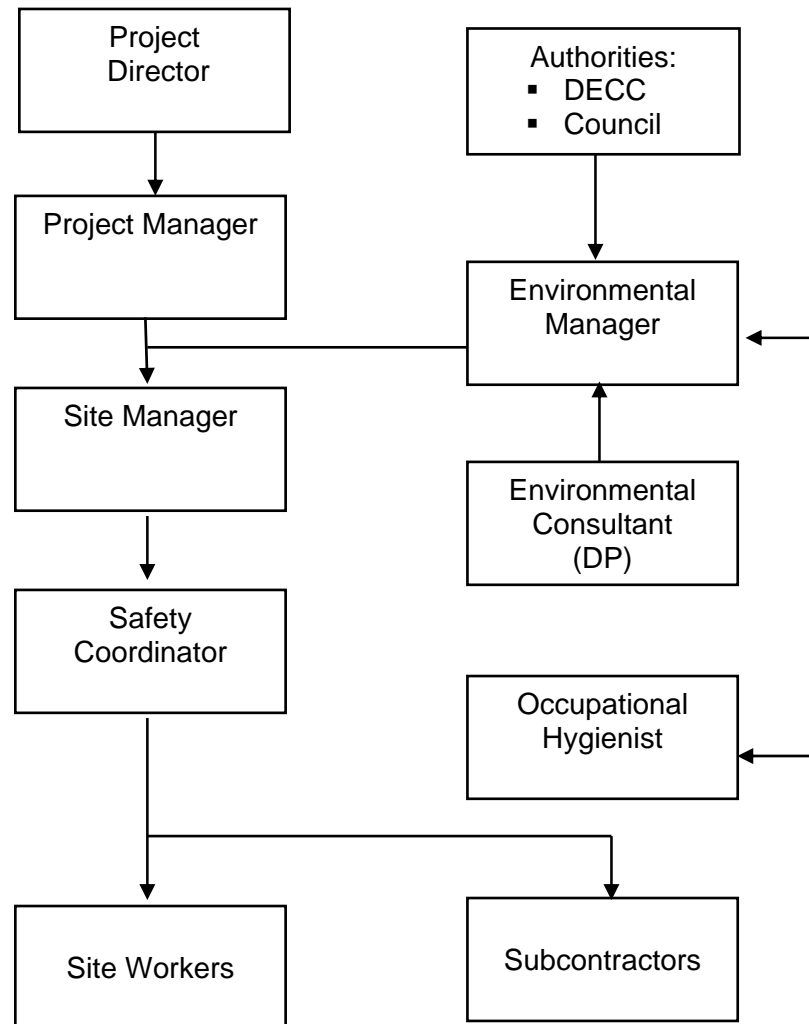
FIGURE 1: Line of Responsibility

- Hutchinson Builders Construction Manager;
- Hutchinson Builders Project Manager;
- Hutchinson Builders Site Manager;
- Hutchinson Builders Environment Manager
- Hutchinson Builders Site Safety Coordinator;
- Individual sub-contractors.

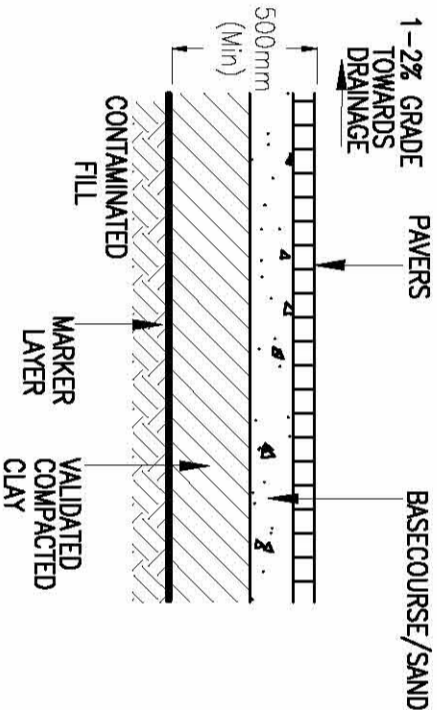
PAVING

Despite the variation in pavement types and uses, a generic physical barrier system has been designed to enable ease of construction and to also marry with the physical barrier system designed for the general landscaped areas. In designing the physical barrier system, consideration has been given to the potential for laying and/or servicing underground utilities in the future, and the likely repair / upgrade of the paving layer itself.

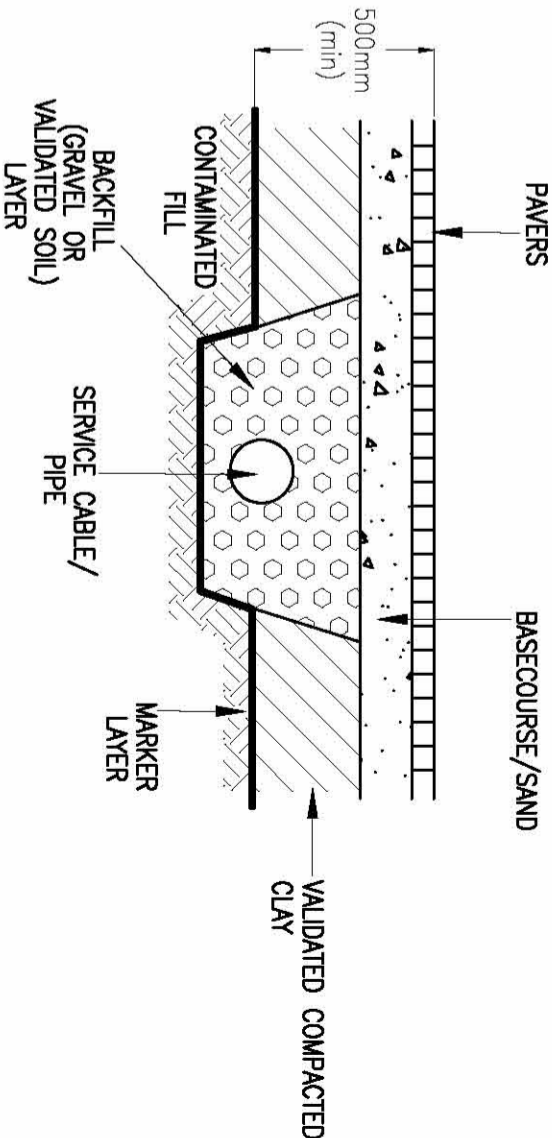
SERVICE LINE

Note that it is important to accurately locate the final positions and alignments of the service trenches, such that minimal disturbance will arise through future maintenance or repair works.

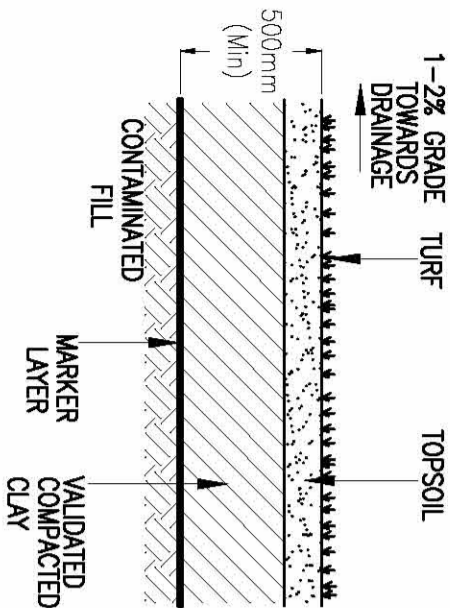
GENERAL LANDSCAPING

designing the physical barrier system, consideration has been given to the potential for laying and/or servicing underground utilities in the future, and the likely repair / upgrade of lawns, gardens and shrub plantings.

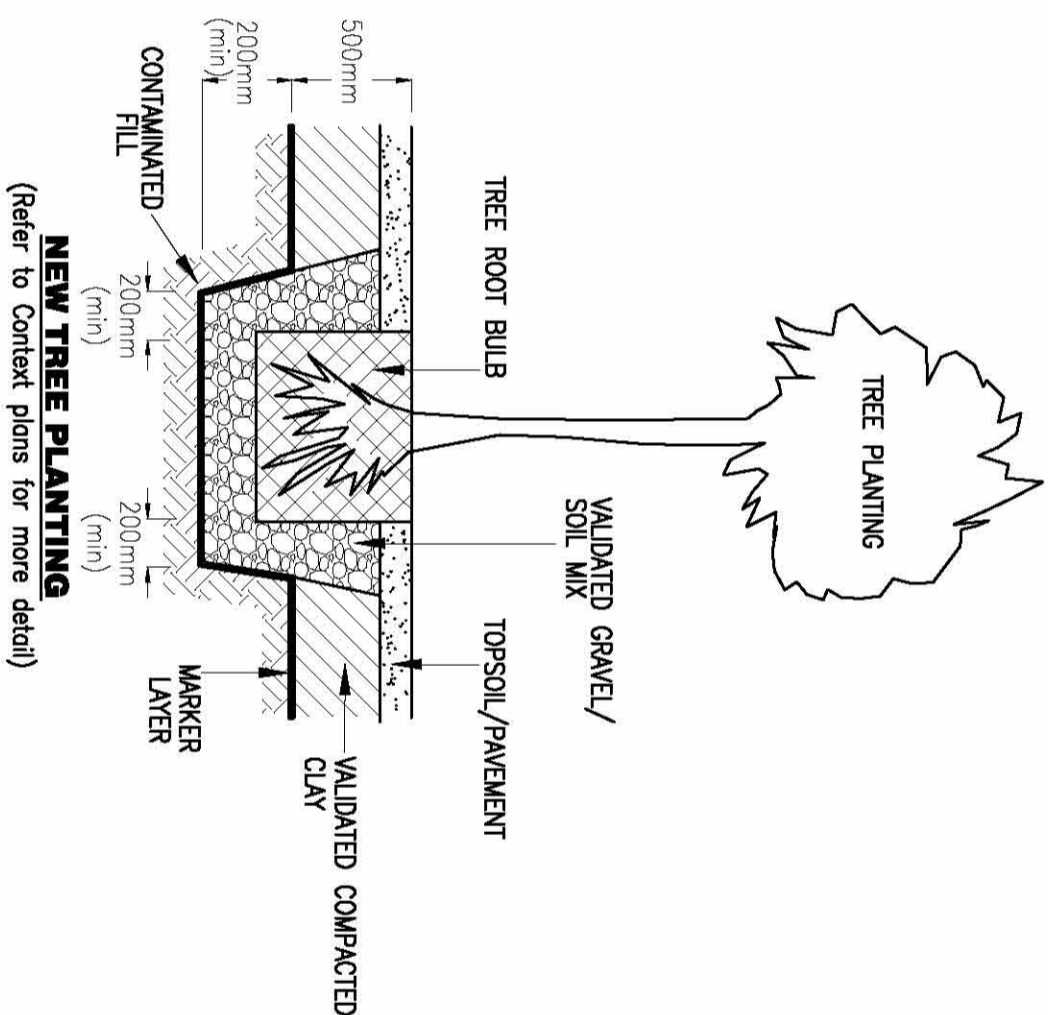
NEW TREE PLANTING

A generic physical barrier system has again been designed to enable ease of the planting works and to also marry with the physical barrier system designed for the paved and landscaped areas. In designing the physical barrier system, consideration has been given to the exposure of the new plantings to the contaminated soils, and the potential for maintenance and/or replacement of the plantings in the future.

(Refer to Context plans for more detail)

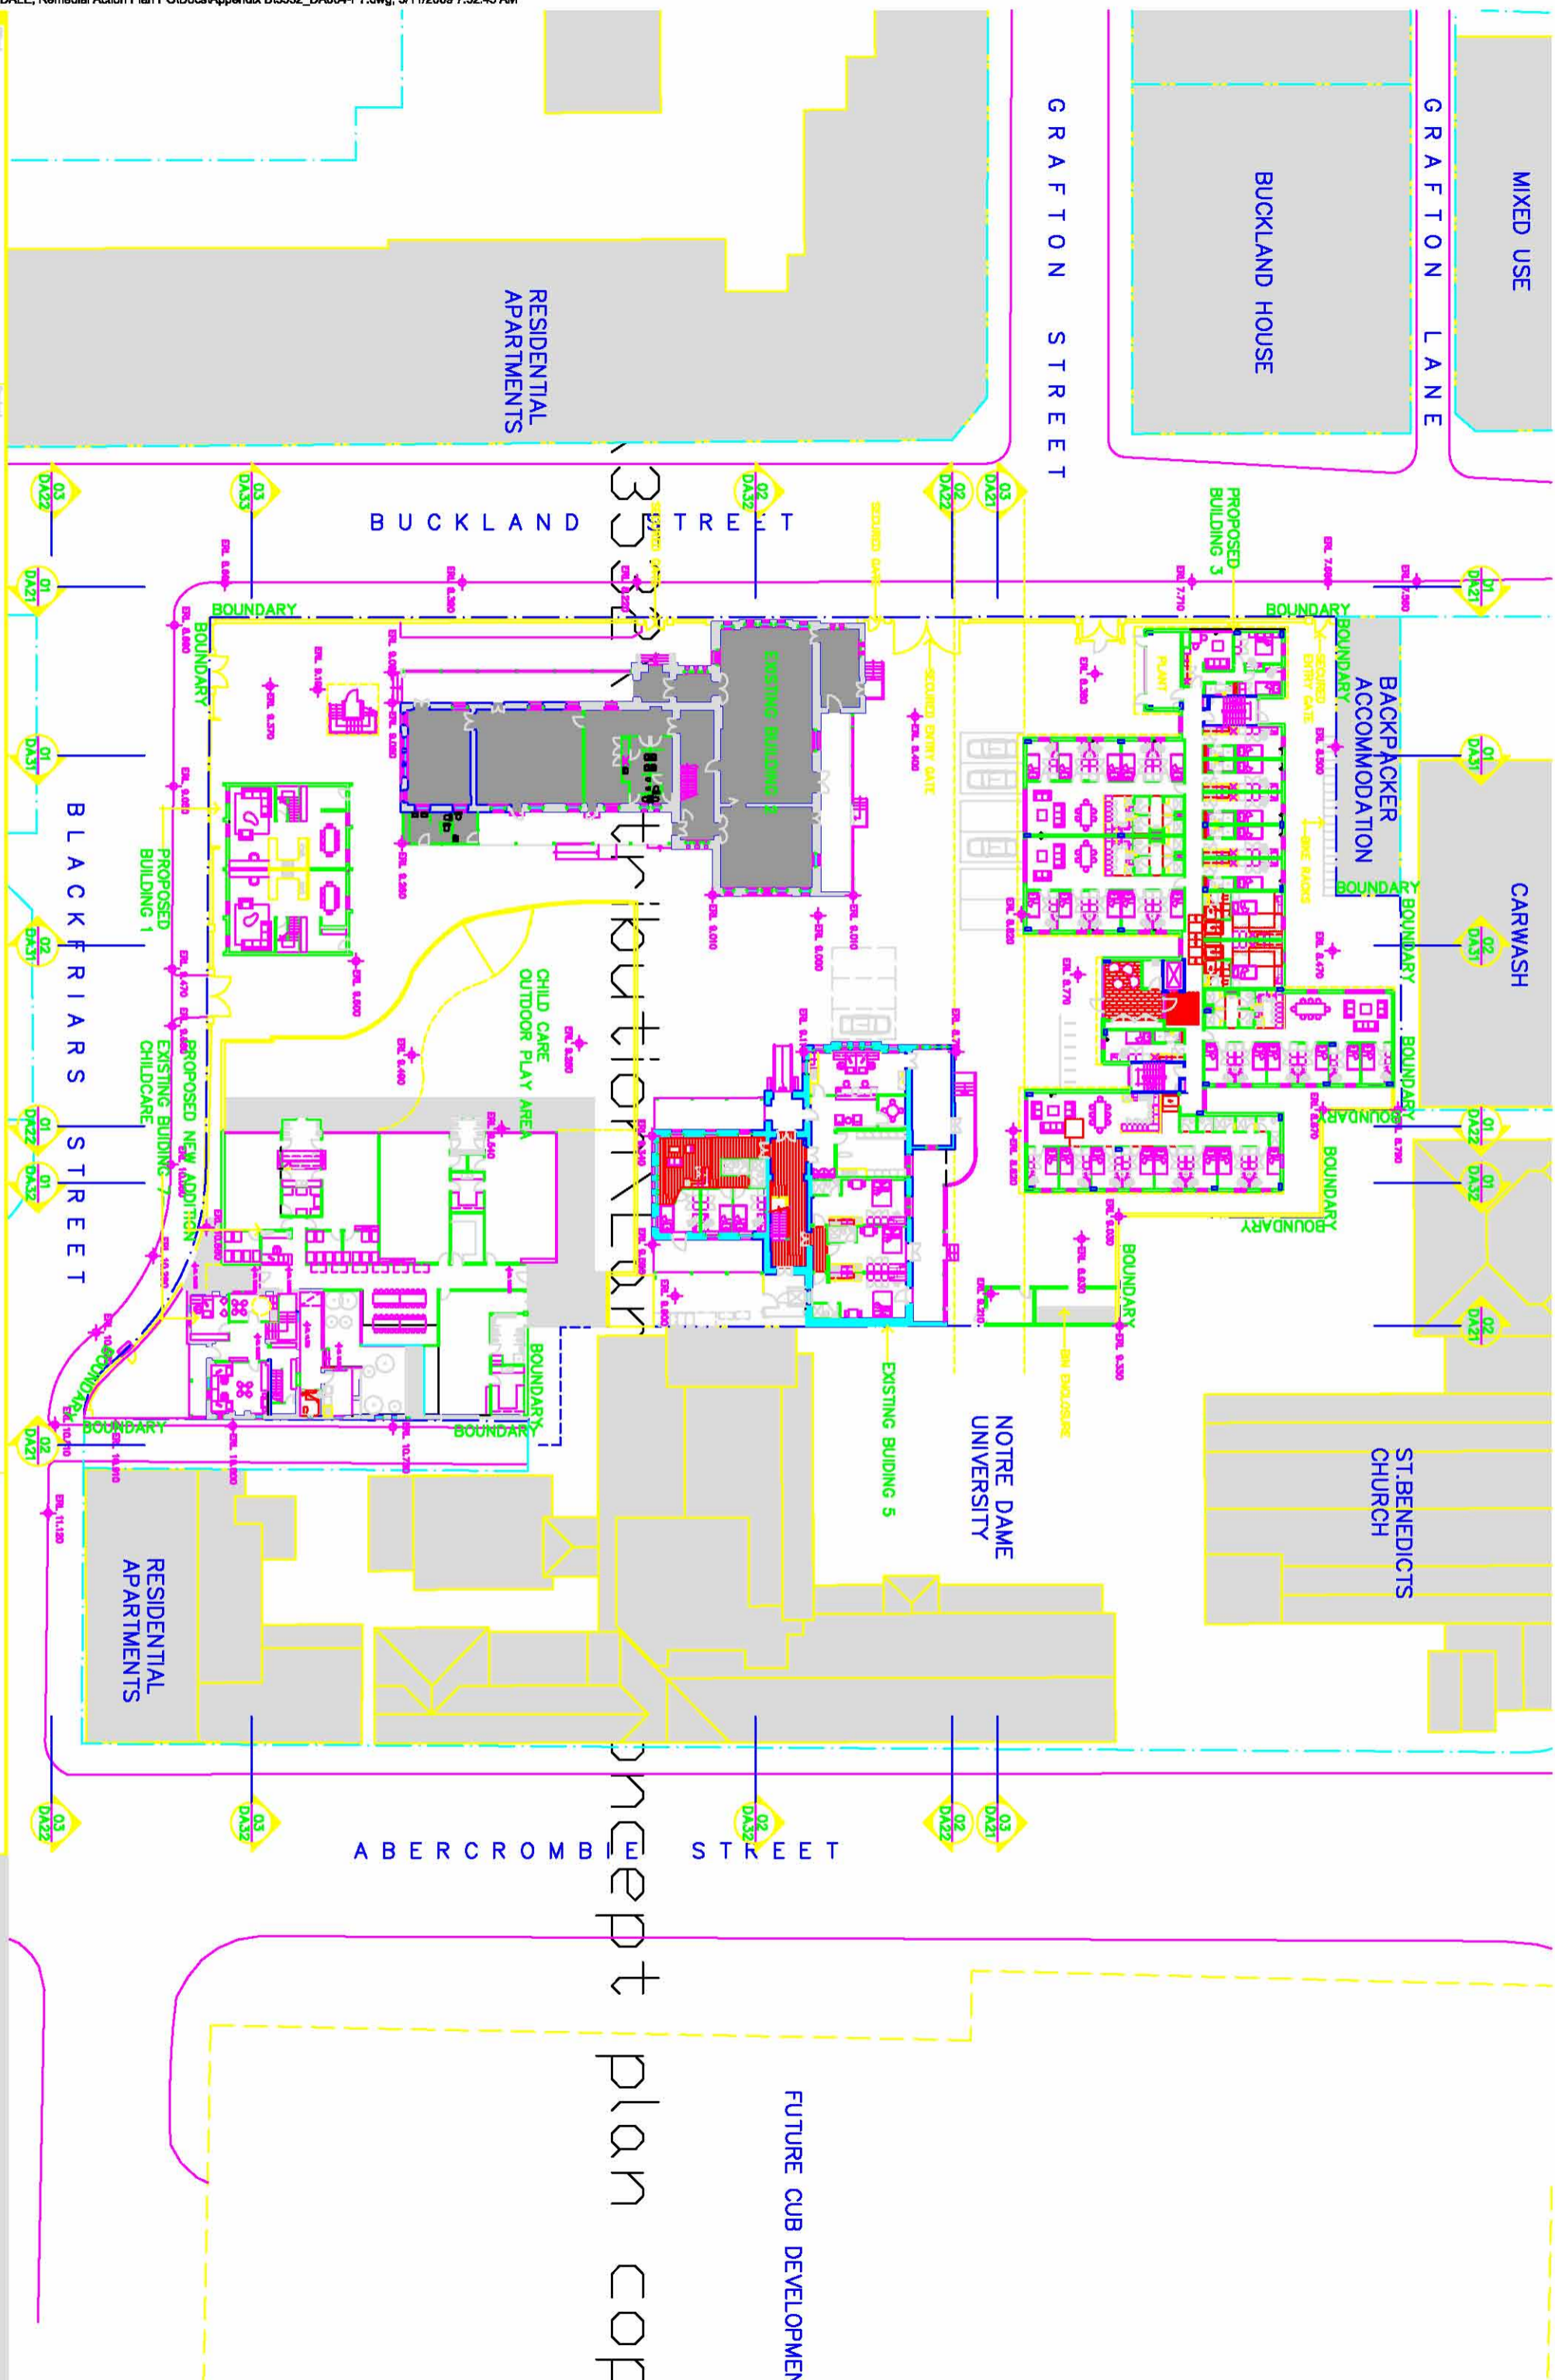
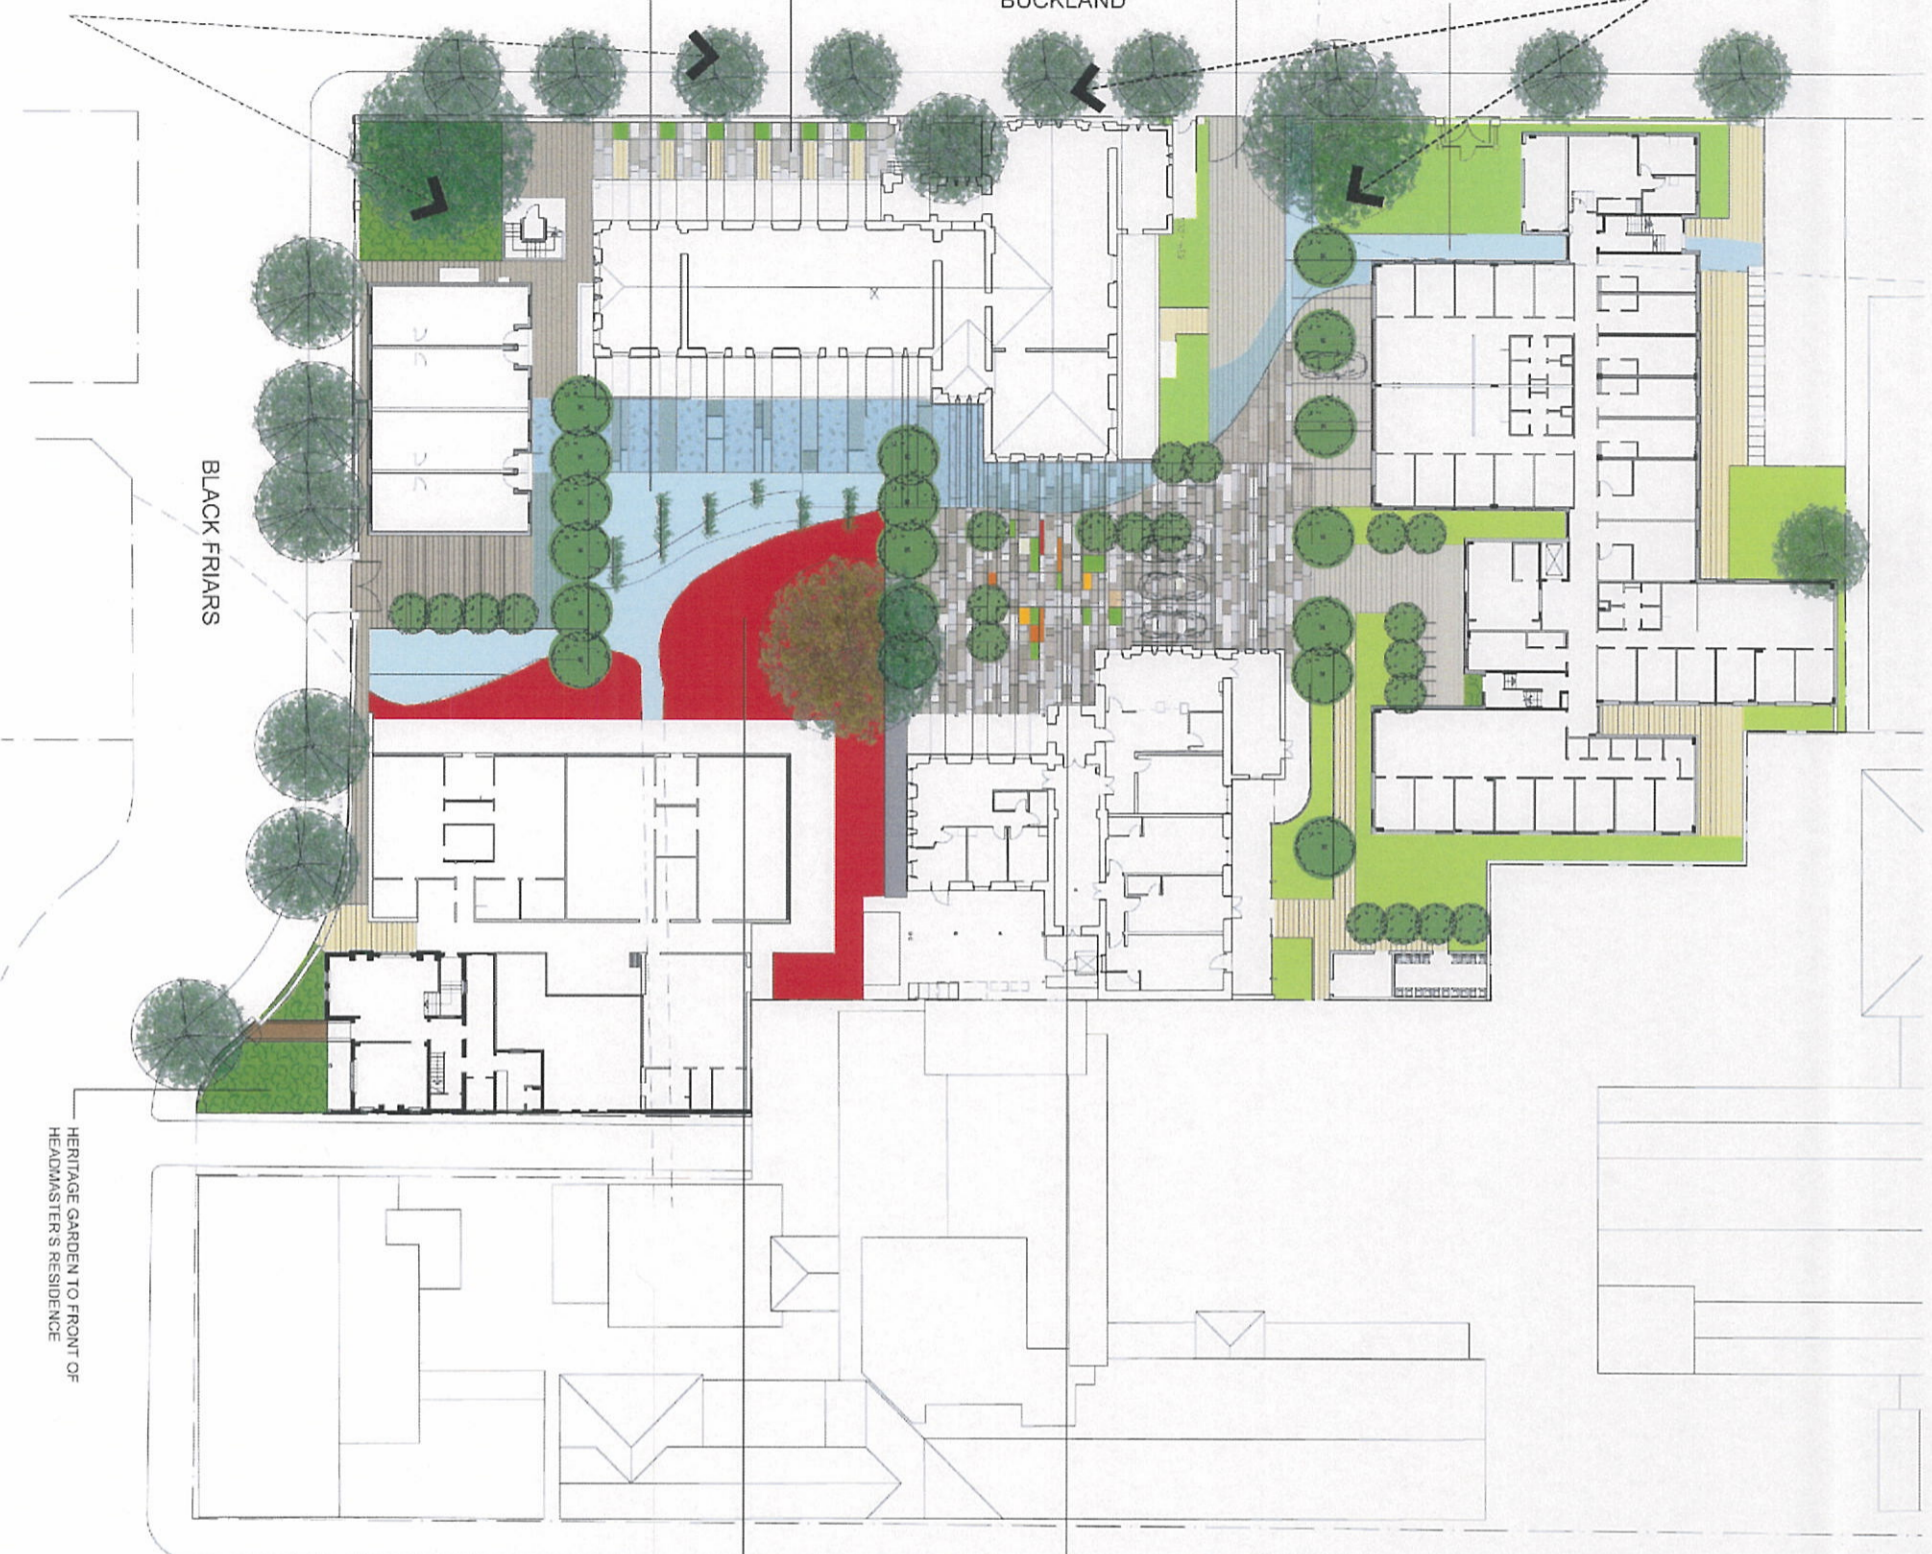
Landscape Concept Plan
UTS Blackfriars Student Accommodation

IMPROVED VISUAL ACCESS
OF HERITAGE BUILDINGS
FROM STREET

REFERENCE TO BLACK WATTLE
SWAMP CREEK - RIBBON OF
WATER'S EDGE ACTS TO
CONNECT SPACES THROUGH
THE SITE

HERITAGE LANDSCAPE TO
FRONT OF SCHOOL HOUSE
REINFORCE HERITAGE
STREETSCAPE

REFERENCE TO COOPER'S
RESERVOIR THROUGH USE OF
MATERIALS AND DECORATION
OF SPACES

CENTRAL COURTYARD IS THE FOCUS OF
THE PRECINCT THE DESIGN WEAVES
URBAN LIVING THEMES WITH SITE
HISTORY TO CREATE A FUNCTIONAL
SOCIAL SPACE WITH A STRONG SENSE OF
PLACE

PLANTING AND SEATING FROMS CAN BE
INTERPRETED FOR INDIVIDUAL OR GROUP
COLONISATION ALSO ACCOMMODATES
GROUP FUNCTIONS WITH BARBEQUE
FACILITIES

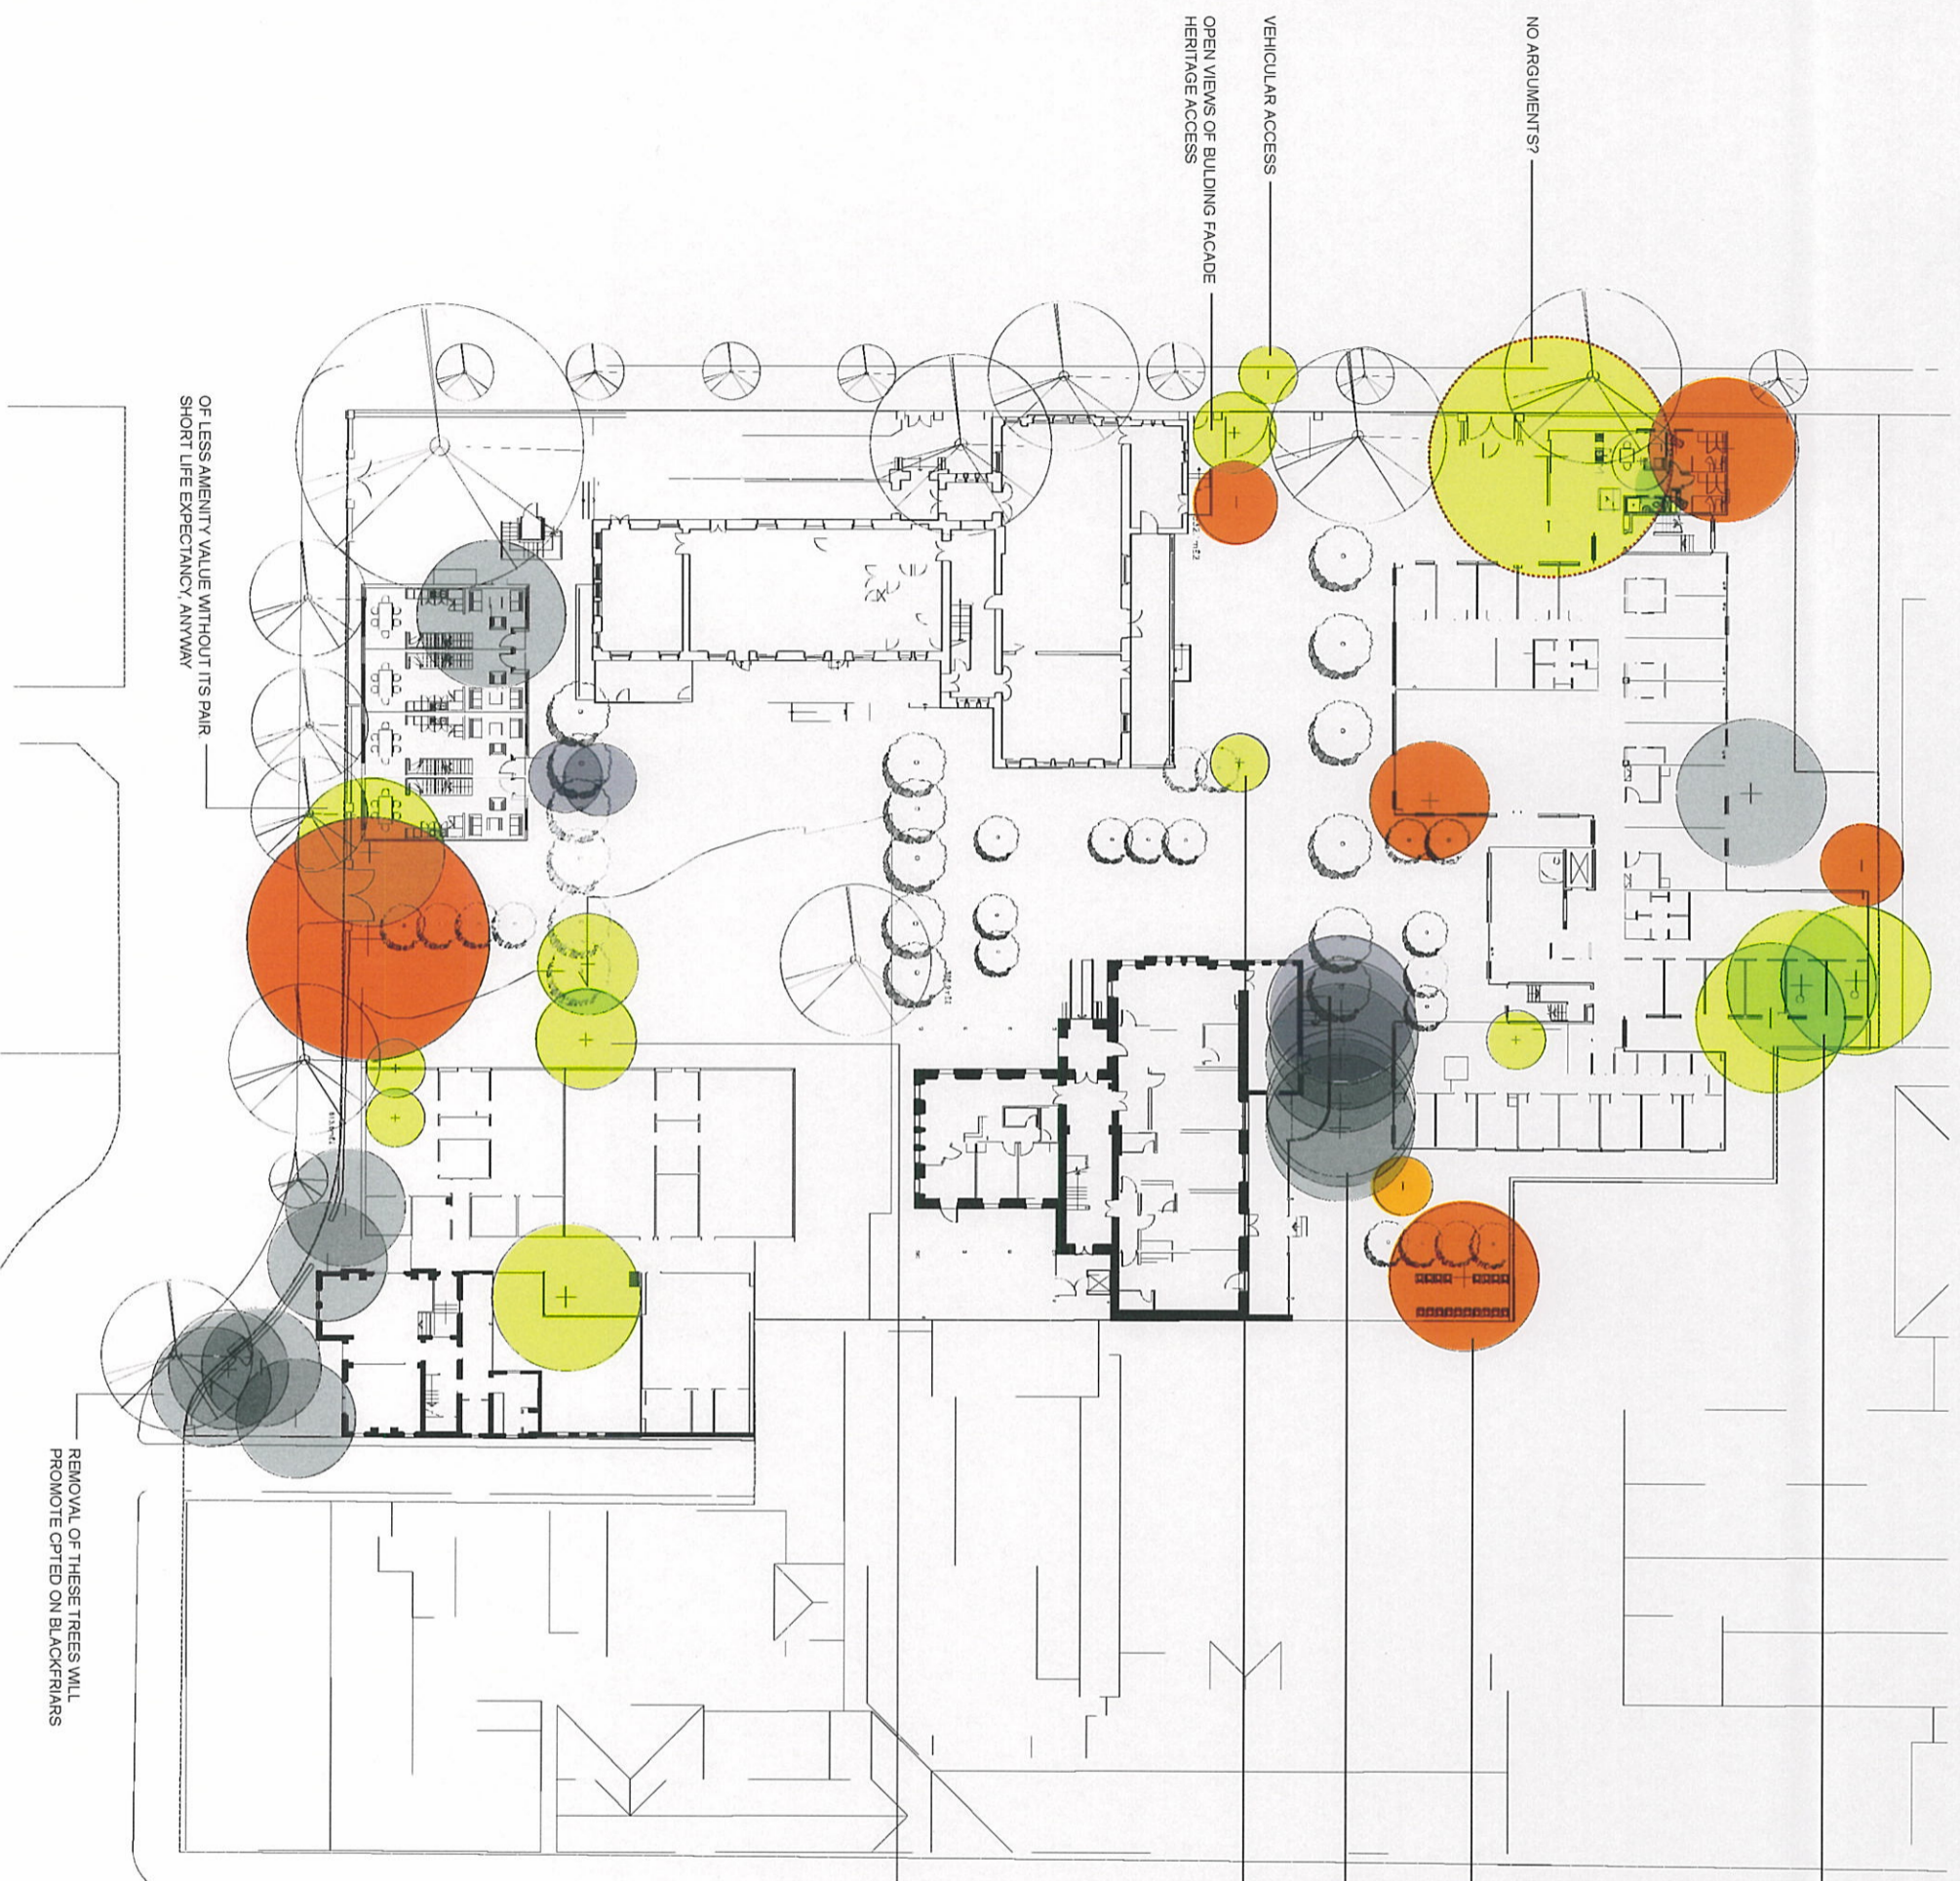
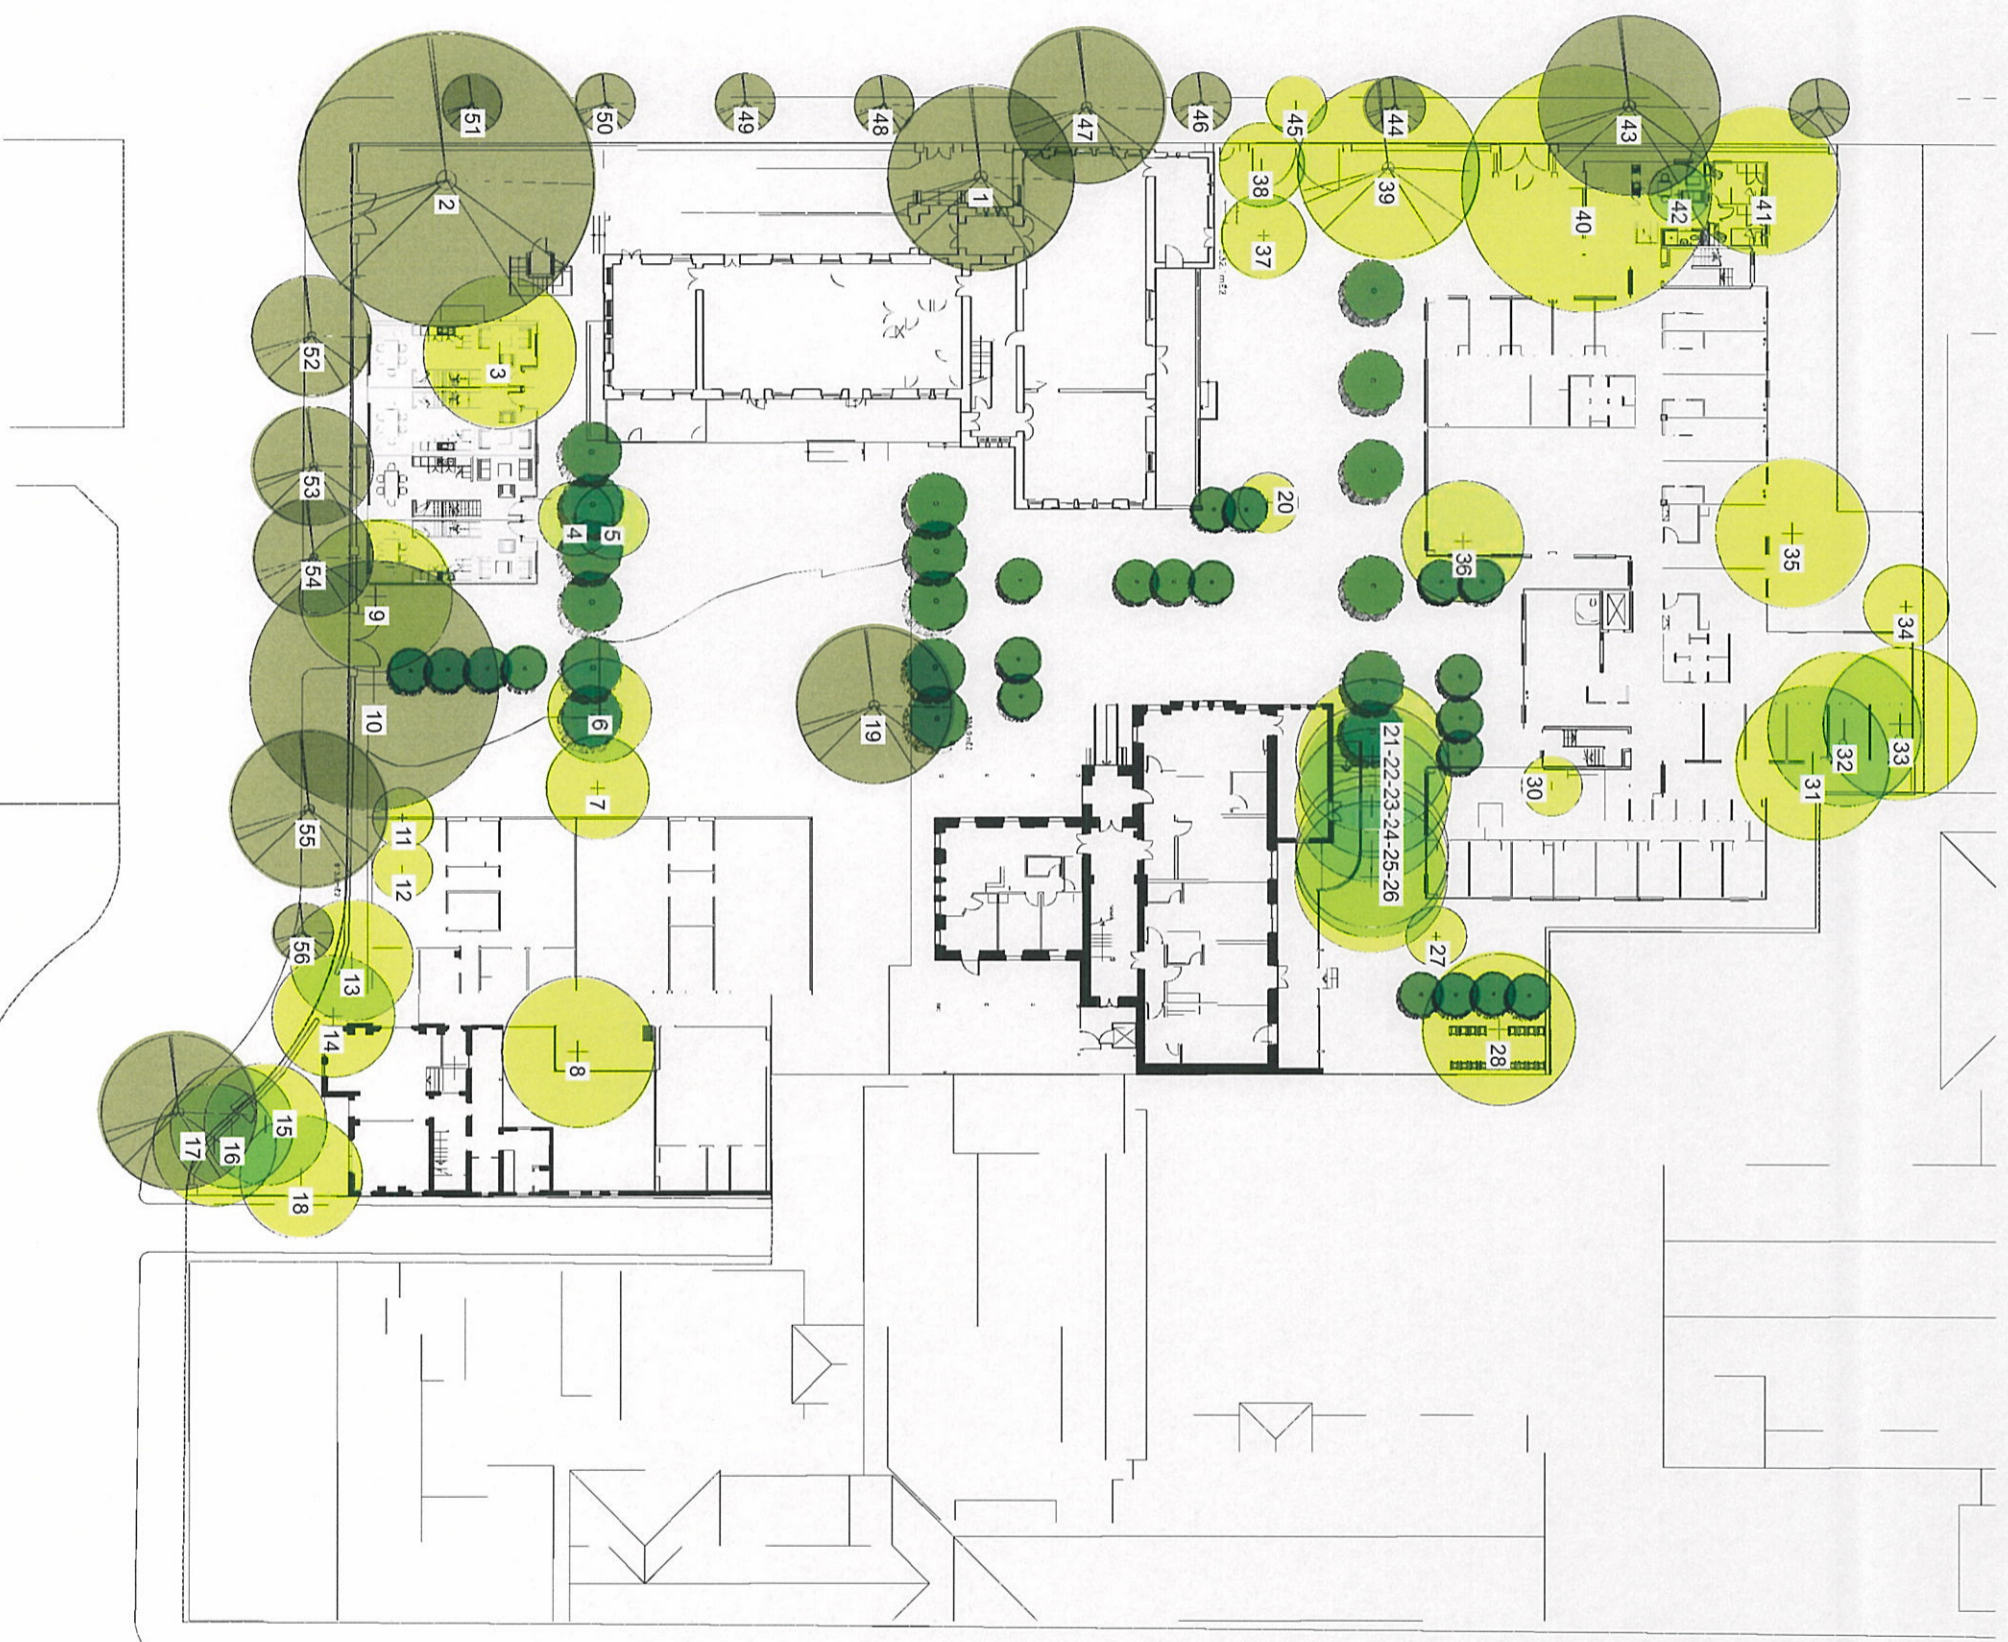
- LEGEND
- TREES WITH HERITAGE SIGNIFICANCE TO BE REMOVED
 - TREES TO BE REMOVED TO FACILITATE DEVELOPMENT
 - EASILY REPLACEABLE TREES TO BE REMOVED AND REPLACED TO FACILITATE DEVELOPMENT
 - TREES TO BE REMOVED ON THE BASIS OF POOR HEALTH, LIFE EXPECTANCY OR SAFETY
 - TREES TO BE REMOVED BECAUSE THEY ARE INVASIVE WEEDS

Due to heritage and/or “ecological significance” reasons, a number of large existing trees will be retained as part of the proposed development. In all, four trees (Number 1, 2, 19 and 39) within the property boundaries will be retained, as indicated on the *Trees to Retain / Remove / Replace* drawing (Reference LSK 08573-004) in Appendix B of this report.

As indicated on the *Trees to Retain / Remove / Replace* drawing (Reference LSK 08573-004) in Appendix B of this report, a number of new trees / shrubs will be planted as part of the proposed redevelopment.
