REPORT
on
PHASE 2 CONTAMINATION ASSESSMENT

UTS BLACKFRIARS CAMPUS
CHIPPENDALE

Prepared for
HUTCHINSON BUILDERS

Project No. 45996.01
March 2009

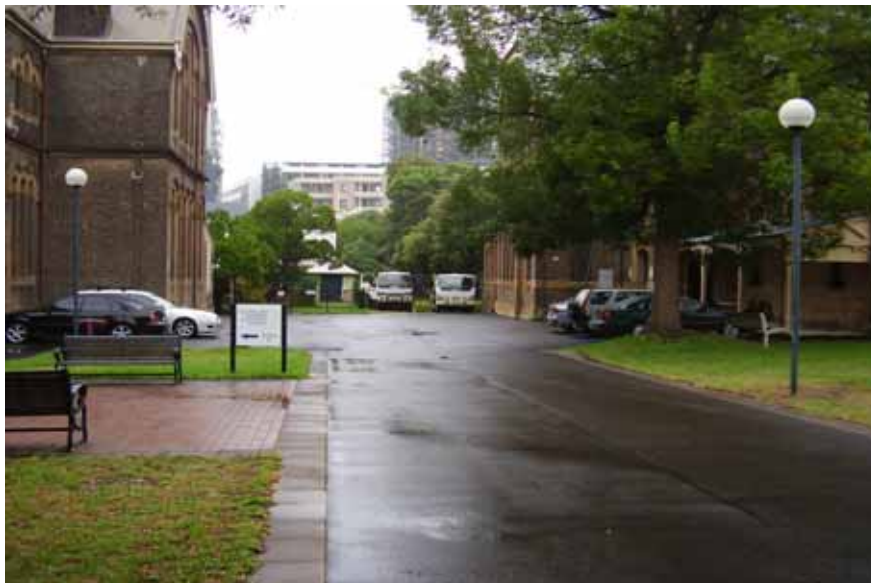
Photo 1: General view of the site

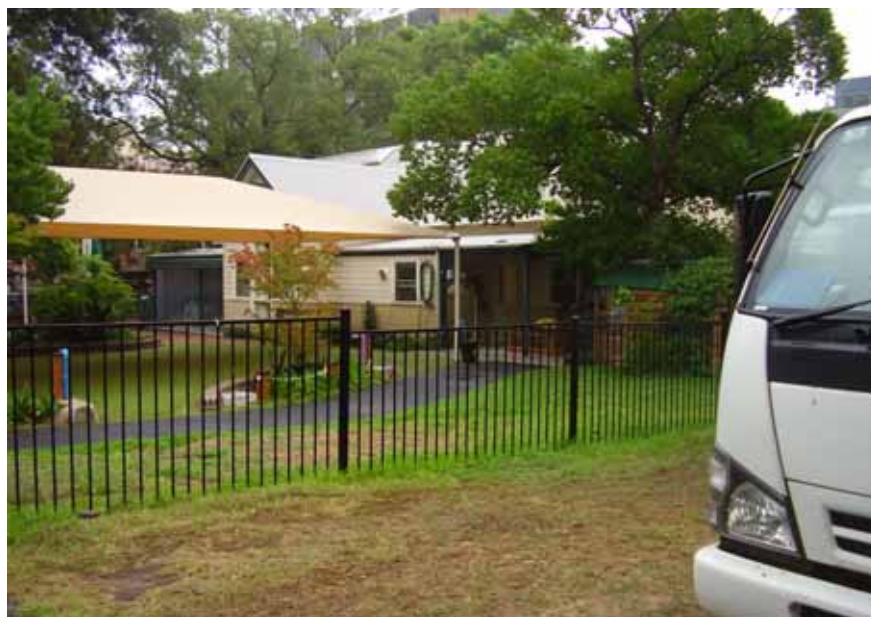
Photo 2: General view of the existing child care centre
