# **Geotechnical Investigation**

RE: GEOTECHNICAL INVESTIGATION at No.14 Rayben Street, Glendenning.

This letter presents a geotechnical report on the inspection and testing services associated with the geotechnical investigation undertaken at the above project.

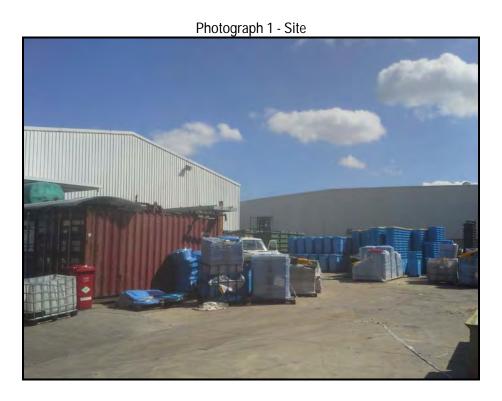
Figure 1 – Site Location

The subject site is near-square in shape, measuring approximately 95m wide along the Rayben Street frontage and approximately 85m deep. It covers an area of approximately 8,000m² and is relatively flat.

The subject site is currently being used as a waste management depot. A small brick office and a steel framed / metal clad workshop are located within the south-western corner of the site whilst the remainder of the site is covered by a concrete hard stand. A small creek / water channel bounds the site to the north which feed stormwater flow to Eastern Creek.

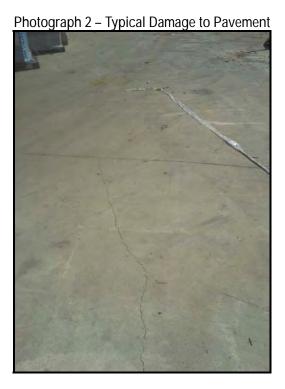
The proposed development is to be constructed within the north-western portion of the site, directly between the existing metal shed and the northern property boundary. This area is currently covered by a concrete hard stand and the remnant of an old awning structure. The concrete pavement is in a moderate condition for its age with numerous fine cracks observed and some degradation of the pavement at the segment joins (see photographs below). The area is currently used for storage of bins and associated materials.

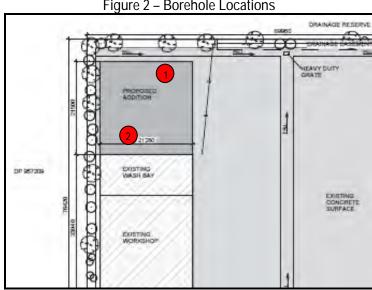
Figure 2 - Borehole Locations

Fieldwork was undertaken on 1st of April 2015 and included drilling two boreholes (TS1 & TS2) using a 4WD Toyota Landcruiser Ute mounted drill rig with 100 mm solid flight spiral augers at the locations shown on Figure 1. Five samples were recovered during the course of the investigation in order to undertake a preliminary Acid Sulphate Soils assessment. Full borehole log and field observations are presented in Appendix A.

The geotechnical investigation included drilling two boreholes using a 4WD Toyota Landcruiser Ute mounted drill rig with 100mm diameter solid flight spiral augers at the locations shown on drawing Figure 1. Sampling and testing for Acid Sulphate Soils was undertaken during the course of the investigation. This report provides a geotechnical assessment on the existing soil conditions.
