Aboriginal Archaeological & Cultural Heritage Assessment

Taronga Zoo, Mosman, New South Wales

Aboriginal Heritage Impact Permit Application for AHIMS Sites #45-6-1959
Part 6 of the *National Parks and Wildlife Act 1974*

Dominic Steele Consulting Archaeology
16 February 2015

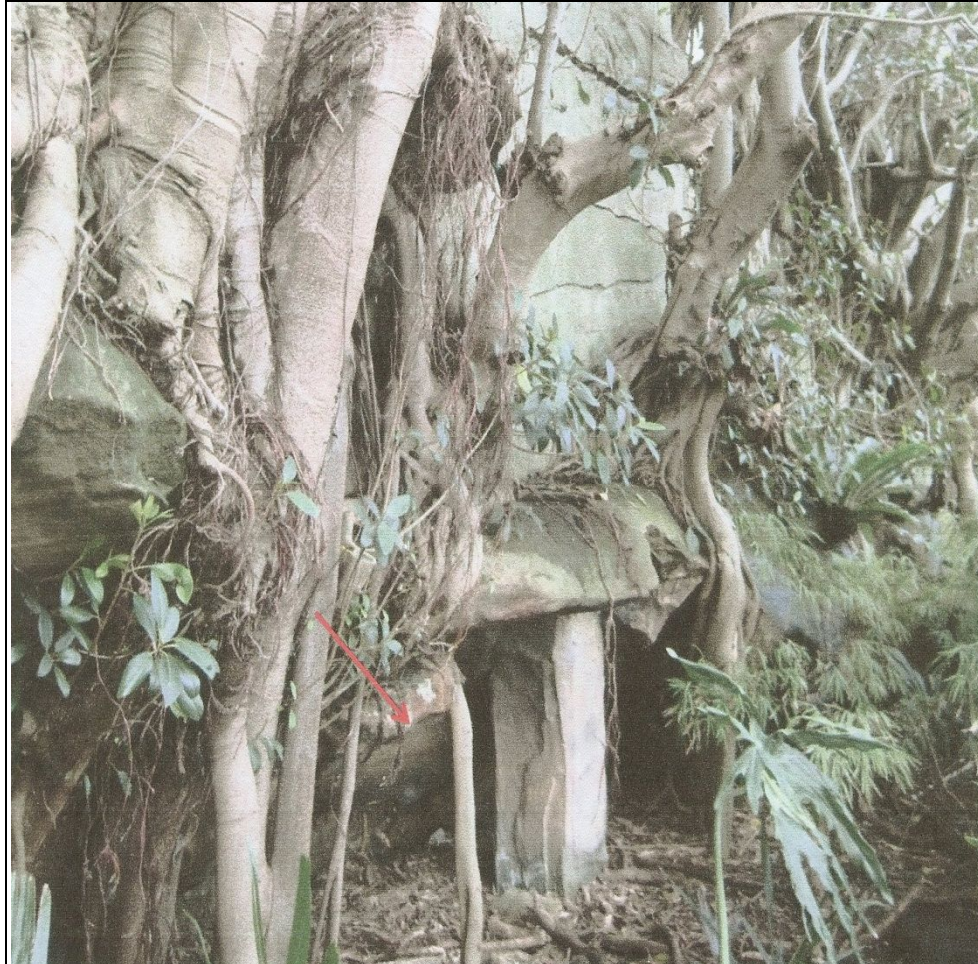
In combination, the fig trees are causing the cliff face to become unstable by growing into the cracks and expanding and this growth is progressively pushing the rock joints apart. While the structural engineering advice is that the fig trees growing along the cliff face are not transferring significant loads onto the sandstone, water passing from the site above the cliff to the area below along Bird Show Road is also causing damage to areas of the cliff face and water seepage down the back wall AHIMS Site #45-6-1959 is apparent that appears to have affected the visibility of the hand stencils since 1990.

Figure 1.9: Cracked masonry structure built above the rock face over AHIMS Site #45-6-1959 (arrowed)

Figure 1.10: This image shows the rock overhang, masonry pillar and several fig trees growing into the rock face. The Aboriginal heritage site (arrowed) is under the overhang to the left of the pillar. A masonry wall is built over the rock overhang which has a masonry pier supporting it (may not actually provide much support).

It has been advised that selective tree elements can be safely cut down to prevent further damage. The roots and tree trunks that are engaged into the cliff face are to be left in place. The remaining tree stumps/roots are to be treated regularly with herbicide and as the roots die and decay; cracks in the rock would be carefully grouted to stop settlement and further movement. Some form of support structure is also recommended to be installed near the new crack above and to the west of the heritage site, and drainage from upper areas above Bird Show Road needs to be addressed to stop water runoff and seepage.

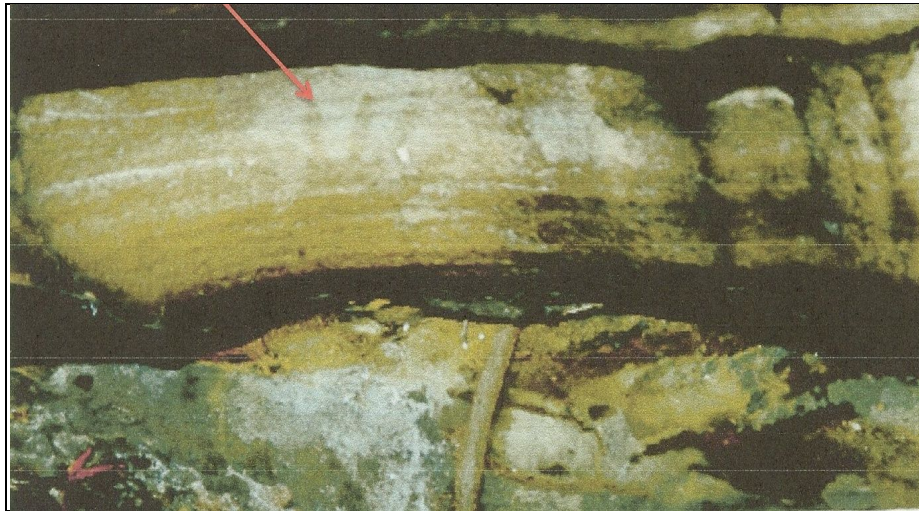
Figure 2.3: A c.1997 photo of at least one hand stencil at the site. The surface of this stone is now or heavily deteriorated and has a large tree root growing across it

It is also evident that the conditions of the rock surfaces within the shelter have deteriorated considerably since 1990 as a result of tree root growth, water seepage down the rear wall, and the loss of considerable sections of surface rock. An annotation to the AHIMS record for Site #45-6-1959 notes that eight hand stencils were visible in 1991, and the last reliable sighting of any of these motifs was in 1997 when the shelter was inspected during

the preparation of the zoo's Heritage and Conservation Register. Only one or possibly two of the seven or eight stencils are partly visible now, and the others may have either faded or eroded away entirely from water run-off over the last 25 years and/or as a result of the weathering, cracking and general exfoliation of the sandstone surfaces on the rear wall of the overhang that has been directly caused (and/or accelerated) by tree root growth and cracking from weight stress on the cliff line from above.

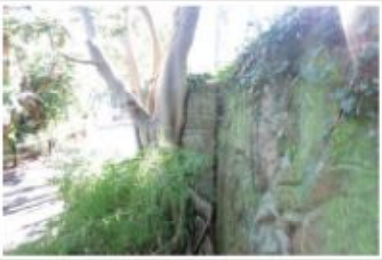
Secondary view of the fig tree growing at the 5m chainage. The tree is not actively engaged into the cliff face, the trunk has grown over the edge of the sandstone cliff.

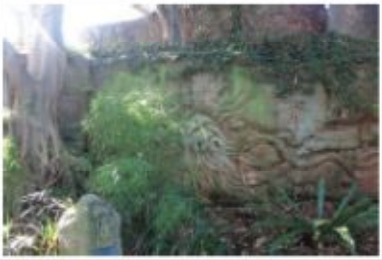
2.3. 10.0m

Stable cliff face at 10m chainage. Cliff face has been carved with a mural.

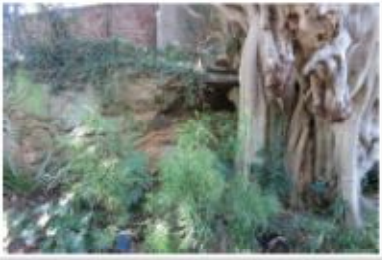
2.4. 15.0m

15m is the location of a major fig tree which is causing damage to the cliff face.

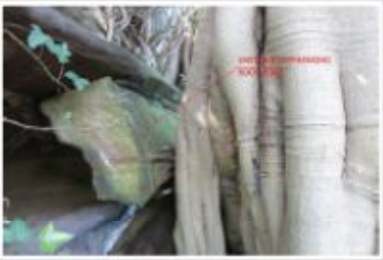
2.4.1.
LHS view of the fig tree growing at the 15m chainage. An unstable rock overhang is present.

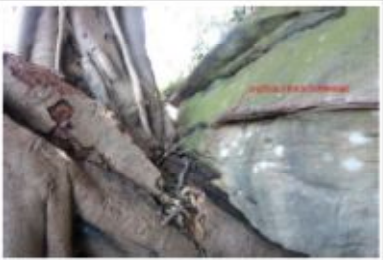
2.4.2.
A view of the rock overhang from the RHS of the fig tree.

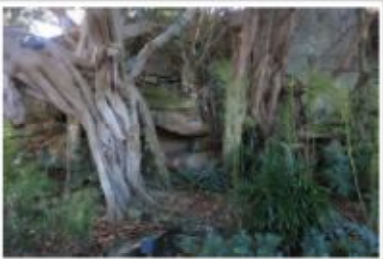
2.4.3.
A general view of the location of the intrusive fig tree. Several other invasive trees are seen in the photograph to the right.

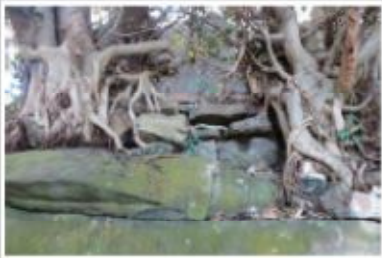
The smaller fig tree to the left is growing out of the wall directly behind the large tree at 15m chainage. The tree to the right is heavily engaged with the retaining wall it is growing in front of.

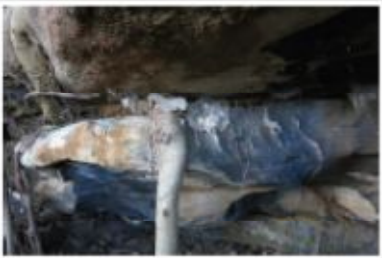
2.5.2.
The fig tree is growing into the rock face, expanding a fault in the rock as it grows.

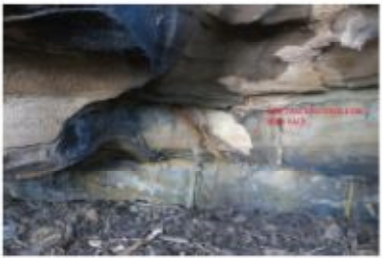
2.5.3.
A detail view of the area in the region of the Aboriginal heritage site. The exfoliating rock face is indication of water passing over the rock face.

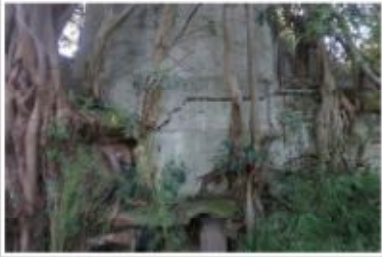
2.5.5.
The disused masonry building above the Aboriginal heritage site is cracking due to the intrusion of the fig tree roots.

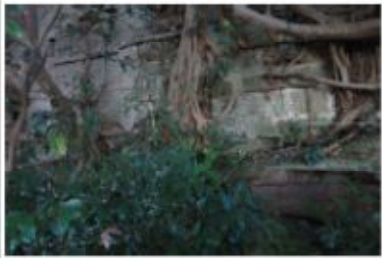
2.6. 25.0m
25m chainage. The sandstone block wall commences at a higher height at this chainage. Two fig trees are growing in this location.

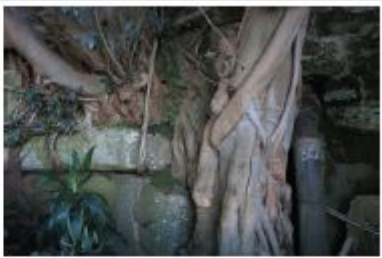
2.7. 30.0m
Location of pipe at 30m chainage. A large fig tree grows near the base of the pipe.

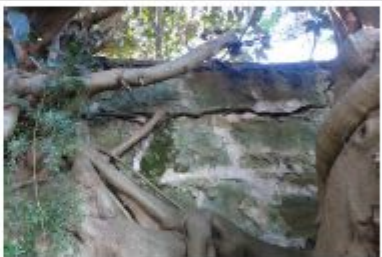
2.7.1.
The sandstone wall at the 30m chainage has been cracked by intrusive root growth.

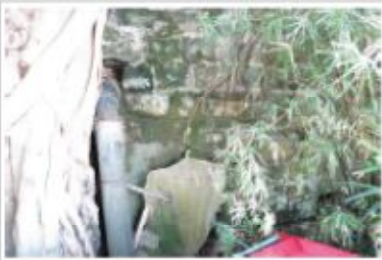
The 30m chainage marks the beginning of the full height sandstone block wall. The wall shows signs of water ingress with areas growing algae and moss. The ground in the location of the pipe is saturated with water.

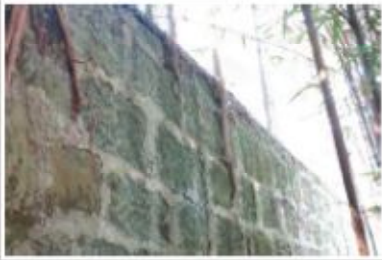
2.7.4.

Young fig tree roots are growing in the sand stone wall.

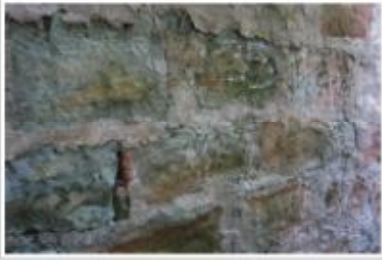
2.8. 35.0m

The mortar joints in the wall have developed cracks in them at this location.

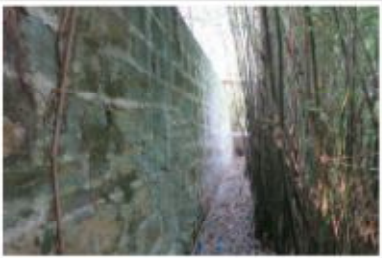
The sandstone wall is approximately 3.3m in height.

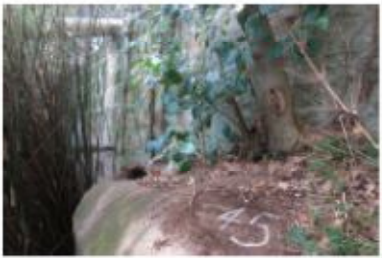
2.9. 45.0m

At chainage 45m, a sandstone out crop emerges from the base of the wall.

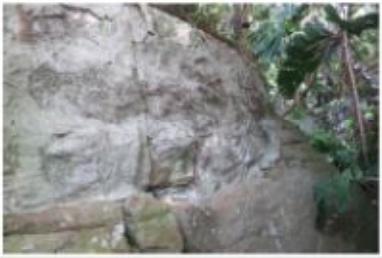
2.10. 50.0m

The sand stone wall is covered in render.

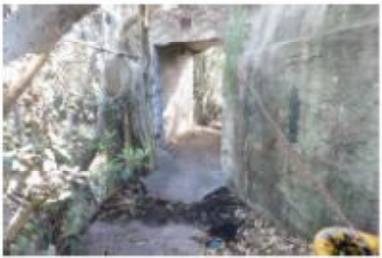
2.12.

A view of the structure above the area at the 25m chainage. Dark organic matter can be seen together at the base of the path caused by water flow across the surface in the area. The water drains through the path to the sand stone area below. This location is above the Aboriginal heritage site.

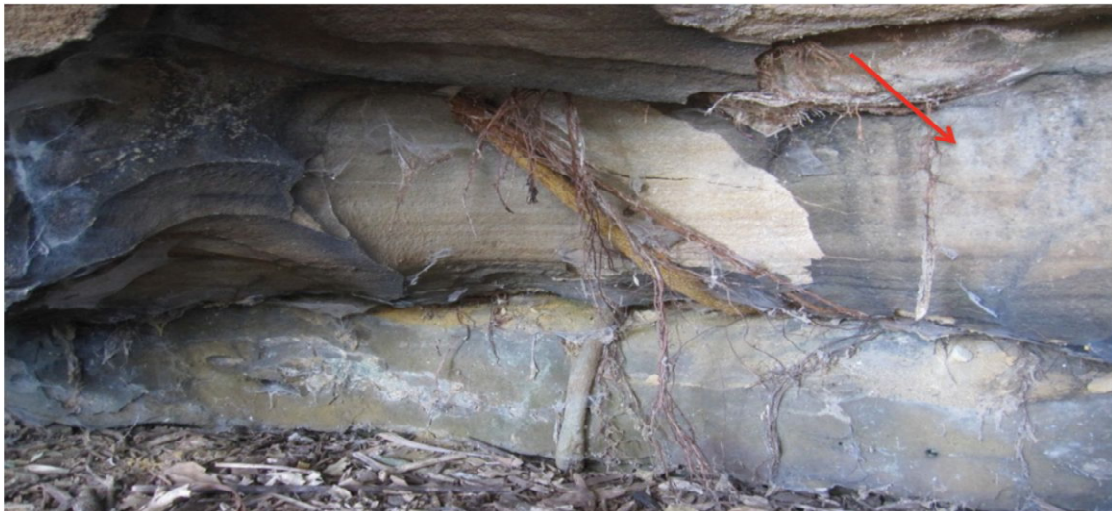
Fig. 4 Photo of site in 2014. Note the lower root and the centre of the photo in both images. There is a new root running diagonally across the rock and the face of the stone has been lost. A possible partial handprint is arrowed at right.

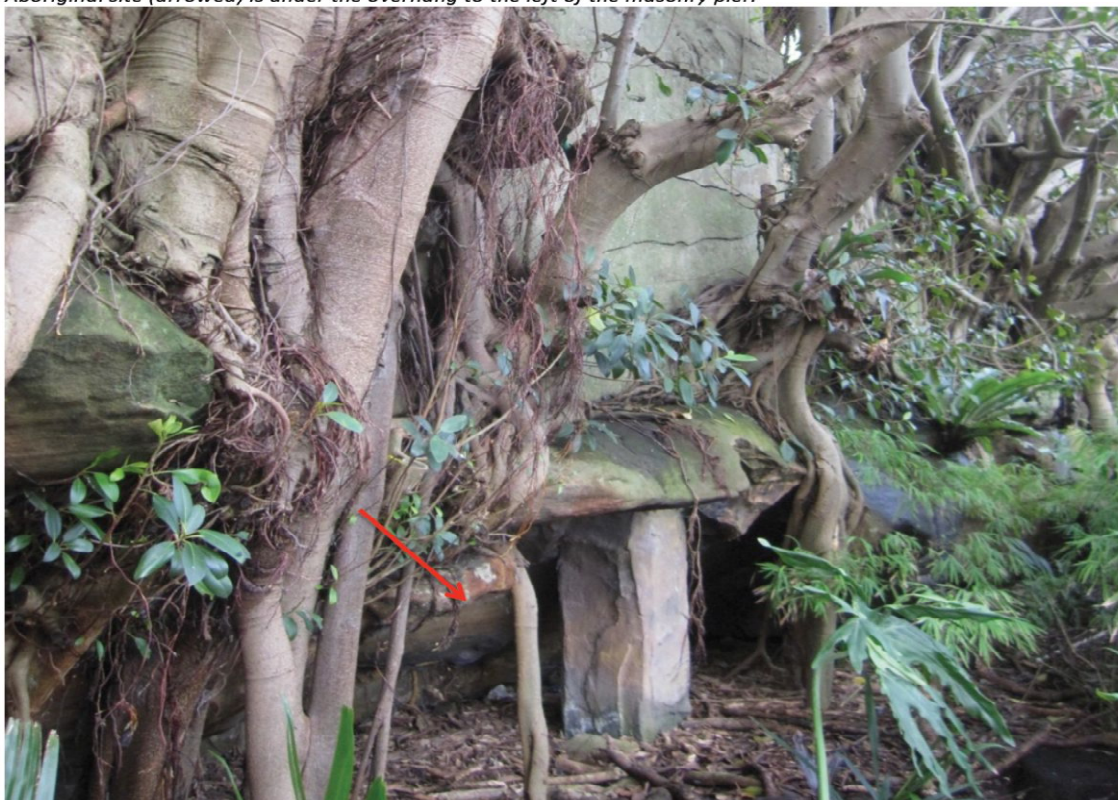
Fig. 6 2014 photo showing the rock overhang, masonry pillar and several fig trees growing into the rock face. The Aboriginal site (arrowed) is under the overhang to the left of the masonry pier.

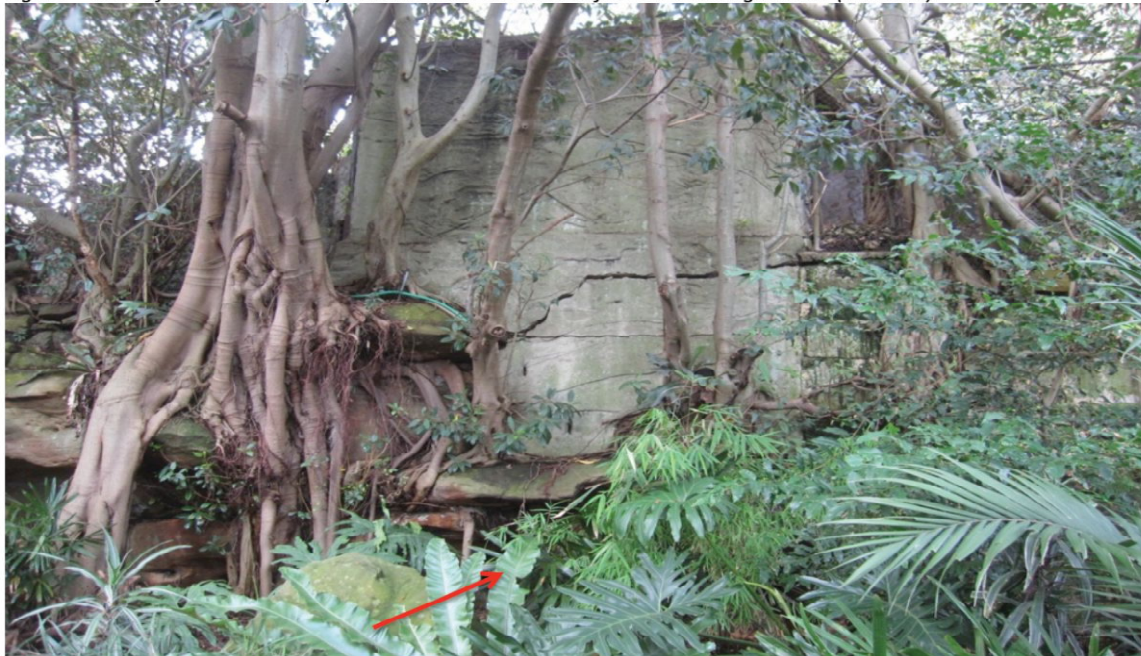
Fig. 10 View of cracked masonry structure built above rock face over Aboriginal site (arrowed).
