Brookvale Community Health Centre: Historic Heritage Impact Assessment and Preliminary Aboriginal Heritage Assessment

Prepared by Australian Museum Consulting
For Johnstaff

June 2015

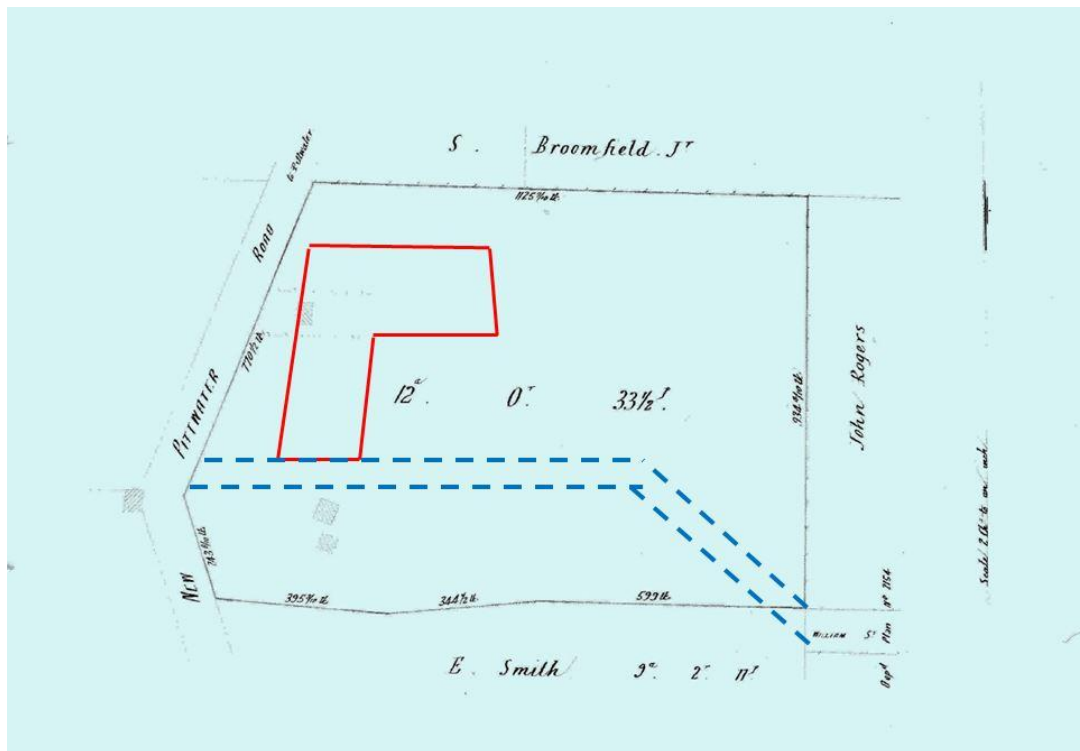
Figure 5.3 Sketch plan attached to the 1894 Certificate of Title Register Book Vol. 1117 Folio 187. The approximate location of the study area is outlined in red, the western boundary of which approximates the present alignment of Pittwater Road. The approximate modern route of William Street is shown by the dashed blue line.

By the time of his death in 1927, William Francis Parker had further subdivided the property. The 1894 Certificate of Title from which the sketch above (Figure 5.3) was taken indicates that some of the land had been sold to various parties over the years, including Thomas Watson in 1894, to Edward Ridge in 1897 and to Arthur Keisle in 1908. On the 26 May 1923, Louis Pincini took possession of the section of the study area that is now 612 Pittwater Road (Certificate of Title, Register Book Vol.3458 Folio 55). The 1948 sketch plan below shows 612 Pittwater Road divided in four, with pink indicating land resumed by the Commissioner of Main Roads for widening the Pittwater Road.

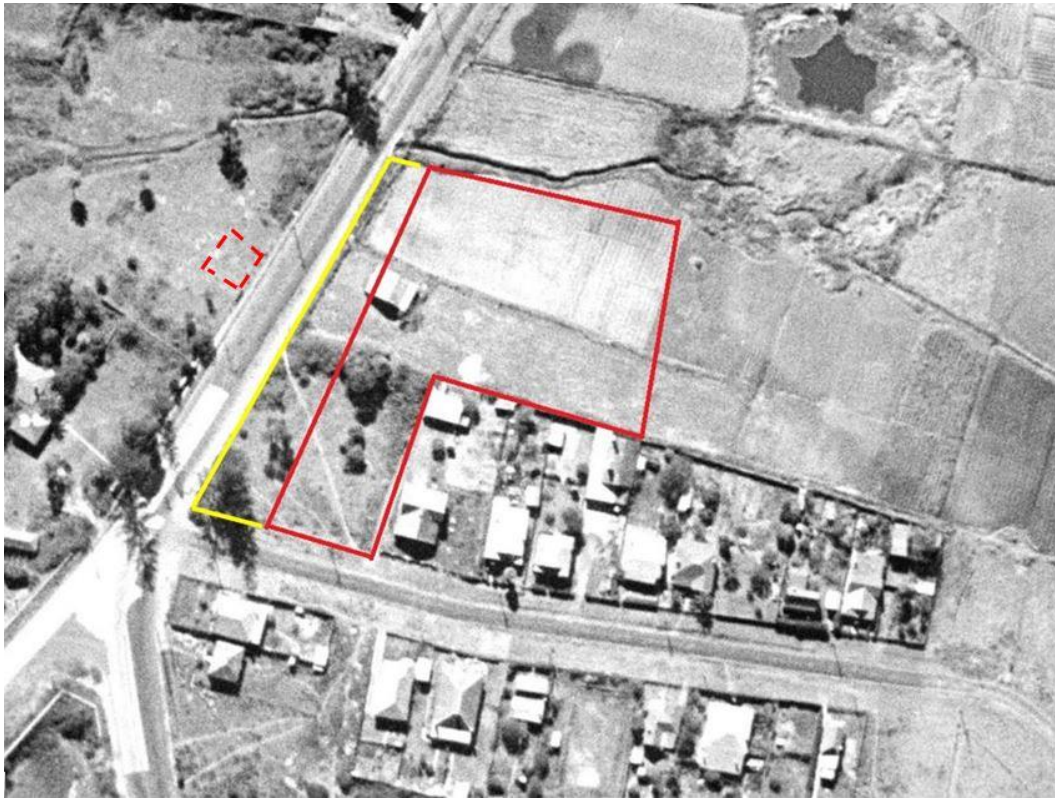
Figure 5.5 1943 Aerial Imagery of the study area (outlined in red) The yellow line represents the portion of the original property resumed for the Pittwater Road widening in 1948. *Brookvale House* is visible on the far left of the image. (<http://maps.six.nsw.gov.au/>).

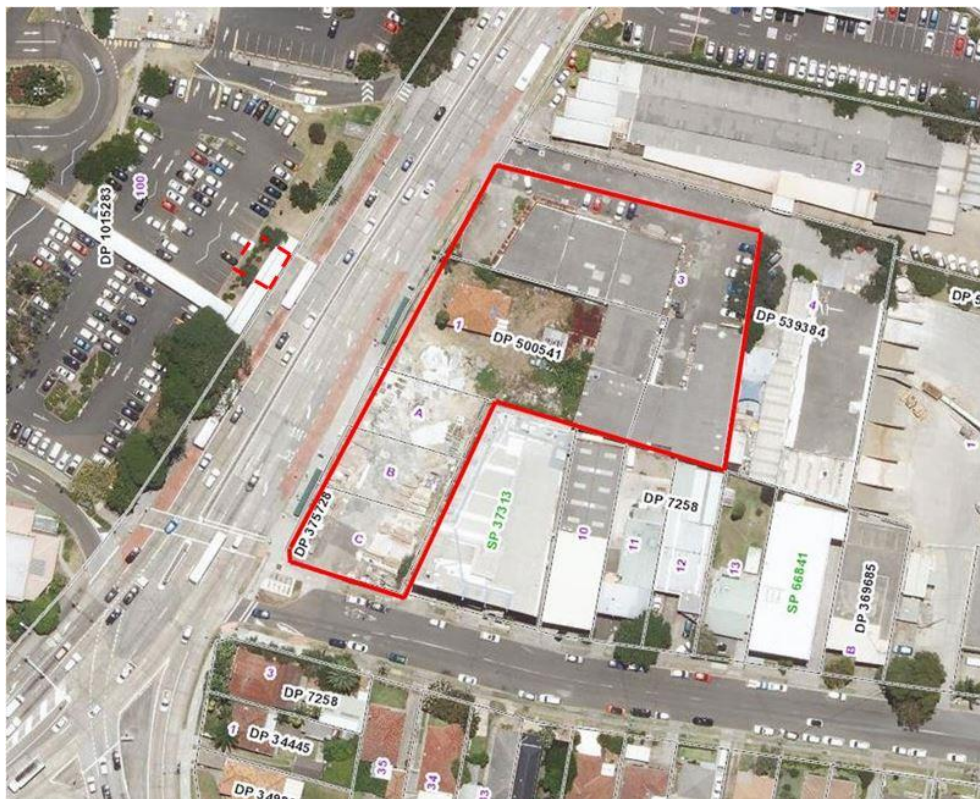
Figure 5.6 Current aerial of the site with a later house on 620 Pittwater Road (DP 500541). (<http://maps.six.nsw.gov.au/>).

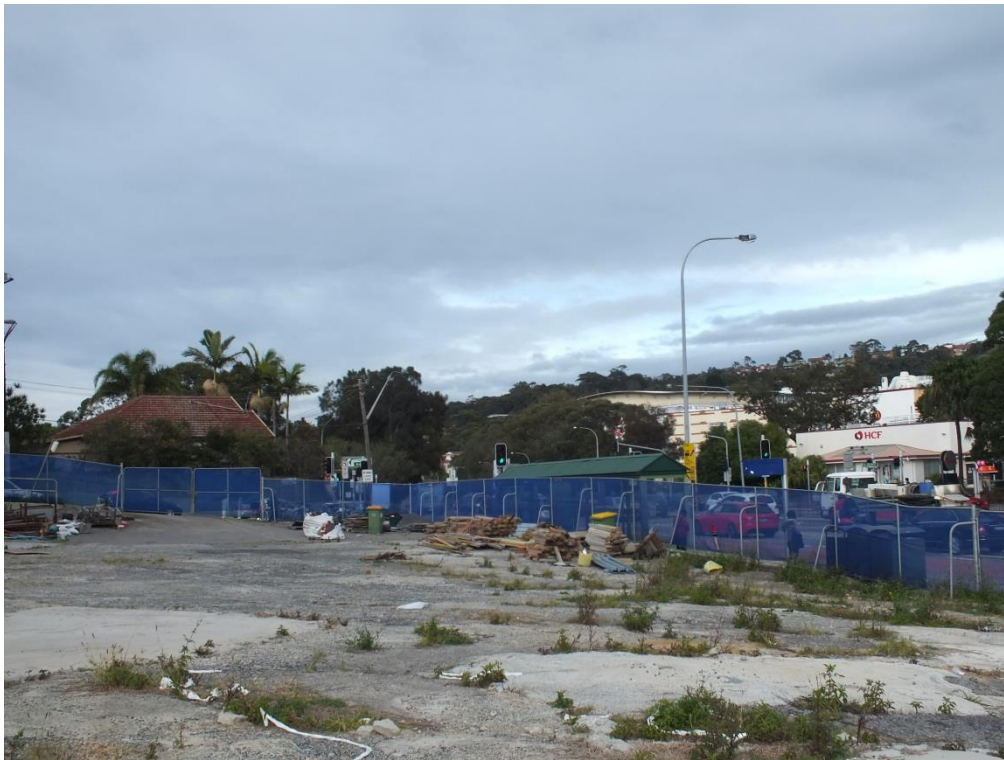
The remains of the concrete forecourt of the service station is extant at 612 Pittwater Road. The concrete surface had evidently been disturbed in several areas, likely as a result of site remediation carried out subsequent to the closure of the service station (Figure 6.1). A chain wire security fence encloses the southern and western boundary of the site, the fence continues across the front of 624 Pittwater Road. This part of the study area has an approximate area of 1385m² and is rectangular in shape.

Figure 6.1 View south-west, from near the boundary between 612 & 620 Pittwater Road, showing the remains of the concrete forecourt of the service station, areas of disturbance caused by remediation activities, the storage of some building materials and partial regrowth of grass and weeds in patches.

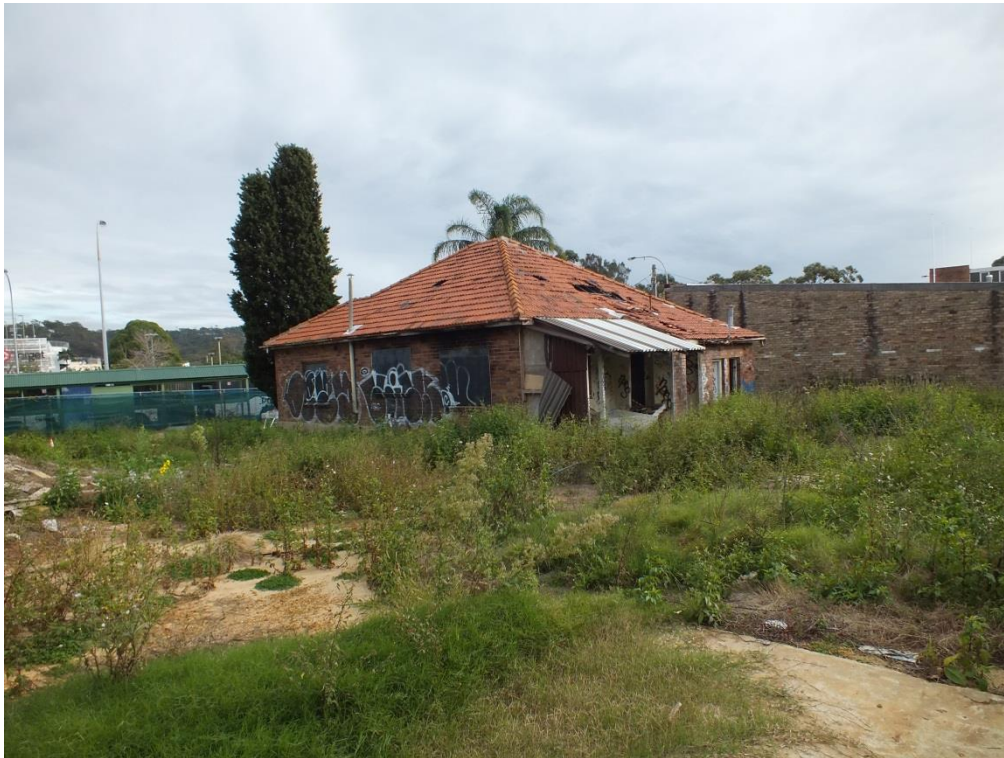
There is no physical boundary between 612 Pittwater Road and 620 Pittwater Road which bordered it to the north. With an area of approximately 1275m², 620 Pittwater Road is rectangular in shape and may have been the only part of the study area to have ever been put to residential use. It is the site of a derelict brick house and two out buildings, with the remains of a third visible through the undergrowth in the south west corner of the property (Figure 6.2). The land surrounding the buildings is considerably overgrown with grass and weeds including *Bidens Pilosa* (Cobbler's Peg). Where exposed, the soil is a sandy clay showing occasional inclusions of crushed demolition material. There are several small areas of dumped material on the property, including a pile of red bricks and some discarded shopping trolleys along the fence line dividing the property from the footpath and bus shelters along the Pittwater Road.

Figure 6.2 View north-west of the house at 620 Pittwater Road. The south wall of Barbeques Galore at 624 Pittwater Road is visible to the right of the house.

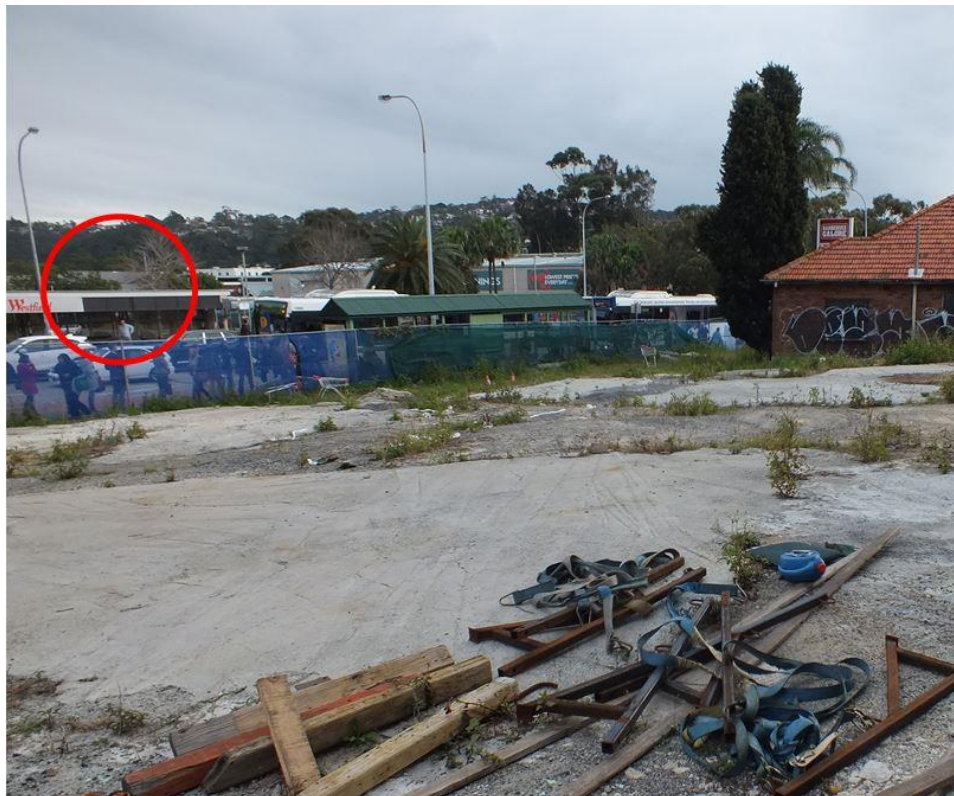
The area on the western side of Pittwater Road; the location of the pedestrian bridge tower, is presently occupied by the Westfield/Warringah Mall bus shelter within a grassed area. The area has been disturbed by construction activities associated with the shopping mall and road improvements.

Figure 6.3 View north--west. The pedestrian bridge tower will be located in approximately the area of the red circle.

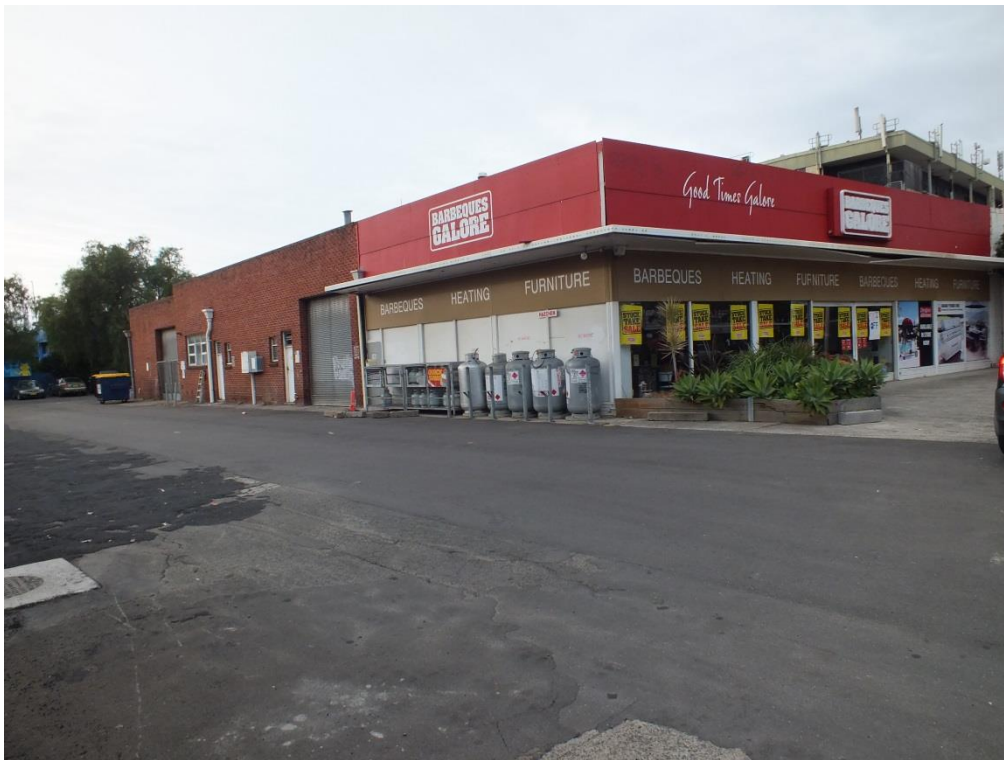
A commercial/warehouse complex stands at 624 Pittwater Road, which is an L-shaped block of approximate area 2720m². The commercial warehouse complex consisted of a single structure divided into several units, with a Barbeques Galore store facing the Pittwater Road (Figure 6.4). The building stands on the south and east boundary with the neighbouring property, 620 Pittwater Road, creating a semi-enclosed area at the rear (east) part of 624 Pittwater Road. The enclosed area acts as a loading bay for the warehouse. It seems likely that the building was extended over time as the rear of the building appears to show more general wear and tear. The area around the warehouse/commercial building has been sealed with an asphalt surface. There is a car park area in front of the Barbeques Galore store, separated from the footpath by a raised brick flower bed. A defined area of concrete in the asphalt surface at the rear of the Barbeques Galore building suggests that a portion of the asphalt surface was excavated for the installation of services. The area consists of a rectangle measuring 2.5m from east to west and 3.2m from north to south. There are two linear cuts, likely infilled pipe trenches, extending from the rectangular area. One runs west of the rectangle into Barbeques Galore, the other exits the site to the north. This is indicative of likely extensive sub surface disturbance of the site.

Figure 6.4 View south-east of the commercial/ warehouse building at 624 Pittwater Road. The darker macadam on the left of the photograph represents the access road to 626 Pittwater Road and the Northern extent of the study area.

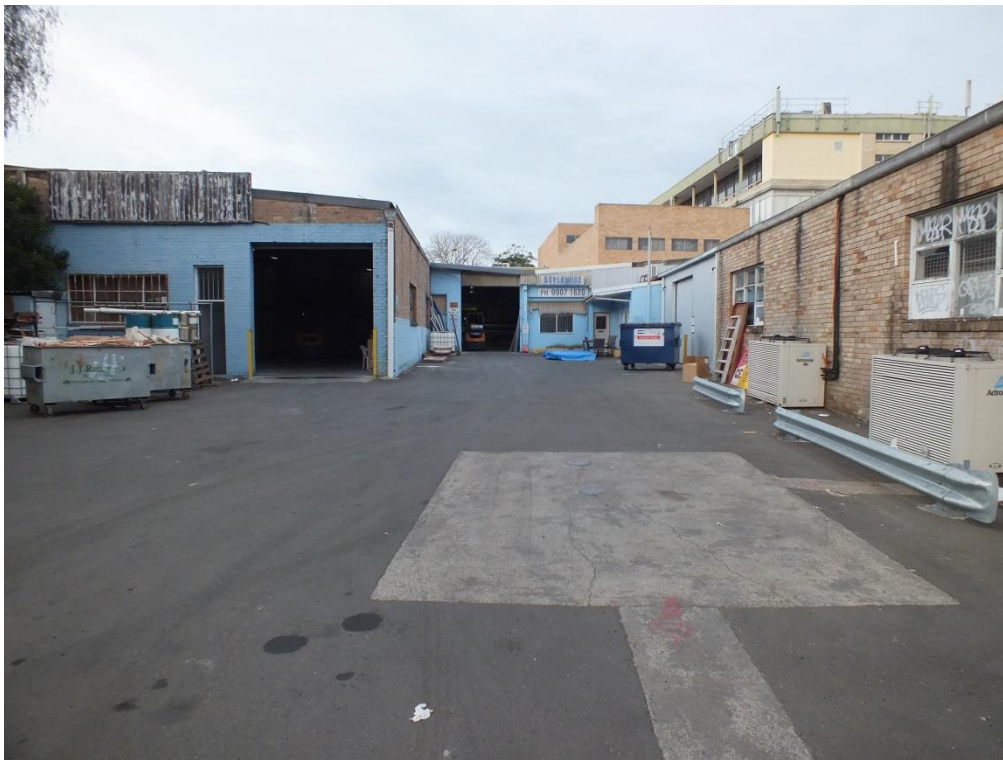
Figure 6.5 View south of the warehouses at the rear of 624 Pittwater Road. The shape of the concrete area in the foreground suggests sub surface services have been installed there.
