# Brookvale Community Health Centre

Eastern Bentwing-bat Survey  
620 Pittwater Road, Brookvale

*Health Infrastructure*

*May 2015*

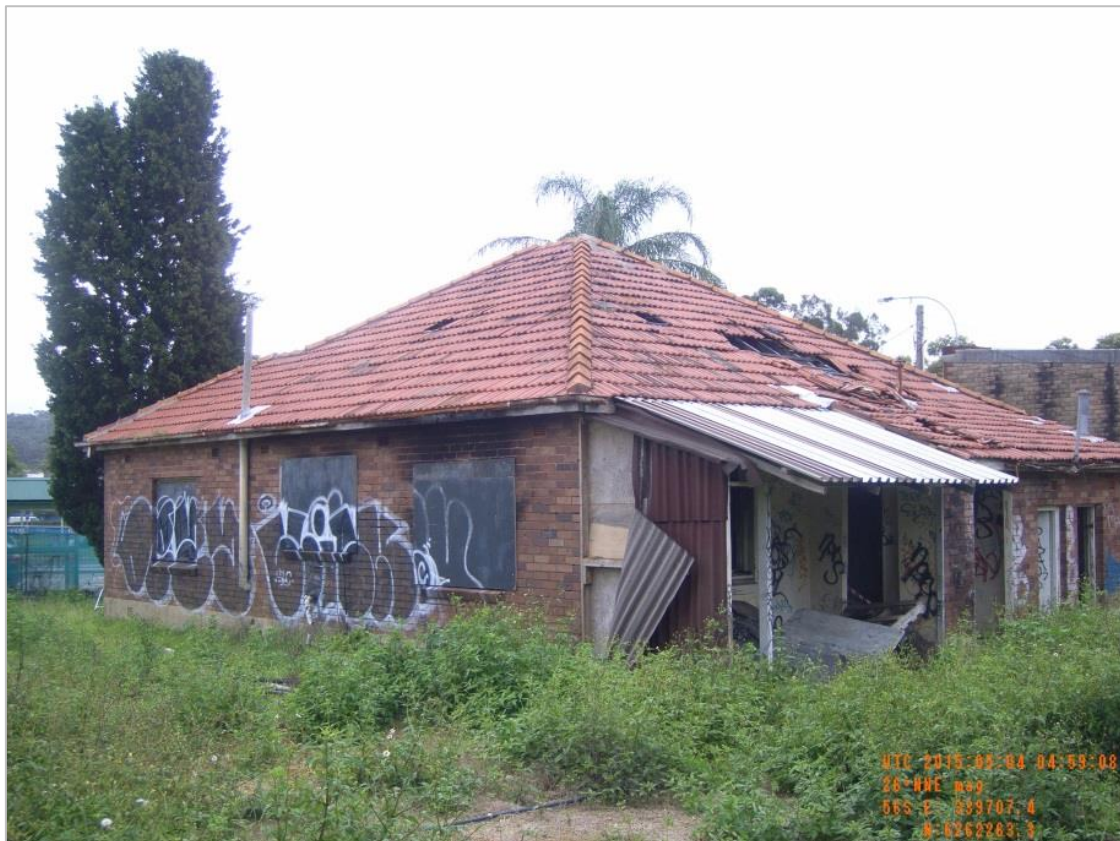
**Photo 1 Building 1**

1. An unoccupied brick and tile residence (Figure 1, Photo 1). The brick house is in a poor state with broken windows, missing tiles on the roof and several rooms have been burnt out.
2. An open timber and tin shed (Figure 1, Photo 2). The shed has piles of timber stored in it.
3. An enclosed brick, timber and tin shed (Figure 1, Photo 3). The structure of the shed is in moderate condition with some internal roof sheets falling down. It is currently being used for storing panels of timber.

The buildings may provide some roosting habitat for the Eastern Bentwing-bat in the roof cavity, particularly of the house (Building 1). However, the roof does have several holes in it with part of the roof cavity falling down from fire damage and large sections of tiles are missing from the roof. One feature of roost sites is the presence of a domed area where temperature and humidity are elevated (DEC 2004). The damage to the roof cavity indicates that there could not be habitat present with a constant elevated temperature and humidity.

- The buildings should be inspected immediately prior to demolition in the unlikely event that the species may opportunistically use the building structures to roost depending on seasonal factors and available habitat in the area.
- Where possible, demolition of the buildings should take place between October and February as this is the time of year when Eastern Bentwing-bats are often absent from most roosts (Hoye 2009).
