Report on  
Geotechnical Investigation

Proposed Site 53 Redevelopment  
2 Figtree Drive, Sydney Olympic Park

Prepared for  
Mirvac Projects Pty Ltd

Project 73946  
August 2014

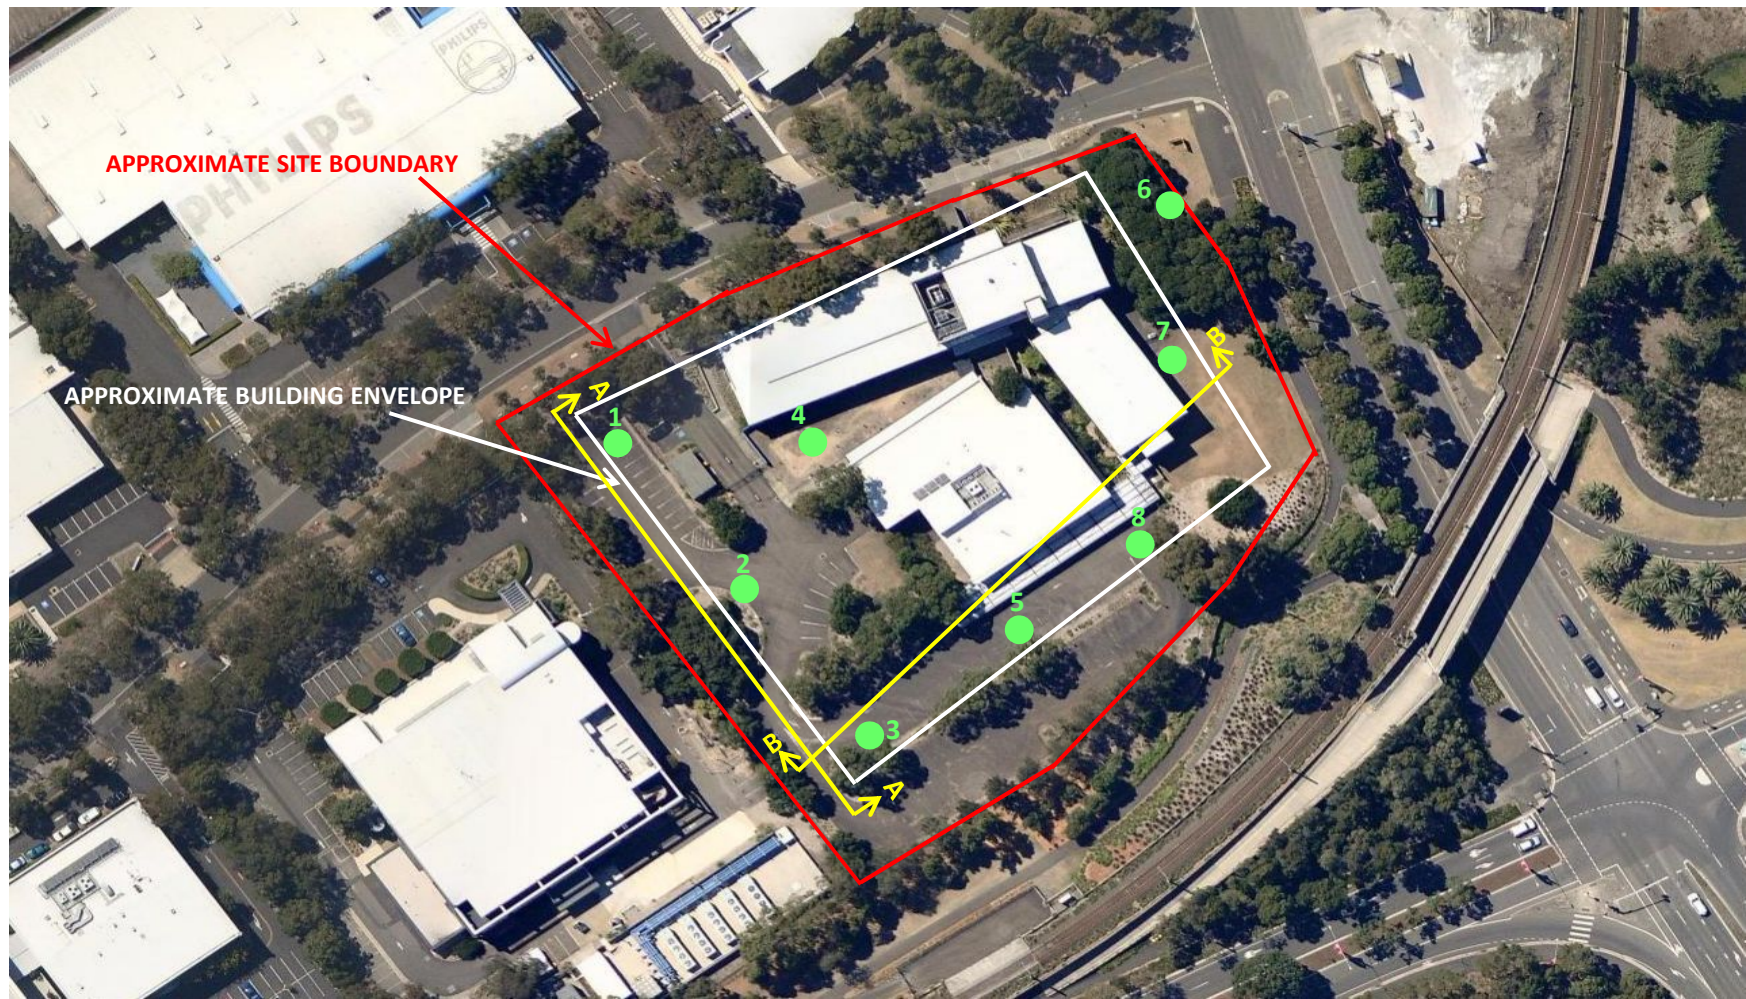
DWG No: 1

● Borehole
