Test Bore Log Results

Project 84897.04
May 2016

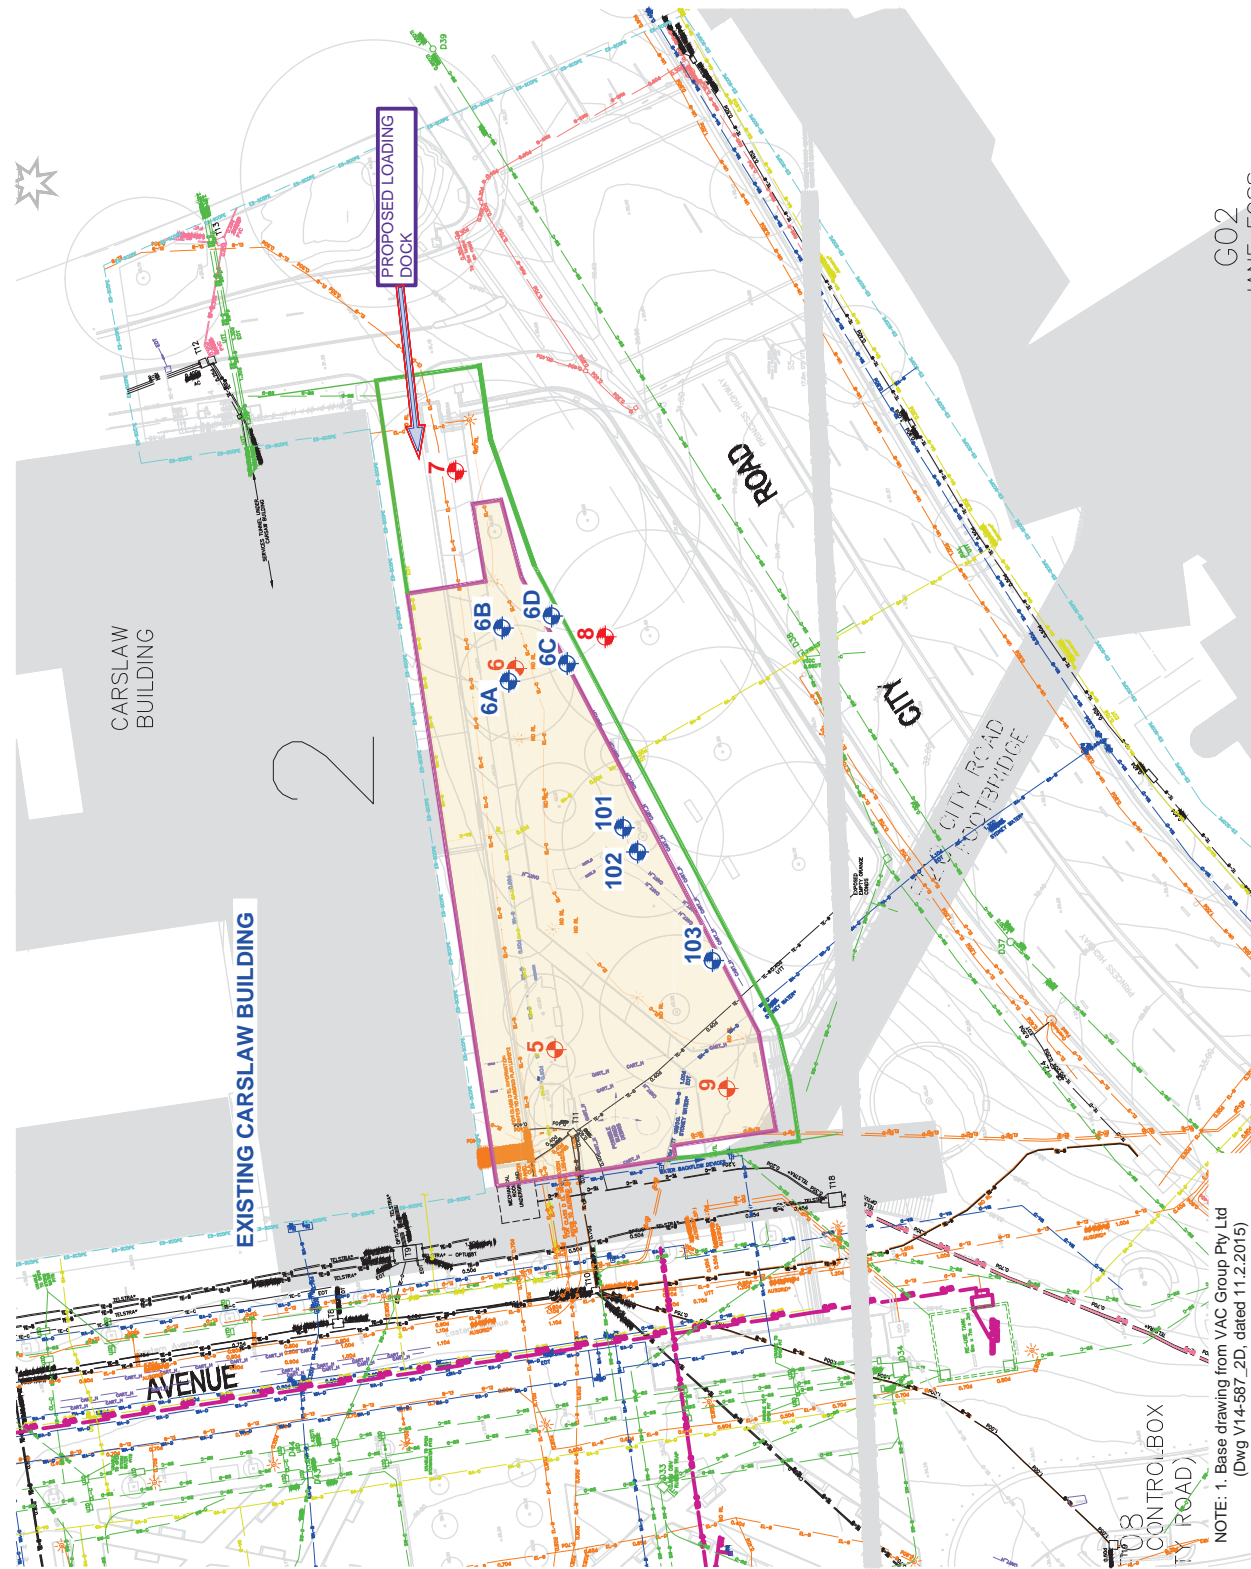
NOTE: 1. Base drawing from VAC Group Pty Ltd (Dwg V14-587_2D, dated 11.2.2015)
2. Test locations are approximate only and are shown with reference to existing site features.

- Current borehole location (4.5.2016)
- Previous borehole location (29.6-17.7.2015)
- Approximate extent of proposed building
- Approximate extent of proposed surrounding public domain works

Field work for DP (2015) included the drilling of five boreholes (Bores 5 to 9) at the locations shown on Drawing 1, Appendix A. The subsurface conditions encountered are presented on the borehole logs, Appendix B. Notes defining descriptive terms and classification methods are also provided in Appendix B.
