Report on
Geotechnical Investigation

Proposed LEES1 Carslaw Extension
Eastern Avenue, The University of Sydney

Project 84897.00
July 2015

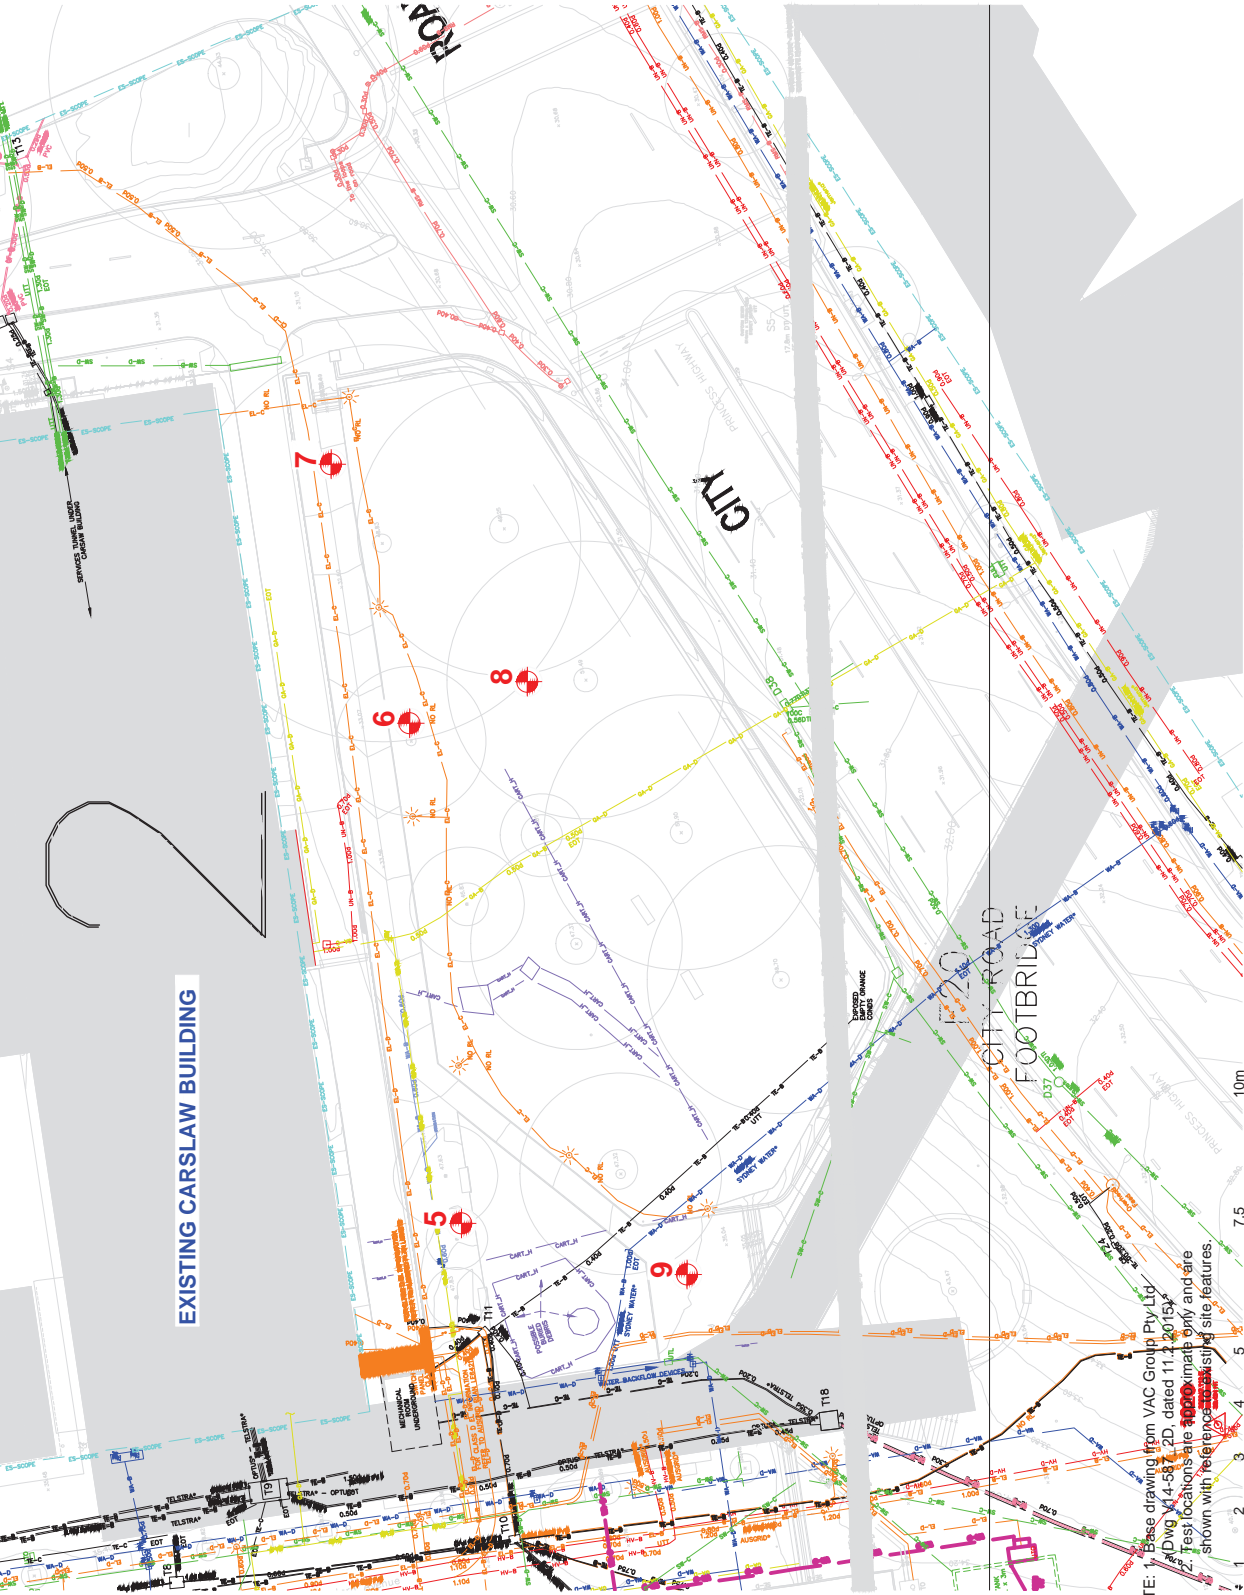
Drawing No. 1A – Location of Tests

NOTE: 1. Base drawing from VAC Group Pty Ltd, dated 11.1.2015.
2. Test locations are 1000m apart and are shown with reference to site features.

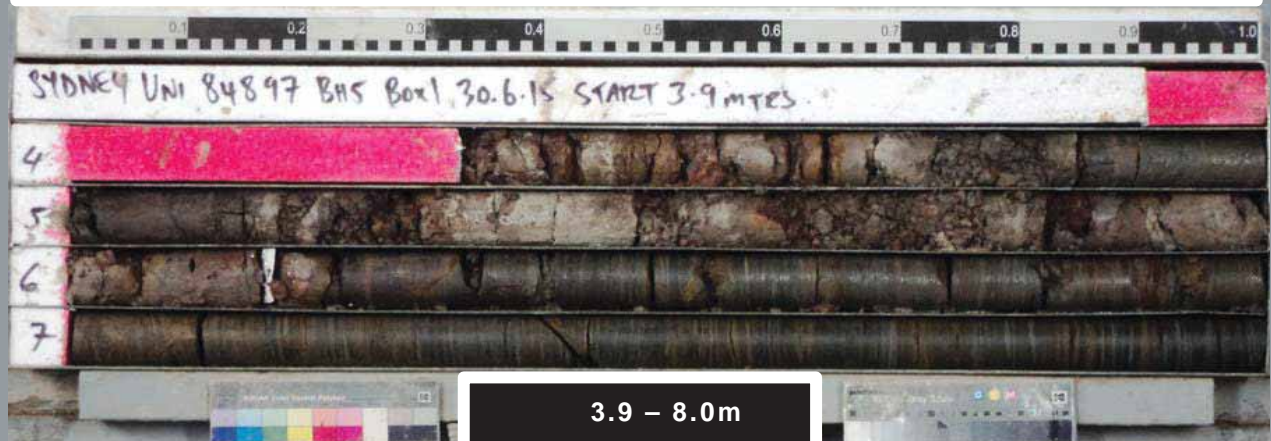
RL	Depth (m)	Description of Strata	Degree of Weathering					Graphic Log	Rock Strength					Water	Fracture Spacing (m)				Discontinuities		Sampling & In Situ Testing						
			EW	HW	MW	SW	FS		FR	Ex Low	Very Low	Low	Medium		High	Very High	Ex High	0.01	0.05	0.10	0.50	1.00	B - Bedding S - Shear	J - Joint F - Fault	Type	Core Rec. %	RQD %
34	0.4	FILLING - light grey-brown, fine sand filling with some silt/clay and a trace of concrete gravel and grass roots, humid																									3,4,6 N = 10
1	1.1	FILLING - apparently poorly compacted, grey, silty clay filling with some fine sand, moist																				A/E					
33		CLAY - stiff, light brown clay, moist																				A/E					
2	2.0																					S					
32		SHALE/LAMINITE - extremely low to very low strength, light grey-brown, shale/laminite																				E					
3																										18,20/100mm refusal	
31

4	3.9	SHALE/LAMINITE - extremely low and very low to low strength, extremely to highly weathered, fragmented to fractured, light grey to grey and brown, shale/laminite with medium strength ironstone bands																									PL(A) = 0.7

4.35																											
5																						C	80	0			
29																											
6																											
6.2		LAMINITE - low to medium then high strength, slightly weathered, fractured and slightly fractured, grey-brown, laminite with approximately 25% fine sandstone laminations																									PL(A) = 0.3
7																											
27																						C	100	77			
8	8.0	Bore discontinued at 8.0m																									PL(A) = 1.3
26																											
9																											
25

WATER OBSERVATIONS: No free groundwater observed whilst augering

It is likely that the elevated PAH and TRH concentrations detected in BH6 are associated with the pavement material composition, and/or the presence of asphalt. It is recommended that additional investigation be conducted in the vicinity of the test bore to define the extent and possible source of

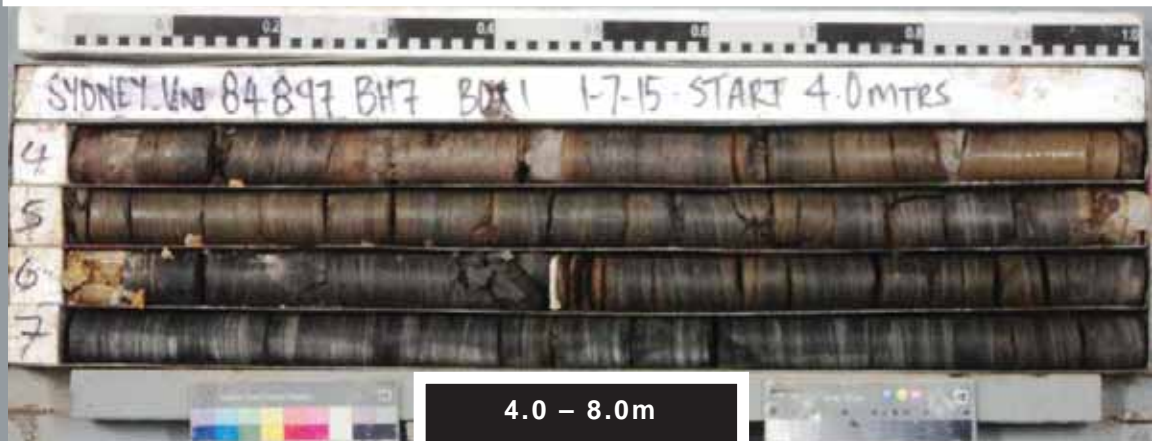
DOUGLAS PARTNERS PTY LTD
PROPOSED LEES1 CARSLow EXT. – THE UNIVERSITY OF SYDNEY
BORE 7 PROJECT 84897 JUL 2015

RL	Depth (m)	Description of Strata	Degree of Weathering					Graphic Log	Rock Strength					Water	Fracture Spacing (m)				Discontinuities		Sampling & In Situ Testing

WATER OBSERVATIONS: No free groundwater observed whilst augering

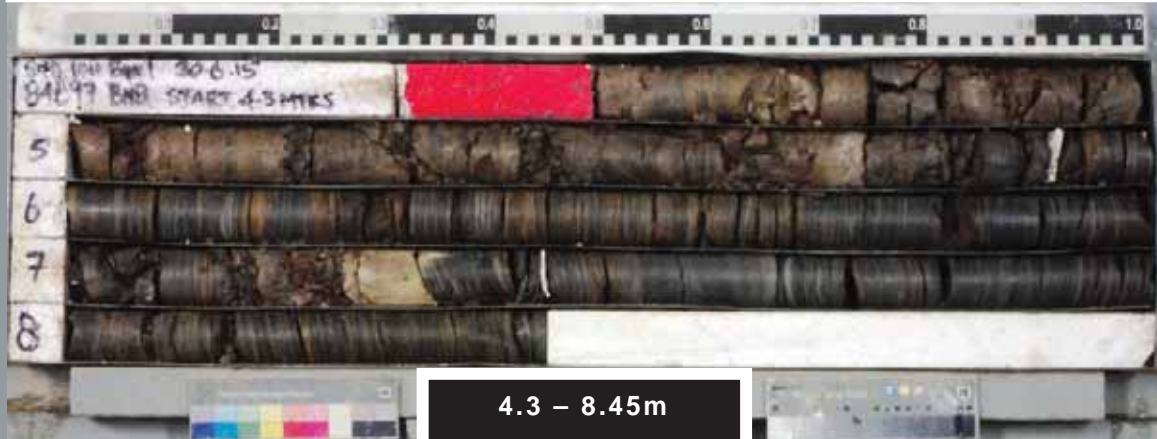
DOUGLAS PARTNERS PTY LTD
PROPOSED LEES1 CARSLow EXT. – THE UNIVERSITY OF SYDNEY
BORE 8 PROJECT 84897 JUN 2015

RL	Depth (m)	Description of Strata	Degree of Weathering						Graphic Log	Rock Strength					Water	Fracture Spacing (m)				Discontinuities		Sampling & In Situ Testing				
			EW	HW	MW	SW	FS	FR		Ex Low	Very Low	Low	Medium	High		Very High	Ex High	0.01	0.05	0.10	0.50	1.00	B - Bedding S - Shear	J - Joint F - Fault	Type	Core Rec. %
33		FILLING - apparently poorly compacted, grey, silty clay filling with some fine sand, moist																				A			3,4,6 N = 10	
1	1.0	CLAY - stiff, light brown clay, moist																				A/E				
32																						S				
2	1.8	SHALY CLAY- hard, light grey mottled brown, shaly clay, moist																				E				
31																						E				
3																						S			7,16,28 N = 44	
30																										
4	4.0	SHALE/LAMINITE - very low strength, light grey shale/laminite																					S			23,25/100mm refusal
29

4.5		LAMINITE - low strength, highly to moderately weathered, fractured, grey-brown laminite with some very low strength bands																								PL(A) = 0.2
5																										
28																										PL(A) = 0.7
6	5.9	LAMINITE - medium then high strength, moderately then slightly weathered, fractured and slightly fractured, grey-brown, laminite with approximately 25% fine sandstone lamination																								
27																										PL(A) = 0.7
7																										
26																										PL(A) = 0.8
8																										
25																										PL(A) = 1.3

RIG: Bobcat **DRILLER:** SY **LOGGED:** SI **CASING:** HW to 2.5m
TYPE OF BORING: Solid flight auger to 2.5m; Rotary to 4.3m; NMLC-Coring to 8.45m
WATER OBSERVATIONS: No free groundwater observed whilst augering
REMARKS:

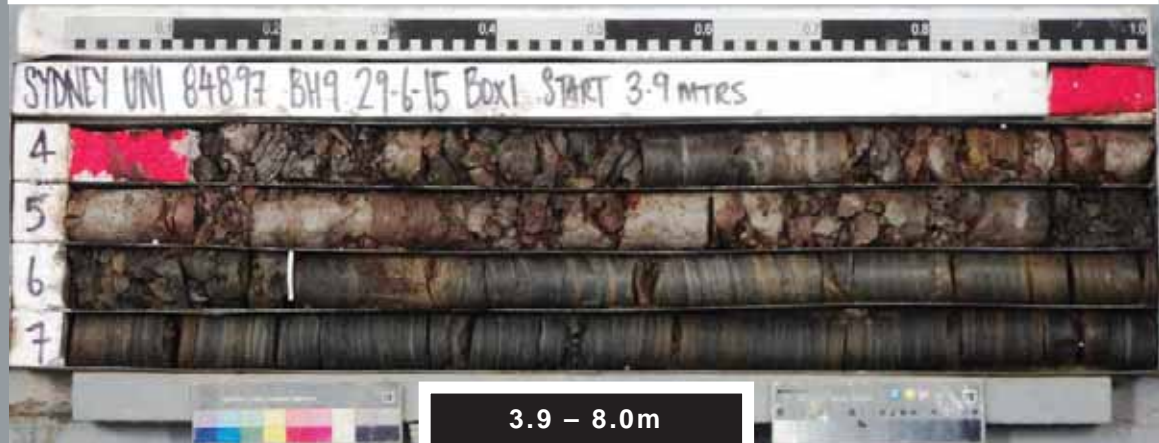
DOUGLAS PARTNERS PTY LTD
PROPOSED LEES1 CARSLow EXT. – THE UNIVERSITY OF SYDNEY
BORE 9 PROJECT 84897 JUN 2015

BOREHOLE LOG

CLIENT: The University of Sydney
PROJECT: LEES1 Carslaw Extension
LOCATION: Eastern Avenue, The University of Sydney

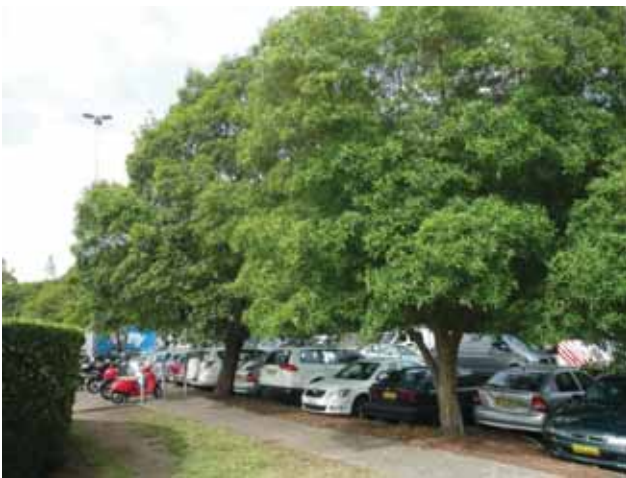
Figure 1: The site of proposed building F23

Both projects are located within the Darlington Campus of the University of Sydney. The F23 building is being constructed to co-locate and consolidate administrative functions. It is going to be constructed on an area currently used for car parking (Figure 1) and is likely to include two basement levels.

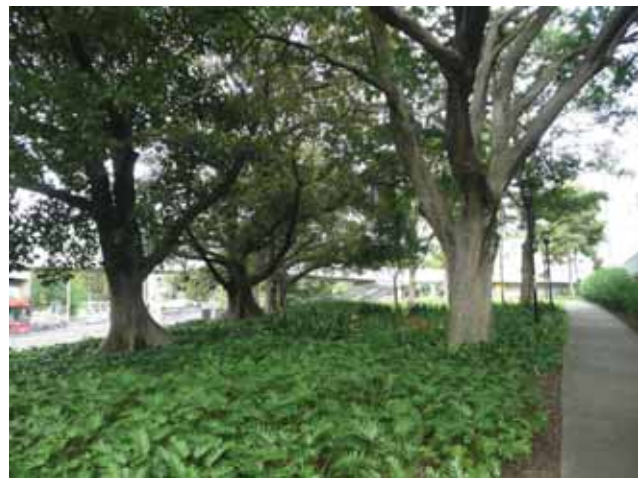
Figure 2: The site of the F07 extension

The F07 extension will be used to co-locate the schools of Molecular Bio-Science and Biological Sciences (Figure 2). The extension to the existing Carslaw building is likely to include one basement level.

The study area for the F07 extension is currently a planted area with large trees, which is bounded by the Carlsaw Building to the north, City Road to the south, Barff Road to the east and Eastern Avenue to the west. The Keith Murray footbridge over City Road is located at the southwest corner of this area. The site for the F07 extension is generally flat with the ground surface generally sloping from north-west down to the south-east from approximately RL 35.5 m AHD to RL 33 m AHD over a length of about 40 m (USYD, 2013 & 2014).

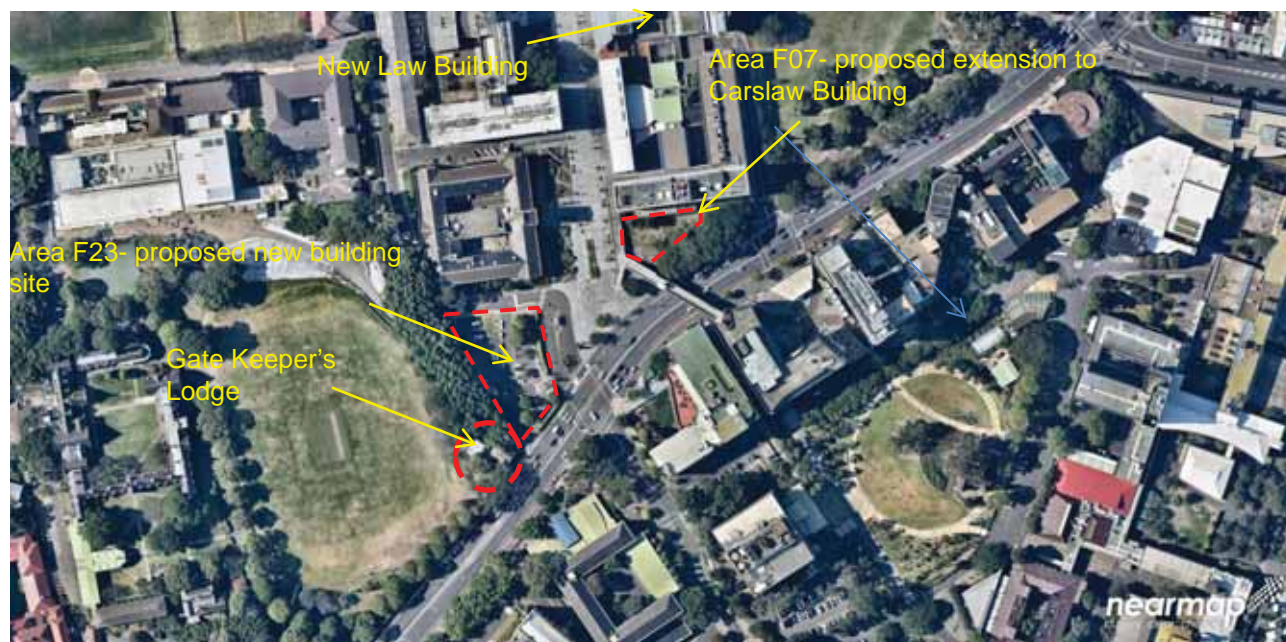
Figure 3: Locality of the study area: F07 and F23 Project sites.

The F23 building and F07 extension sites are located in Camperdown, Sydney within the Darlington Campus of the University of Sydney at the intersection of City Road and Eastern Avenue (Figure 3).

- A main Telstra cable runs across the F23 project site from Fisher Road near the Gate Keepers Lodge (see Figure 3) to the Madsen Building.
- An Ausgrid conduit has been installed along the walkway to the south of Area F23.
