## **HERITAGE INTERPRETATION STRATEGY FOR THE 'DOG-LEG FENCE'**

To Satisfy Conditions of Consent B82 (d)  
of SSD 7142

Prepared by  
**Umwelt (Australia) Pty Limited**  
on behalf of  
**United Wambo Joint Venture**

Project Director: Tim Adams  
Project Manager: Karyn Virgin  
Report No. 4306a/R06  
Date: December 2021

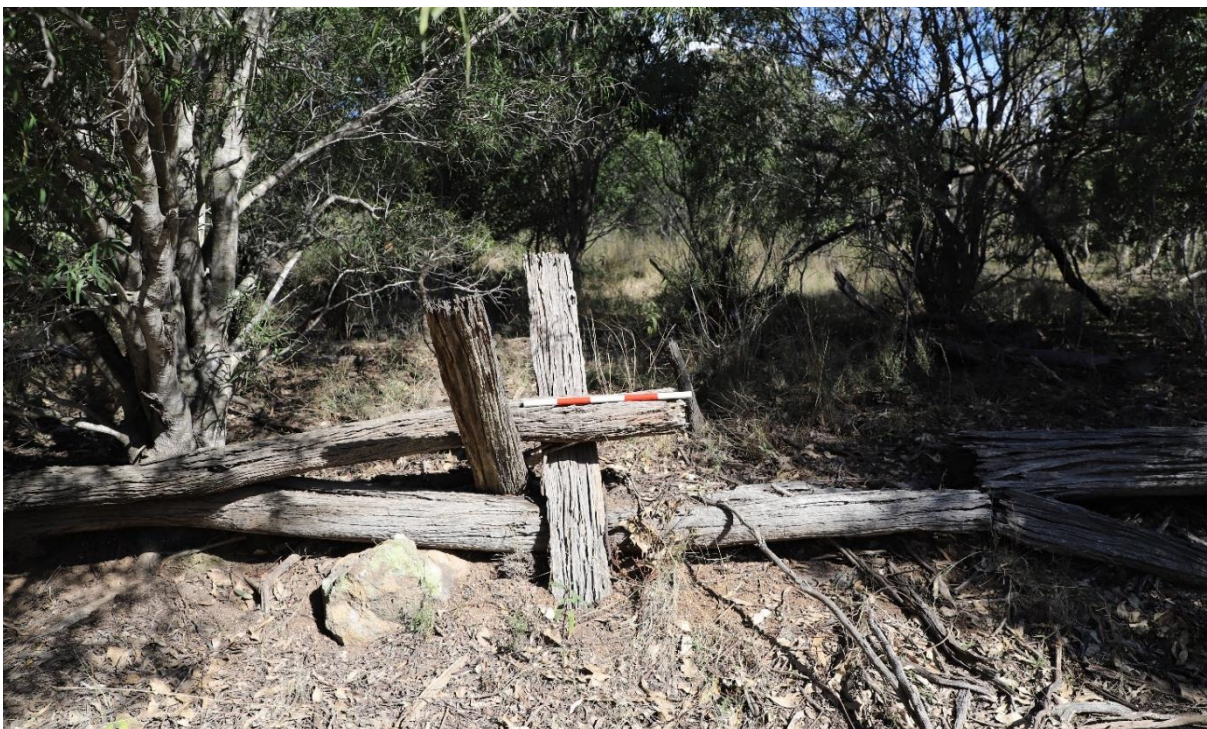
**Photo 4.1** Example of a dog-leg, located within Section 2 of the fence  
Within United Wambo owned land

Due to natural decay and displacement as a result of erosion, much of the timber has been disturbed and damaged. The 'dog-leg' component consists of two pieces of timber arranged across a fence, with a log or logs (or rails) resting in the crutch where they cross. This structure creates a cross or X formation and provides structural stability to the fence (see **Photo 4.1**).

- at least two but ideally four intact ‘dog-legs’ (refer to **Photo 4.1**)
- it is noted that the area of approved works under SSD 7142 contains ample Ironbark, the original material of the dog-leg fence, which would be of a suitable size and species for use in reconstruction.

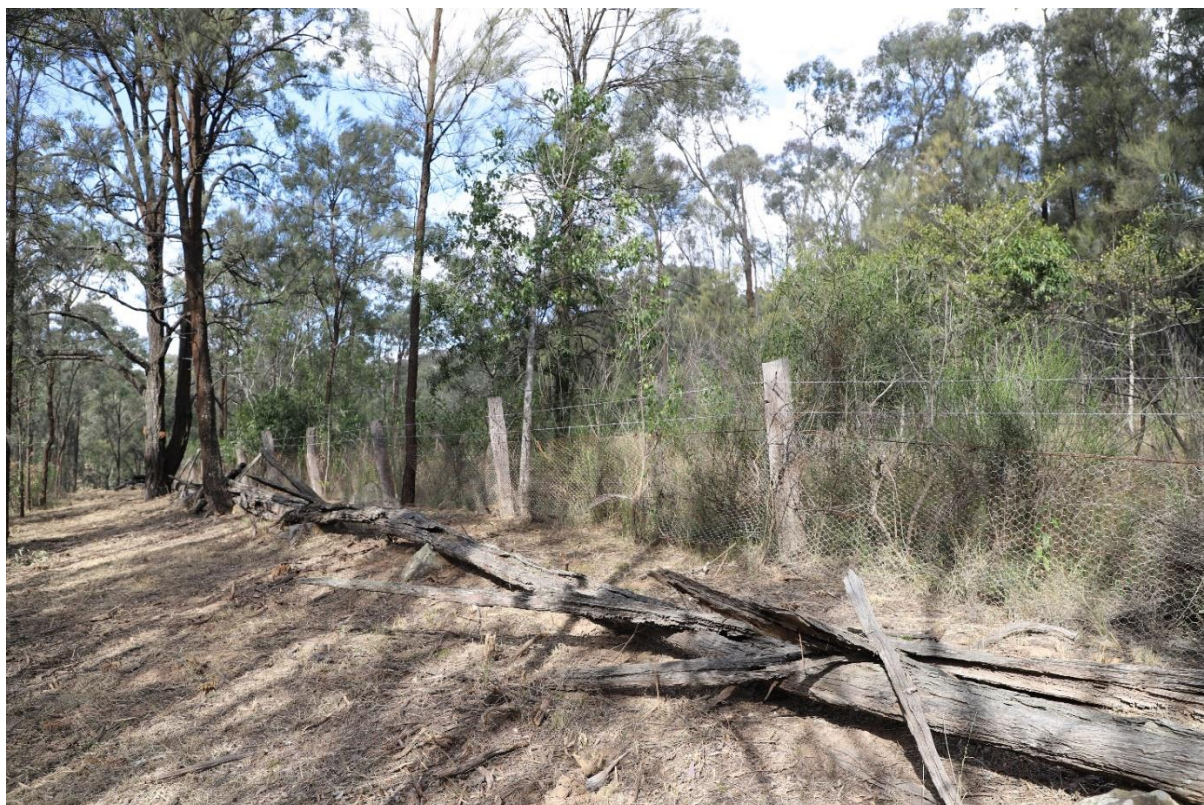
**Photo 4.2** Section 2 of the fence, illustrating the deterioration of timber elements

The fence has experienced substantial damage and deterioration since its construction in the early 19<sup>th</sup> century, in part due to natural decay and bush fires. Currently the fence is in poor to very poor condition, with timber elements of Section 2 in a state of deterioration or entirely absent from some sections of the fence (**Photo 4.2**). For large portions of the fence alignment, the sandstone blocks represent the only remaining physical feature. This is particularly the case for the entirety of Section 1, which comprises sandstone supports only (with no timber elements remaining) (**Photo 4.3**).

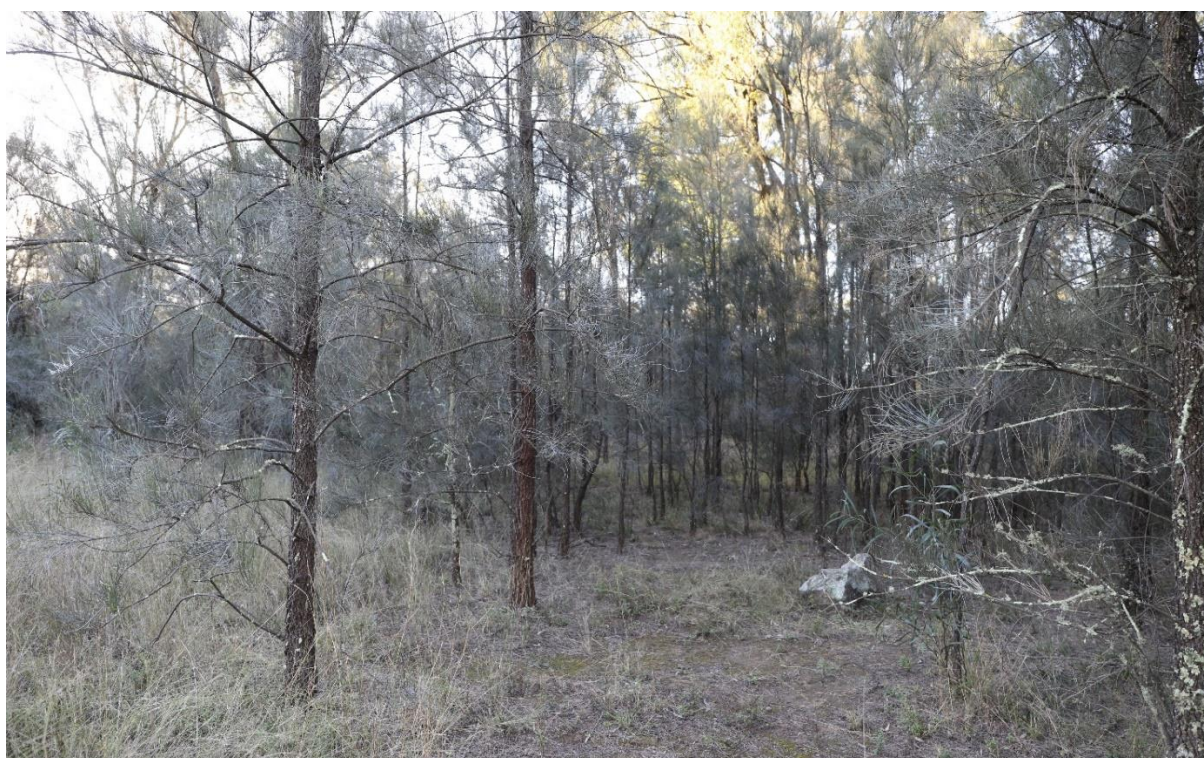
**Photo 4.3** Section 1 alignment of sandstone blocks

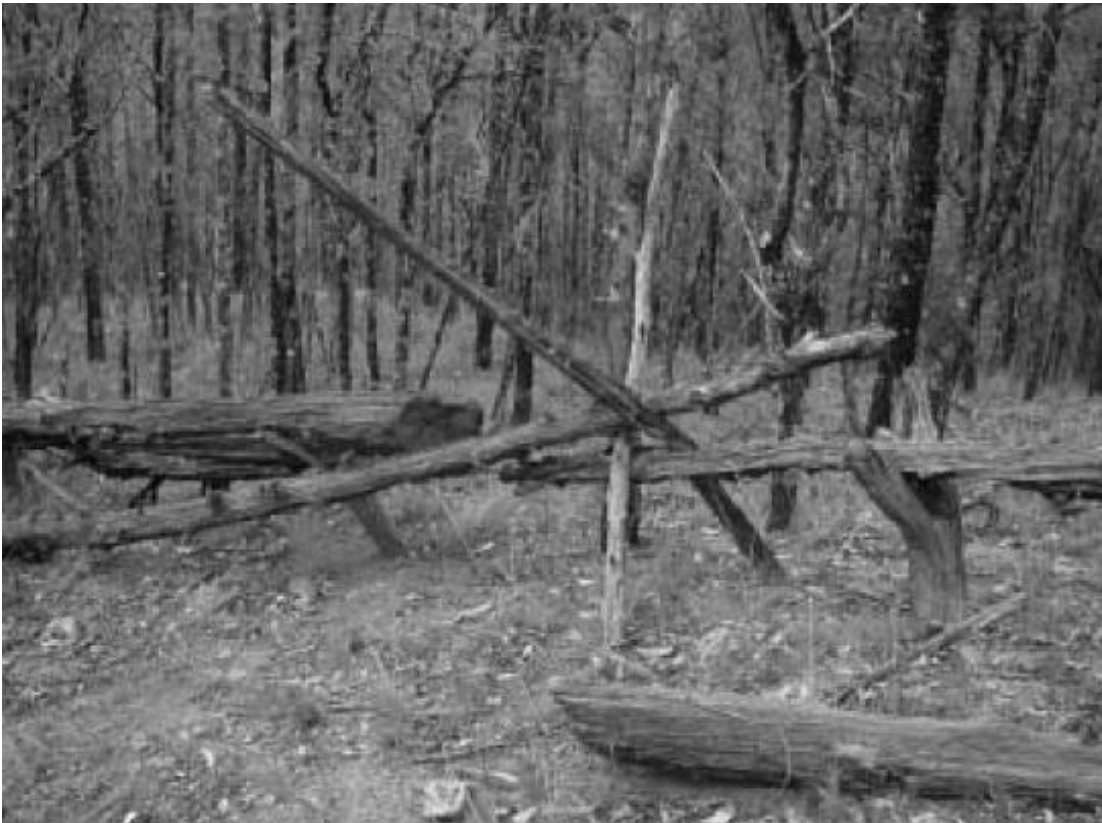
**Photo 5.1** View of the dog-leg fence at Mt Trooper, Kosciuszko National Park

The site of Mt Trooper, Kosciuszko National Park, NSW, provides one of only two other examples of a dog-leg fence within Australia, with the exclusion of the subject of this report. The fence was constructed of eucalyptus and White Cyprus pine and constructed by laying two rows of logs (or rails) head to butt, with a pair of poles placed diagonally across to support an upper line of logs/rails (**Photo 5.1**). The fence was constructed in the late 19<sup>th</sup> century and is currently in poor condition. The remaining 1.5 km of fencing is weathered with severe cracking and is deemed highly susceptible to fire hazards (Pickard 2007).

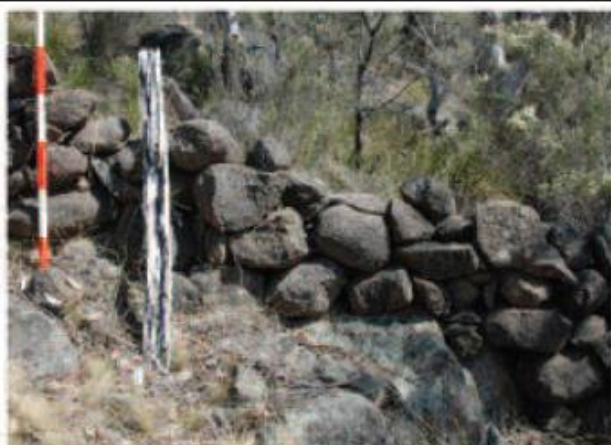
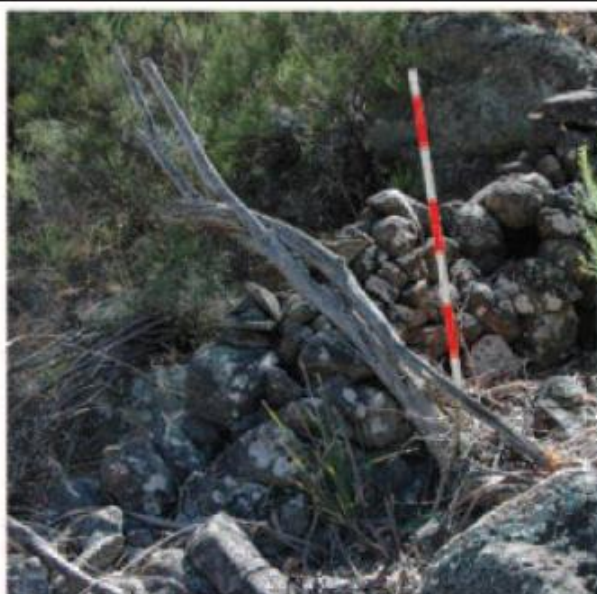
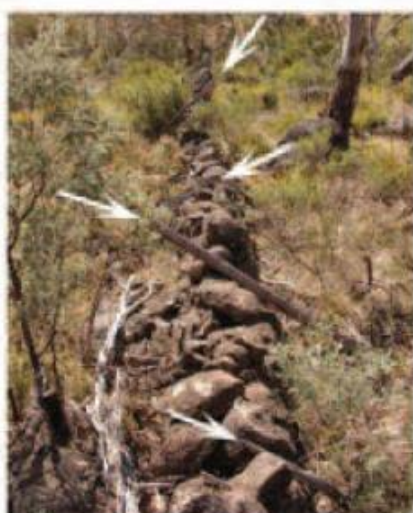
## Photo 5.2 Dog-legs and forks used to increase the height of the Mill Creek wall at Jindabyne, NSW

A truncated pair of dog-legs across a low part of the wall.

A cut fork resting across the wall still retains the cut pole that was originally supported by dog-legs at its uphill end.

Remains of four dog-legs (arrowed) ~5 m apart.

Ranging pole with 200 mm divisions.

Using dog-legs (left) and forks (right) to support a log above walls to increase the height of the fence, or to quickly repair a partially fallen wall.

The fence style can further be used as a contributory component, such as being used to raise the height of low dry-stone walls. Pickard (2015) documents an example of such a style being constructed in the 1880s in Jindabyne, NSW. The fence is described as consisting of a series of paired cut poles and single forks resting against the wall, with the timber posts being spaced 4-5 m apart.
