Preliminary Geotechnical and Constraints Assessment:

Lot 3 DP 568613
& Lot 384 DP 755952
Mundamia
NSW.

P0802193JR01_v2
November 2008

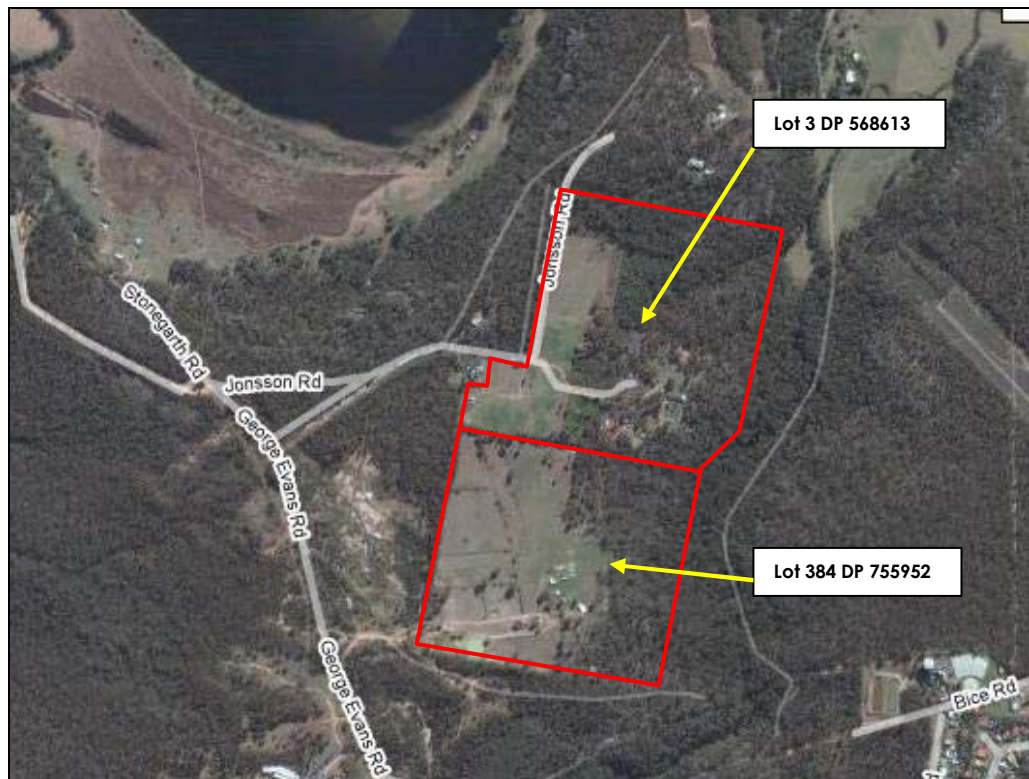
Figure 1: Aerial photograph (2008) showing the site in its environmental context.

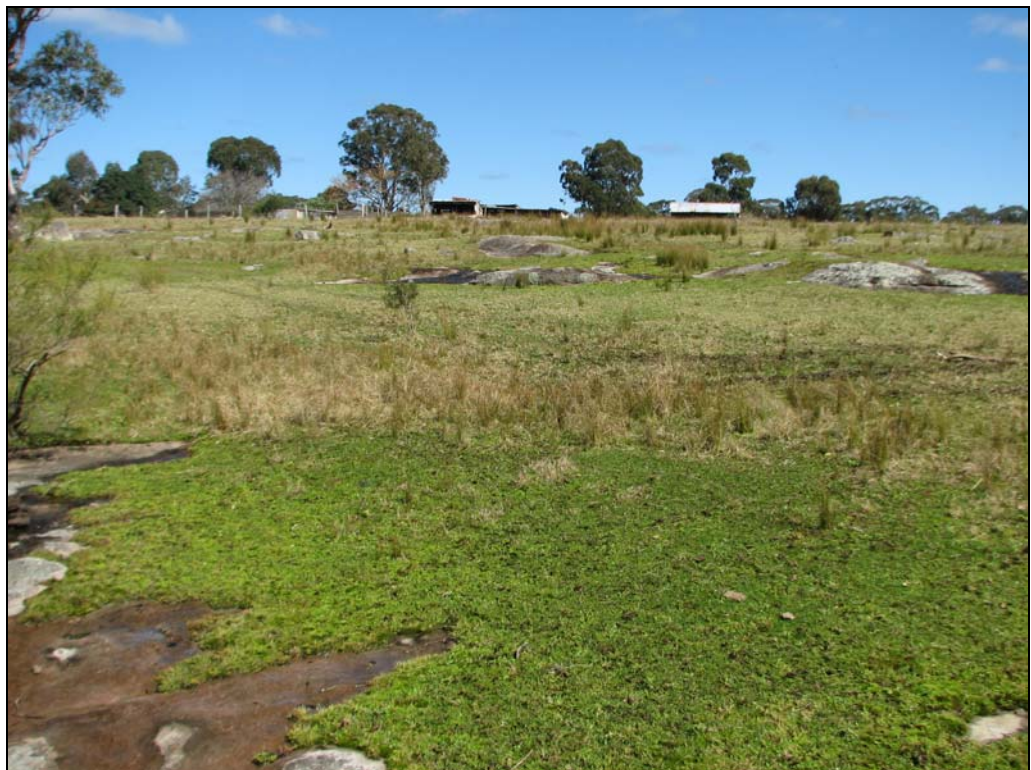
Field investigations indicate depth to weathered rock ranges from 0.5 m b.g.l. in the southern portion of the site (Lot 384) to > 2.5 m b.g.l. in the lower elevations (drainage depressions) in the north western portion of the site. Rock outcropping was observed along the entire eastern portion of the site.

Figure 2: Photo of sandstone outcropping and seepage. View looking south west towards existing buildings on Lot 384.

Based on our investigation we consider that the primary form of slope instability on the site is rock fall, based on the presence of steep gradients coupled with rock outcropping and boulders in the eastern portion of the site. A review of preliminary development plans provided by the Client, identifies this area as being utilised as an environmental buffer zone, with no residential development. Rockfall is expected to be away from the site, and subsequently it is not considered to be a constraint to development. No other obvious signs of recent or relic mass movements were noted on the allotment at the time of inspection.

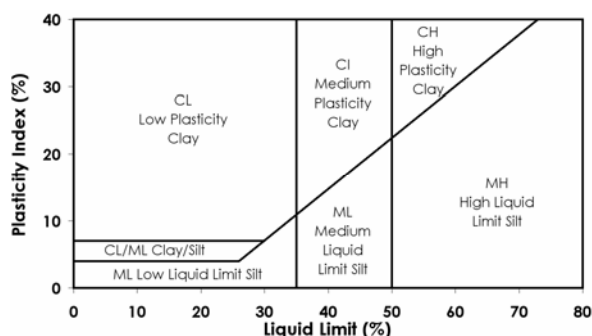
Plasticity Properties

Plasticity properties can be assessed either in the field by tactile properties, or by laboratory procedures.
