Hydrogeological Assessment:

Proposed Sub-division, Mundamia
Release Area, Mundamia NSW.

P1002761JR01V02
June 2011

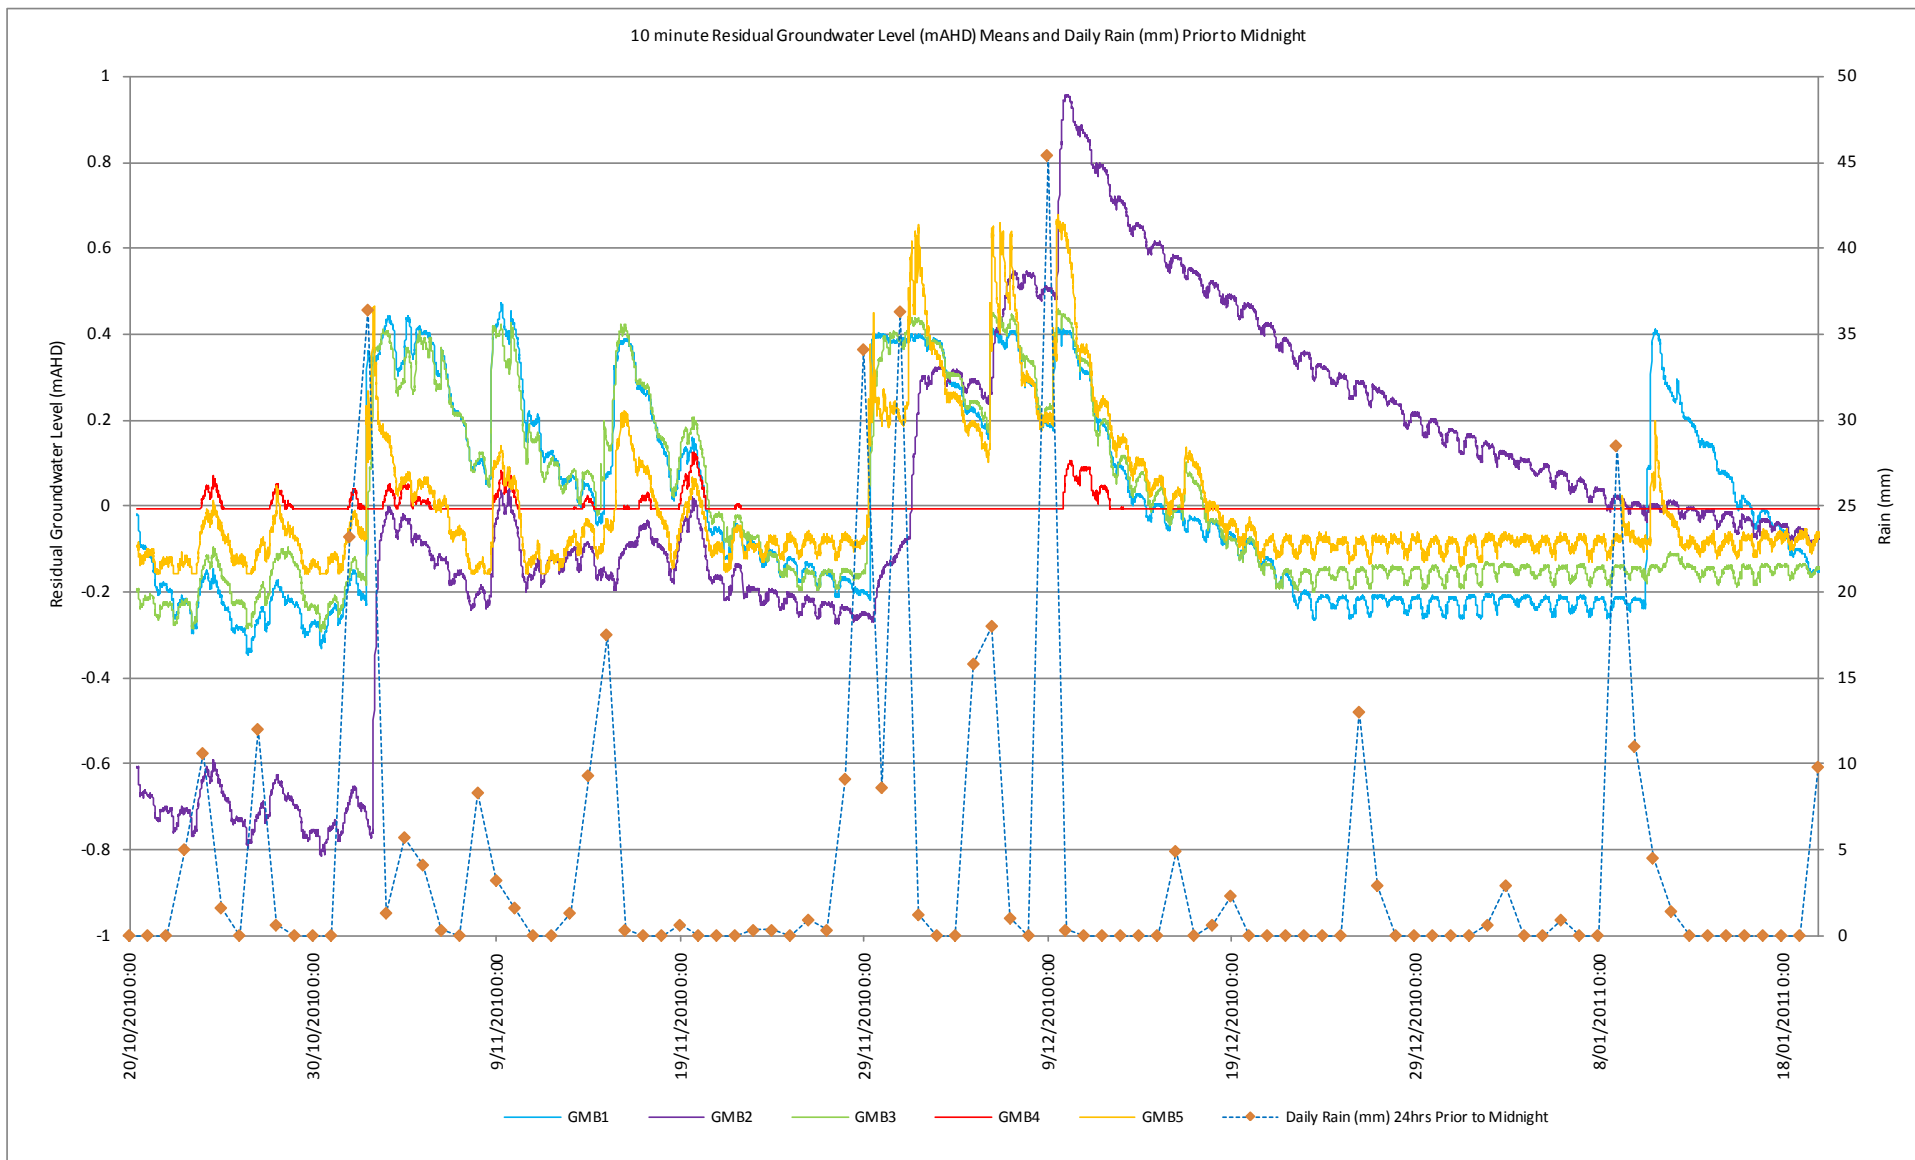
1. Residual mean = observed level – mean GMB level over monitoring period. This was done to normalise data.

Martens & Associates Pty Ltd ABN 85 070 240 890		Environment Water Wastewater Geotechnical Civil Management	
Drawn:	BR	RESIDUAL MEAN GROUNDWATER LEVELS AND SITE RAIN	Drawing No:
Approved:	AN		FIGURE 4
Date:	15.02.2011		
Scale:	NA		Job No: P1002761

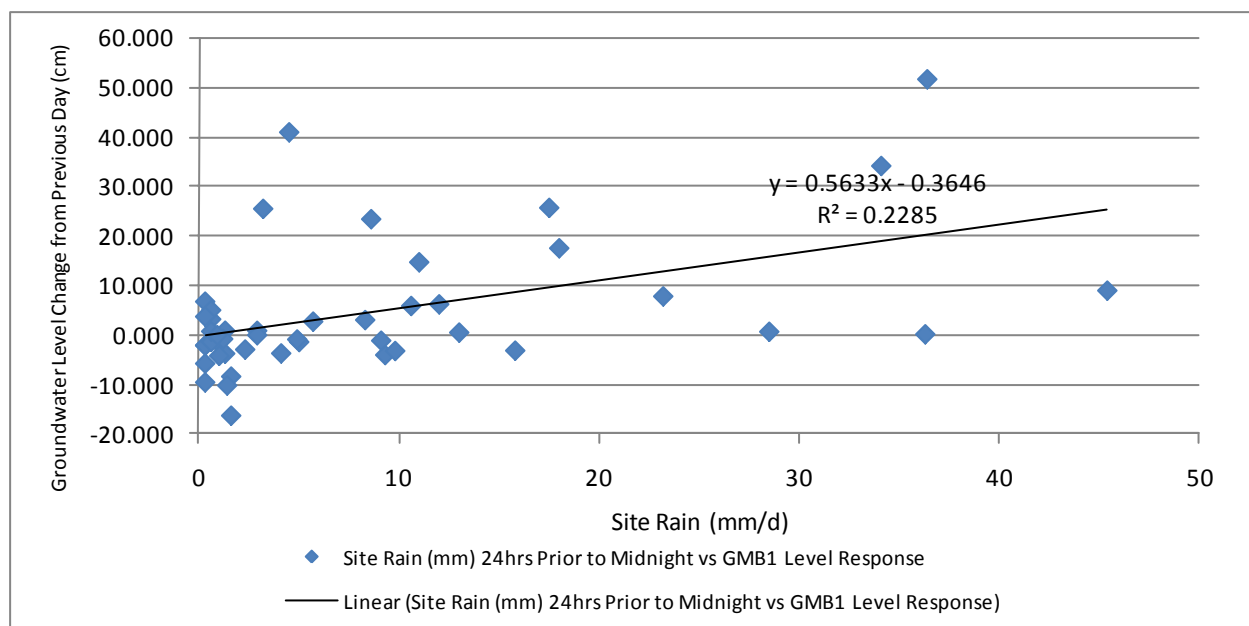
1. Line formula indicates that a groundwater response occurs once daily rainfall exceeds 0.65 mm.

Martens & Associates Pty Ltd ABN 85 070 240 890		Environment Water Wastewater Geotechnical Civil Management	
Drawn:	BR	GMB1 GROUNDWATER LEVEL RESPONSE VS DAILY RAINFALL	Drawing No:
Approved:	AN		FIGURE 10
Date:	15.02.2011		
Scale:	NA		Job No: P1002761

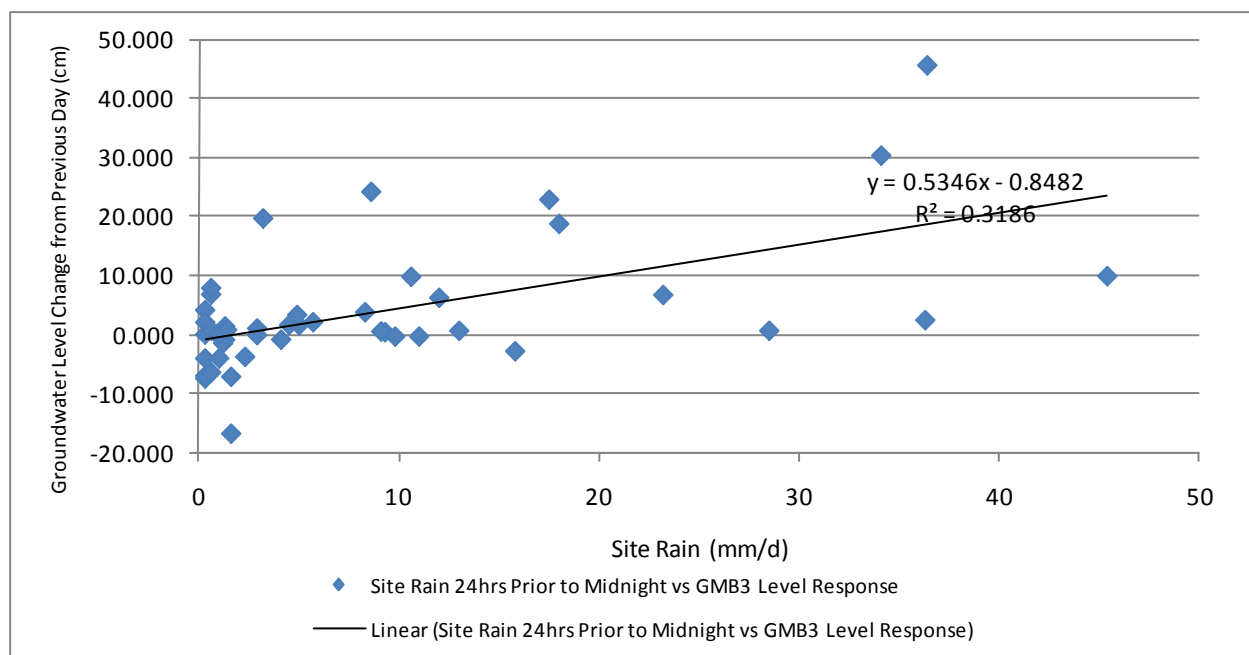
1. Line formula indicates that a groundwater response occurs once daily rainfall exceeds 1.59 mm.

Martens & Associates Pty Ltd ABN 85 070 240 890		Environment Water Wastewater Geotechnical Civil Management	
Drawn:	BR	GMB3 GROUNDWATER LEVEL RESPONSE VS DAILY RAINFALL	Drawing No:
Approved:	AN		FIGURE 11
Date:	15.02.2011		
Scale:	NA		Job No: P1002761

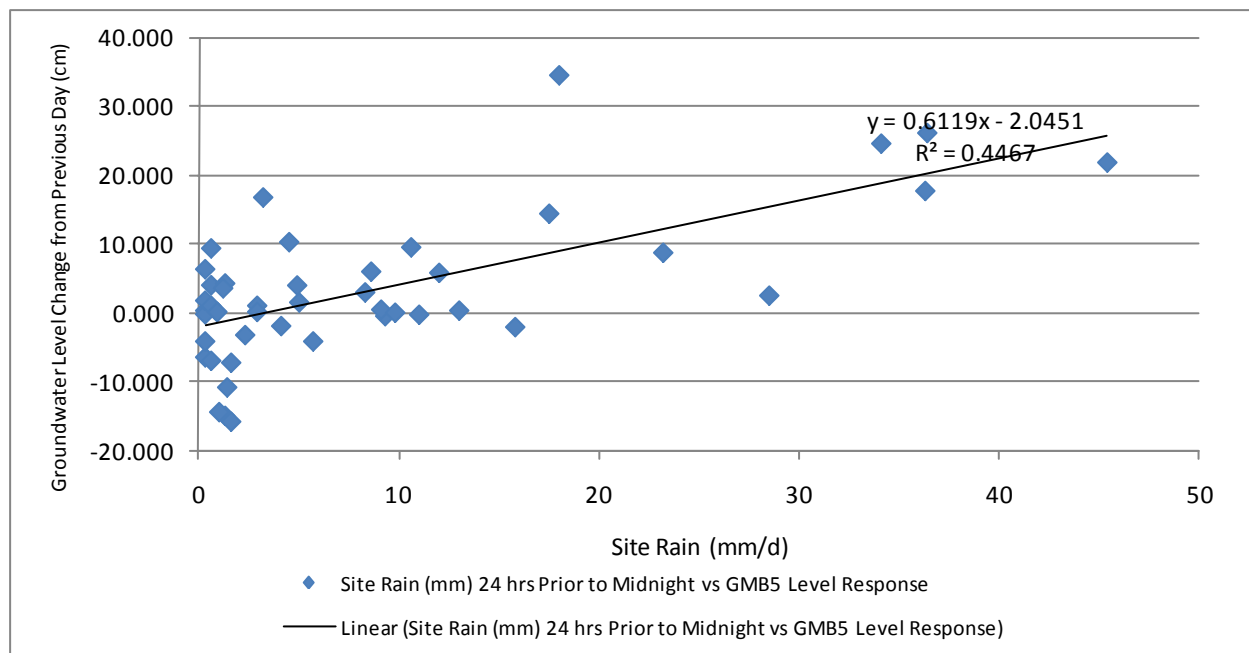
1. Line formula indicates that a groundwater response occurs once daily rainfall exceeds 3.34 mm.

Martens & Associates Pty Ltd ABN 85 070 240 890		Environment Water Wastewater Geotechnical Civil Management	
Drawn:	BR	GMB5 GROUNDWATER LEVEL RESPONSE VS DAILY RAINFALL	Drawing No:
Approved:	AN		FIGURE 12
Date:	15.02.2011		
Scale:	NA		Job No: P1002761

- 189 mm/ha/yr of supplementary recharge is required to replace lost recharge.
- The SRS is designed to recharge water for events of 3 mm/d rainfall or greater based on observed groundwater response to this size of rainfall event. Review of climate information indicates rainfall of 3mm or more occurs on average 63 days per year based on local climate record analysis.

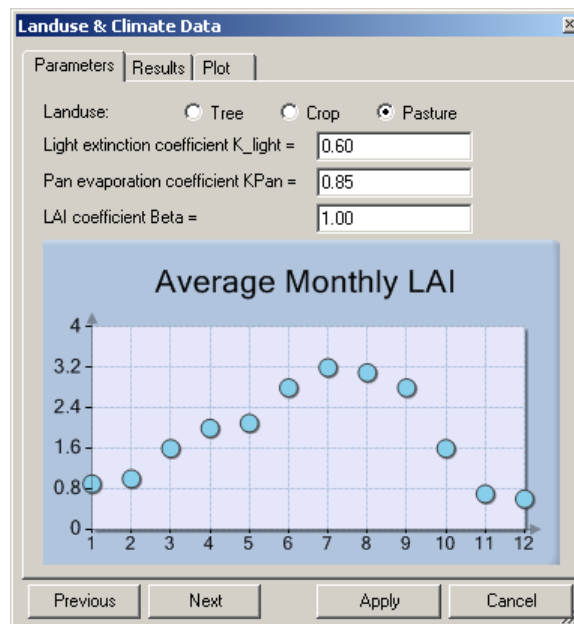
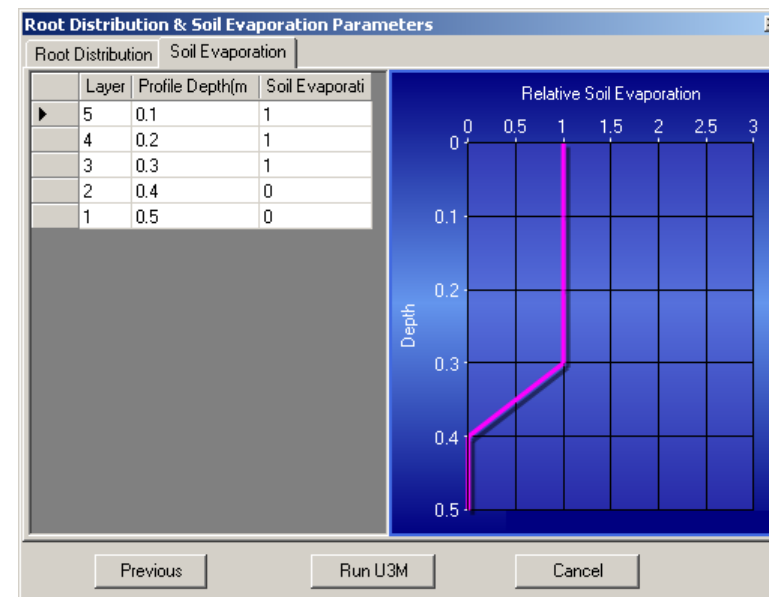
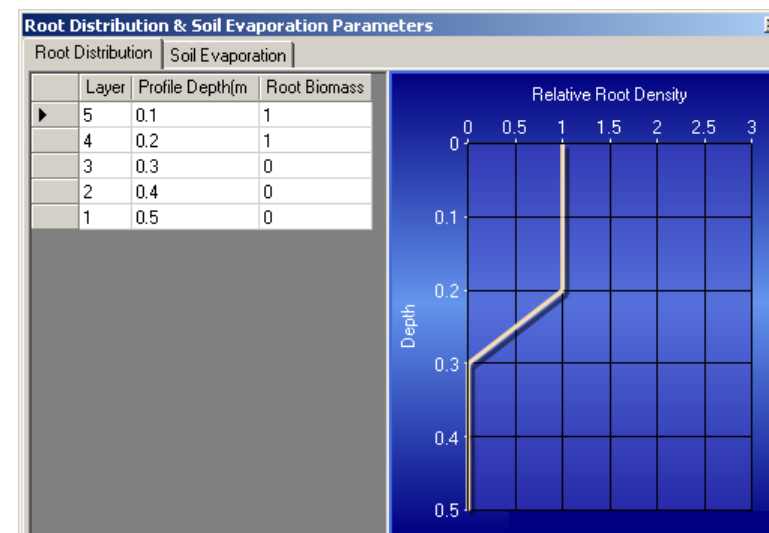
FIGURE 14

Discrete Soil Layers

Parameters for soil hydraulic properties

The CLASS soil moisture model developed by eWater Cooperative Research Centre is used to assess site groundwater recharge flow to the Spring Tiny Greenhood Orchid and Nowra Heath Myrtle. The model utilises site rainfall and evaporation data together with soil profile properties to assess the net recharge to groundwater.

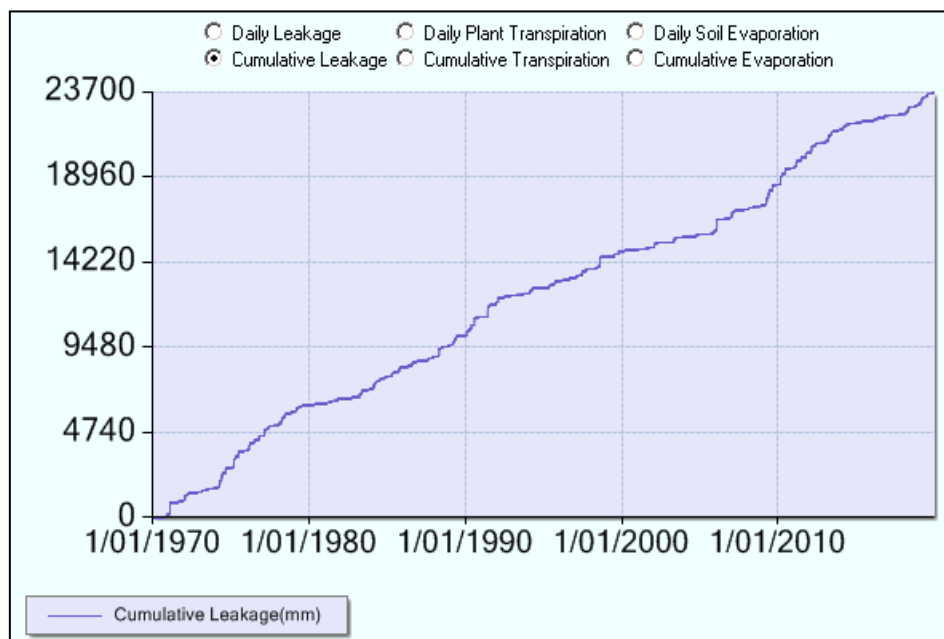
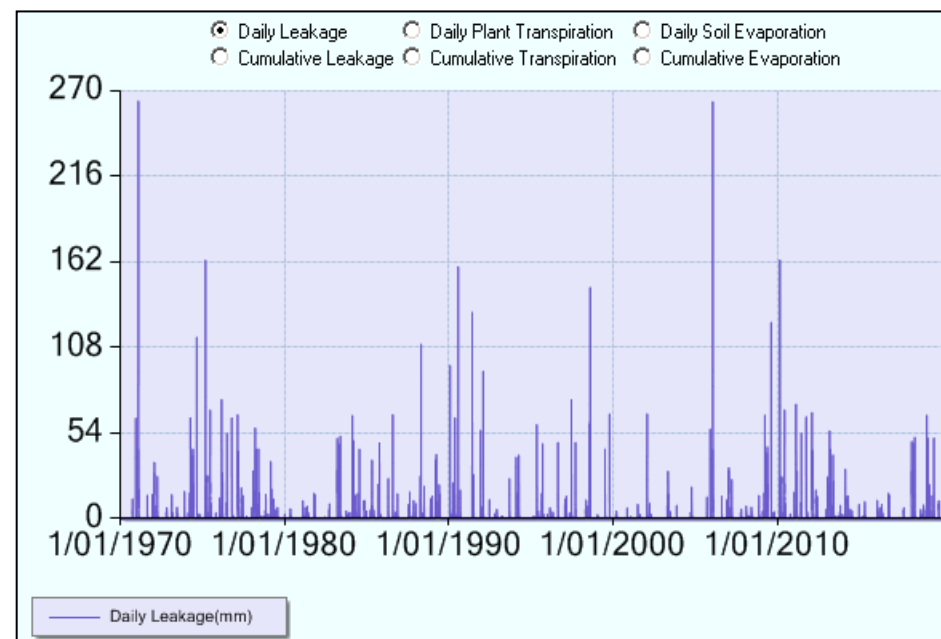
Martens & Associates Pty Ltd ABN 85 070 240 890		Environment Water Wastewater Geotechnical Civil Management	
Drawn:	BR	CLASS MODEL OUTPUT PLOTS	Drawing No:
Approved:	AN		FIGURE 15
Date:	18.02.2011		
Scale:	NA		Job No: P1002761

Total seepage flux determined by the CLASS modelling system indicate an average of 473 mm/yr of water passes beyond root zones for undeveloped site conditions.
