Re: Ecological assessment for the realignment of a 1st order watercourse, Lot 2 // DP 1233392, 579 Mamre Road, Orchard Hills

Background and purpose of report

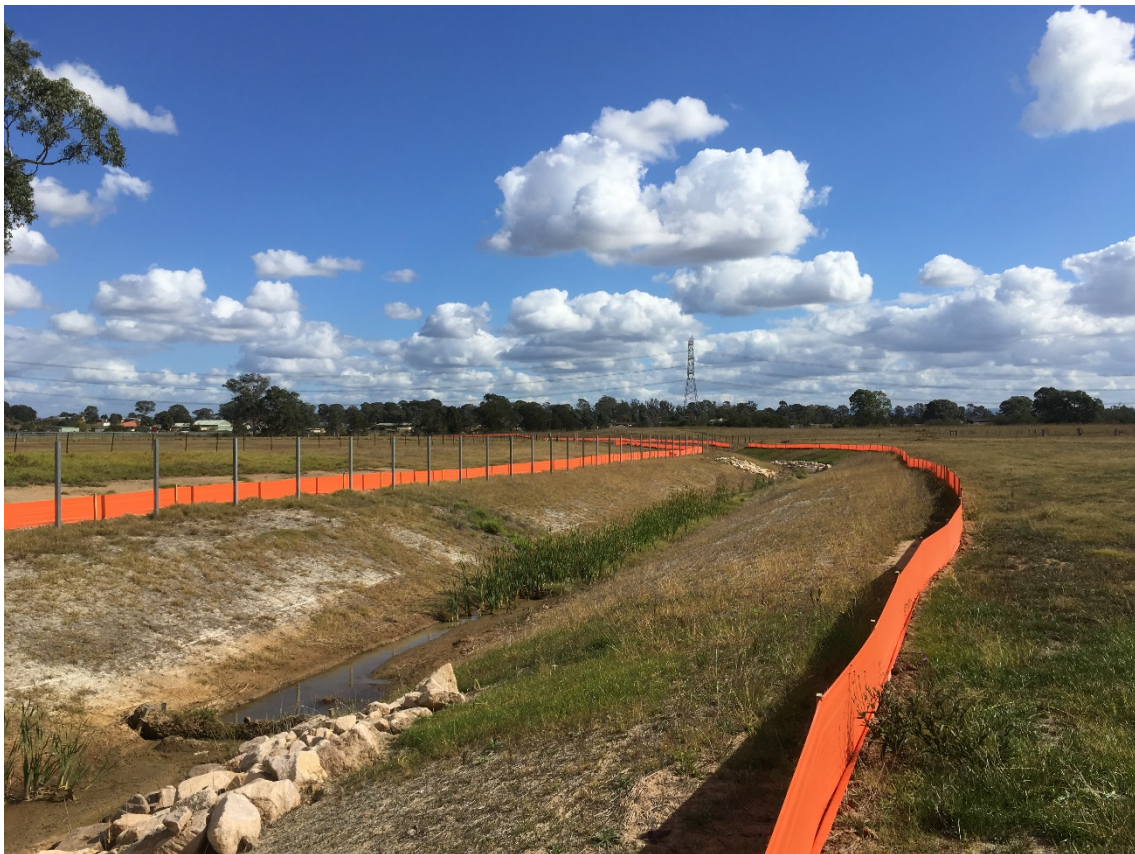
Figure 6: The existing reconstructed channel with jute matting for bank retention.

Desktop survey and field assessment determined the subject site to contain a 1st order tributary of South Creek (**Figure 7**). The Section 96 modification would involve the realignment of the 1st order tributary to the north of its current location. The constructed channel would be revegetated and stabilised with jute matting and coir logs, much like the improvement works that were conducted along the existing channel (**Figure 6**).
