WEST NOWRA RECYCLING AND WASTE FACILITY

**Proposed Stage 4 Landfill Extension
Soil, Water and Leachate Assessment**

Prepared for: Arcadis Australia Pacific

SLR Ref: 610.15781
Version No: -v1.0
December 2018

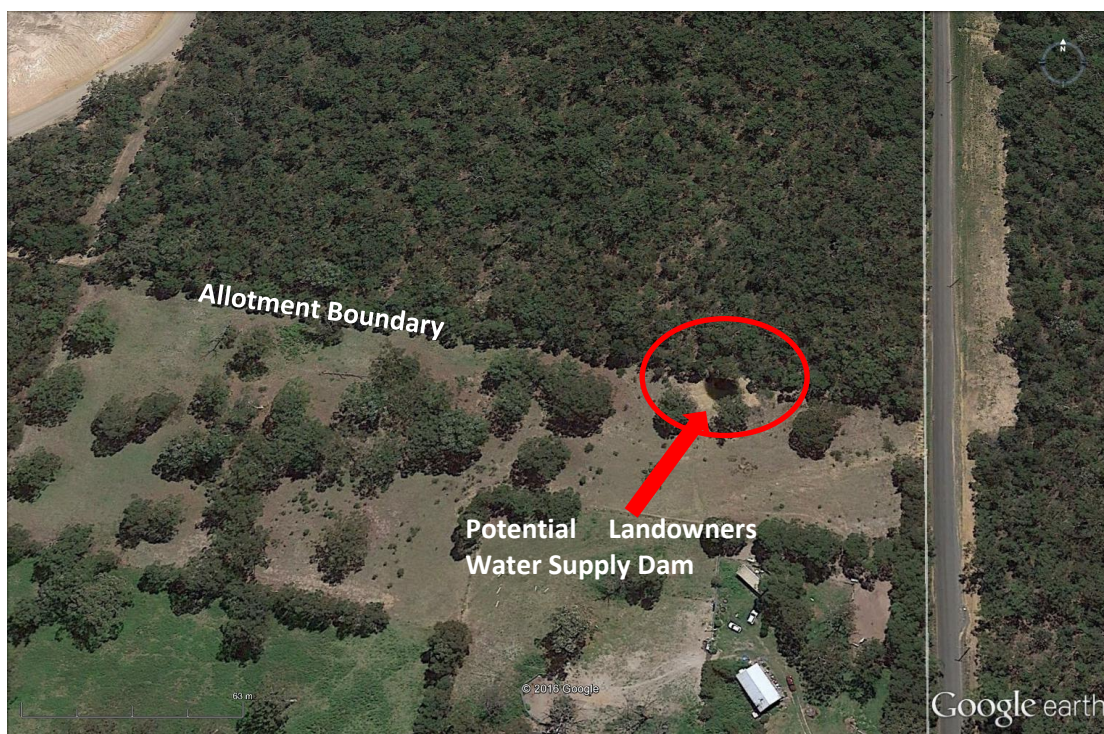
Figure 3 Potential Landowners Water Supply Dam

There does appear to be a small water body possibly a Dam along the southern boundary, on the neighbouring rural residential property (**Figure 3**).

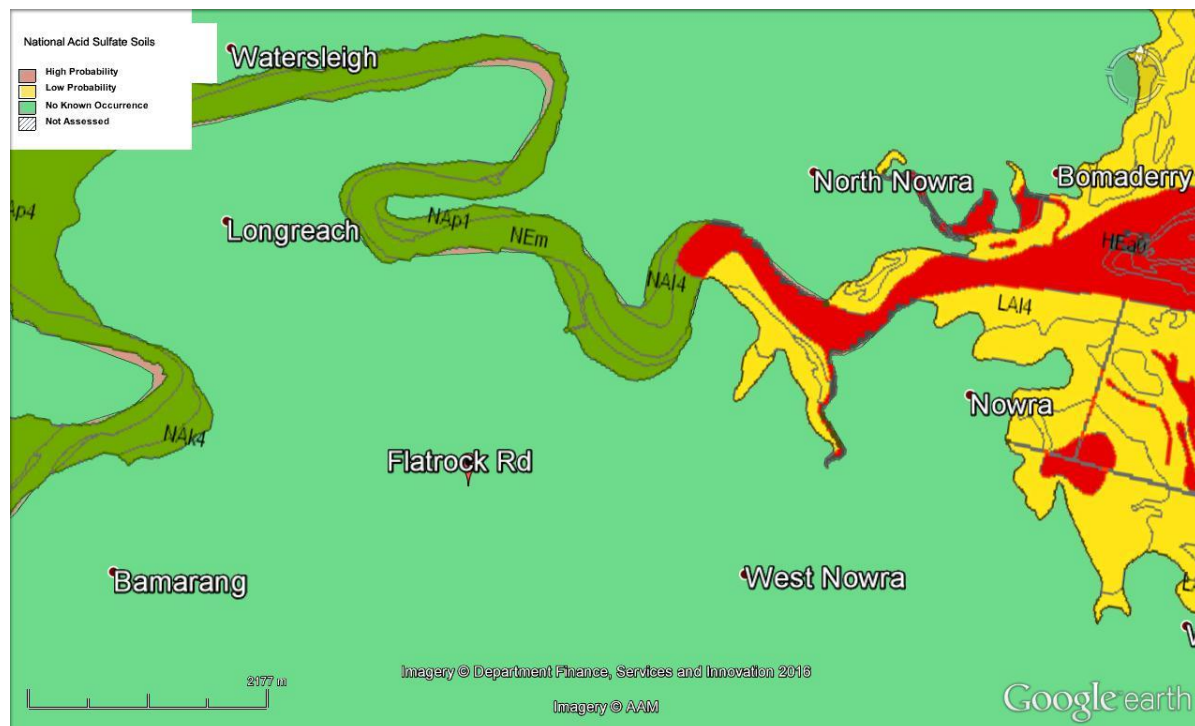
Figure 4 Acid Sulfate Soil Mapping (source www.asris.csiro.au January 2017)

Information obtained from Australian Soil Resource Information System (www.asris.csiro.au) indicated that the site has no known occurrence of Acid Sulfate Soils (ASS). Also, due to the topographical height of the site being 40-50m AHD and Acid Sulfate Soils (ASS) predominately being encountered at <20m AHD, ASS are not expected to be encountered on Site.

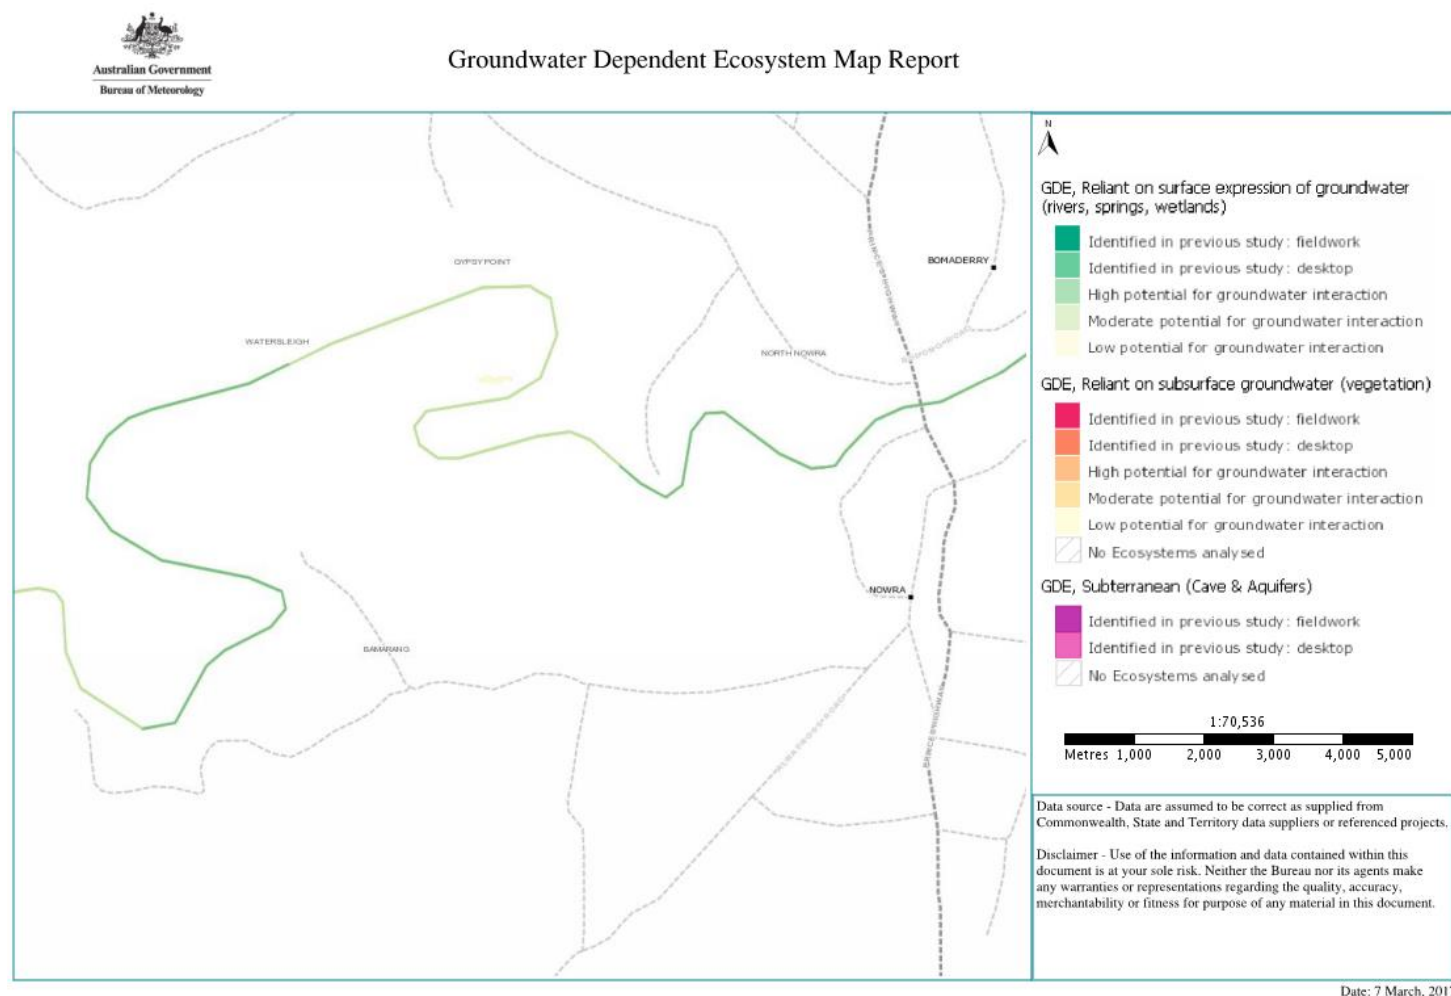
Figure 5 Groundwater Dependent Ecosystems Map Report

Information obtained from the Bureau of Meteorology (BOM) Groundwater Dependent Ecosystem Atlas indicates Shoalhaven River is the only groundwater dependant ecosystem within 5km of the site (**Figure 5**).

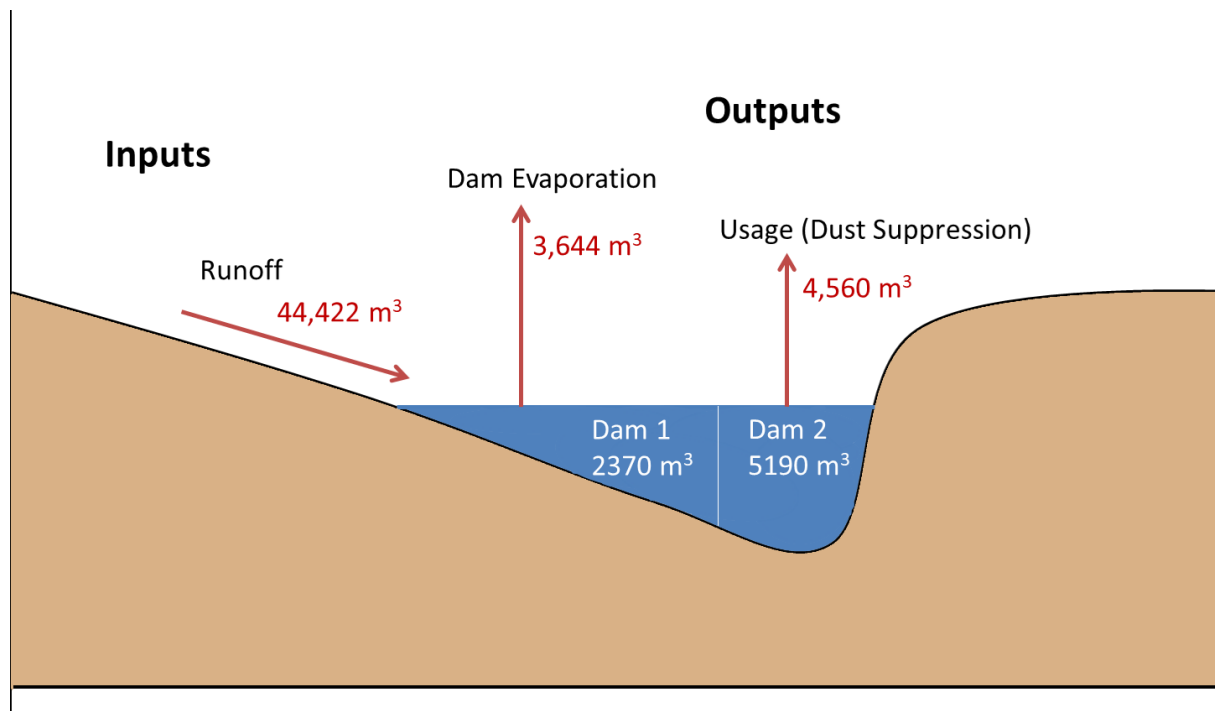
Figure 7 Water Balance for On-site Water Demand

The water balance shows the annual predicted flow volumes and predicts there will be excess on-site water for dust suppression uses. The catchment is large and the estimated re-use is low which results in an overflow that greatly exceeds the onsite re-use demands as is represented in **Figure 7**.

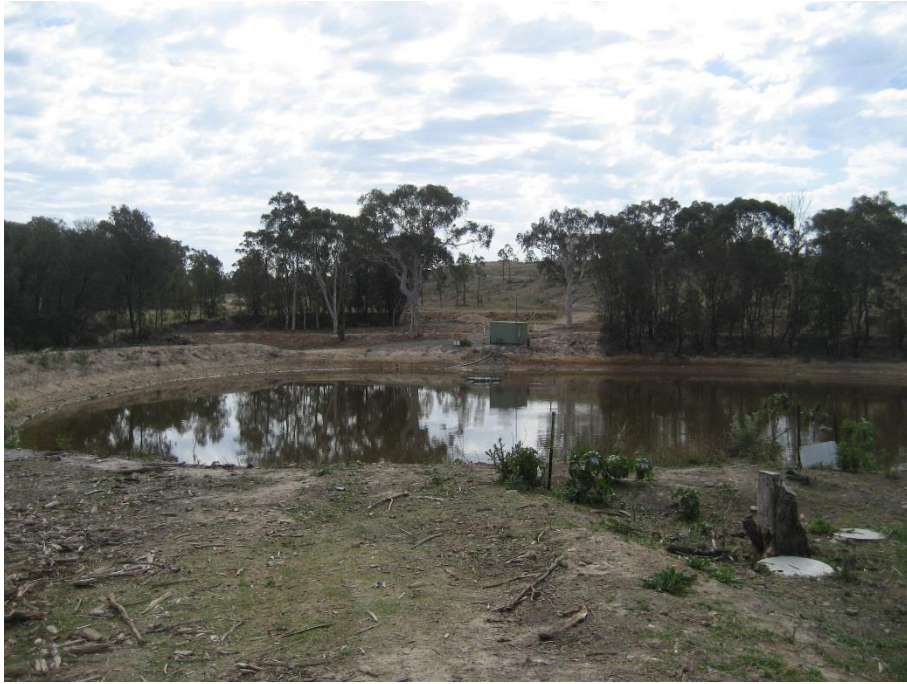
At the time of drilling the boreholes, the leachate dam was approximately half full. The ground surface was generally firm with no deformation under the excavator/drilling rig.

Photo 1: View of existing leachate dam looking north.

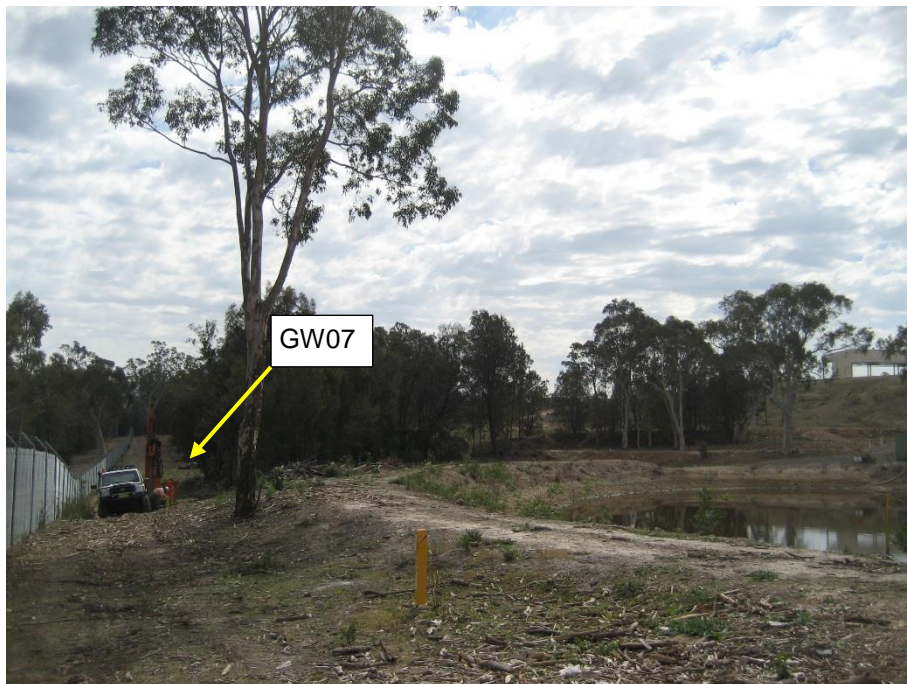
Photo 2: View of location of downstream borehole (GW07) adjacent to existing leachate dam.

Groundwater inflow was observed in GW07 at about 2.5m below ground surface, which was approximately the water level in the leachate dam. In GW06 groundwater inflow was observed at depth of about 8.0m below ground surface.

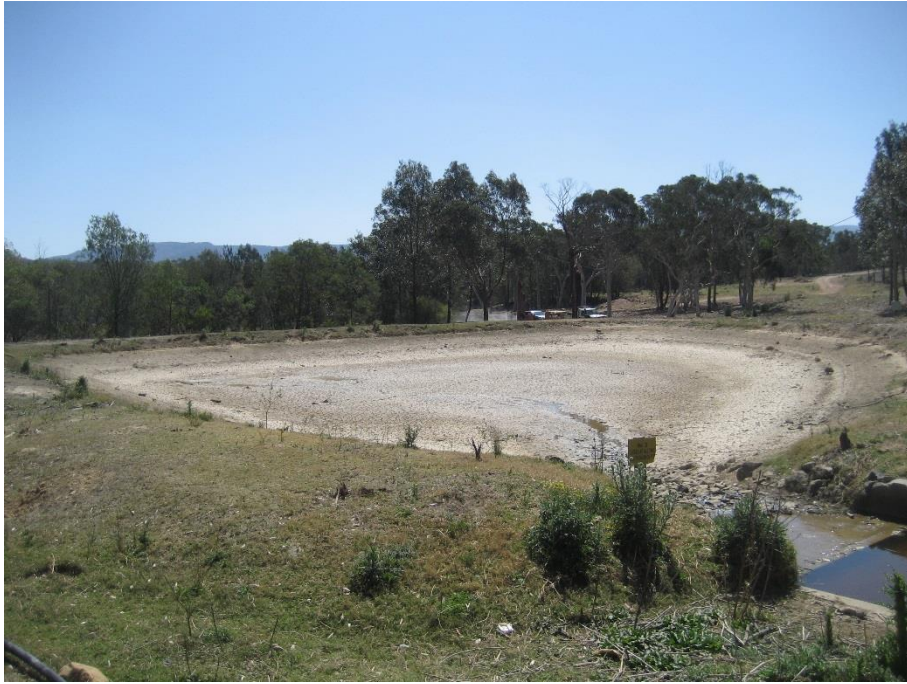
Photo 3: View of the first flush dam with existing leachate dam in the background.

- The boreholes (GW06 and GW07) were drilled at the proposed locations shown in Photo 1 and Photo 2, or as agreed with SCC's representative to a maximum depth of nine (9) and seven (7) metres below ground level (BGL) using a track-mounted drilling rig. At tungsten carbide bit refusal, the boreholes were extended to the target depth by air hammer. Standard penetration tests were carried out at 1.5 m intervals in the soil profile. Approximate borehole locations are shown in Photos 2, 3 and 4.

Photos 1 to 4 show the general site surface conditions at the borehole locations.

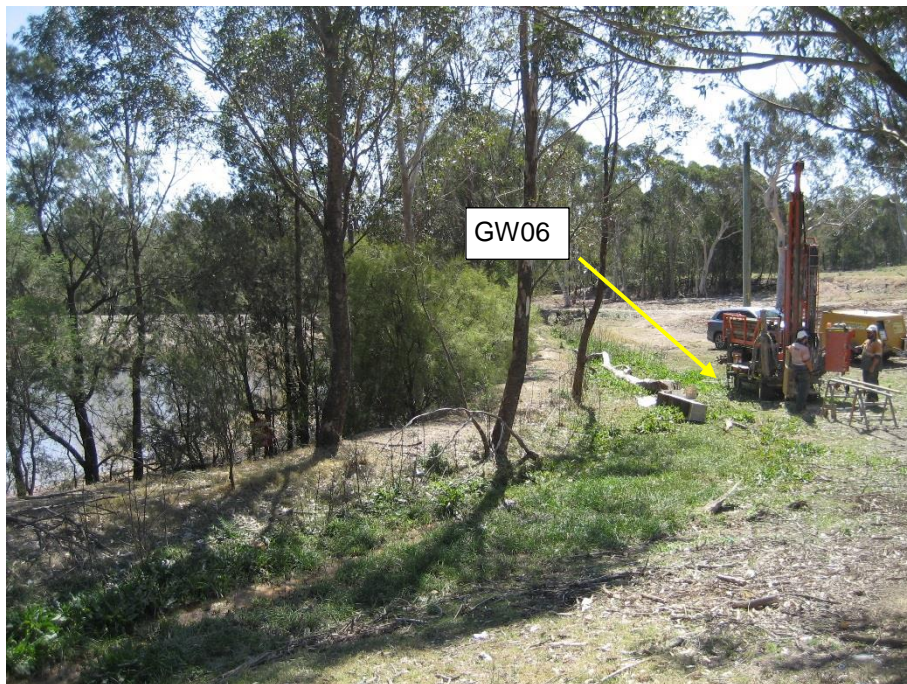
Photo 4: View of location of upstream borehole (GW06) adjacent to existing leachate dam.

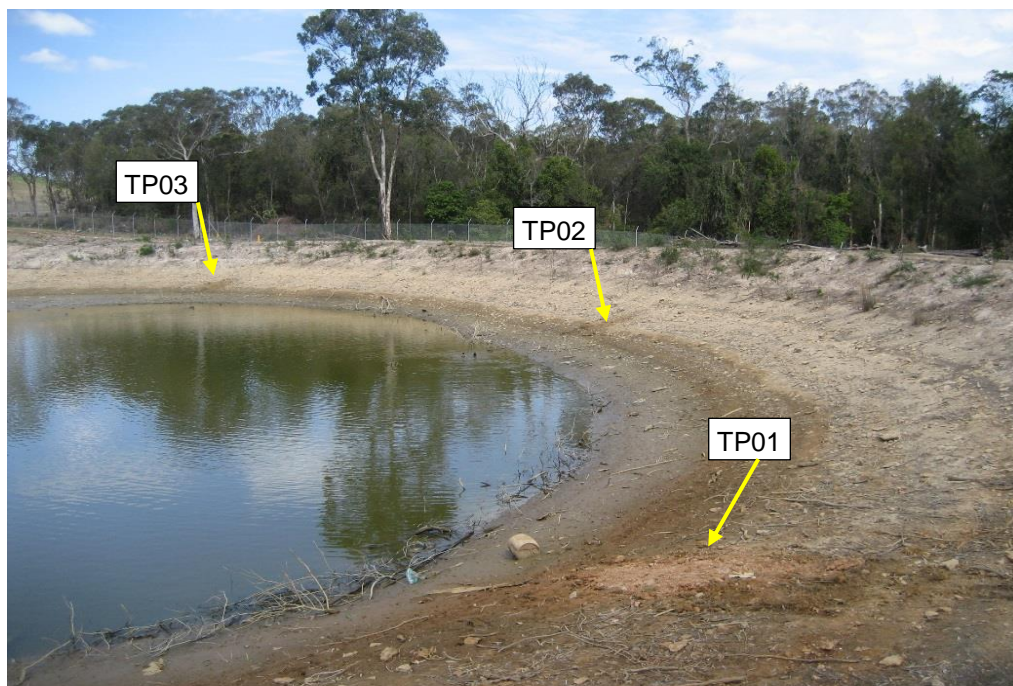
Following de-watering of the leachate dam to lower the water level, three shallow test pits were excavated in the exposed liner material to collect samples (TP01 to TP03) for permeability testing on 18 October 2017. The samples from the liner were generally described as sandy to gravelly clay, yellow to orange brown, firm and moist to wet. Photos 5 to 7 show typical materials encountered in the test pits during sampling for permeability testing.

Photo 5: View of approximate locations of test pits within the liner of leachate dam (permeability testing).

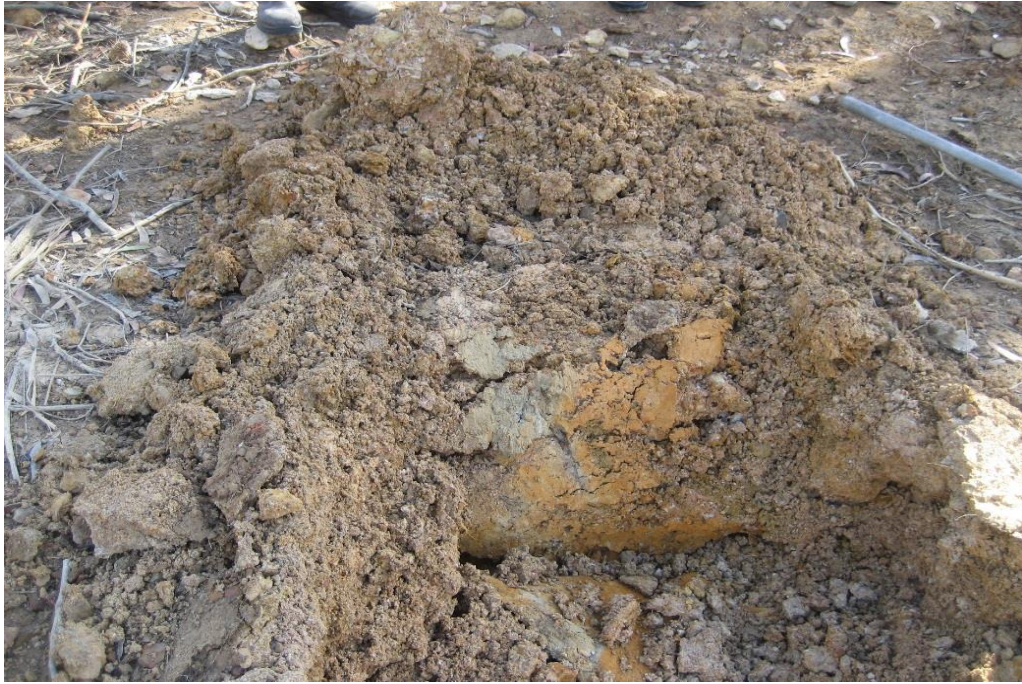
Photo 6: View of clayey material encountered during test pit excavation along leachate dam.

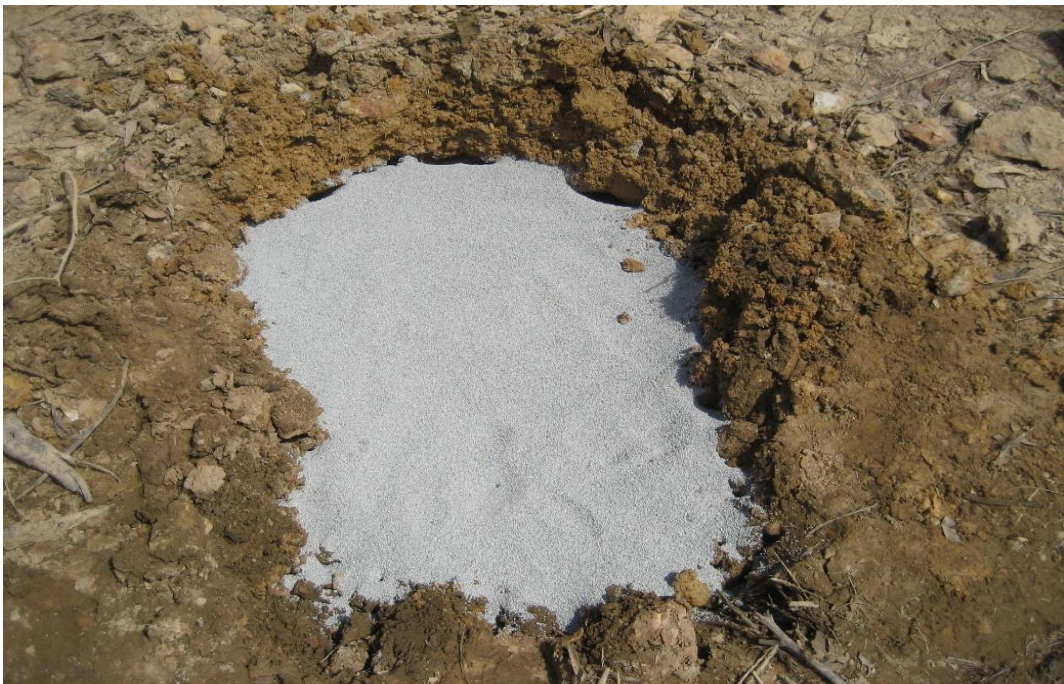
Photo 7: Bentonite used to backfill test pits in leachate dam liner.
