# WEST NOWRA RECYCLING AND WASTE FACILITY

## Proposed Stage 4 Landfill Extension Concept Design Report

SLR Ref: 610.15781-R01  
Version No: v1.2  
January 2019

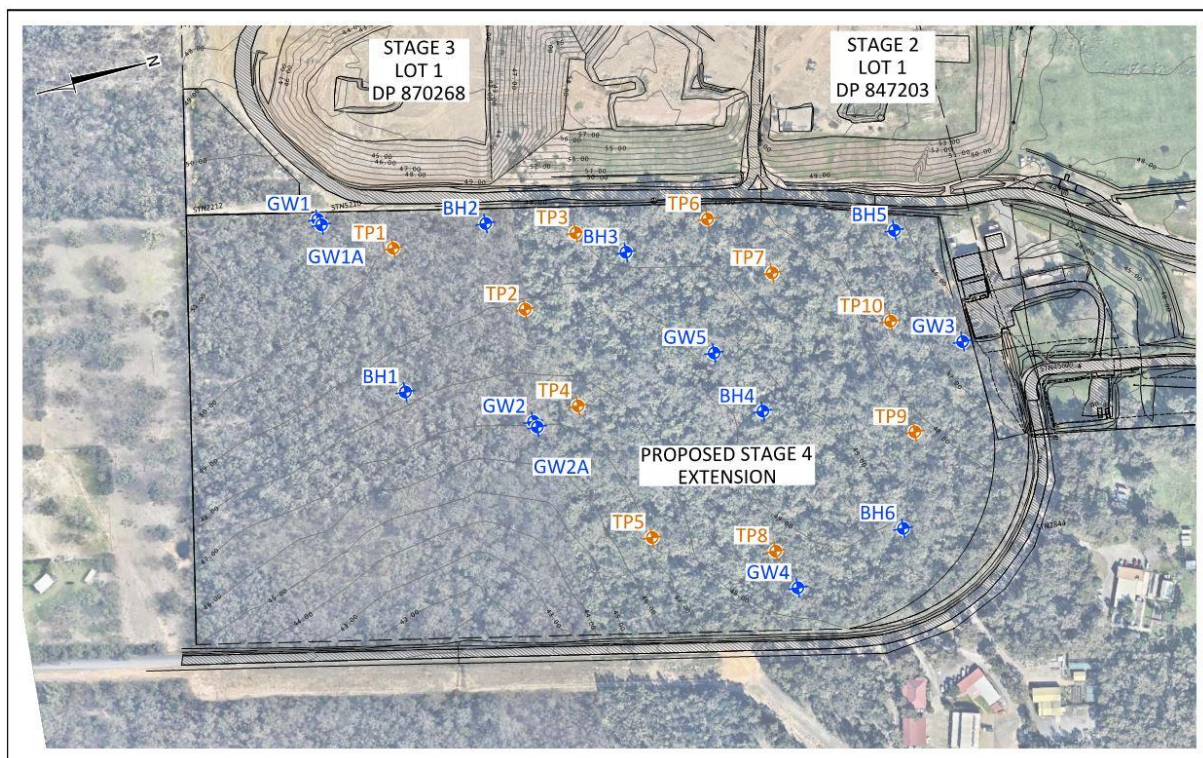
**Figure 5 Site Investigation Test Location Plan**

The boreholes, piezometers and test pits were logged and sampled by Coffey's geotechnical engineer on site. The locations of the test locations can be found in **Figure 5**.

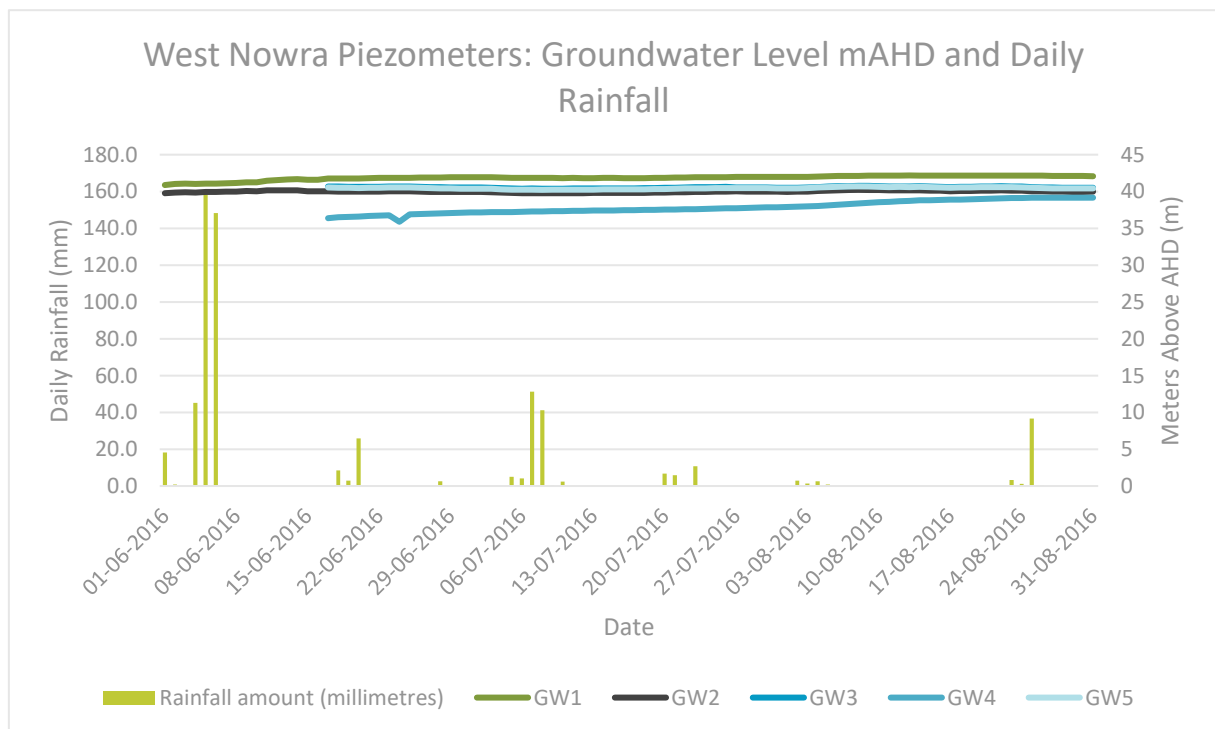
**Figure 6 West Nowra Groundwater Monitoring and Daily Rainfall**

The water monitoring data has also been plotted with the local rainfall data to show any fluctuations due to surface water infiltration; this can be found in **Figure 6**.

The piezometers have been consistently monitored from 7 June, 2016 to 15 August, 2016. The average water levels of each piezometer over this time period can be found in **Table 3**.

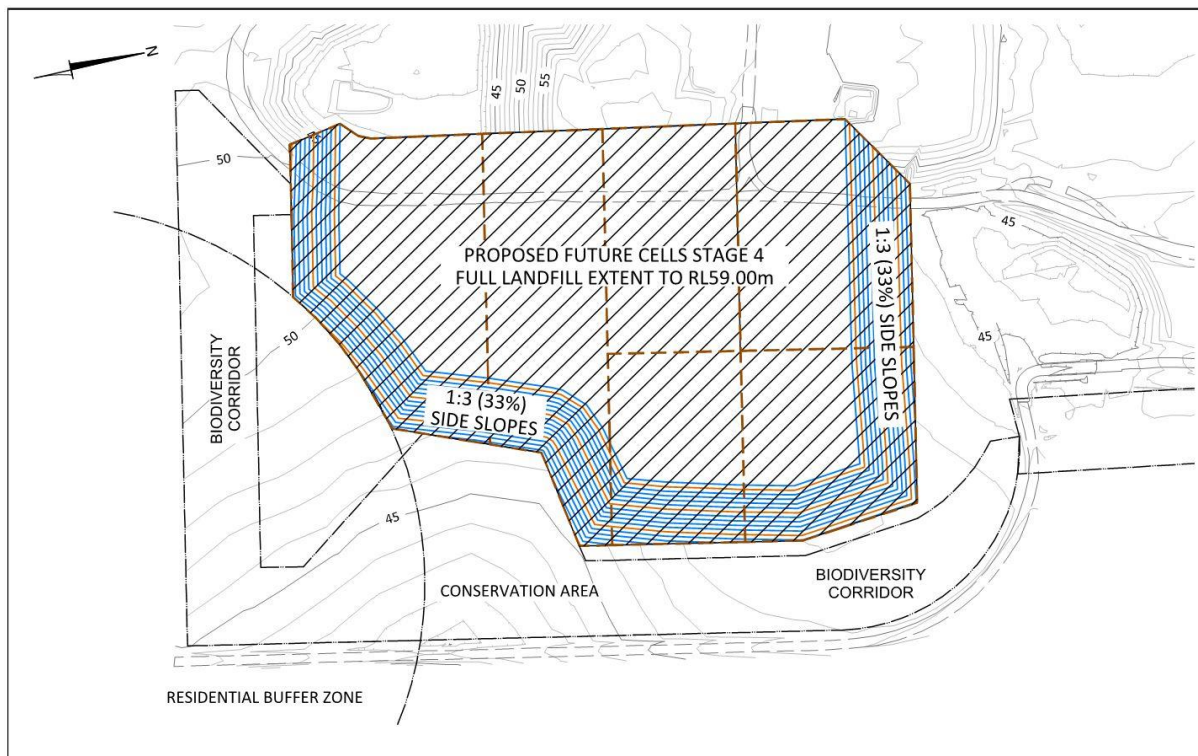
Figure 10 Final Landform

The stage 4 landfill final landform can be found in **Figure 10**. The completed batter slopes shall have a gradient no greater than (1V:3H) and an approximate height of RL59m, which is equivalent to the maximum height on the Stage 3 development at the top of the batter slope.

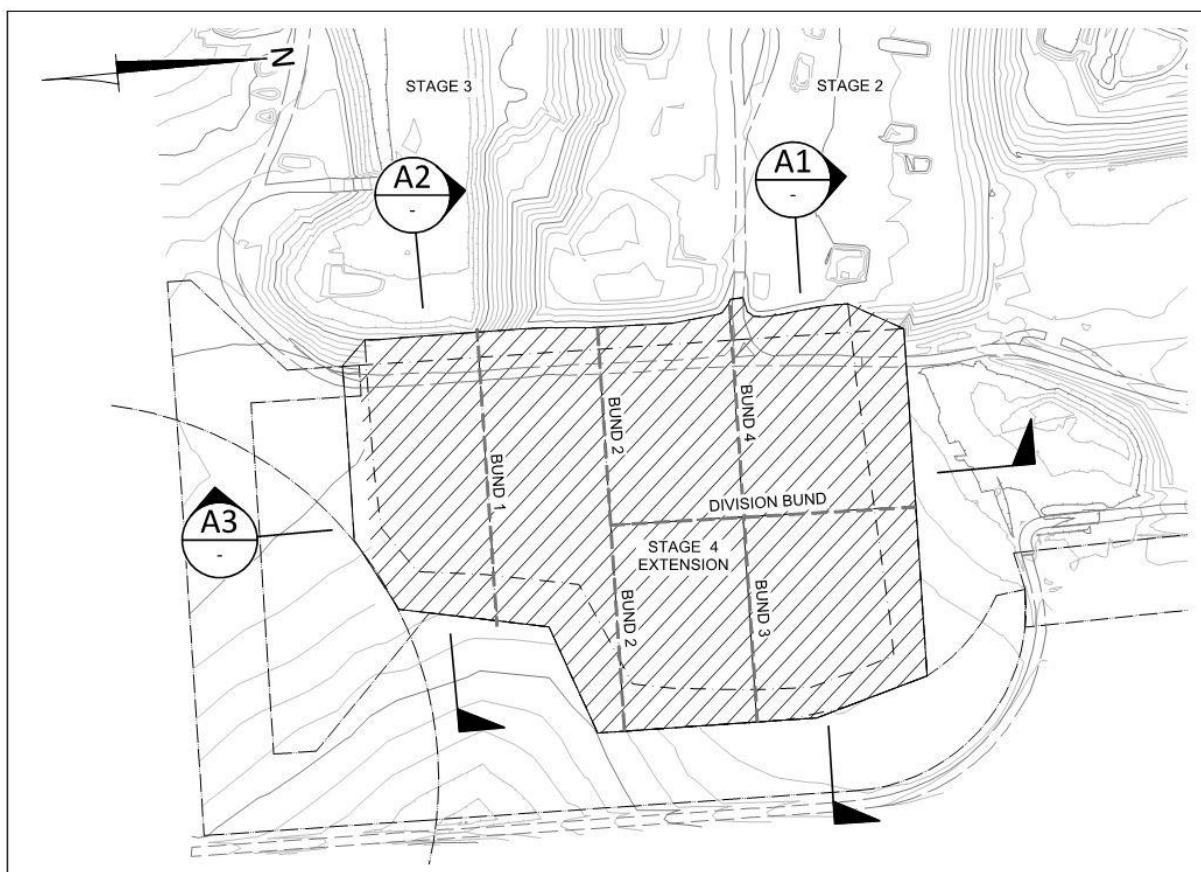
**Figure 11 Section Locations for Filling Profiles**

The location of the filling profile sections is shown in **Figure 11**. The profiles associated with the final landform are shown in **Figure 12**. The proposed landfilling plans can be found in **Figure 13** to **Figure 18**.

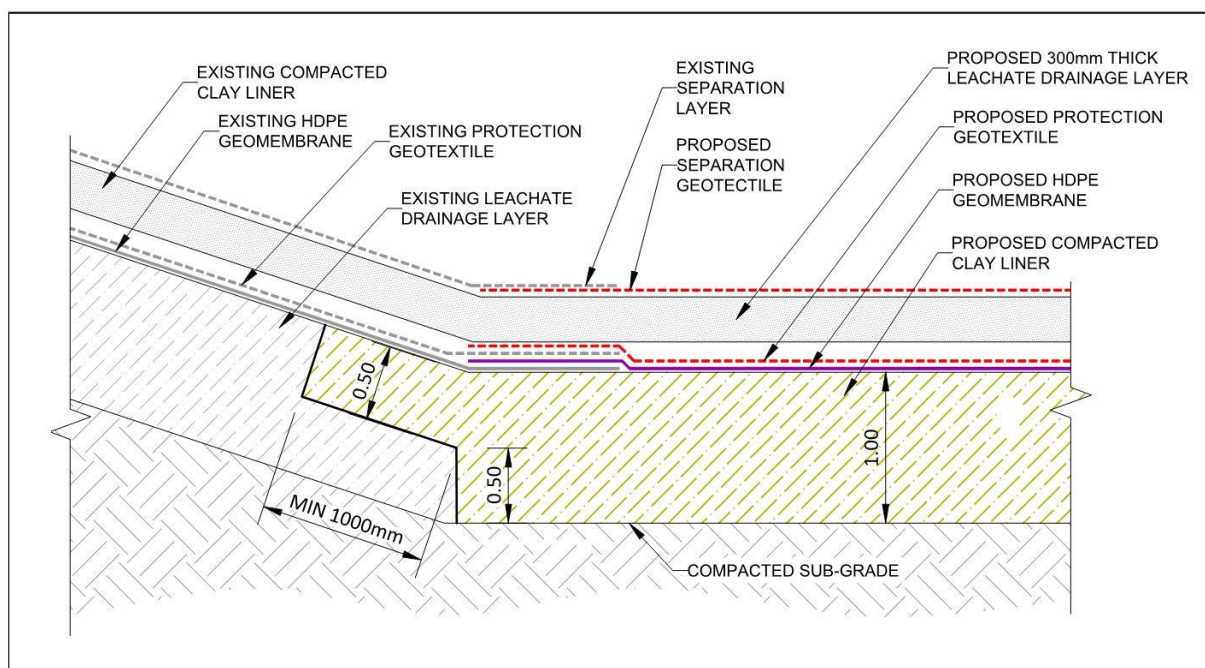
**Figure 19 Overlapping Liner Tie-in Detail Between Stage 4 and Stages 2 and 3 for CCL**

Stage 4 will overlap the eastern edges of existing Stages 2 and 3. The Stage 4 lining system shall tie into the existing liner to ensure integrity of the system. The tie in detail is shown in **Figure 19**.

The CCL for Stage 4 may be replaced with a GCL if required.

- Composite liner for the base and side batter slopes. The composite liner shall comprise (from subgrade up):
  - A 1,000 mm thick CCL or alternatively an approved GCL. The excavated clay material from site has been found in the past to be generally suitable for use in the CCL, and this has been confirmed by the field investigation results (refer Section 3.2.2), which indicates the in-situ clay to be of low to moderate plasticity with a permeability of less than  $1 \times 10^{-9}$  m/s for the majority of the samples.

- HDPE Liner – A 2 mm thick double-rough HDPE liner overlain by a protection geotextile shall be placed over the CCL or GCL, to provide a relatively impermeable barrier to leachate migration. At this concept design stage and based on information available, a double rough HDPE is recommended. Further investigation could be undertaken in the detailed design phase to establish if an alternative liner, such as smooth both sides, would be appropriate.

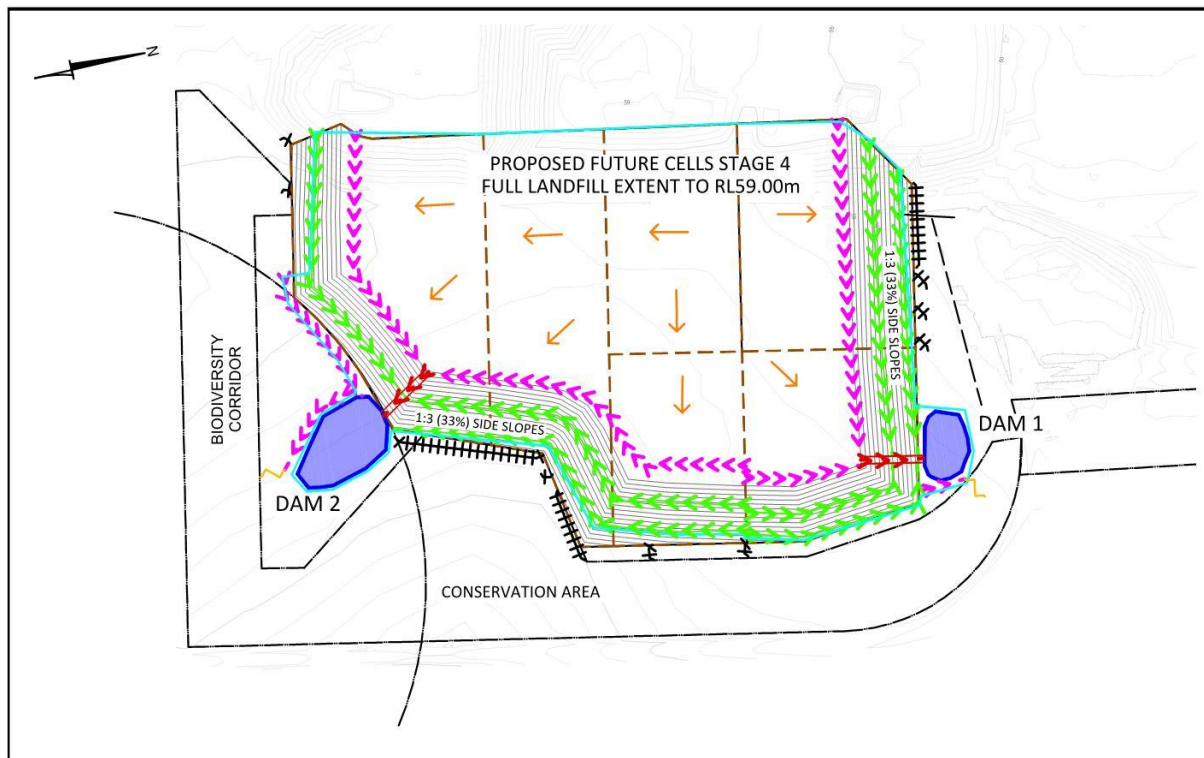
**Figure 20 Conceptual Erosion and Sediment Control Plan**

A conceptual erosion and sediment control plan has been developed and is shown in **Figure 20**.

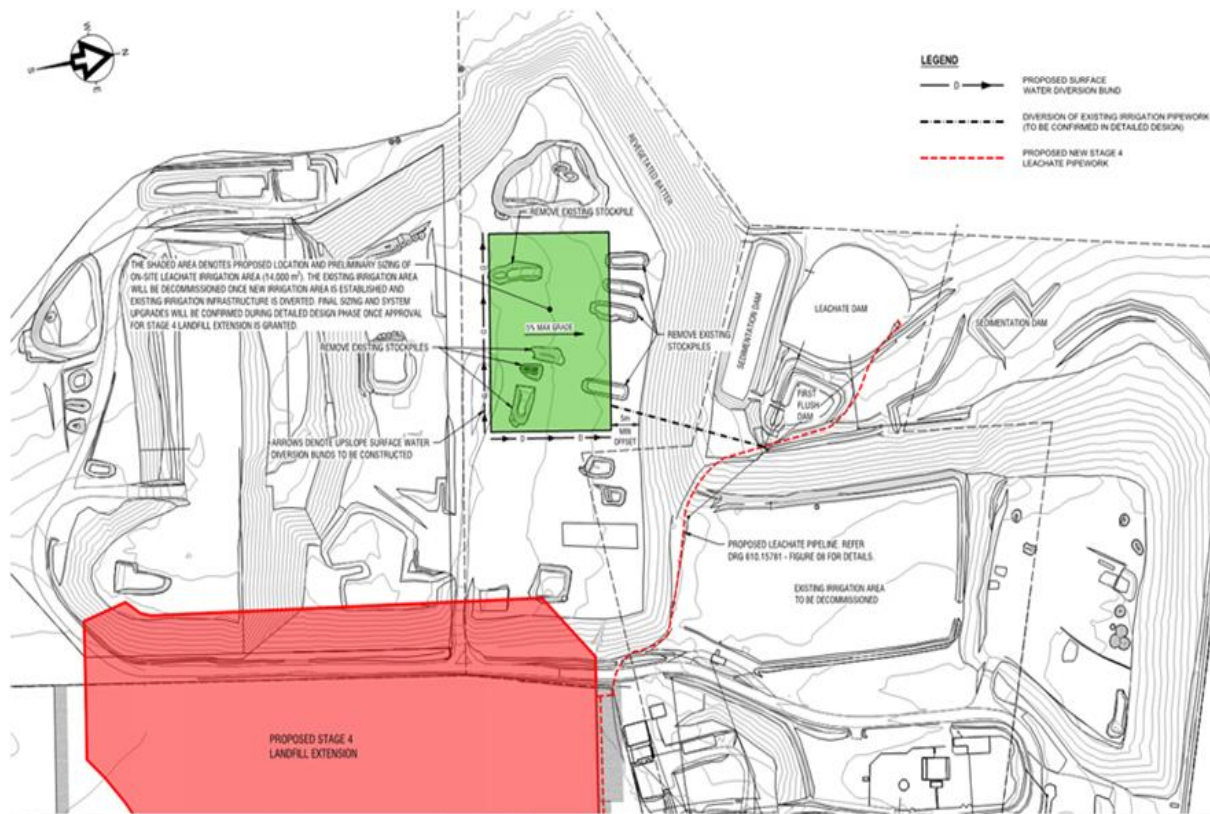
### Figure 22 Proposed Stage 4 Irrigation Area

The proposed location for the Stage 4 Landfill Irrigation Area is presented in **Figure 22** and **Appendix C**.

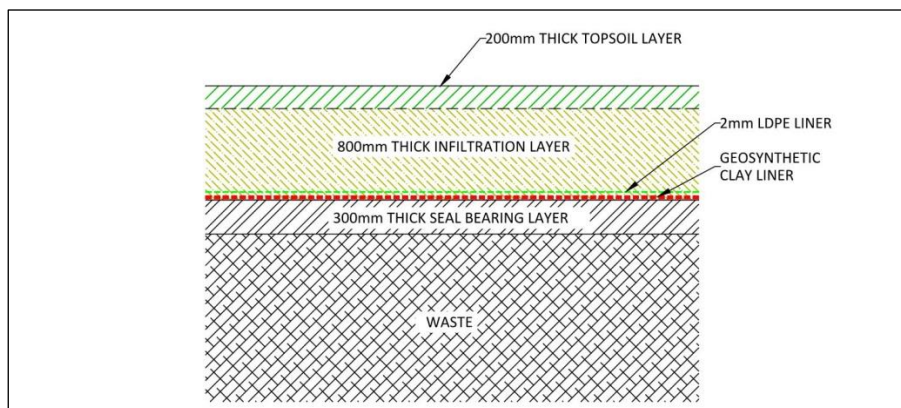
**Figure 25 Typical Capping and Rehabilitation Detail**

A typical section through the capping layer is shown in **Figure 25**.

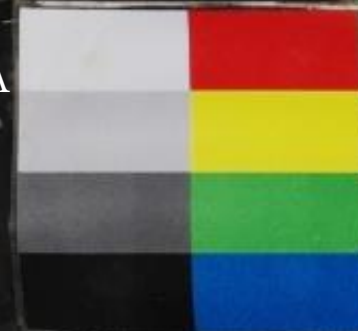
BH2 - GEOTWOLL03957AA (box 1 of 1) depth: 6.7m-9.5m

BOX # 1 of 1 DATE: 24/5 / 2016

DEPTH: 6.7m to 9.5m

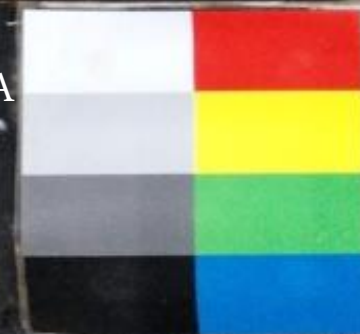
**BH4 - GEOTWOLL03957AA      (box 1 of 1)      depth: 7.0m-10.0m**

**BH #** 4      **JOB #** GEOTWOLL03957AA  
**BOX #** 1 of 1    **DATE:** 30/5/2016  
**DEPTH:** 7.0m to 10.0m

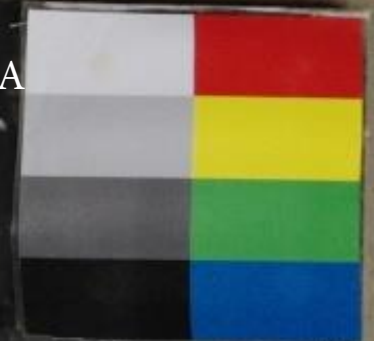
BH5 - GEOTWOLL03957AA (box 1 of 1) depth: 8.3m-9.39m

BH # 5 JOB # GEOTWOLL03957AA  
 BOX # 1 of 1 DATE: 25 / 5 / 2016  
 DEPTH: 8.30m to 9.39m

8.0m Started coring at 8.3m

EOH at 9.39m

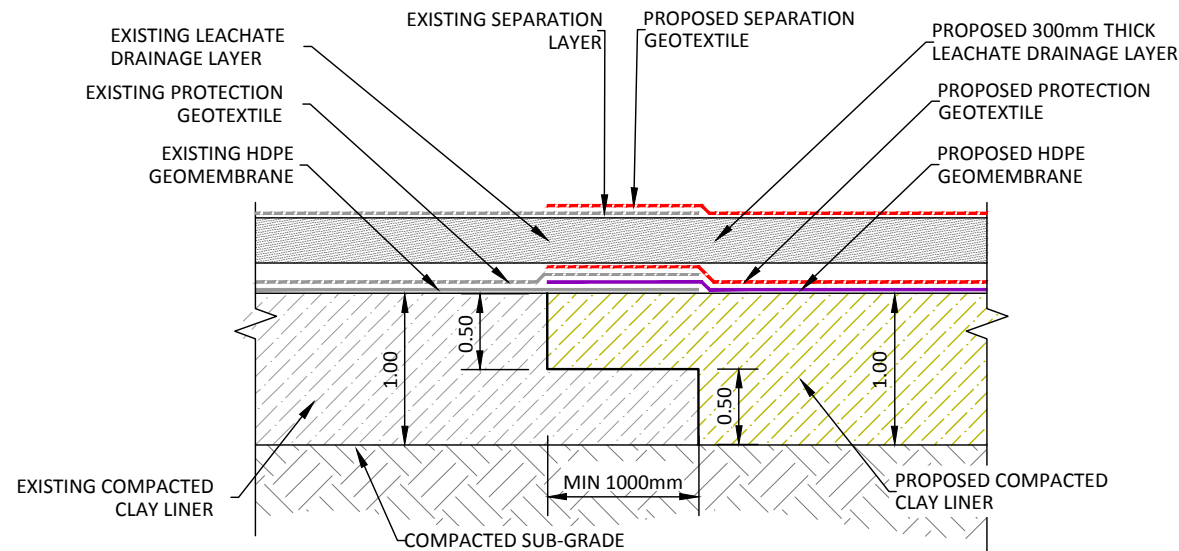
TYPICAL SECTION THROUGH COMPACTED CLAY LINER KEY-IN DETAIL BETWEEN CELLS  
SCALE 1:50

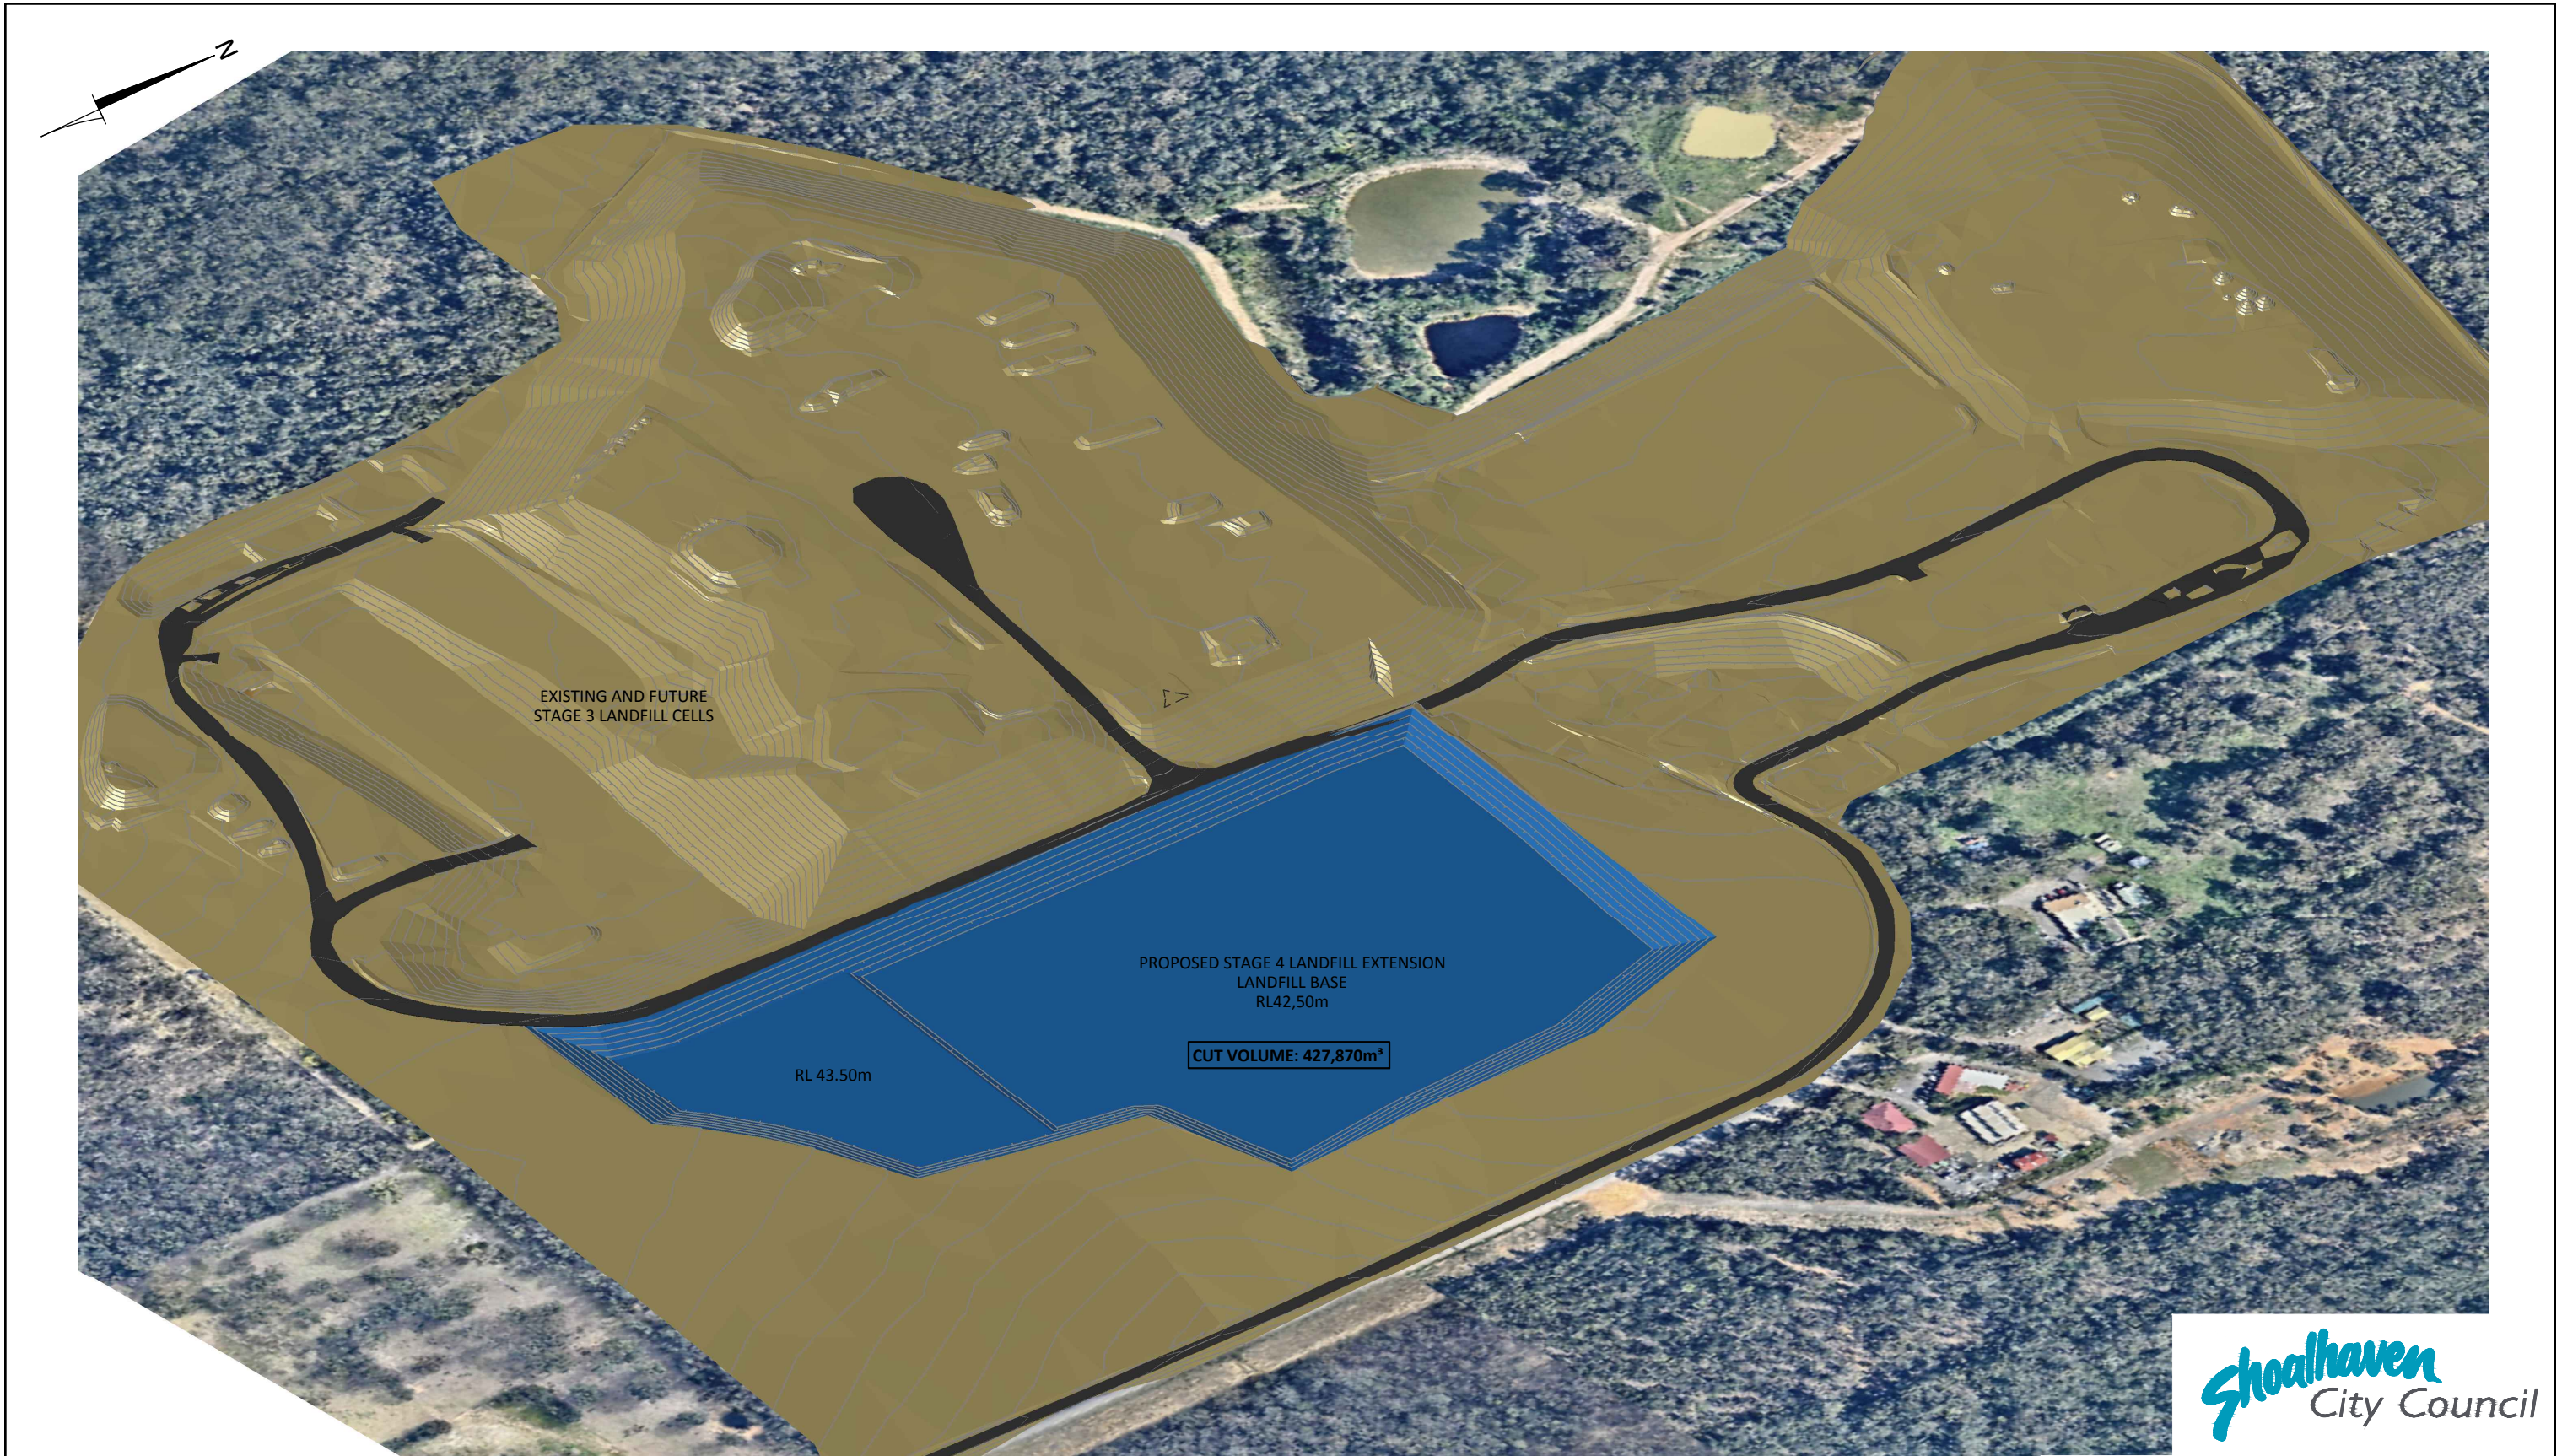
APPROVED			SHOALHAVEN CITY COUNCIL		SCALE:
DEPT.	DATE	SIGN			
Civil	-	-	WEST NOWRA RECYLING AND WASTE FACILITY		SHOWN
Engineering	-	-			
Production	-	-			
PROJ. ENG.	-	-			
PROJ. MNG.	-	-			
			FILLING PLAN STAGE 4 CELL 6		SHEET:  1 of 1
DATE	NAME				
DRAWN BY:	AB				
CHECKED:	AD		SLR PROJECT NUMBER: 610.15781    DRAWING NUMBER: FIGURE 15    REV:		
APPROVED:	-

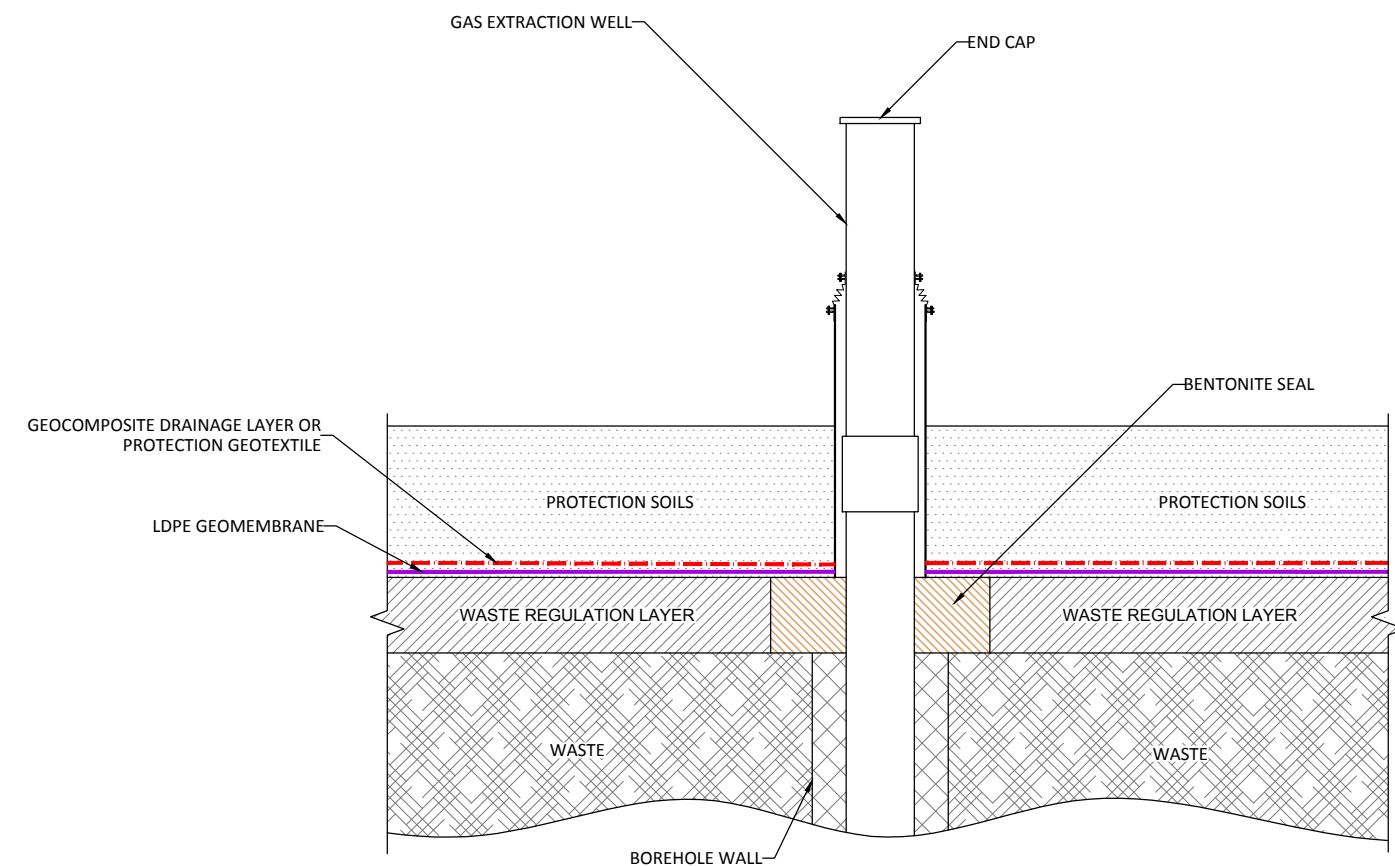
TYPICAL SECTION THROUGH SEALING DETAIL  
AROUND GAS EXTRACTION POINT

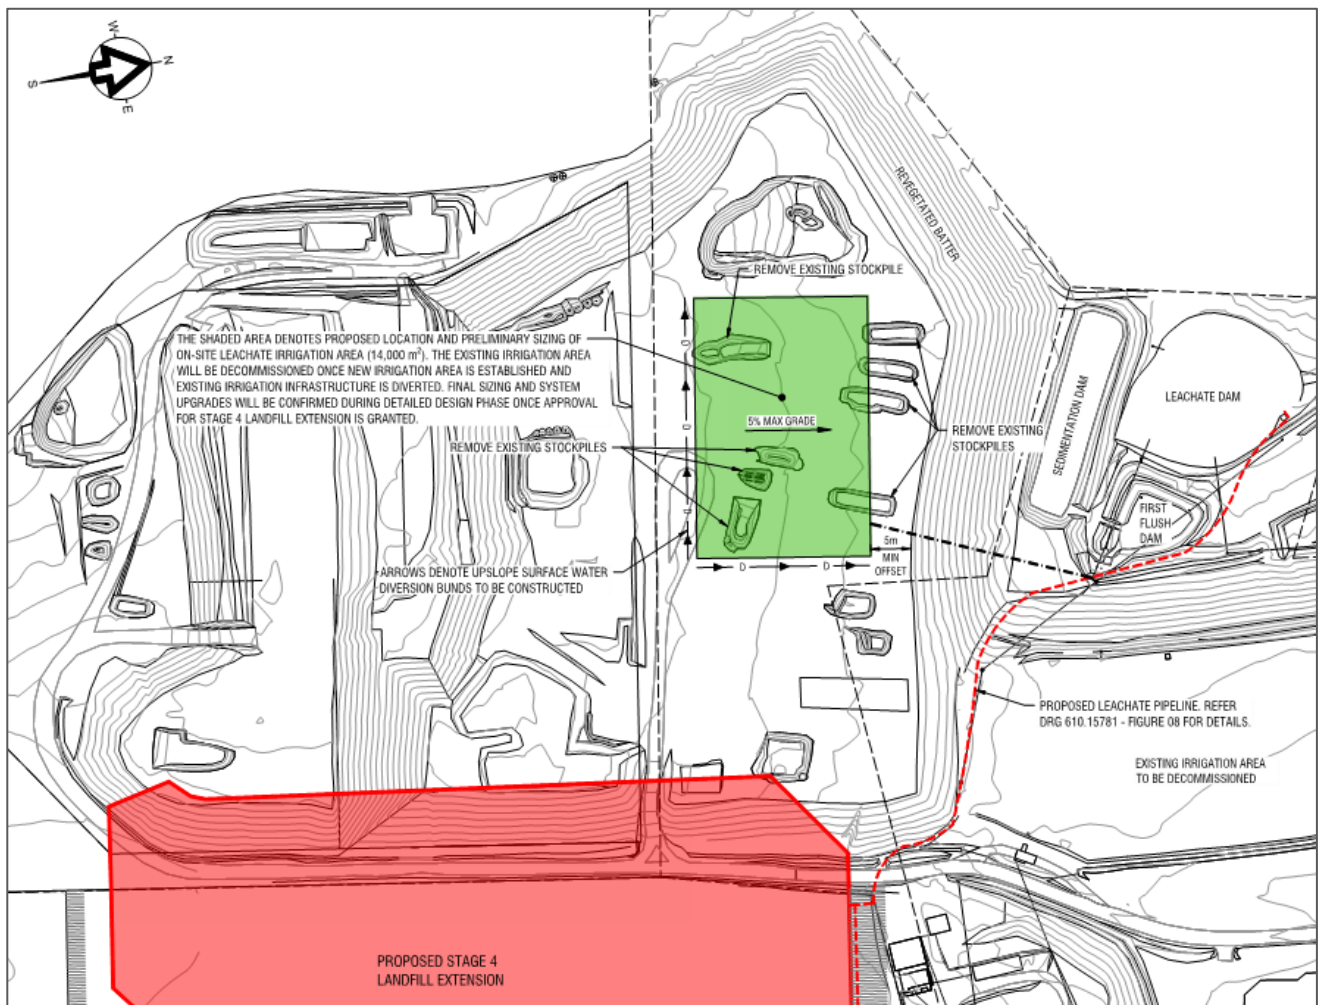
**Figure 3 Proposed preliminary irrigation area**

The area proposed to be utilised for irrigation is located in the central area of Stage 2, as shown in **Figure 3** below. This area was previously used for waste disposal and has a liner underlying the waste. The area has been capped with 200mm topsoil, 800mm silty sand, and 600mm clay.

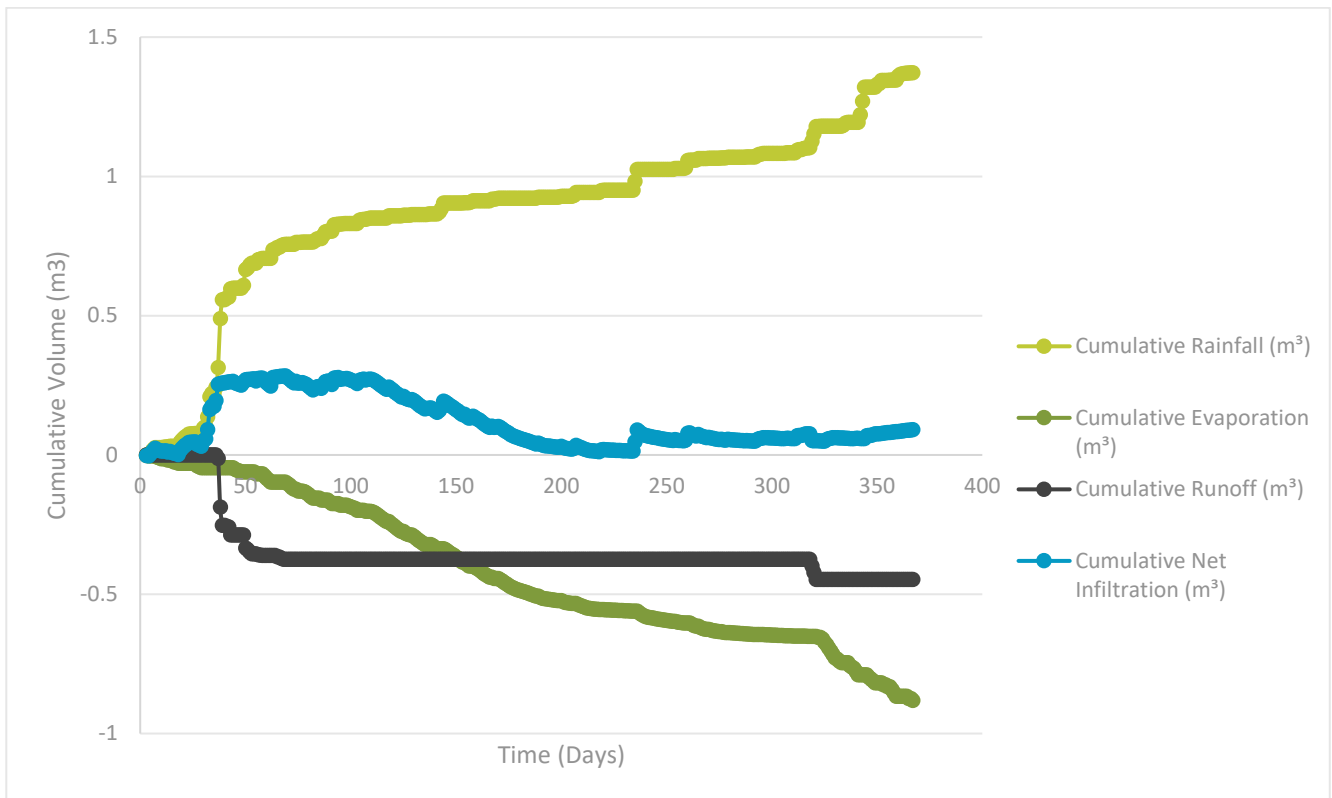
**Figure 5 Cumulative climate and infiltration rates**

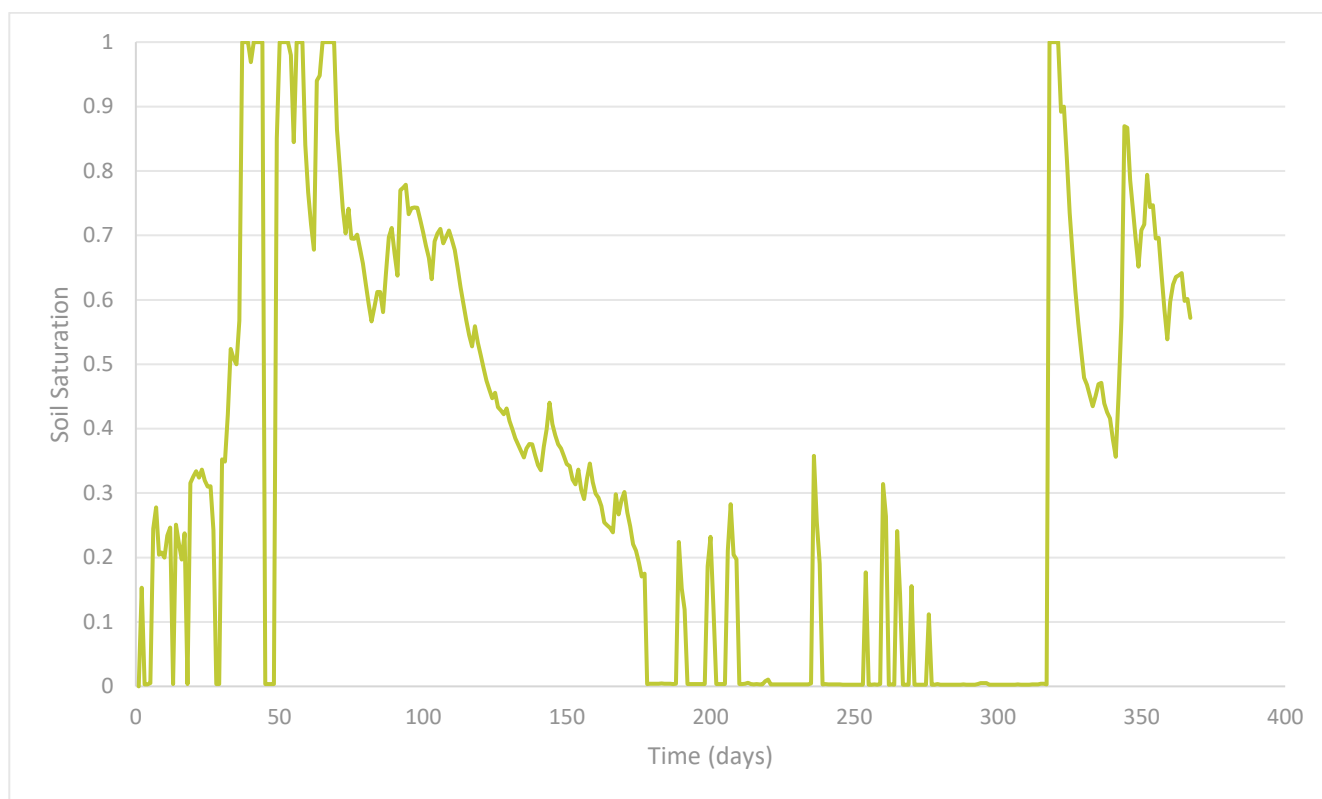
**Figure 6 Soil Saturation over modelling period of 365 days**

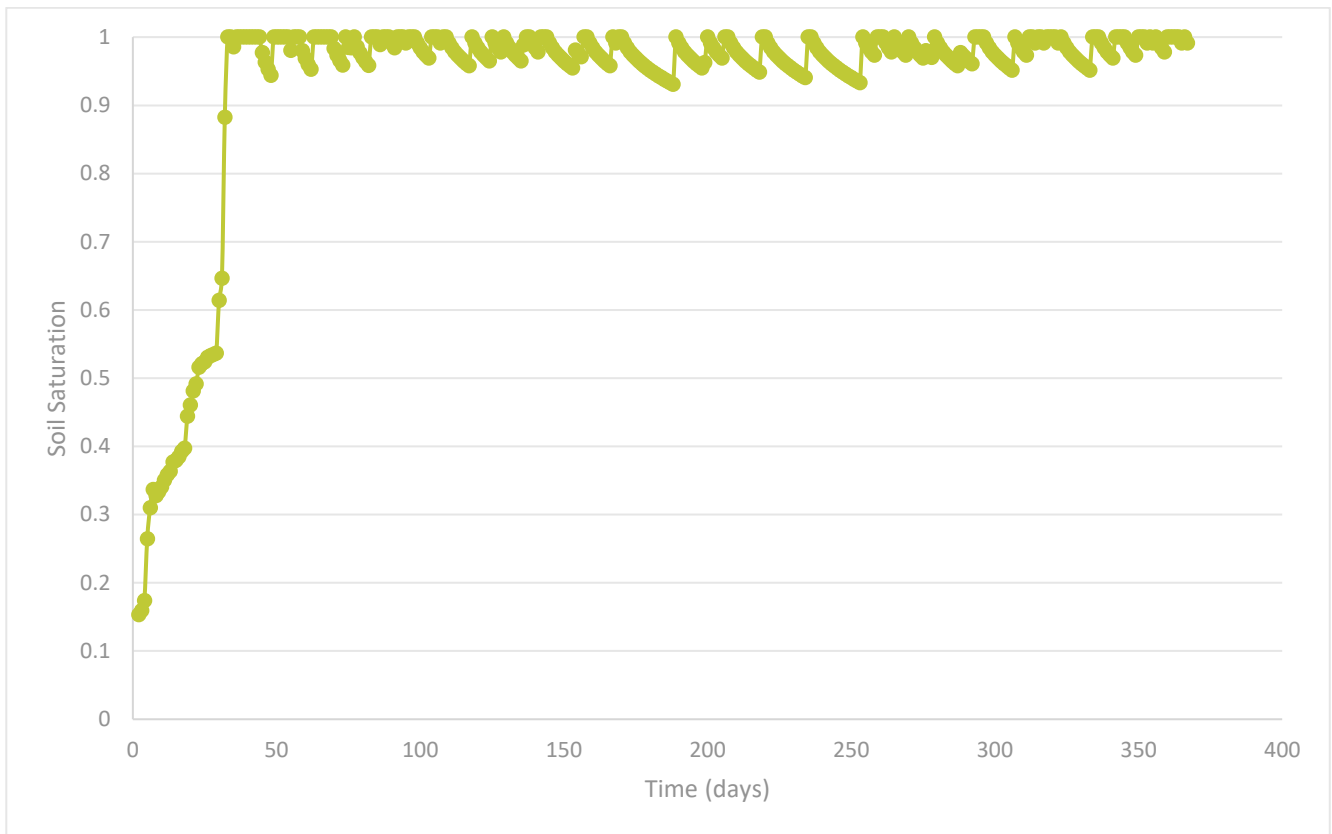
**Figure 7 Soil Saturation at 0.1mm leachate application to the 1D column**

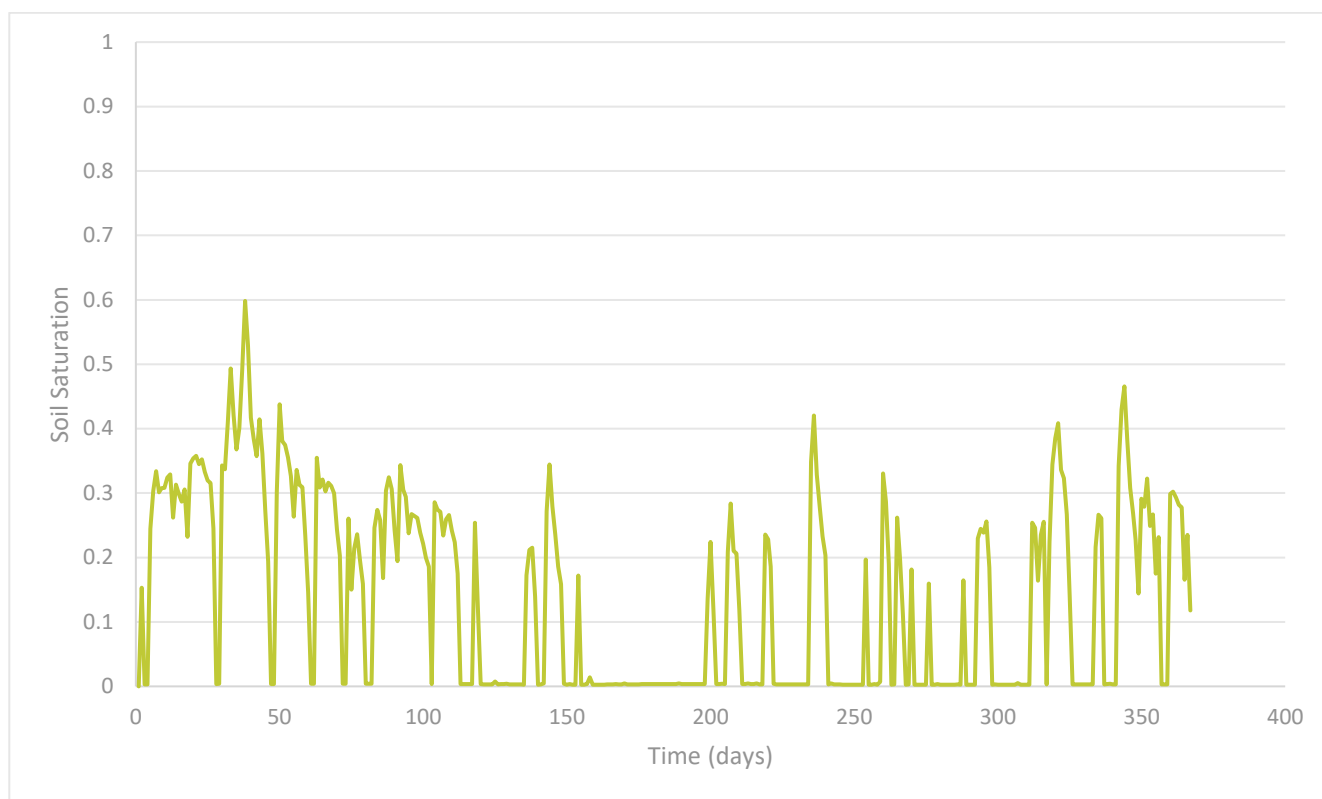
**Figure 8** Degree of Soil Saturation with clay removed from capping system

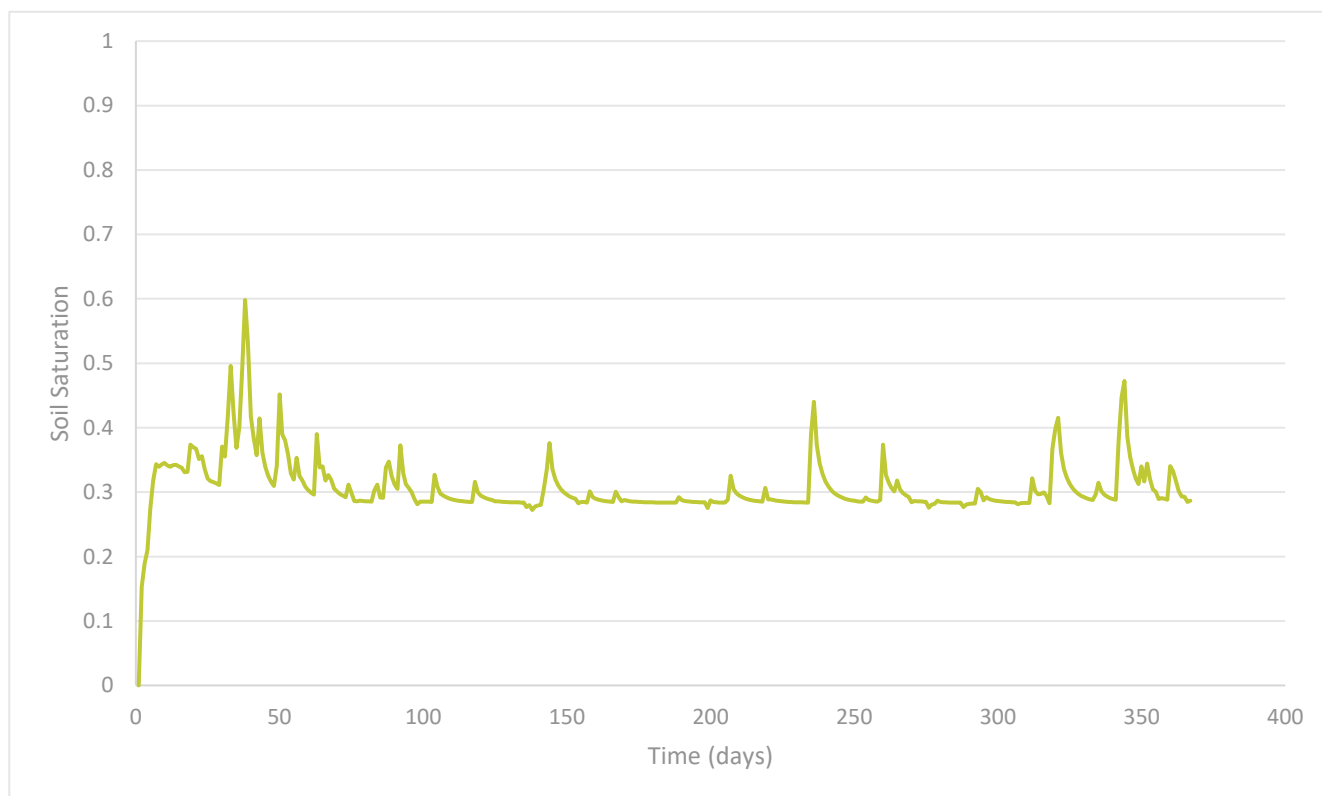
**Figure 9** Degree of Soil Saturation with clay removed and 2mm of leachate applied daily (except on days with rainfall)
