Stage 1 (Desktop Study) Land Contamination Assessment

Lot 1 DP 1097743 and Lot 6 DP 252223 Pacific Hwy, Moonee Beach, NSW

P1002663JR01V02 March 2013

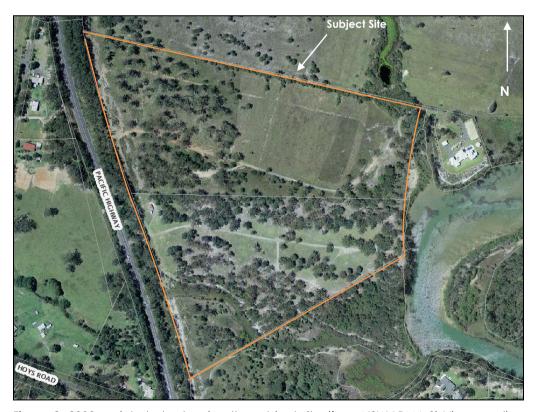
Figure 2: 2008 aerial photo showing the subject site (from NSW LPMA SixViewer online mapping).

2008	The site is partly cleared and there is a dwelling in the north-west corner of Lot 6 (Figure 2). Neighbouring properties remain predominantly rural although Lot 2 DP 1097743 is being used exclusively for residential purposes.

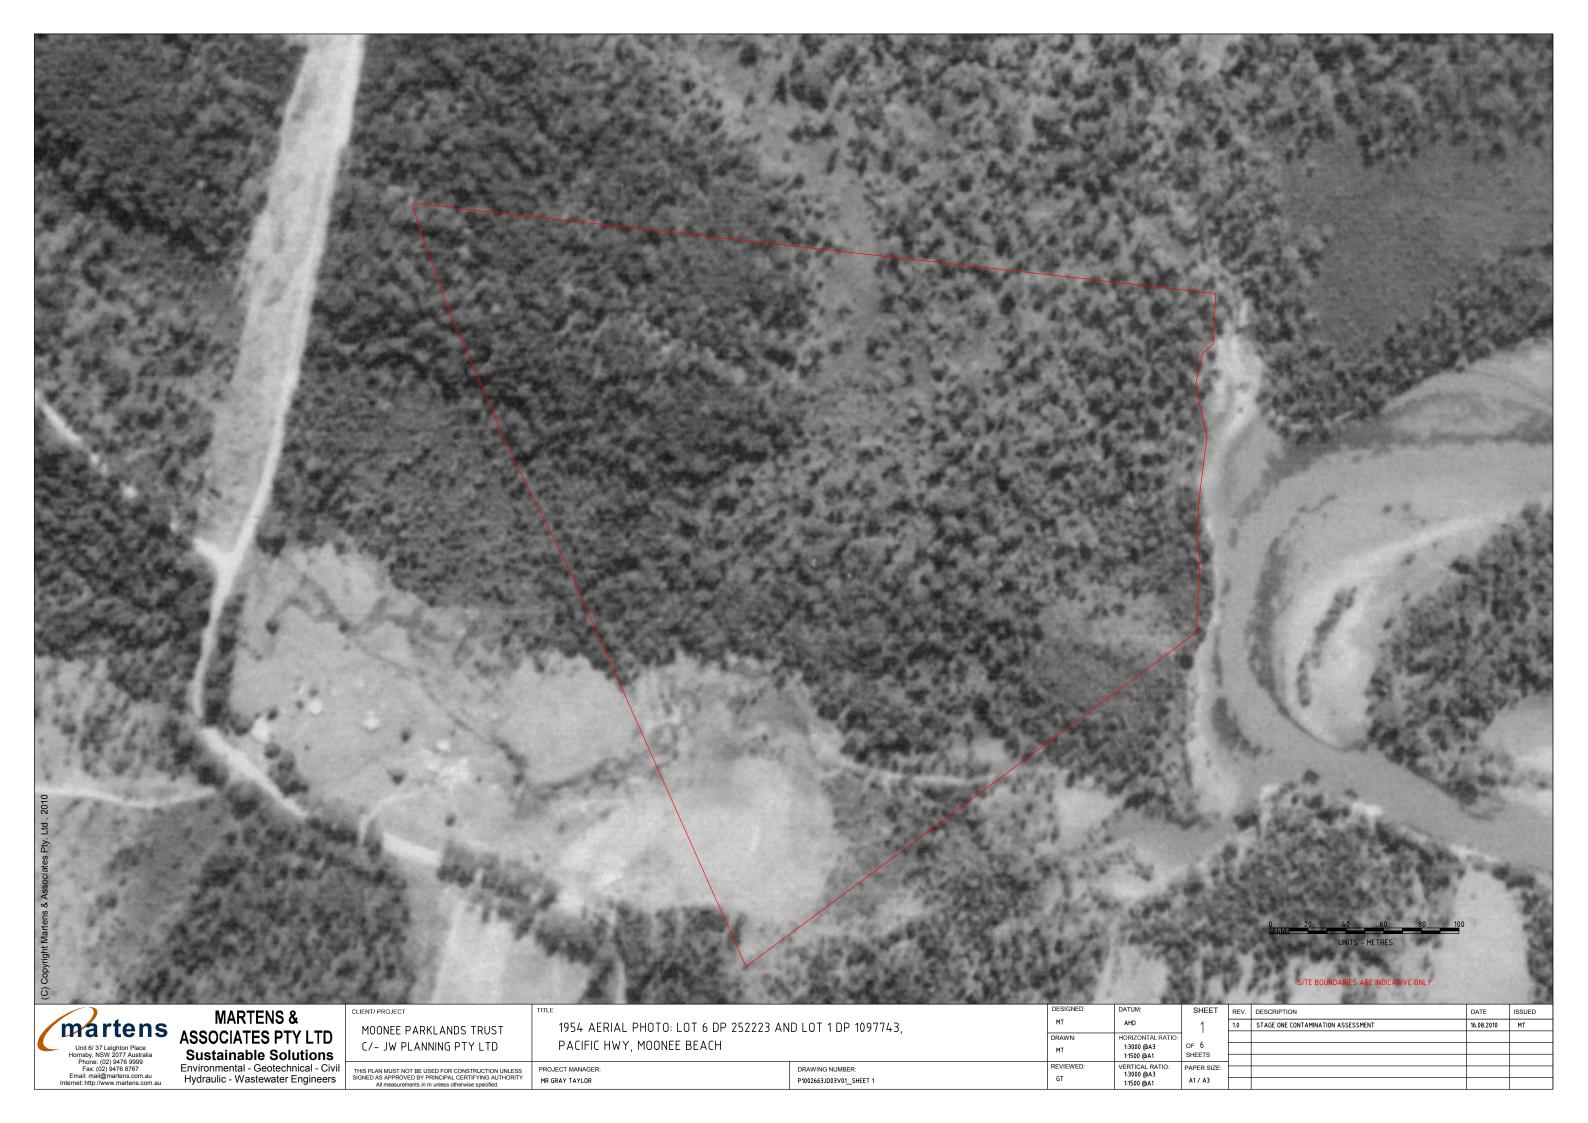
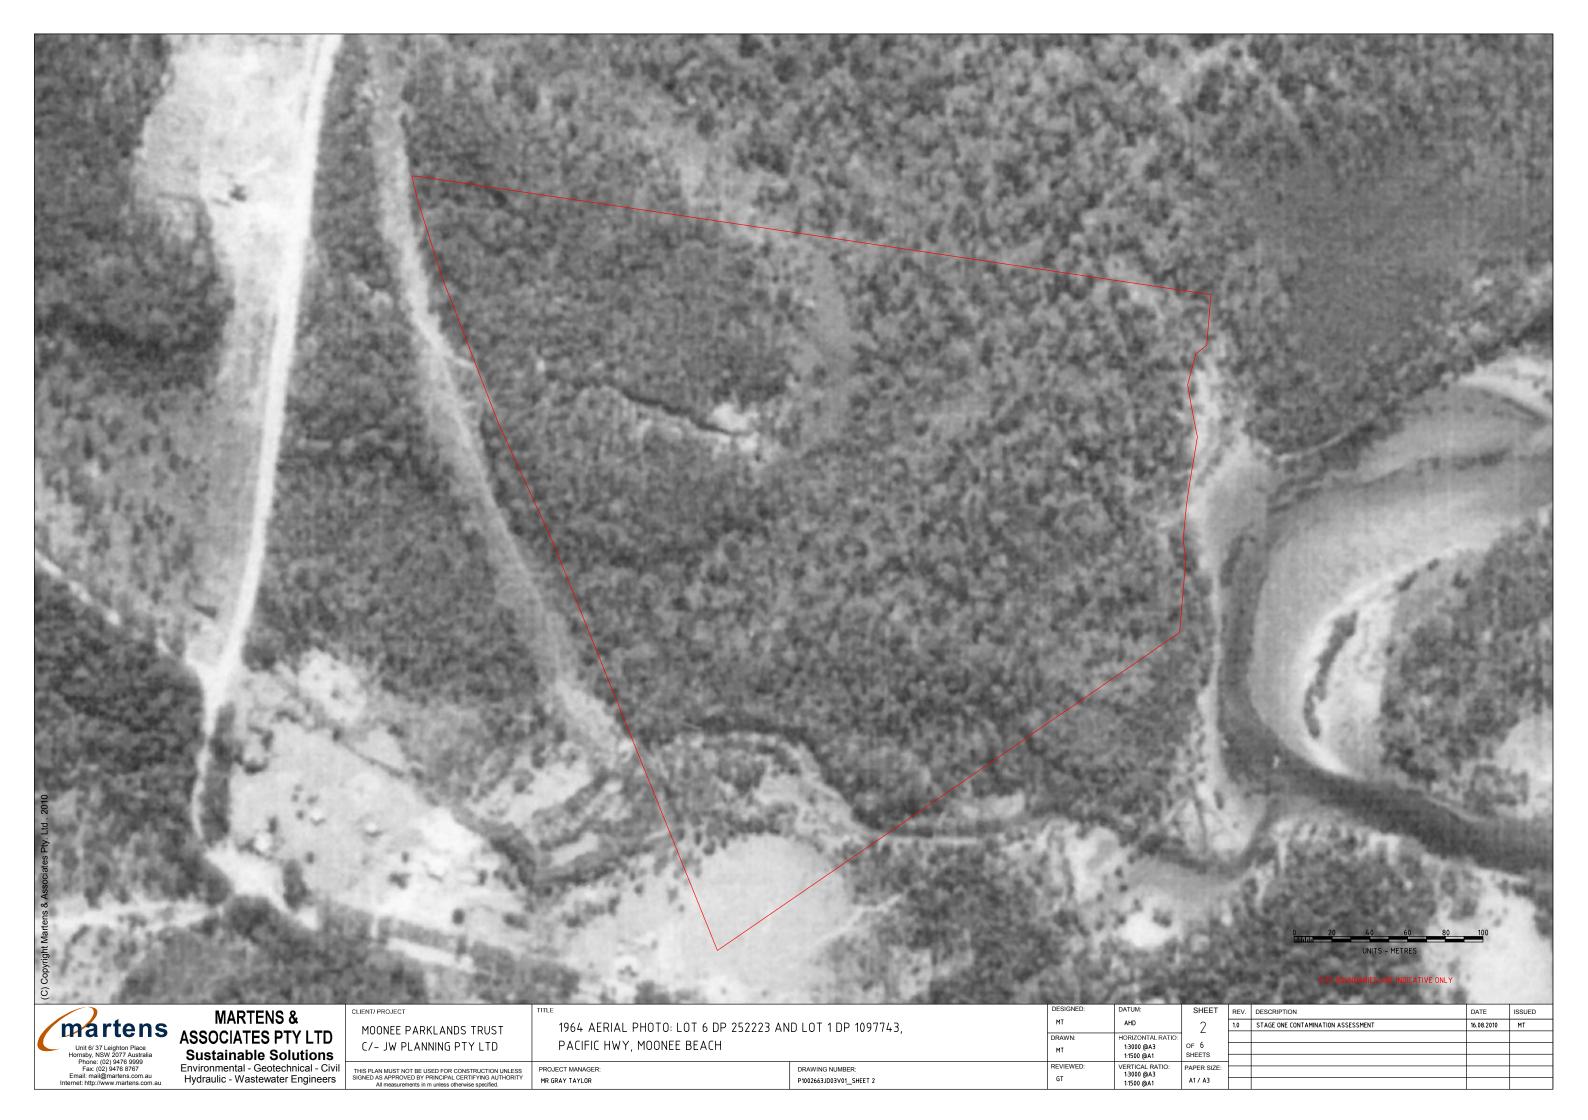
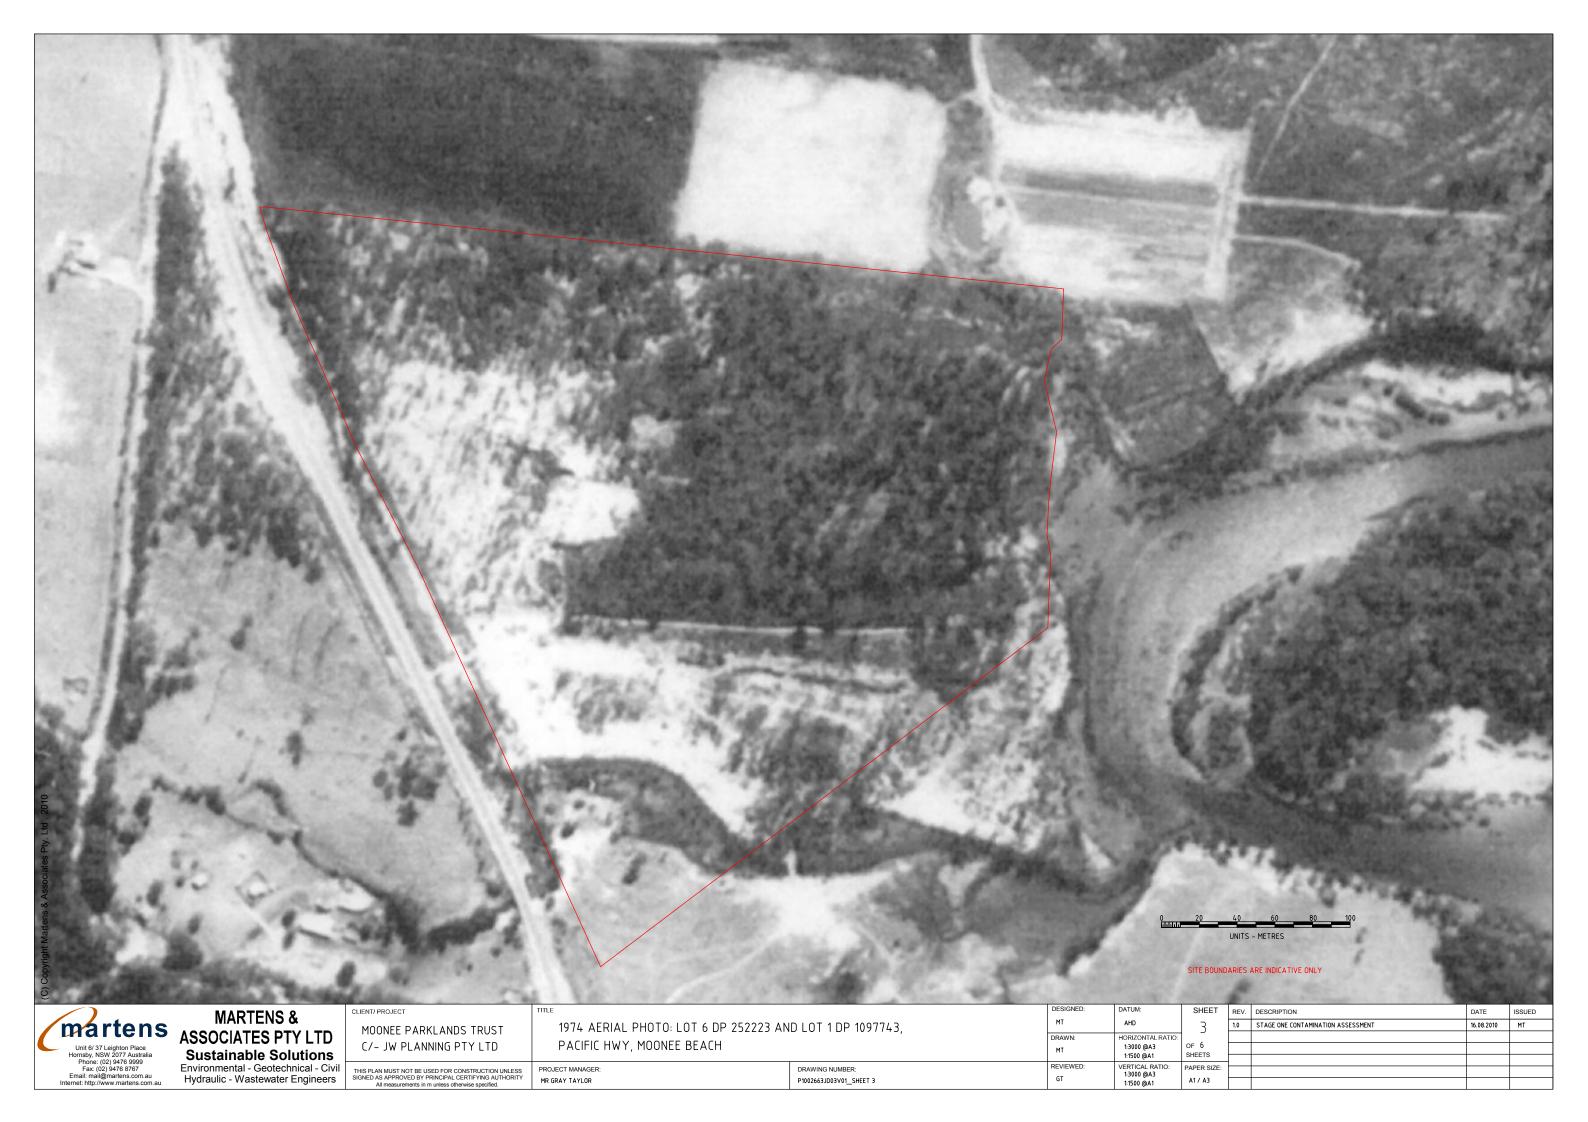
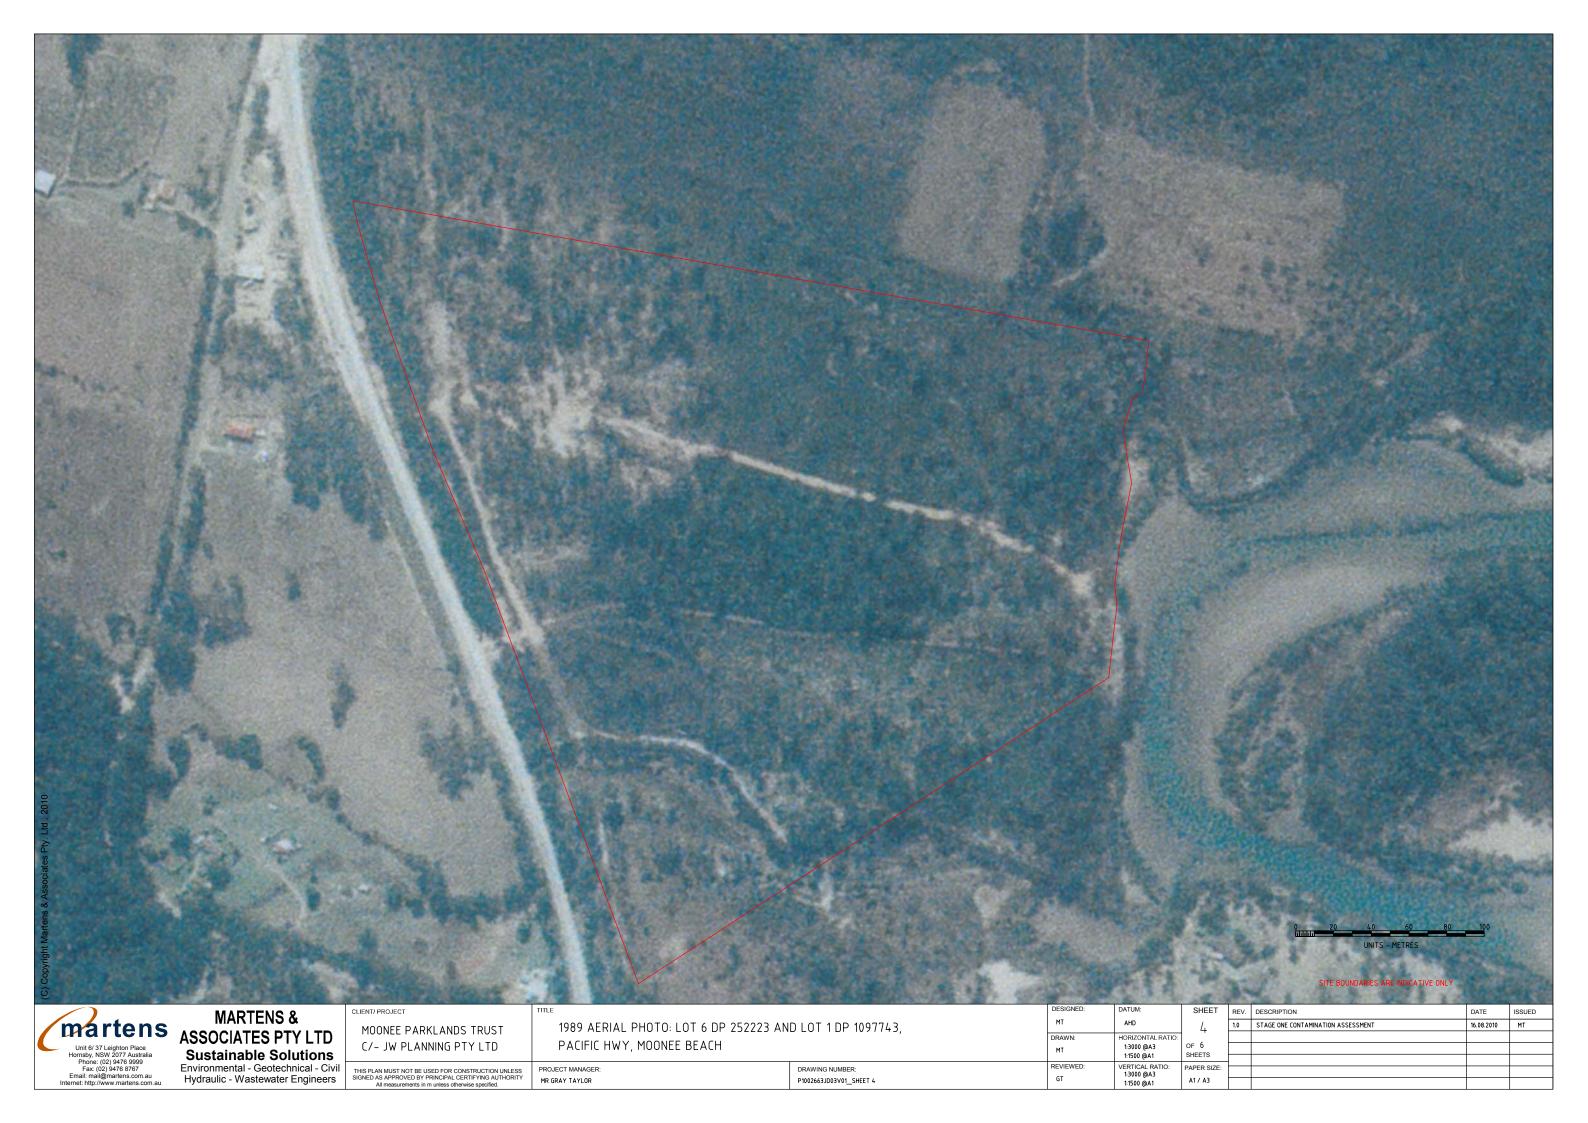
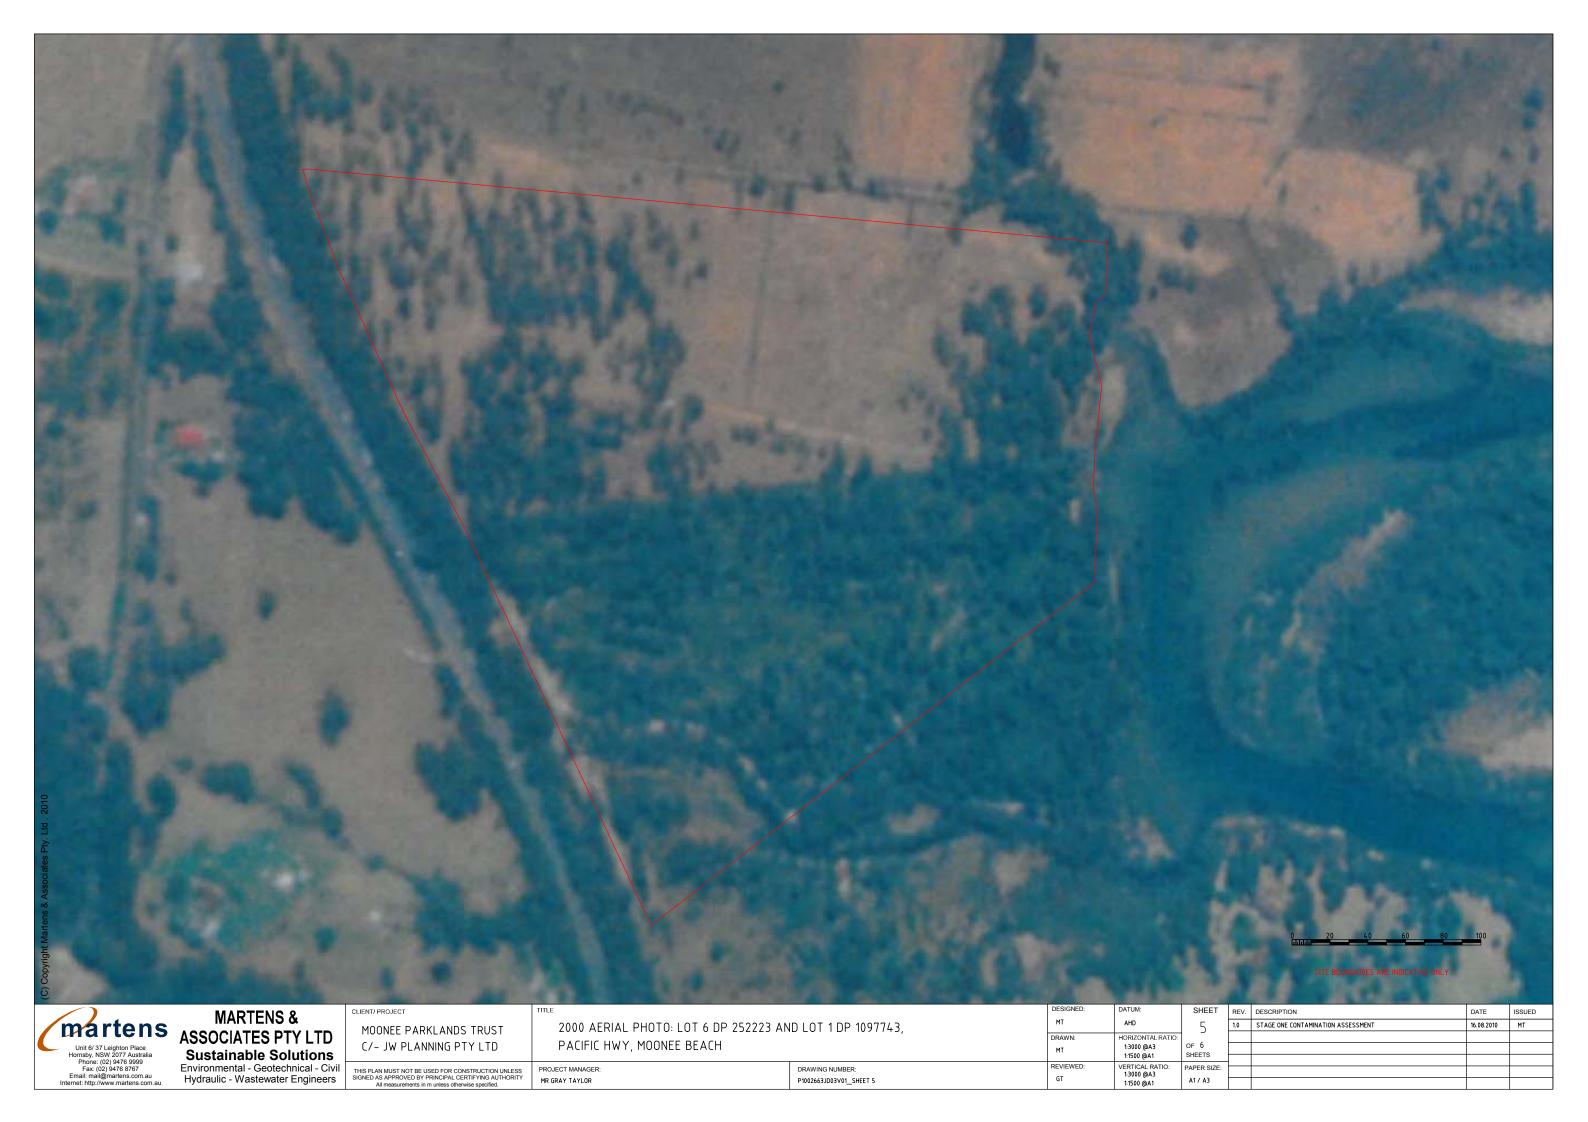
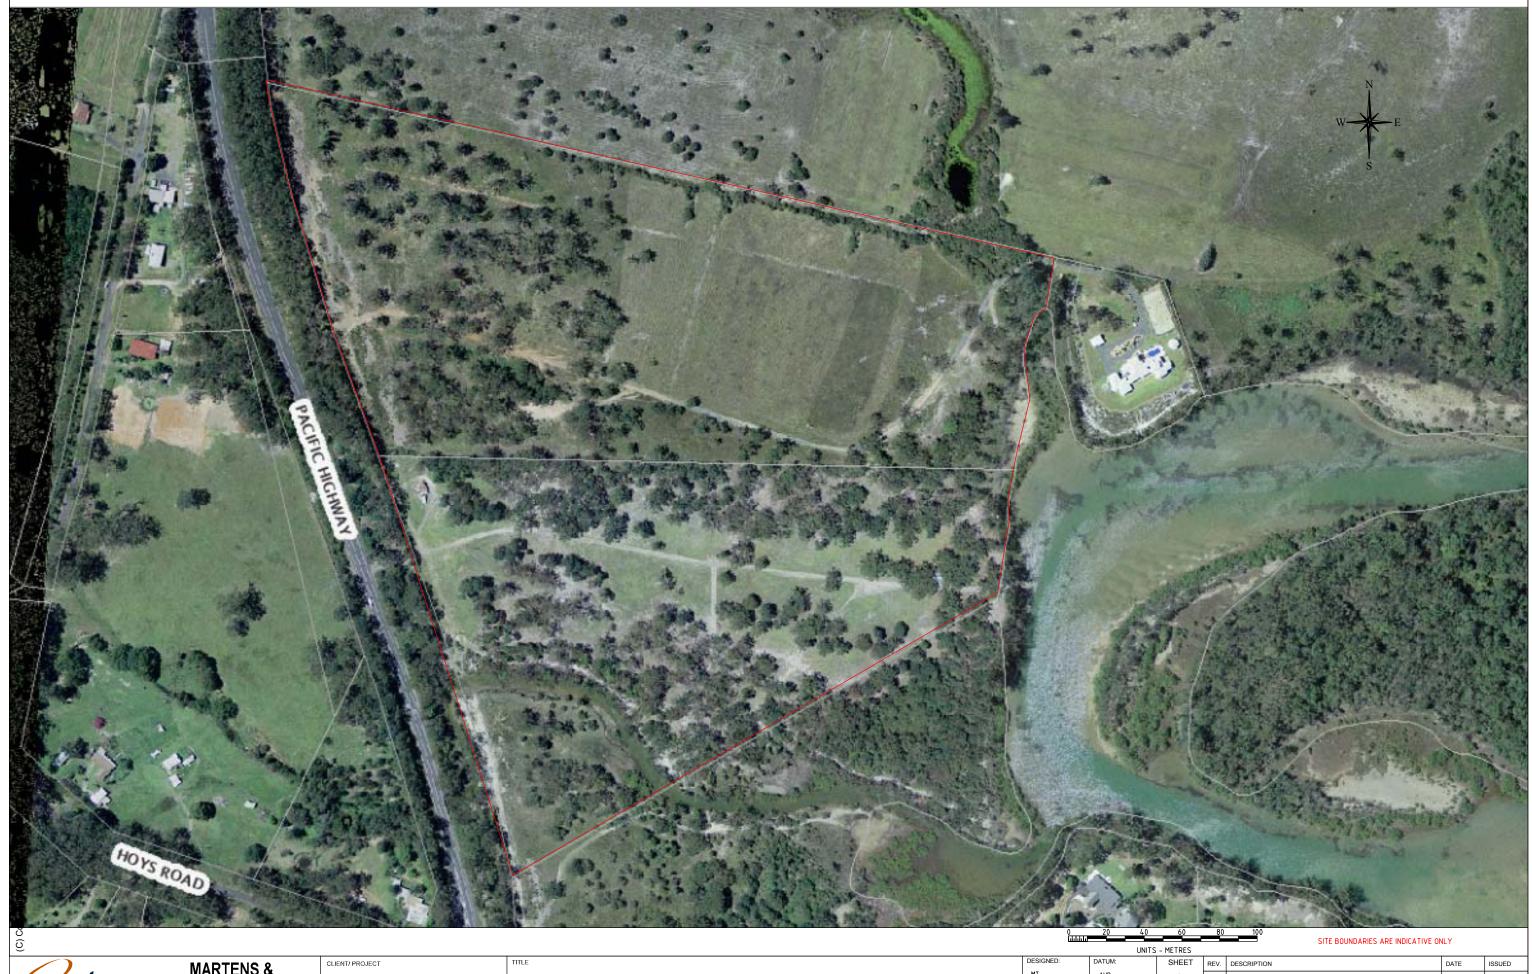
Attachment B – Historical Aerial Photographs 8

Year	Description
1954	The site is forested except for a small portion in the south-west corner that is cleared (most likely encroached on by the neighbouring property). No structures or intensive land use are seen on the site. Surrounding land use is rural (mainly pasture) and forested.
1964	As per 1954, the site is mostly forested and surrounding land use is rural (pasture) and forested.
1974	The southern and western portions of the site have been cleared and an access track is evident through the centre of the property. Adjacent properties to the north and west have been intensively cleared. Pacific Hwy has been reorientated since 1964.
1989	As per the 1974 photo, the site is partly cleared and there is an access track through the centre. Immediately adjacent properties are mostly cleared for agricultural land use.
2000	Lot 1 has been more intensively cleared; otherwise land use is consistent with previous photos.
