Report Type: Remedial Action Plan and Asbestos Management Plan
Site Address: Arthur Phillip High School and Parramatta Public School
Report Number: 1915/ER-1-2
Report Date: 14th August 2015

RE: REMEDIAL ACTION PLAN & ASBESTOS MANAGEMENT PLAN – ARTHUR PHILLIP HIGH SCHOOL AND PARRAMATTA PUBLIC SCHOOL

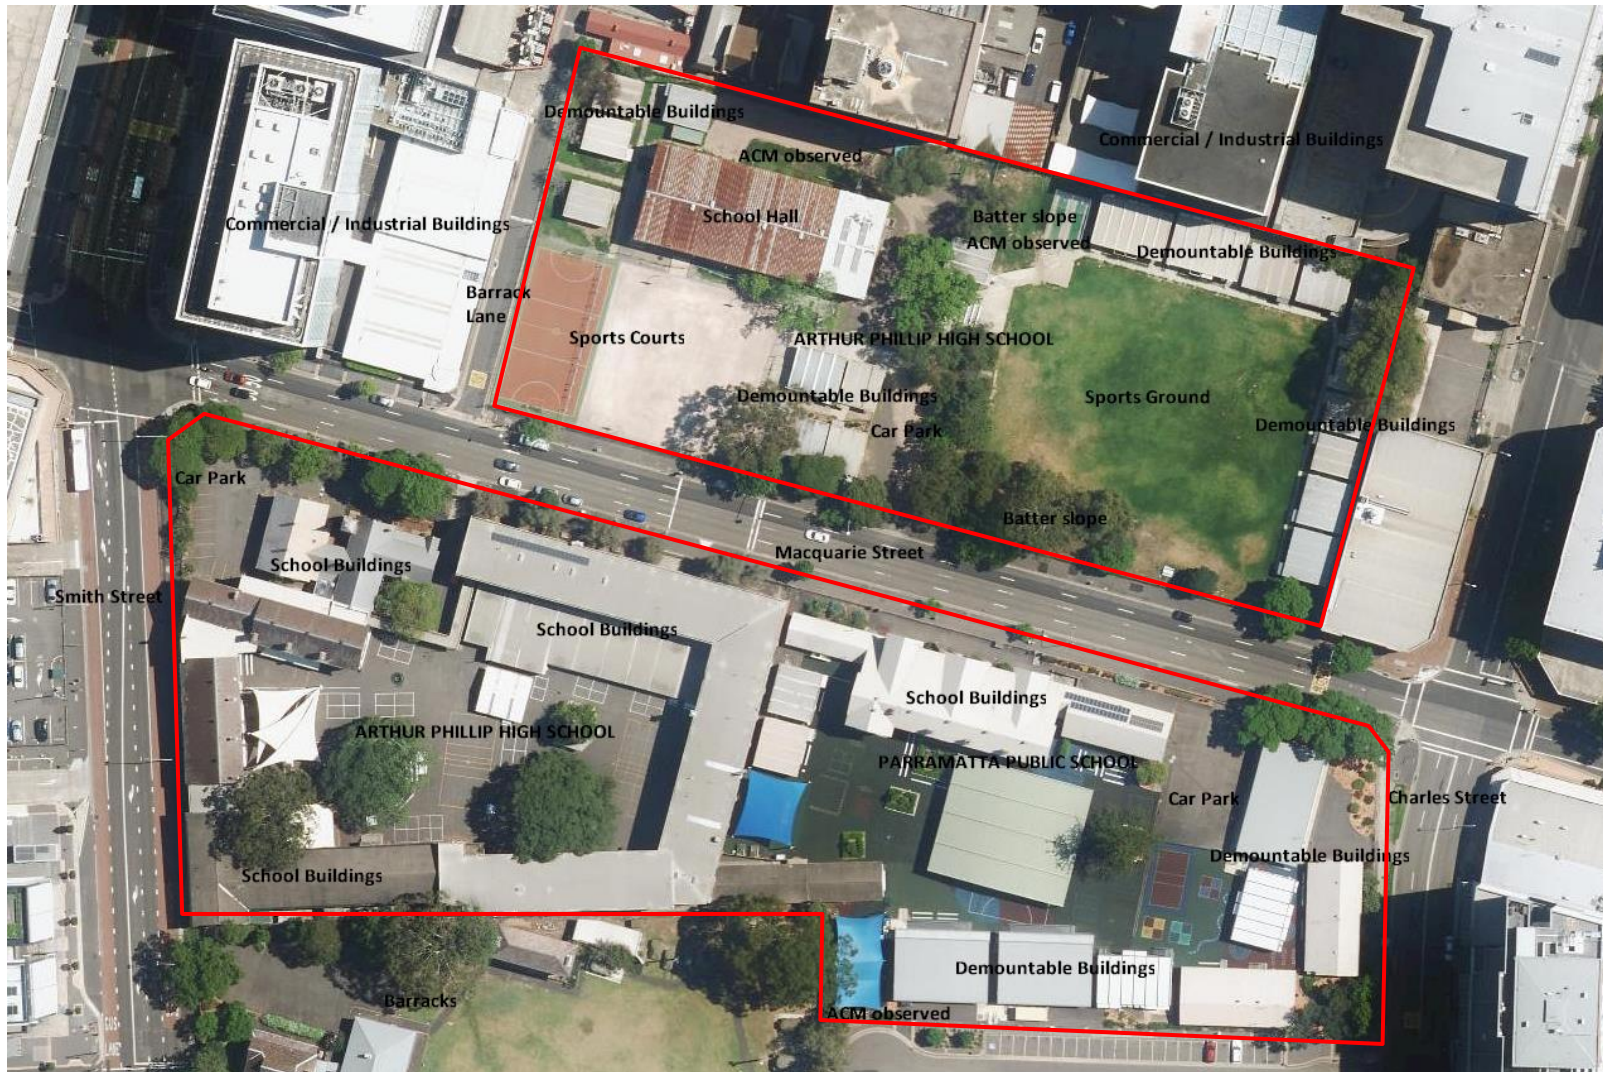
Figure 2: Site Features

A site inspection was completed during soil investigation works on 9 – 13th July 2015 by one of AG's trained and experienced environmental consultants. During the site inspection, the site was observed to comprise a high school and primary school with Macquarie Street running through the centre (refer to **Figure 2** for locations of site features).

Suspected asbestos containing material (ACM) fragments were observed in the following areas (refer to **Figure 2**):

- Former agricultural uses of the site;
- Potential for hazardous materials in footprints of former site structures;
- Known asbestos in building materials used to construct current site structures;
- Suspected ACM fragments on the ground surface at a number of locations at the site (refer to **Figure 2**); and
- Fill material of unknown origin at the site.

Several fragments of non-friable ACM were observed at soil sample locations BH7, HA9 and HA16, refer to **Figures 2 & 3**. The fragments were observed on the surface and were removed to the laboratory during the AG (2015a) site assessment. It is anticipated that soils below the ground surface could potentially contain further ACM fragments. Further assessment in these areas are recommended to further assess asbestos impacts at the site (refer to **Section 4.3**).

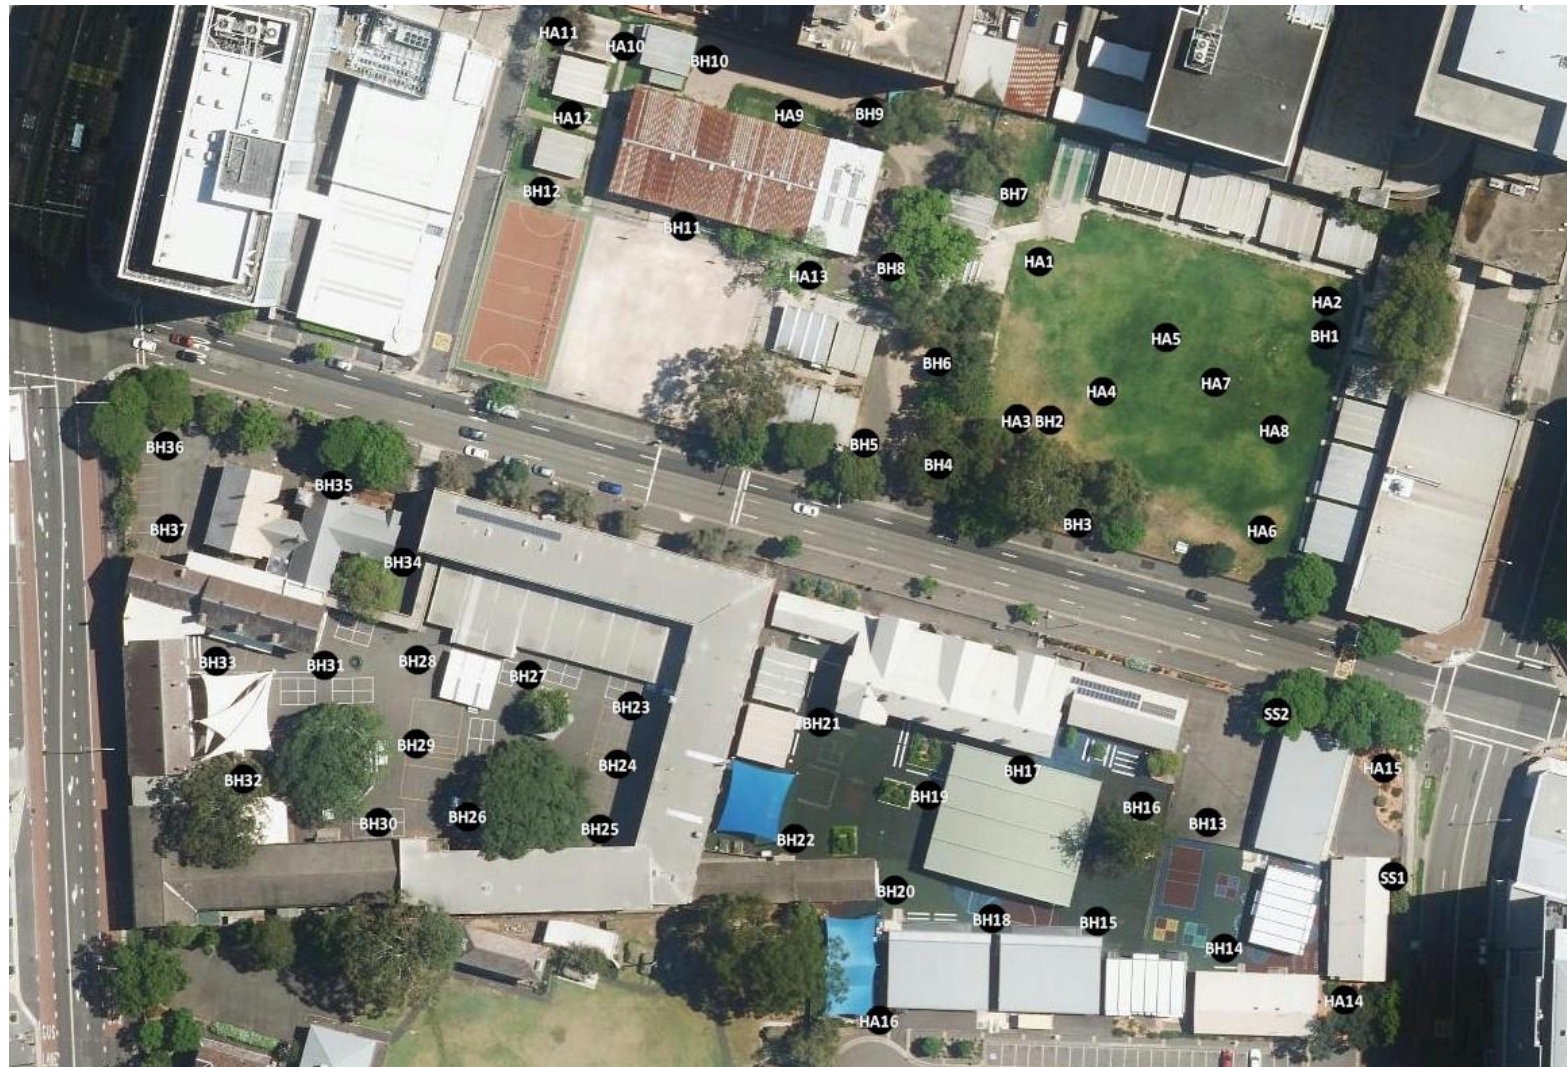
Figure 3: Sample Locations and Remedial Areas
