Geotechnical Investigation Report

Arthur Phillip High School and Parramatta Public School
Macquarie Street, Parramatta

Project Number: 1915

Report Number: 1915-GR-1-1

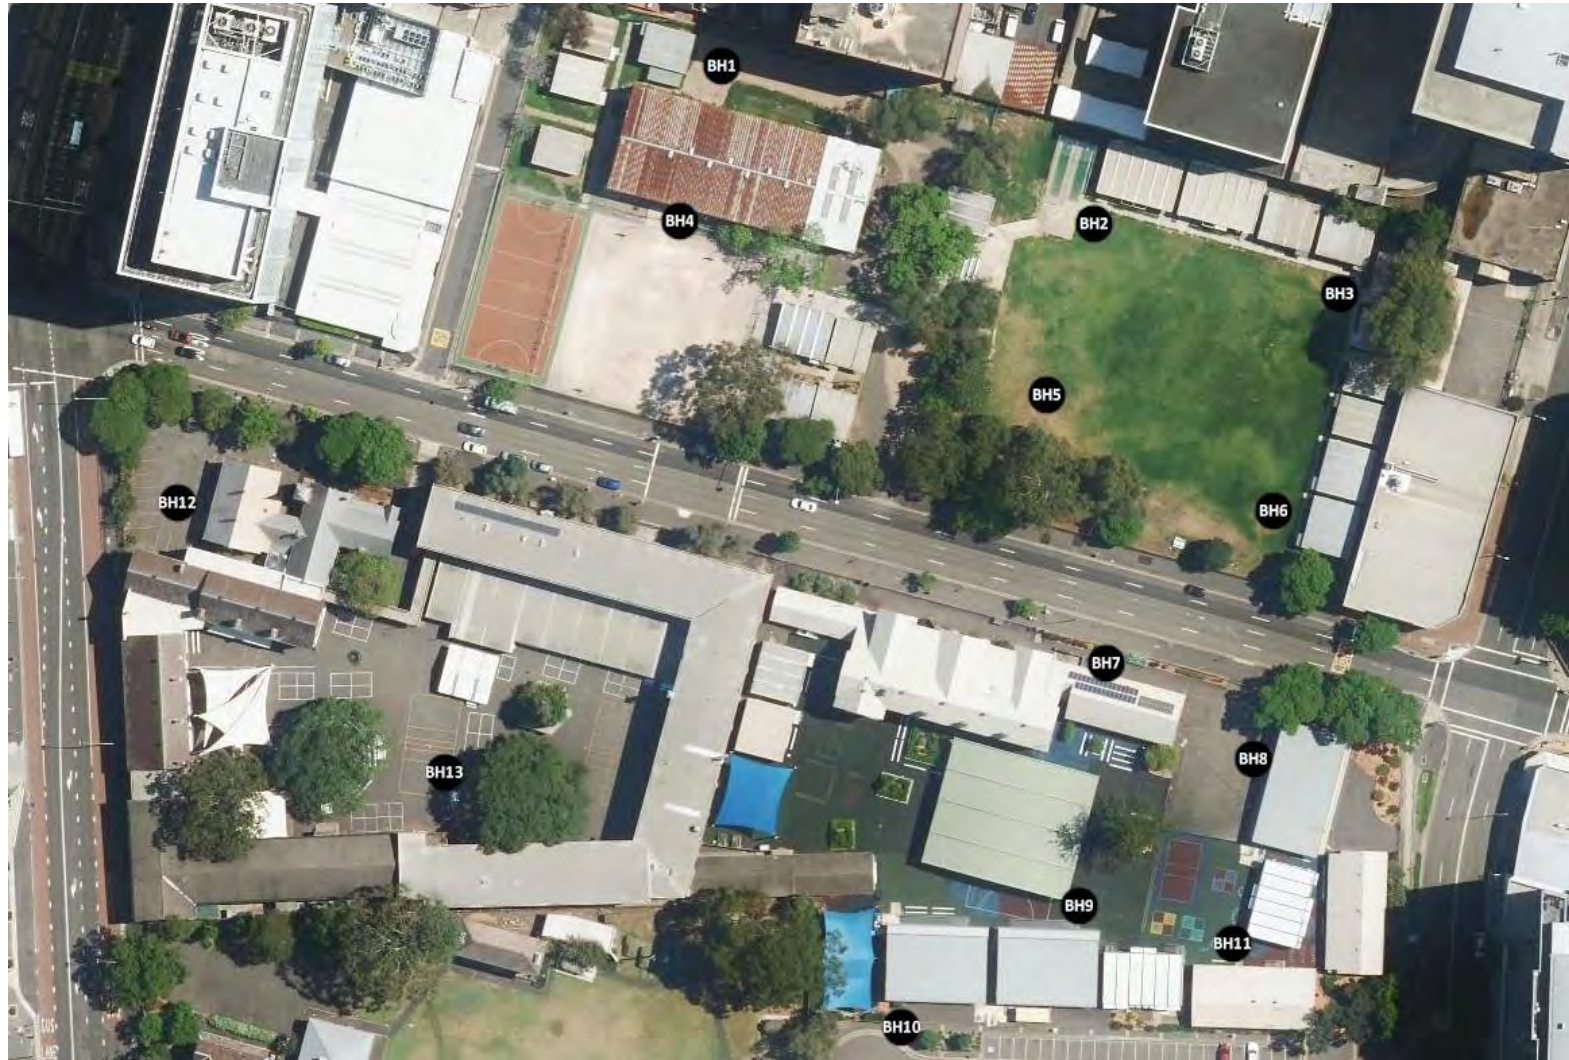
Geotechnical Borehole Locations

Borehole	Easting	Northing	Level (m AHD)
BH1	315568.571	6256533.243	9.735
BH2	315631.553	6256507.705	7.568
BH3	315677.928	6256494.505	6.678
BH4	315558.207	6256504.413	10.739
BH5	315625.083	6256470.690	7.812
BH6	315668.319	6256453.391	6.886
BH7	315637.142	6256424.862	10.202
BH8	315663.172	6256412.153	8.166
BH9	315633.394	6256383.191	11.080
BH10	315600.240	6256359.543	12.732
BH11	315660.554	6256374.616	9.146
BH12	315465.874	6256451.696	11.485
BH13	315517.413	6256400.255	12.955

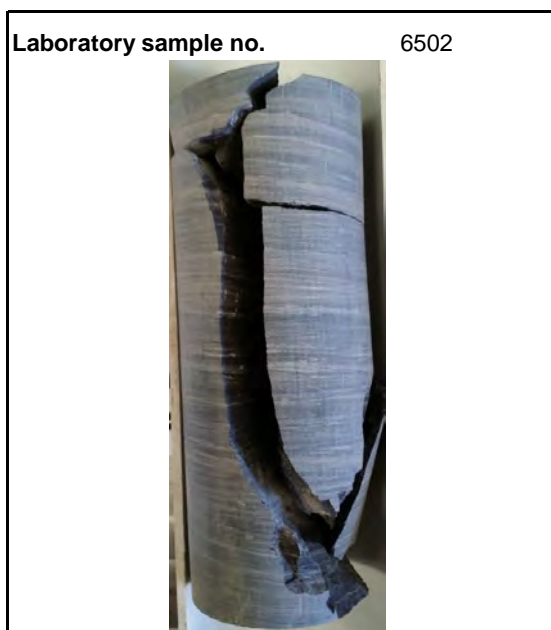
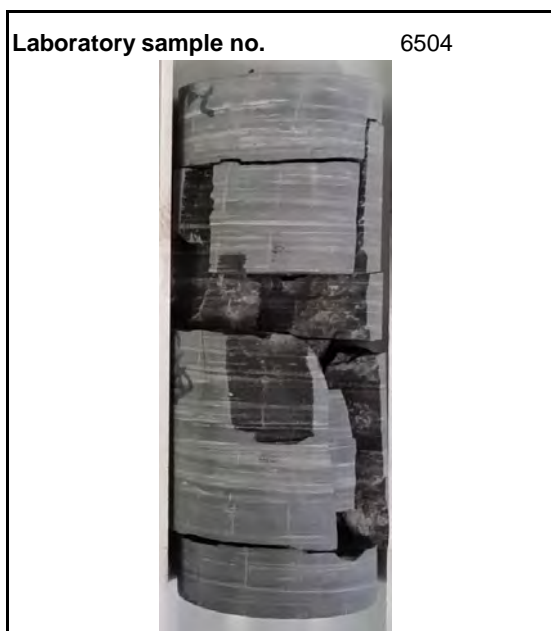
Specimen after failure

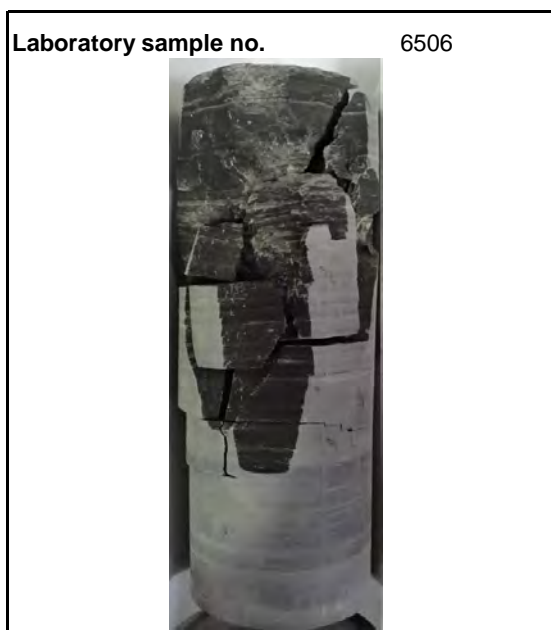
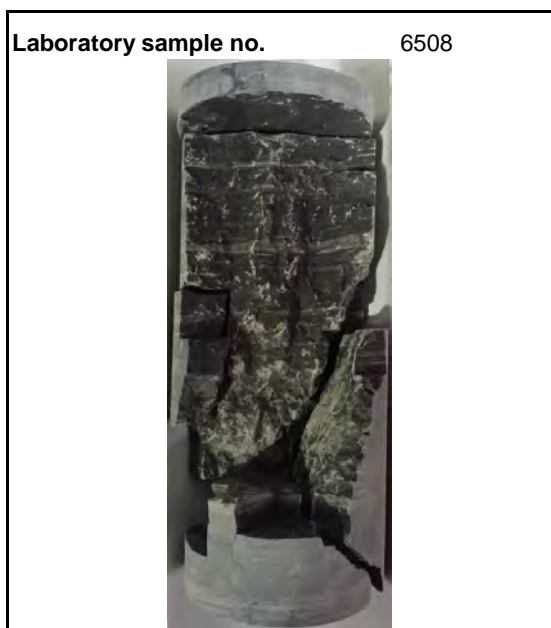
Specimen after failure

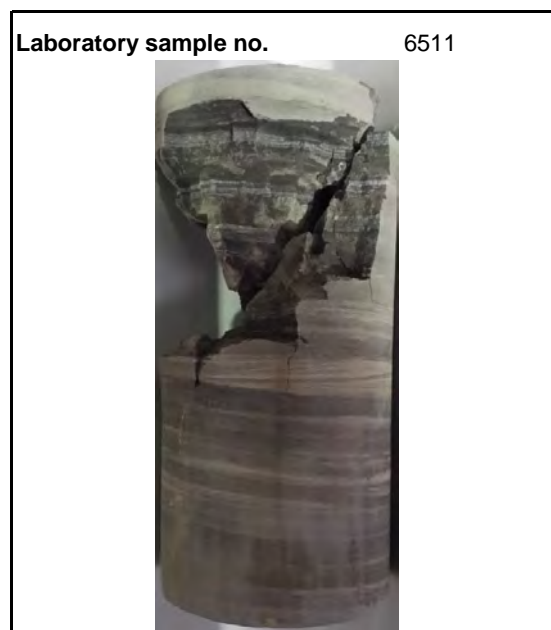
Specimen after failure
