Report on  
Groundwater Level Investigation

Proposed St Marys Freight Hub  
2 Forrester Road, St Marys, NSW

Prepared for  
Pacific National (NSW) Pty Ltd

Project 94525.00  
March 2019

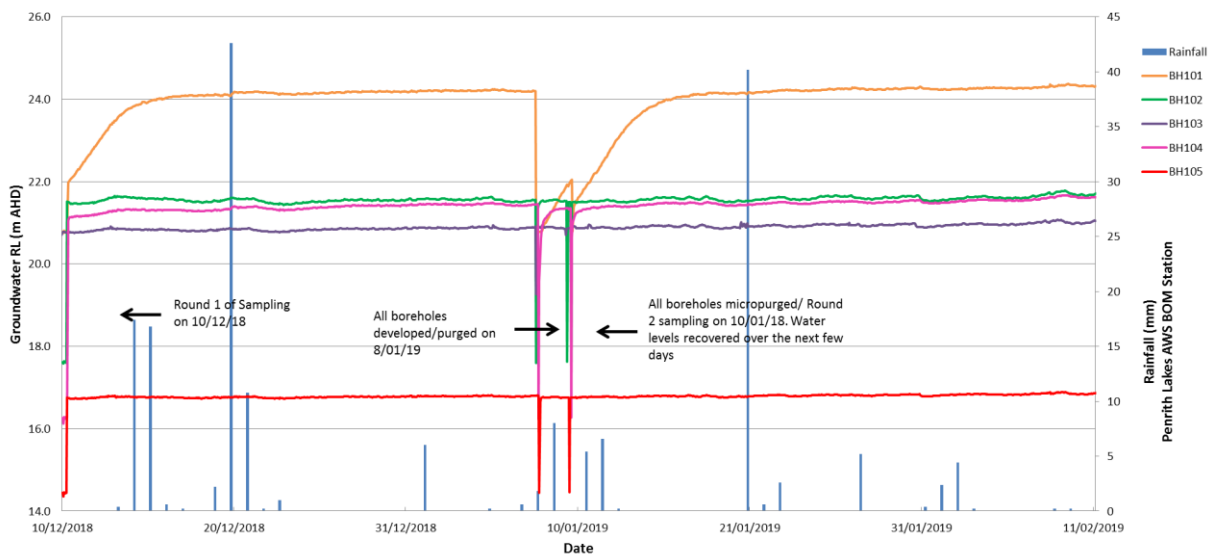
**Figure 1: Results of Groundwater Data-logger Monitoring**

The range of groundwater measurements recorded in the wells are outlined in Table 2 (excluding periods where development or sampling occurred) with the full range of results, together with rainfall data obtained from the nearest Bureau of Meteorology Weather Station, plotted on Figure 1 (both on following page).

The groundwater levels have generally been recorded within the natural clays, between approximately 1 m and 3 m above the soil/rock interface.

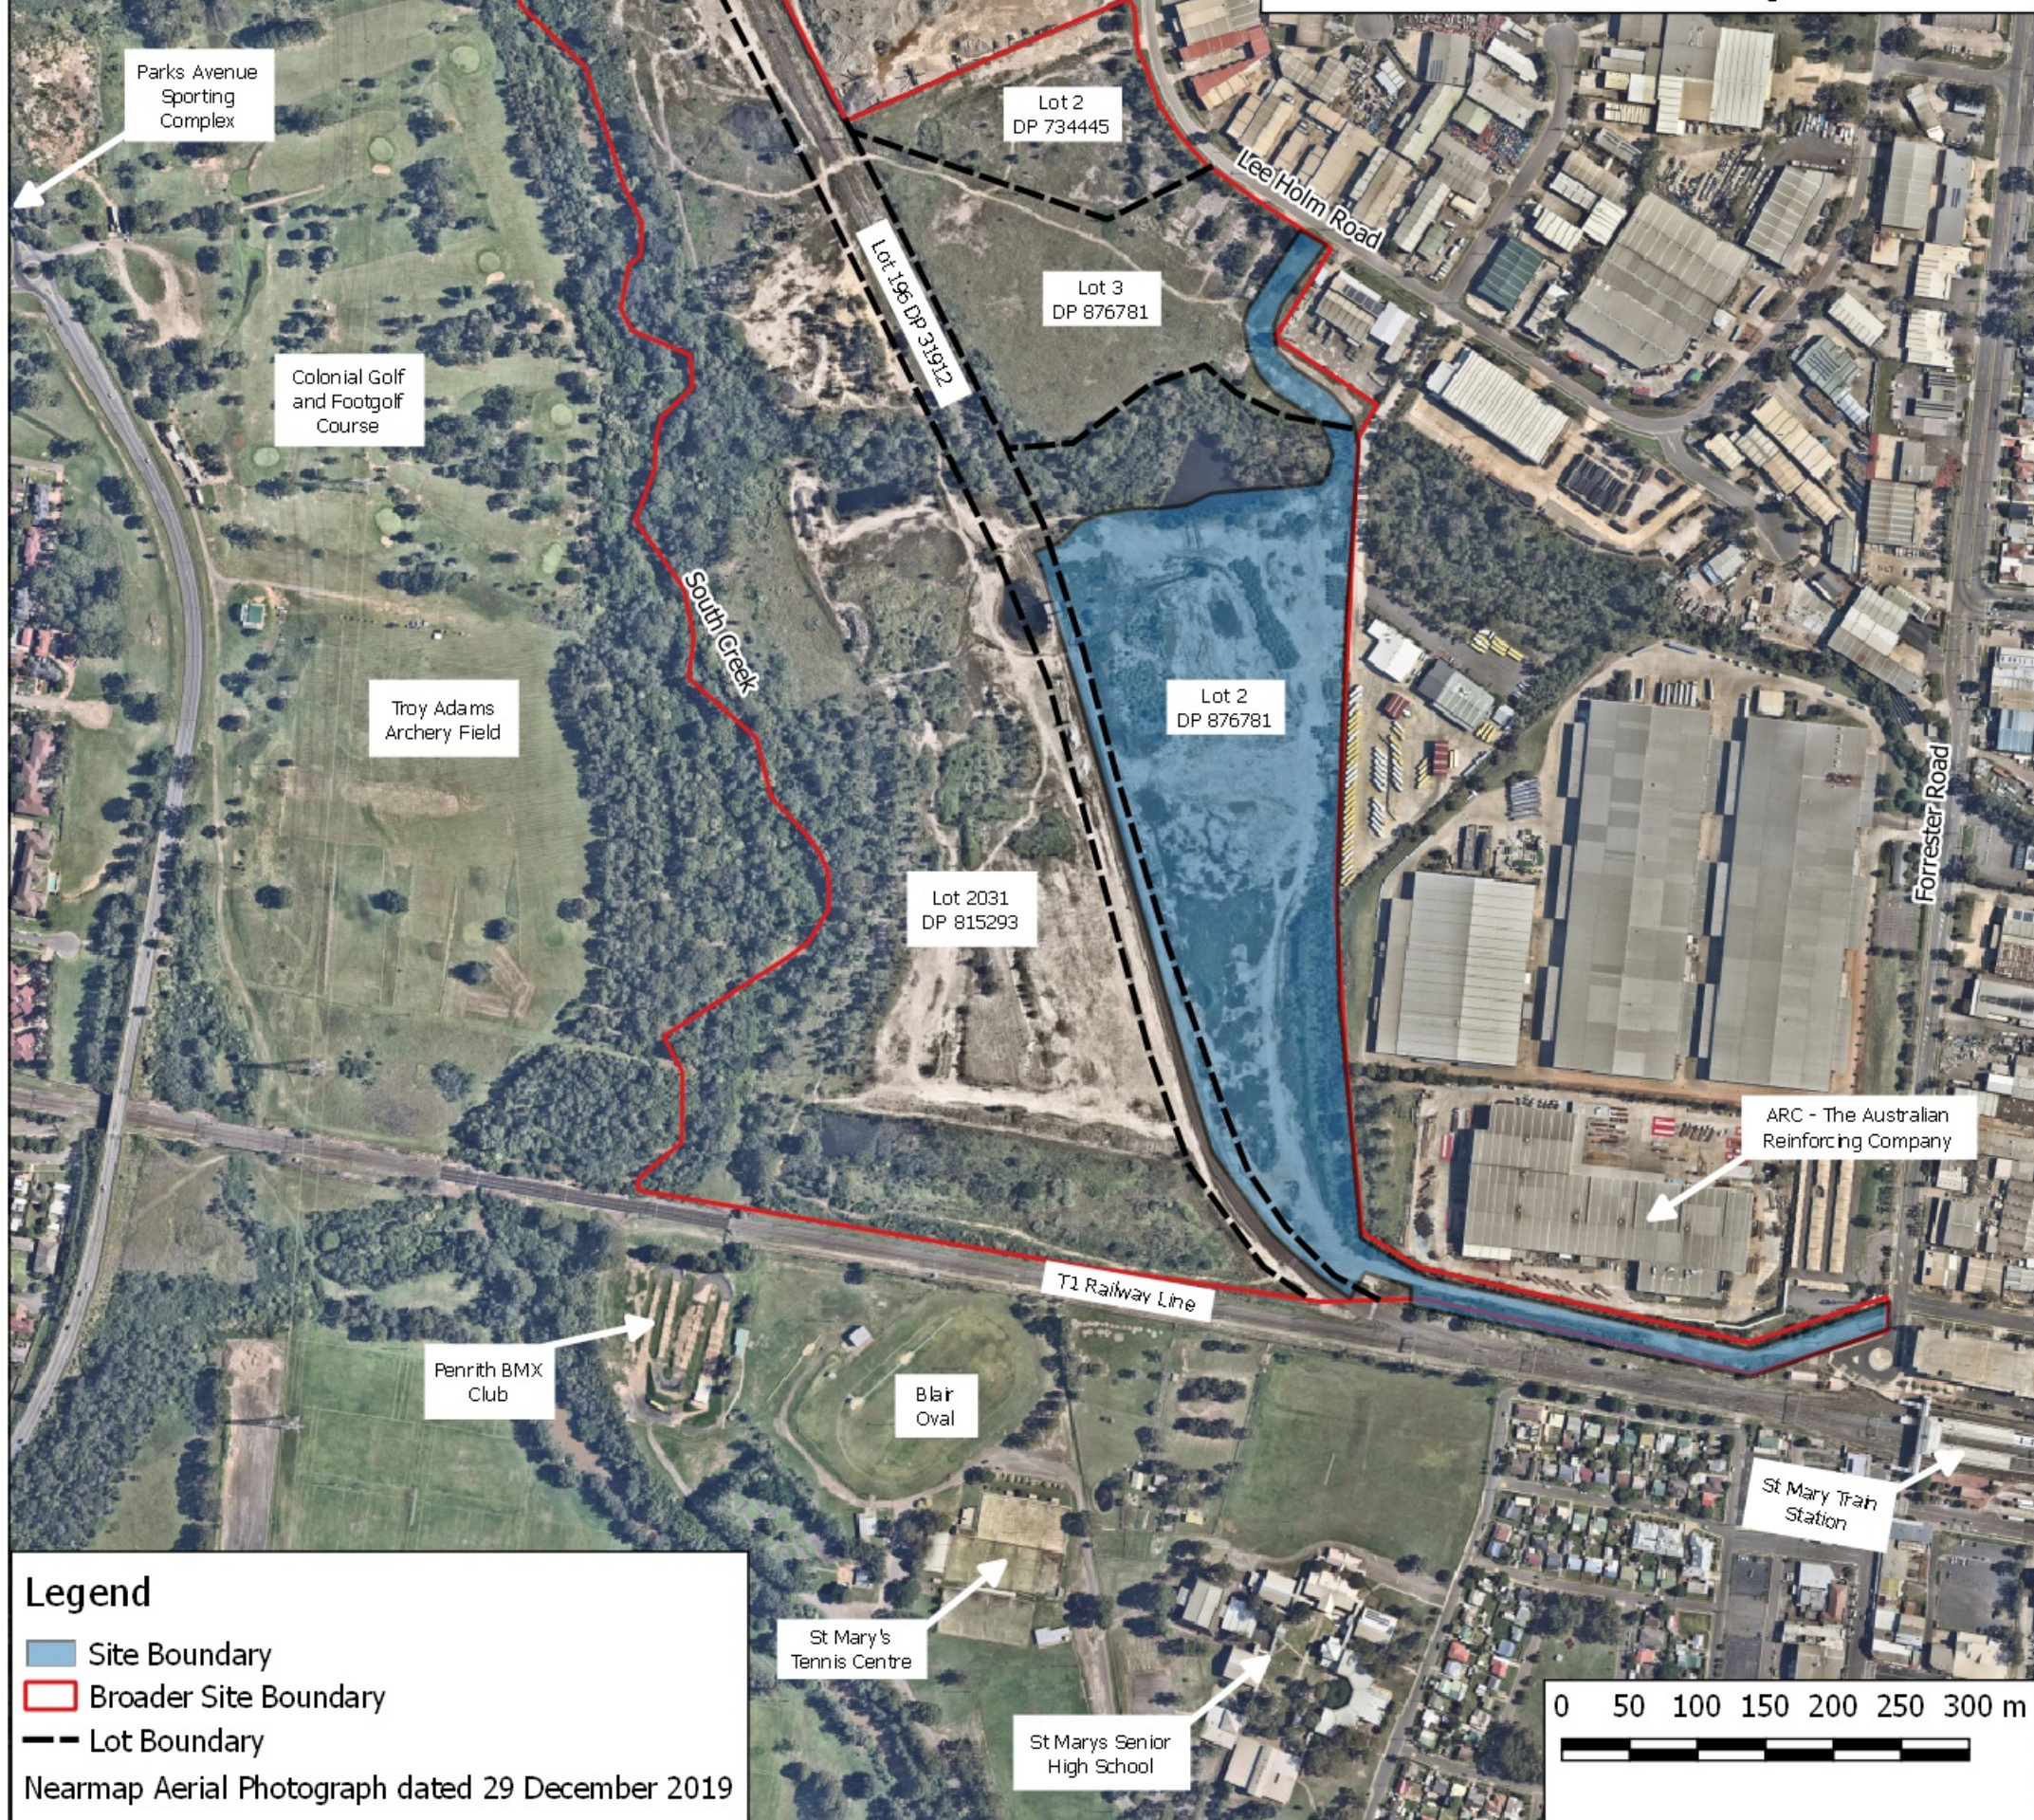
DRAWING No: 1

The location and boundary of the site (and the broader site) are shown on Drawing 1, Appendix B.

Surrounding land uses are shown on Drawing 1, Appendix B.

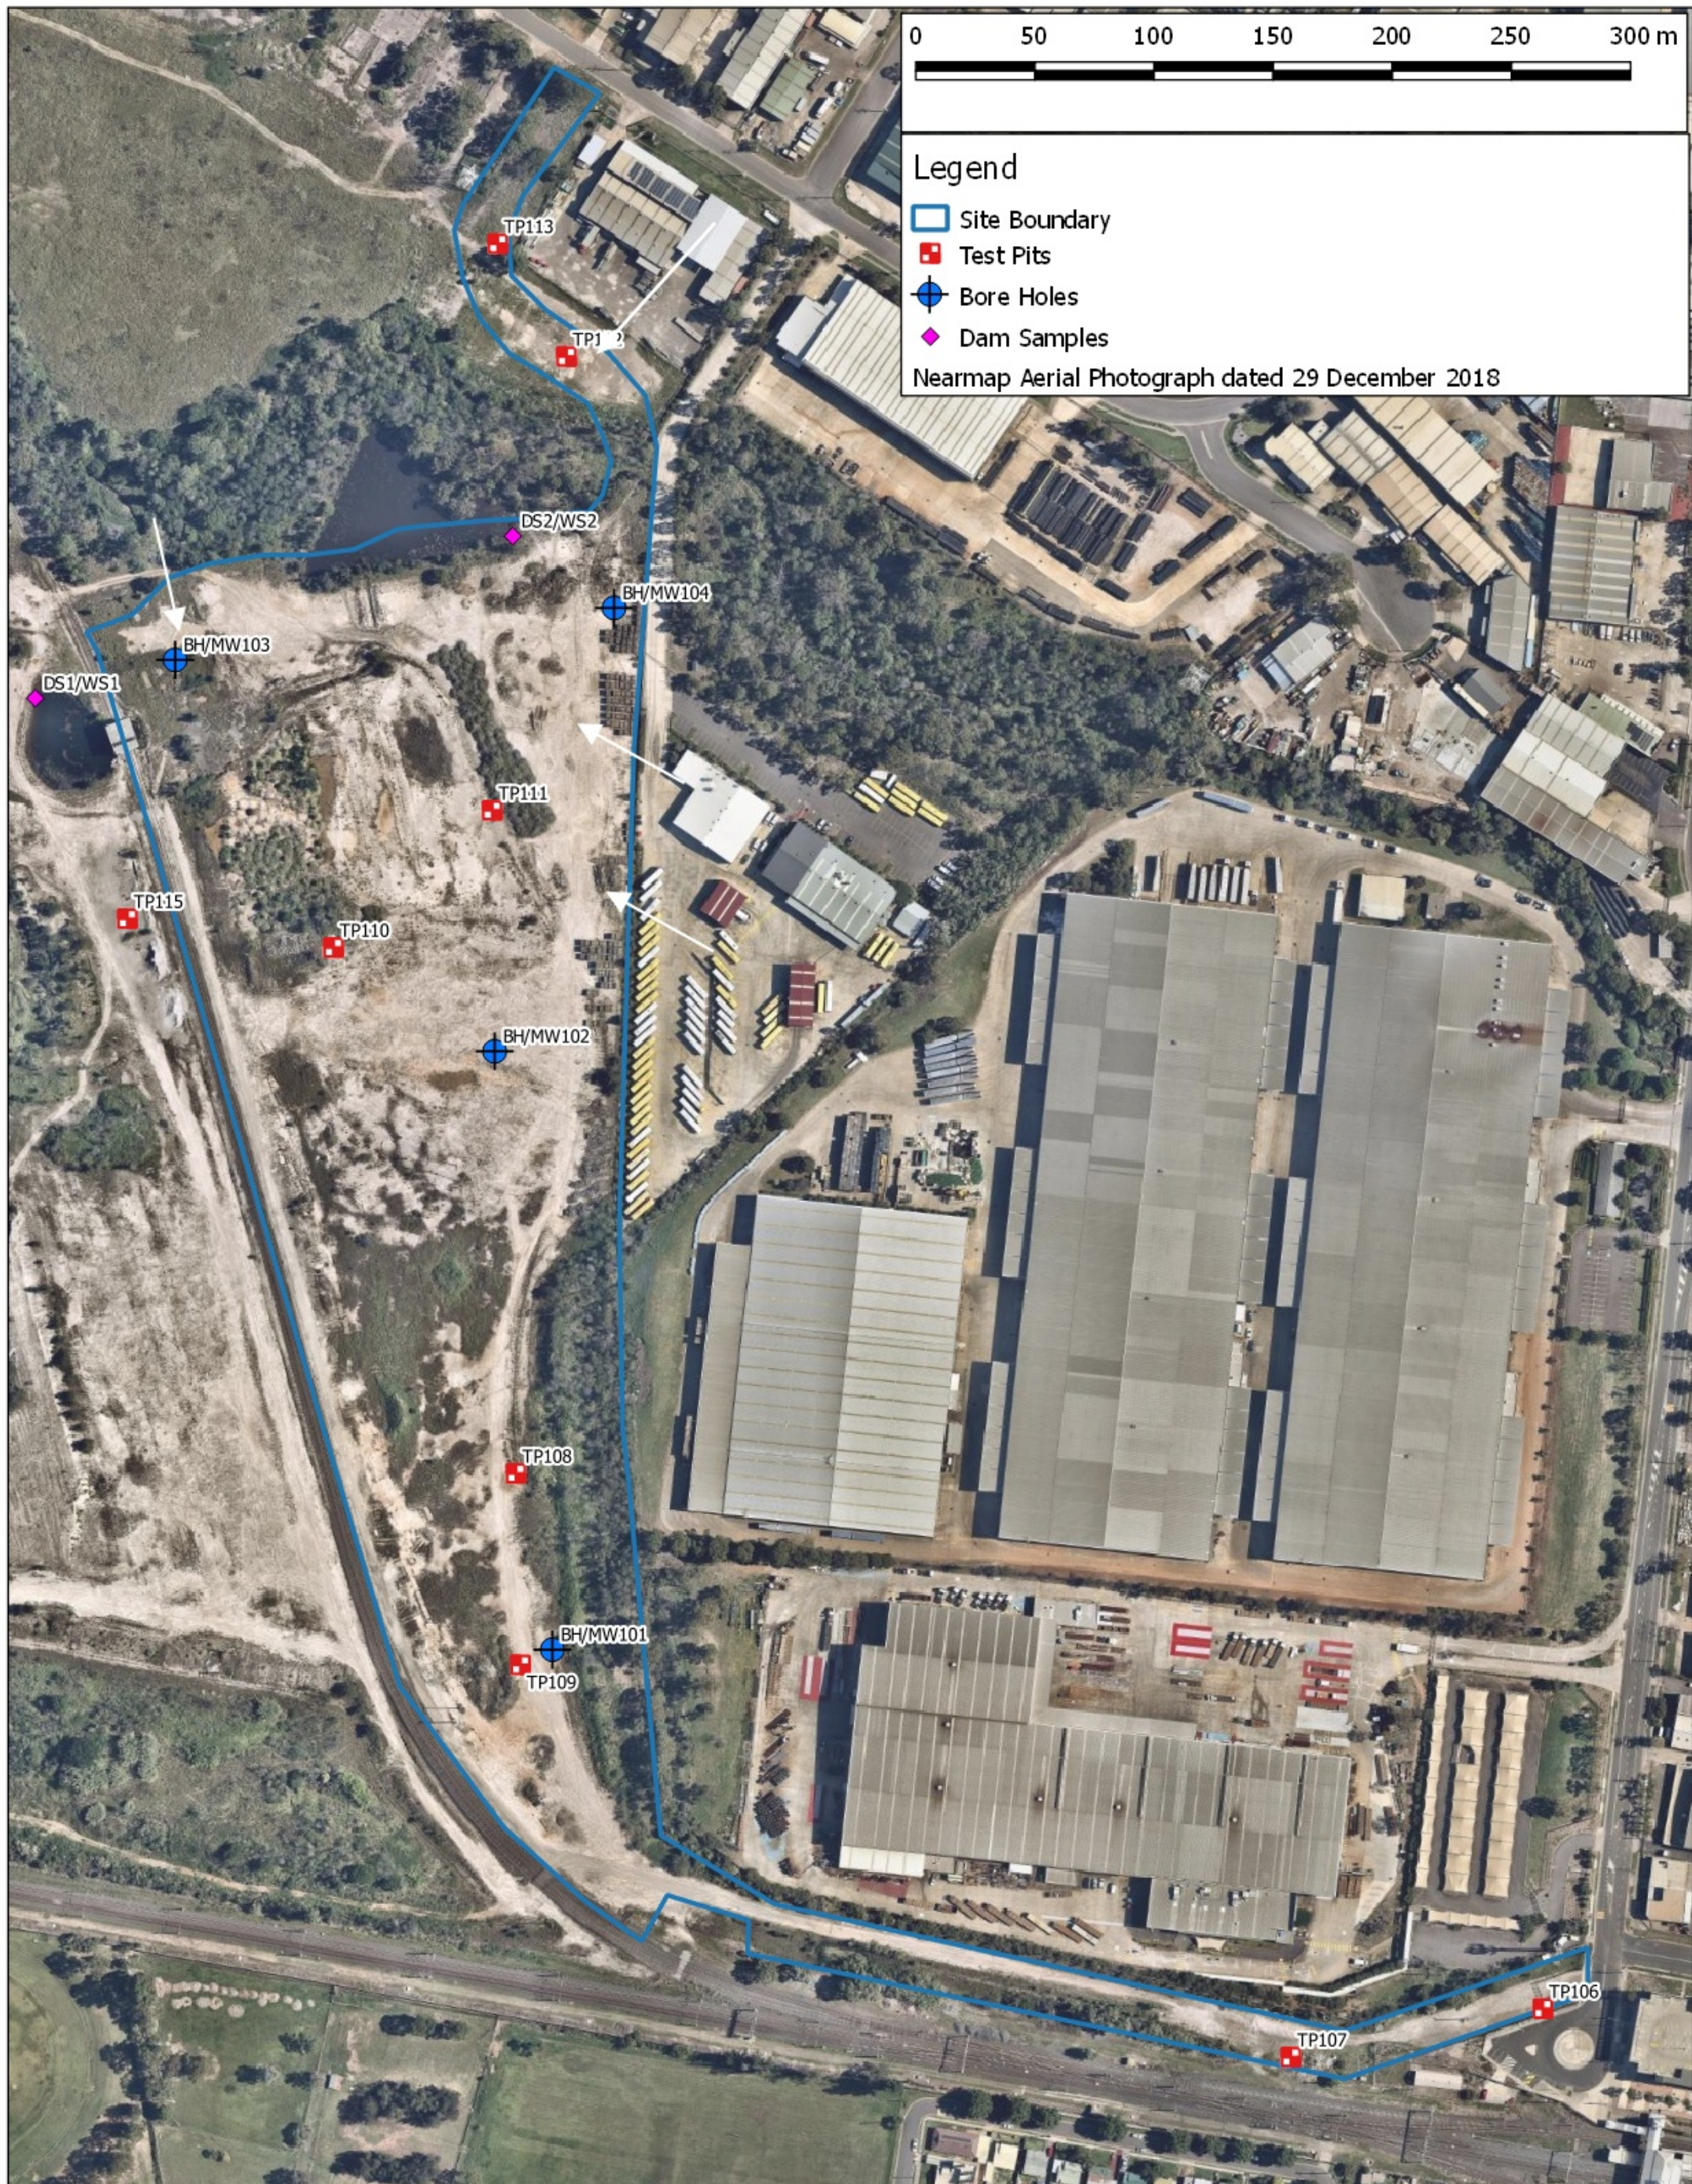
TITLE: Investigation Locations  
Groundwater Level Investigation  
2 Forrester Rd, St Marys, NSW

Monitoring well locations are shown on Drawings 2 and 3, Appendix B.
