MARINE POLLUTION RESEARCH PTY LTD

19 June 2017

EAGLETON QUARRY PROJECT SSD7332 REQUEST FOR RESPONSE TO SUBMISSIONS (RRTS)– AQUATIC ECOLOGY ASPECTS

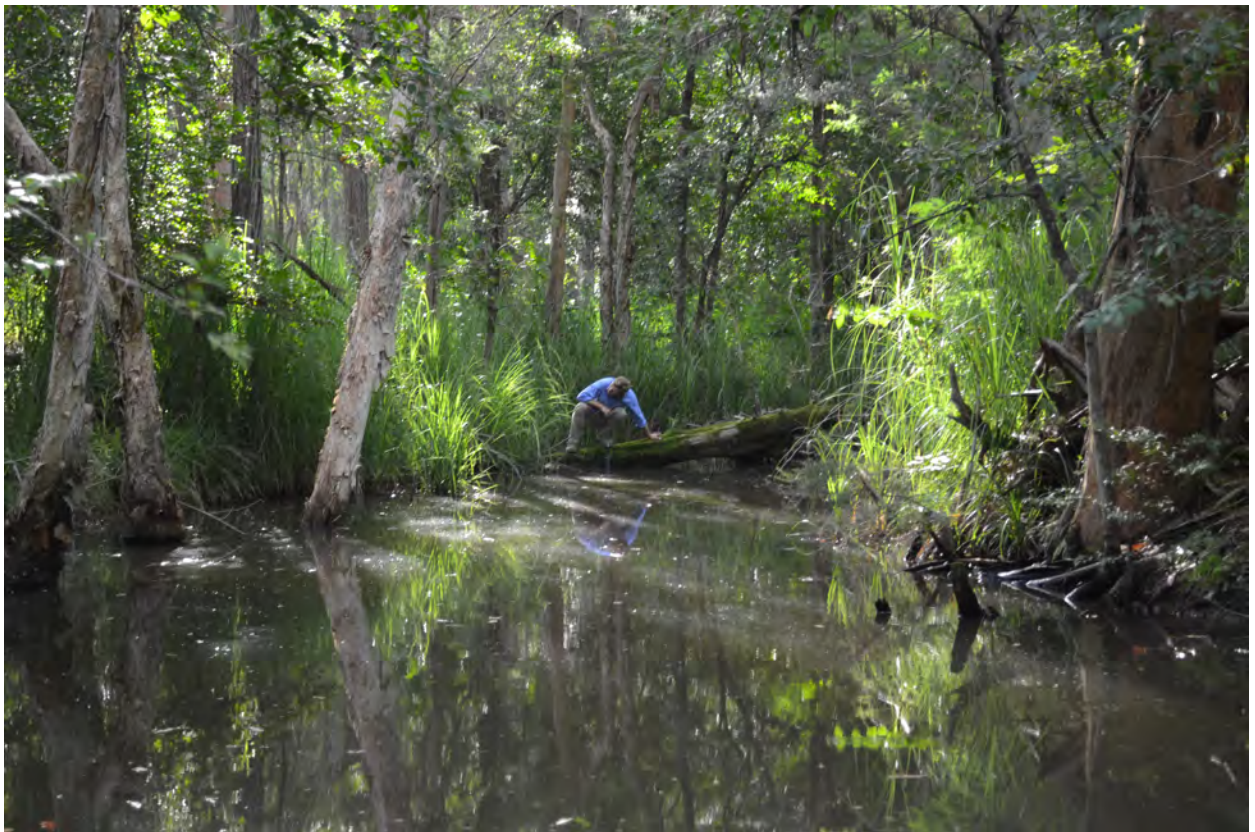
Figure 1 Water Quality Sampling Site A2 in Seven Mile Creek above Road Crossing.

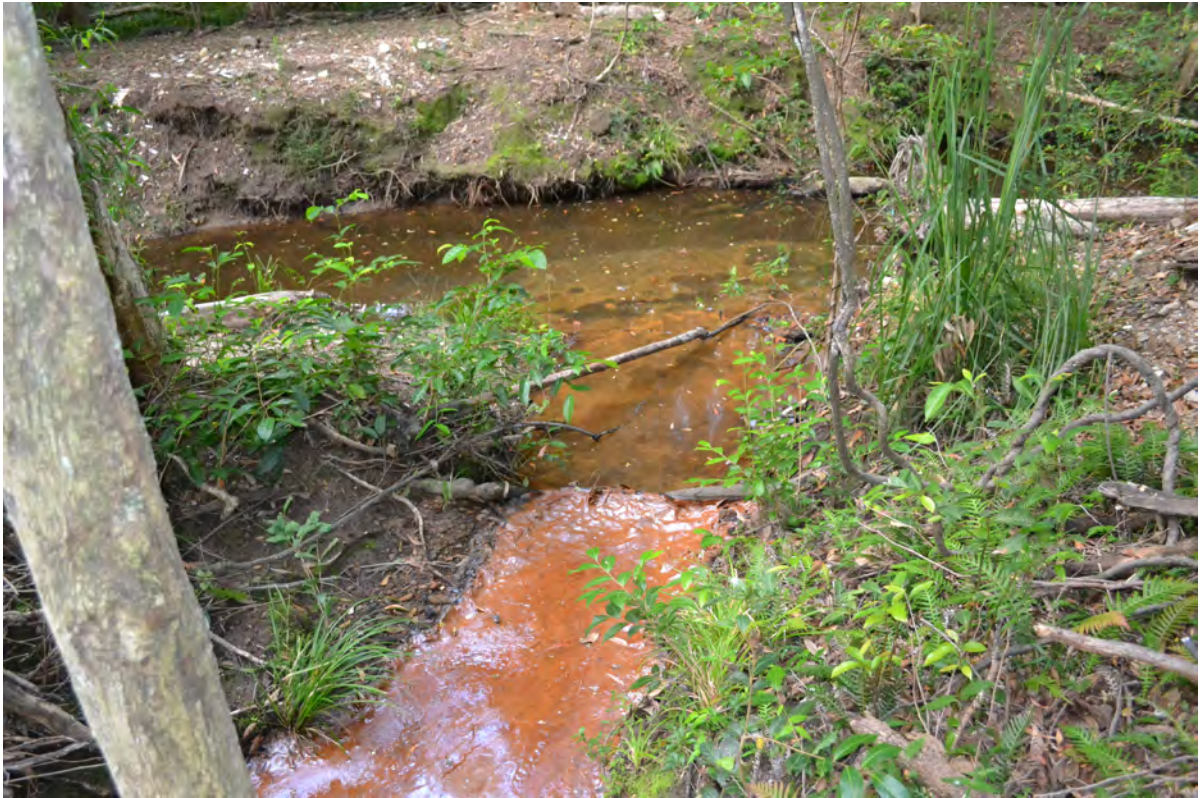
Whilst total metal concentrations in both the creek and feeder drainages were low, total manganese concentrations in the creek were less than 30 $\mu\text{g/L}$ whilst the sub-catchment waters had concentrations ranging from 66 to 632 $\mu\text{g/L}$. Total iron ranged between 90 to 690 $\mu\text{g/L}$ for most sites with 6060 $\mu\text{g/L}$ at the lower southern feeder creek site A3. This site, including the lower section of the creek to the confluence was also noted to have a very high iron bacteria/precipitate presence (Figure 3).

Figure 3 Confluence of Southern west to east sub-catchment drainage and Seven Mile Creek showing iron bacteria/precipitate in the sub-catchment drainage mixing with Seven Mile Creek drainage.
