TITLE: Site Boundary, Site Locality

Phase 2 Contamination Assessment

Lot 701, Deposited Plan 1154772, Gregory Hills Drive, Gledswood Hills

## Waste Analysis and Waste Classification Report

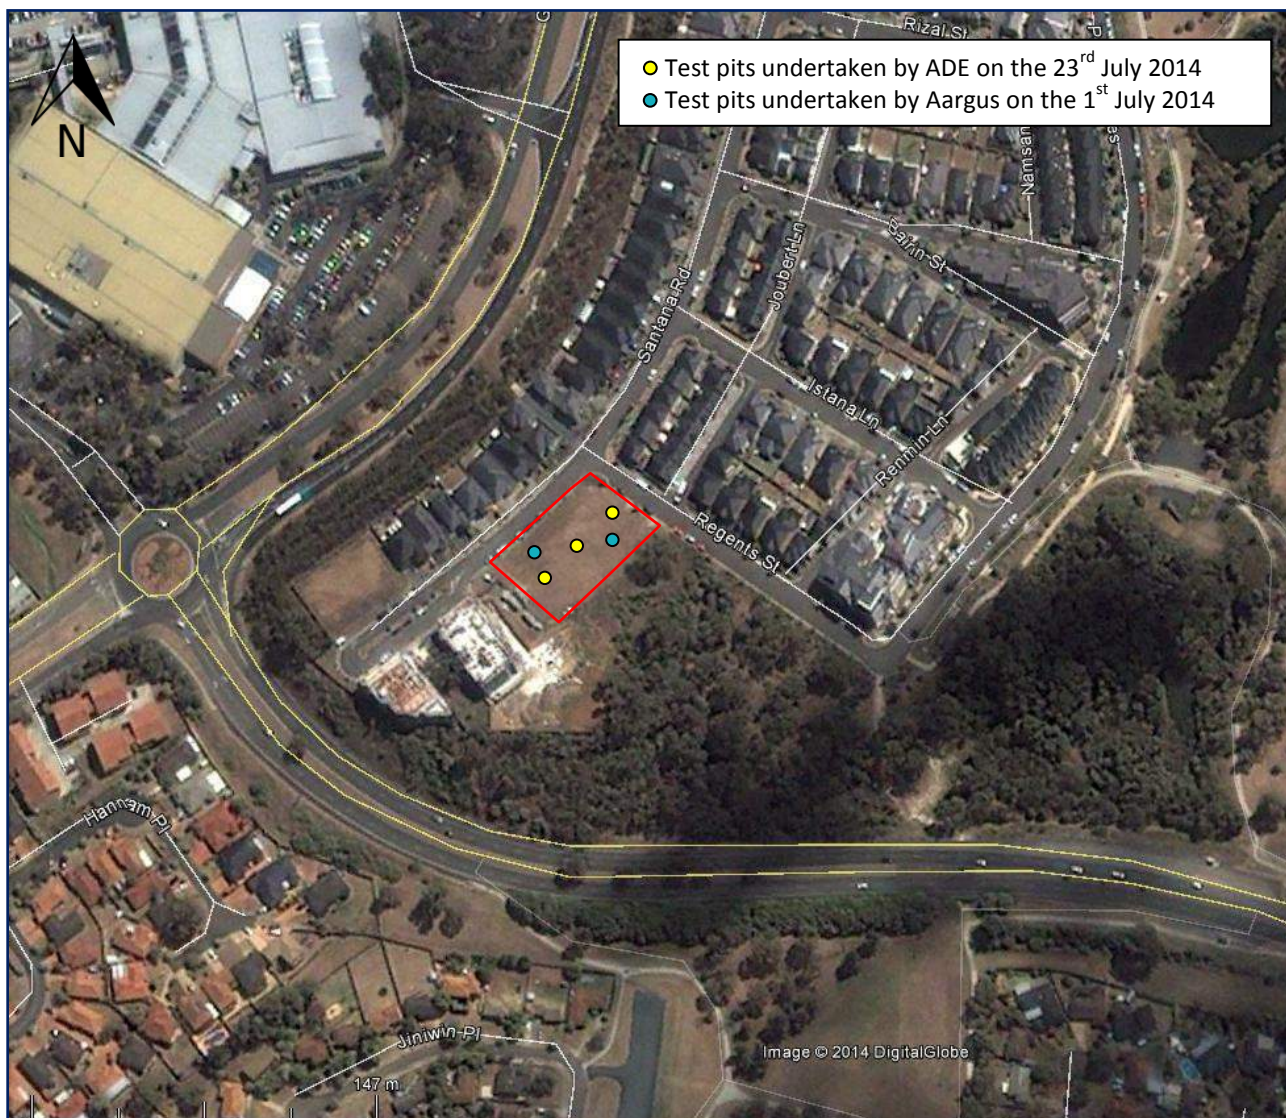
**Photograph 1.** Aerial photograph of the subject area, Lot 612, Corner of Regents St and Santana Road, Campbelltown NSW. Outline of site boundary and approximate test pit location. Map adapted: 'Google Earth 2014, date accessed 01.08.2014'.

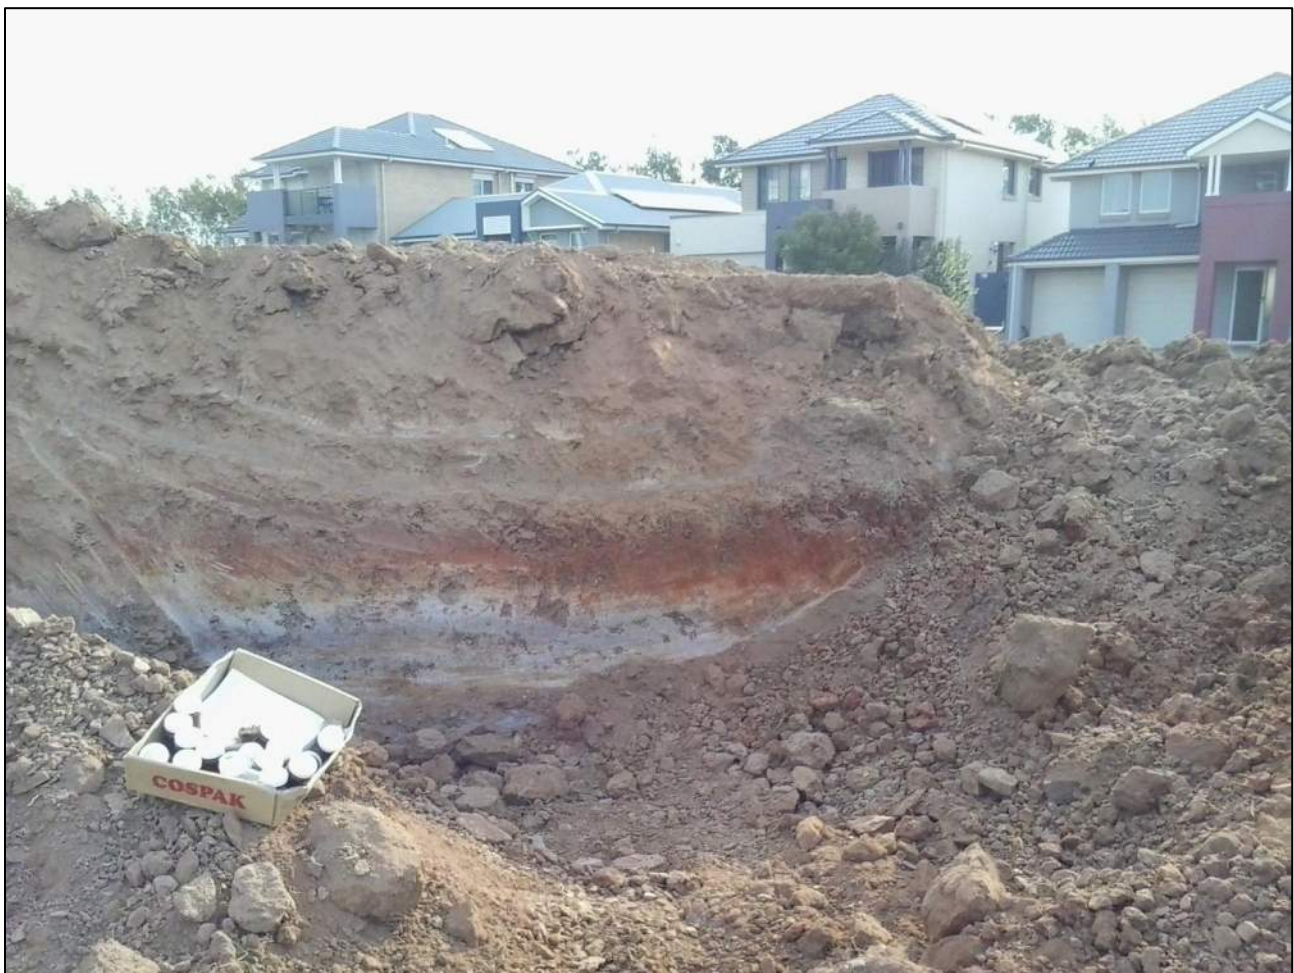
**Photograph 1** - Soil profile of test pit 3 undertaken by ADE on the 23rd of July 2014.
