Prepared for
Bettergrow Pty Ltd

Project 85126.03
August 2017

Douglas Partners <small>Geotechnics Environment Groundwater</small>	Site Photographs Proposed Resource Recovery & Recycling Centre 24 Davis Road, Wetherill Park	PROJECT: 85126.03
		PLATE No: 1
		REV: -
	CLIENT: Bettergrow Pty Ltd	DATE: 14-Jul-17

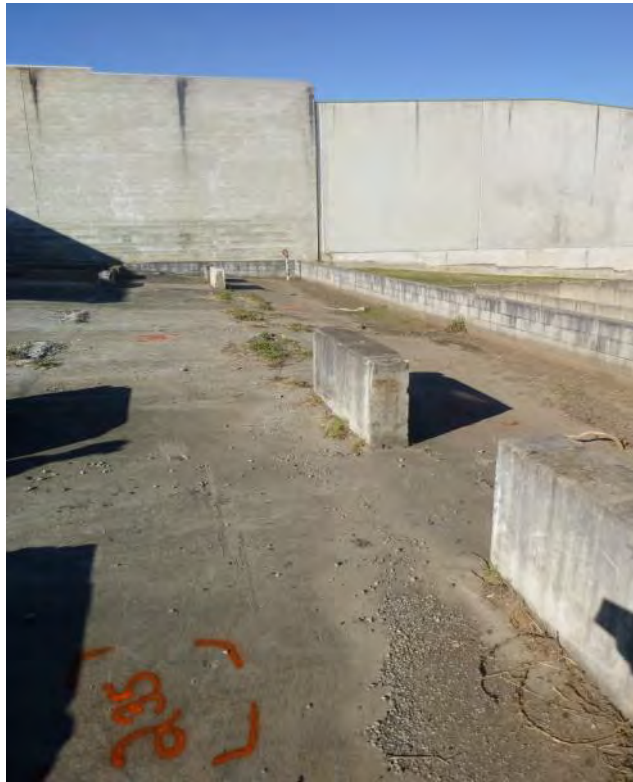
Photograph 1 - Remnant concrete stands for ASTs

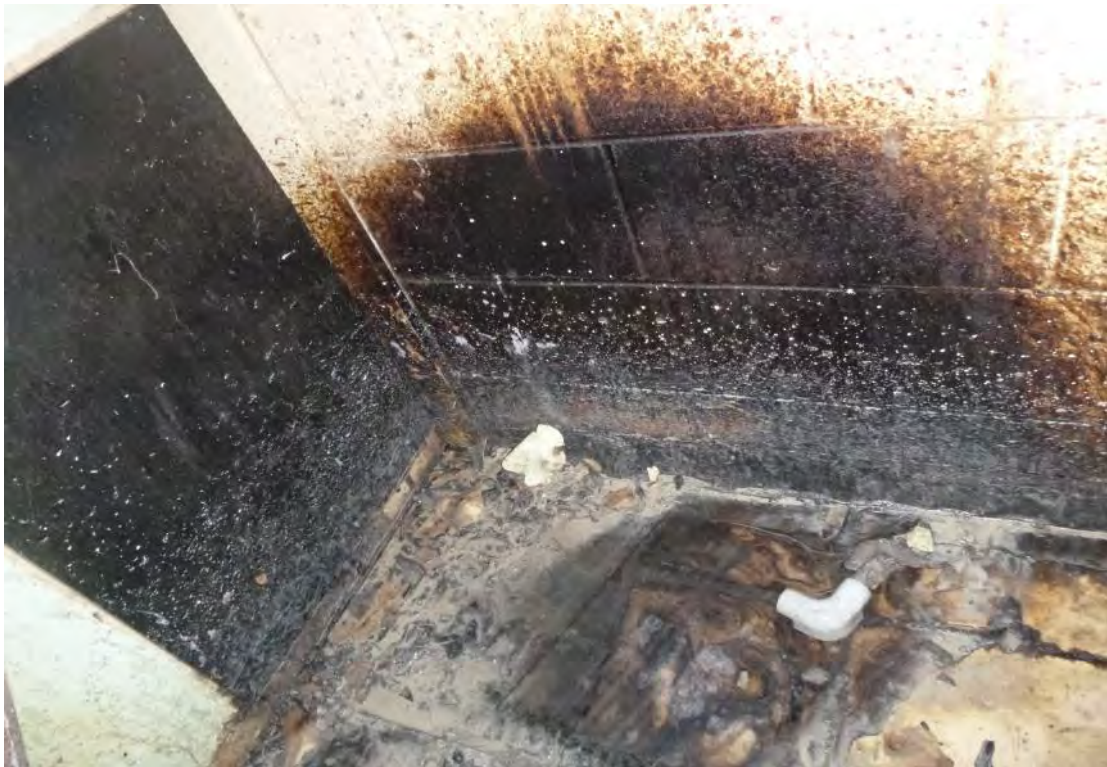
The laboratory building had old dilapidated work benches at the southern part of the building and a storeroom at the northern end. A relatively small patch of damaged and stained walls and floor was observed at the south-eastern corner of the building and may be indicative of a previous chemical fire (Photograph 2, Appendix B). Concrete slabs were observed in good condition.

Photograph 2 - Damaged and stained walls and floor in laboratory building

244	Near previous sample location SB104 where elevated TRH C ₁₀ -C ₃₆ in soil was identified (see Section 3.6).	Upper 0.5 m based on data from URS.
245	At stained/fire-damaged part of former laboratory.	Near surface soils (beneath concrete slab)

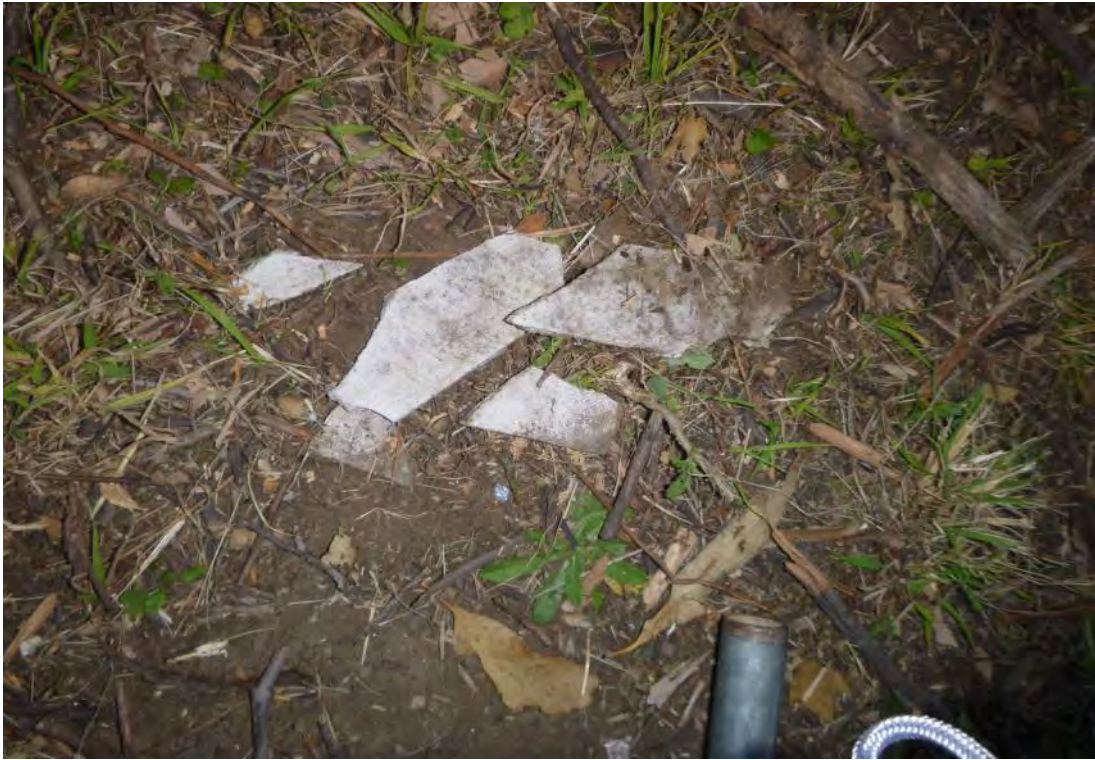
A small cluster of five fibre-cement pieces was observed on the ground surface at the landscape area at the south of the site (immediately next to Bore 201) (Photograph 3, Appendix B). The pieces ranged from 4 cm to 13 cm in length and were observed to be in good (bonded) condition. The pieces were collected as a sample (labelled 'A1'). The surrounding garden area was inspected for similar materials, however, none were observed. Other litter, such as pieces of tile and plastic, were observed on the ground surface in this area. Given the close proximity of the fibre-cement to Davis Road, the observed general litter and the absence of structures at this part of the site, it is considered that the fibre-cement was probably sourced from fly-tipping. Also, it is noted that the landscape area at the front of the site is not completely fenced-off to the public as the lockable gate is set back from the southern site boundary.

Photograph 3 - Cluster of fibre cement fragments

- J The soil sample from the surface of Bore 201 was analysed for asbestos as it was immediately next to the observed fibre-cement on the ground surface (that was analysed for asbestos as sample A1).
