Report on
Geotechnical Investigation

Proposed Australia Habitat and Taronga Wildlife
Retreat
Bradleys Head Road, Mosman

Prepared for
Taronga Conservation Society Australia

Project 73876.01
March 2016

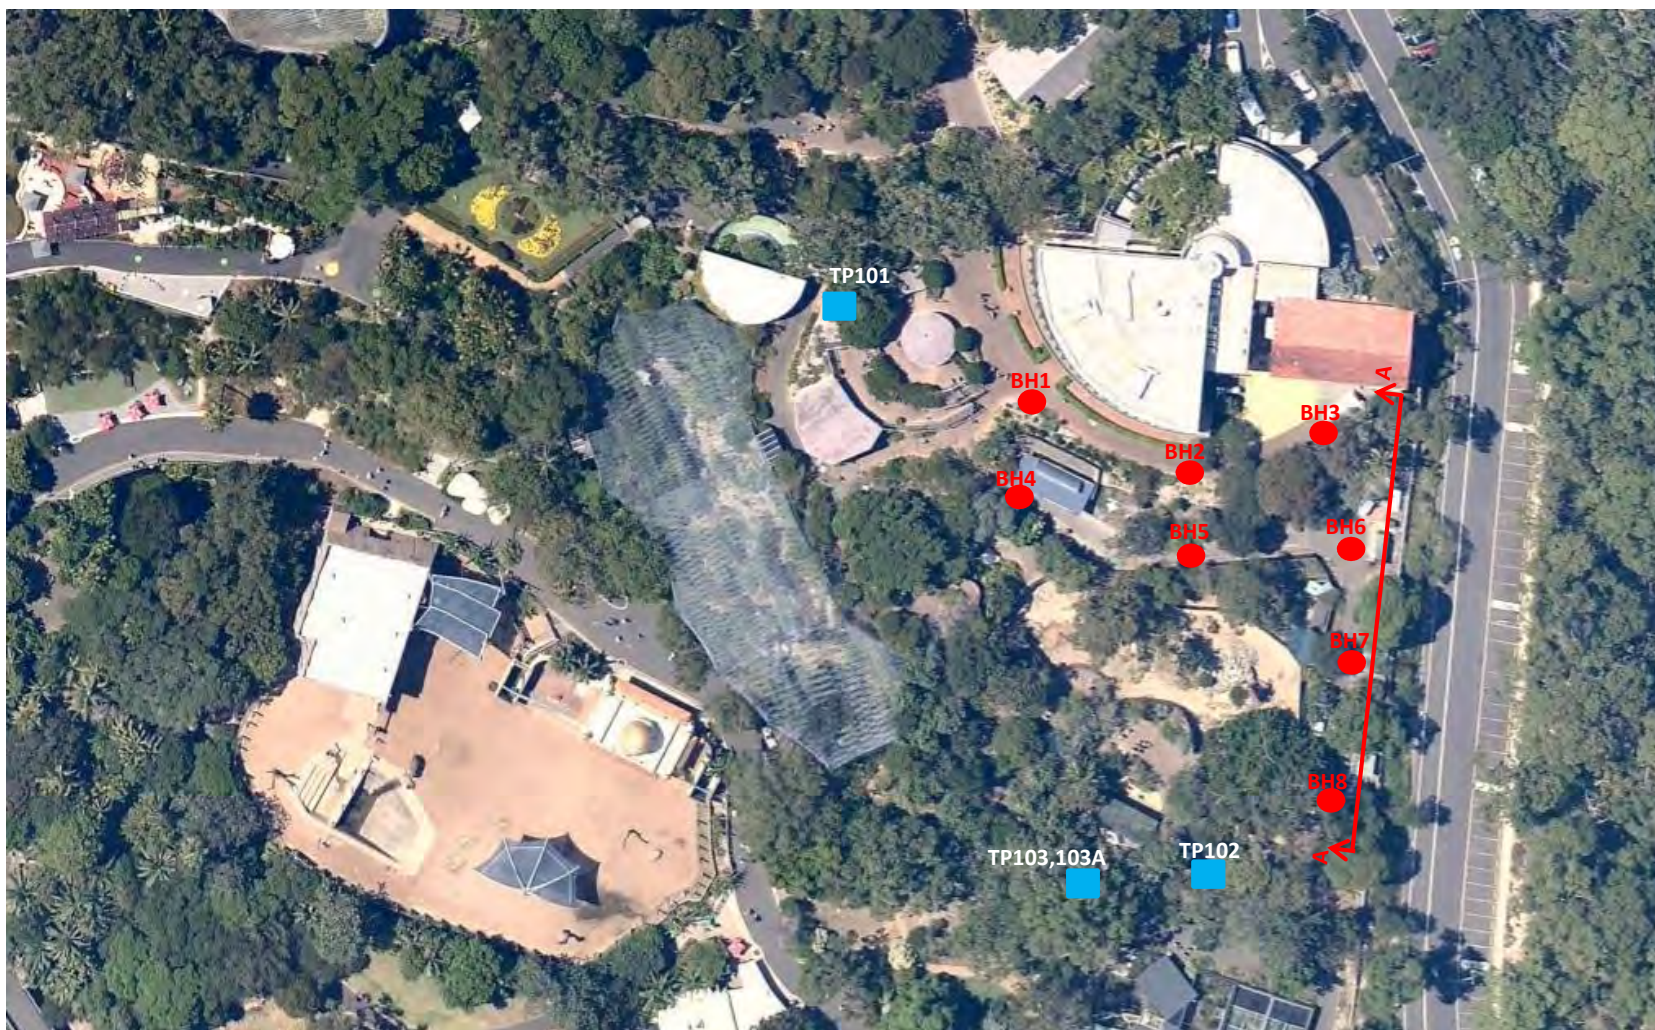
DRAWING
No: 1

Cored Borehole
