Remedial Action Plan

Western Sydney Stadium Redevelopment
Confidential Privileged Communication

31 March 2017

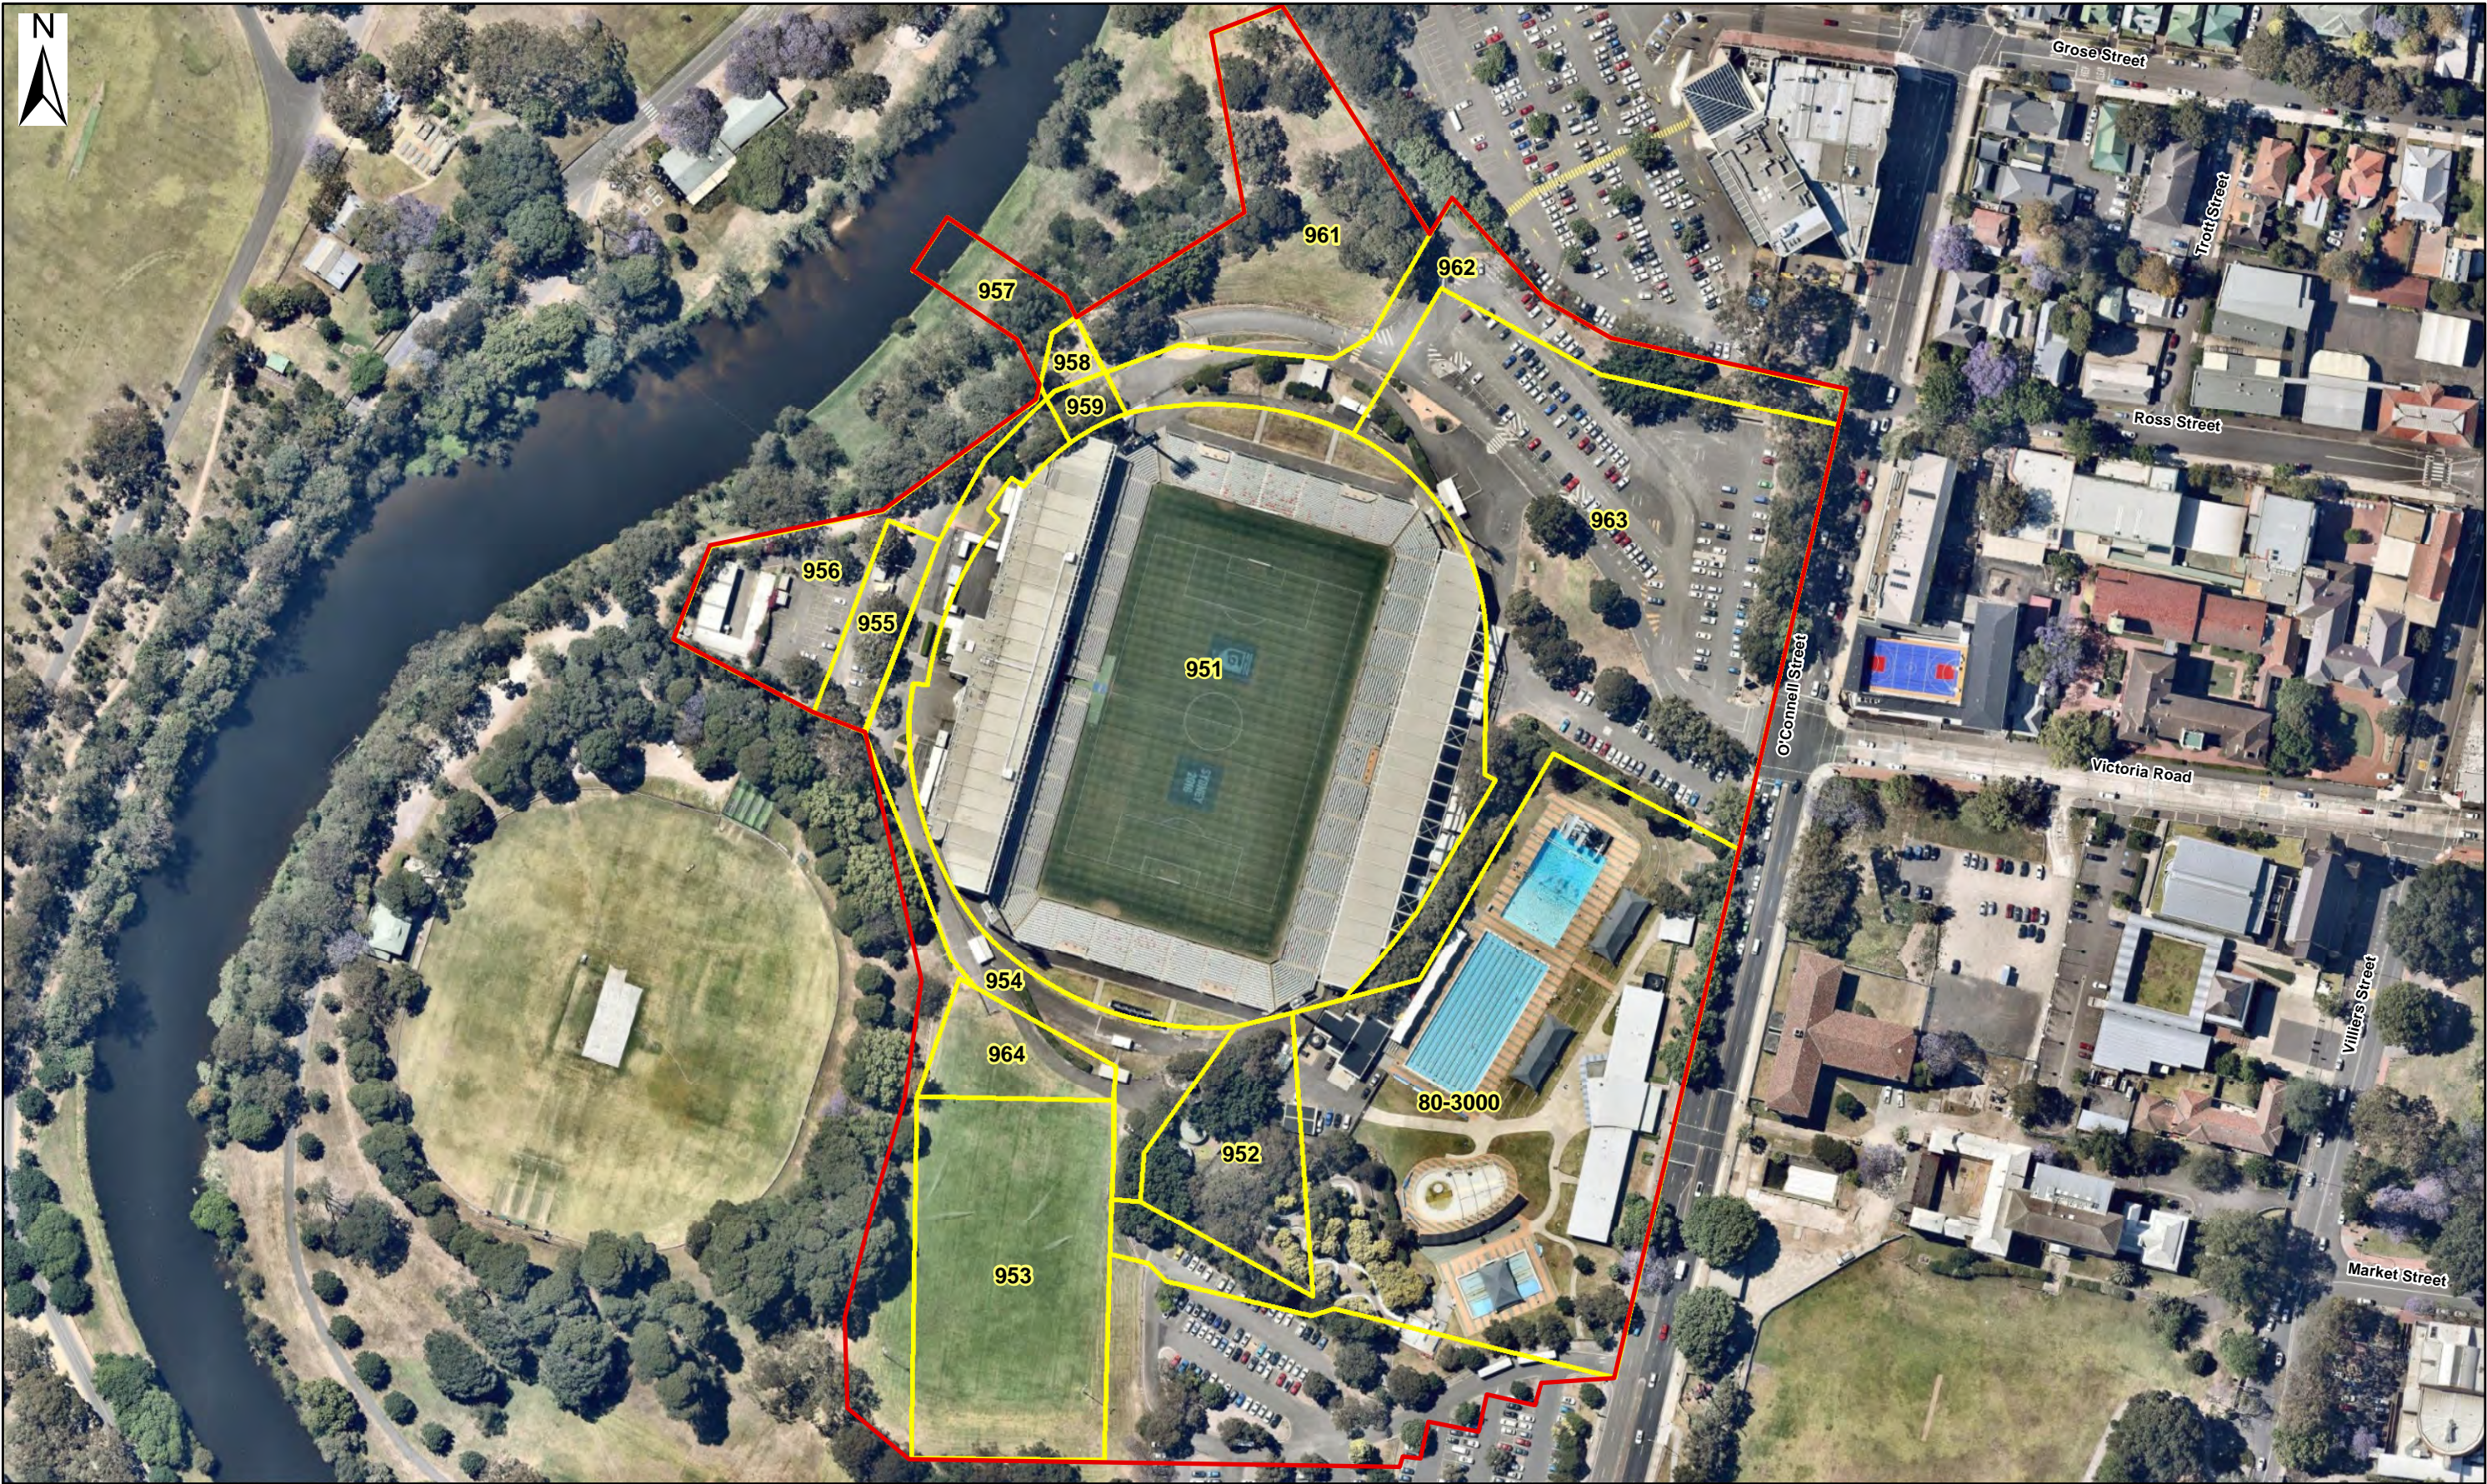
Figure 5: Areas Requiring Remediation

The location of these areas is illustrated within **Figure 5**.
