**Re: Western Sydney Stadium: S96, Submission Response
Historical Archaeology**

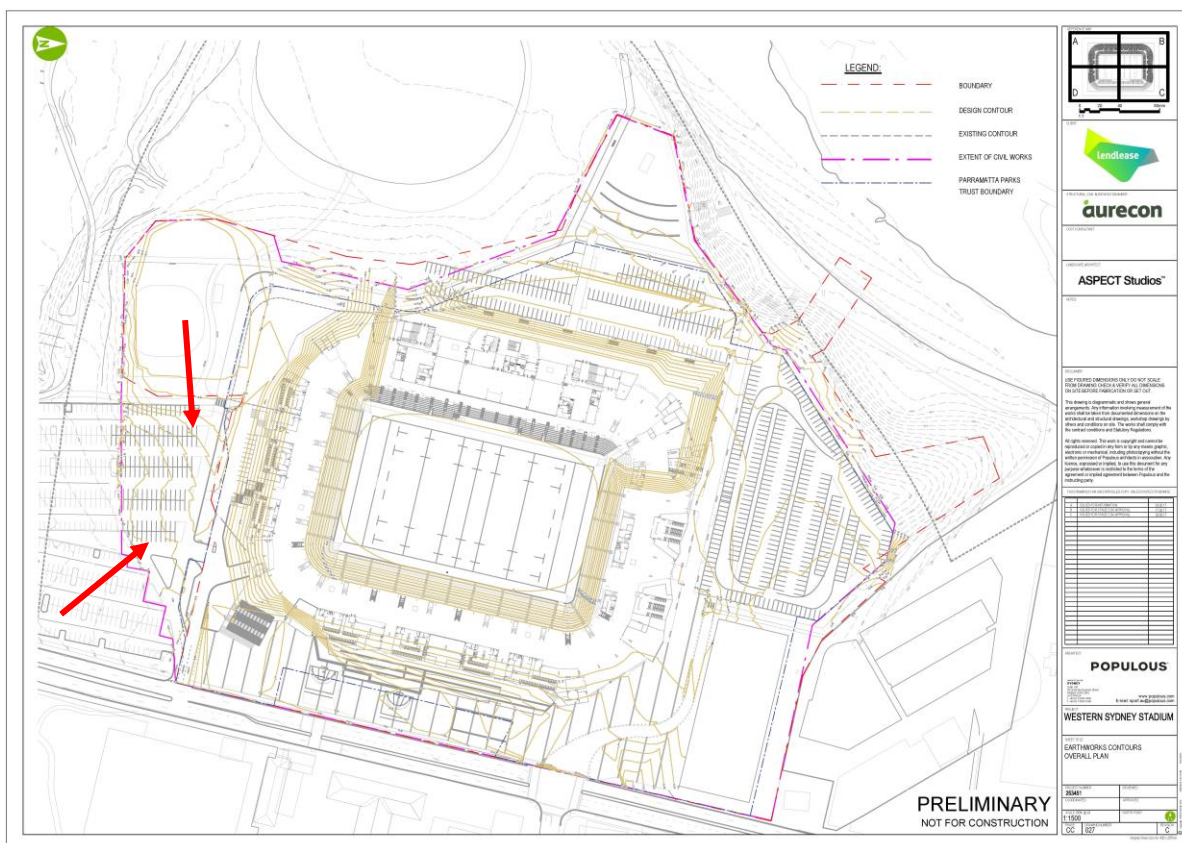
Figure 1: Plan of the Western Sydney Stadium showing the area to be included in Modification 1.

- In the Stage 2 application we identified the subject area to be within a State Heritage Register area (SHR:00596) and outside of the Stage 1 EIS boundary (Figure 1, See report, Section 2.0, Figure 2.6).
- It is outside of the National Heritage-listed curtilage of Old Government House and Government Domain (see report, Section 2.0, Figure 2.3).
- It is outside of the World Heritage Area (WHA) and the nearby buffer zone but its values are similar to those included with the WHA (see report, Section 2.0, Figures 2.1, 2.2, 2.3). The works are within a zone of high sensitivity in relation to the WHA (Report, Figure 2.4).
- An Archaeological Research Design (ARD) was written outlining an appropriate methodology to manage the remediation and retain the archaeological significance of the Government Farm and its full range of archaeological values.

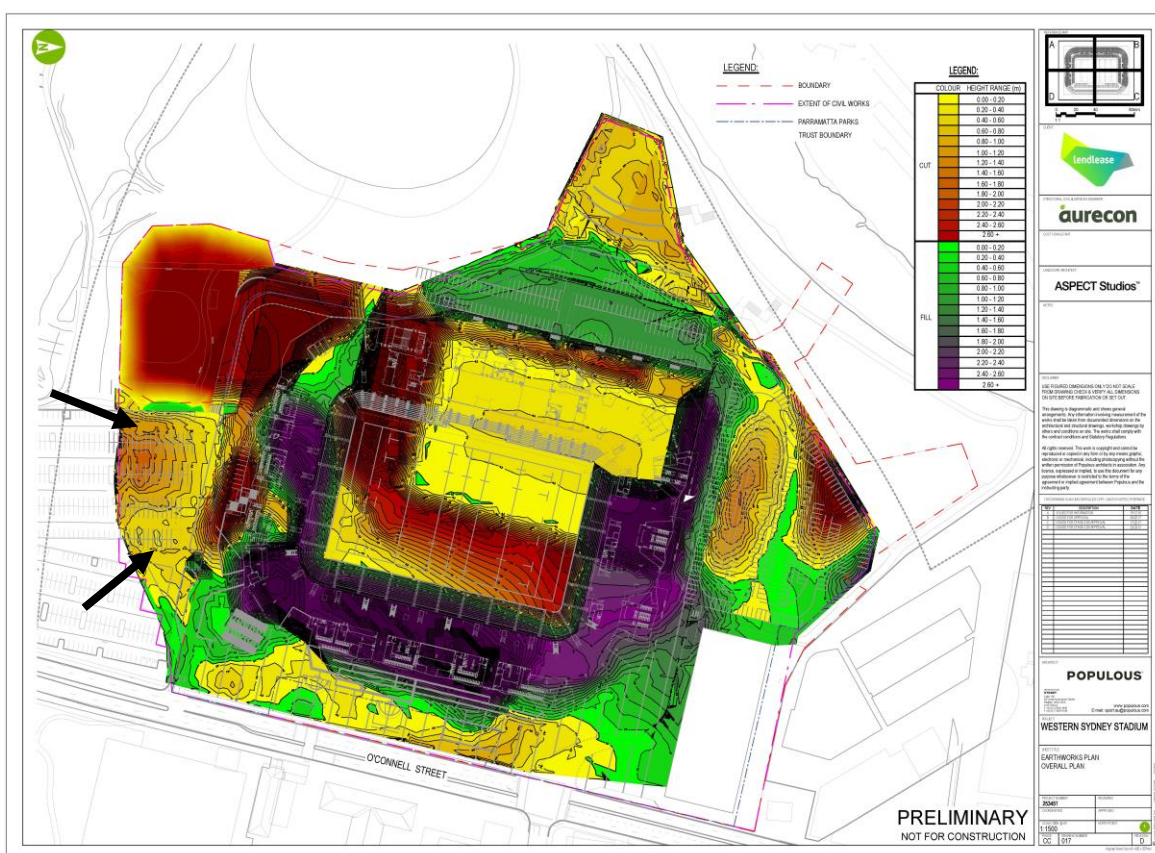
Figure 2: Plan of bulk excavation showing the subject area, with excavation up to 1.4m deep in the southern area.

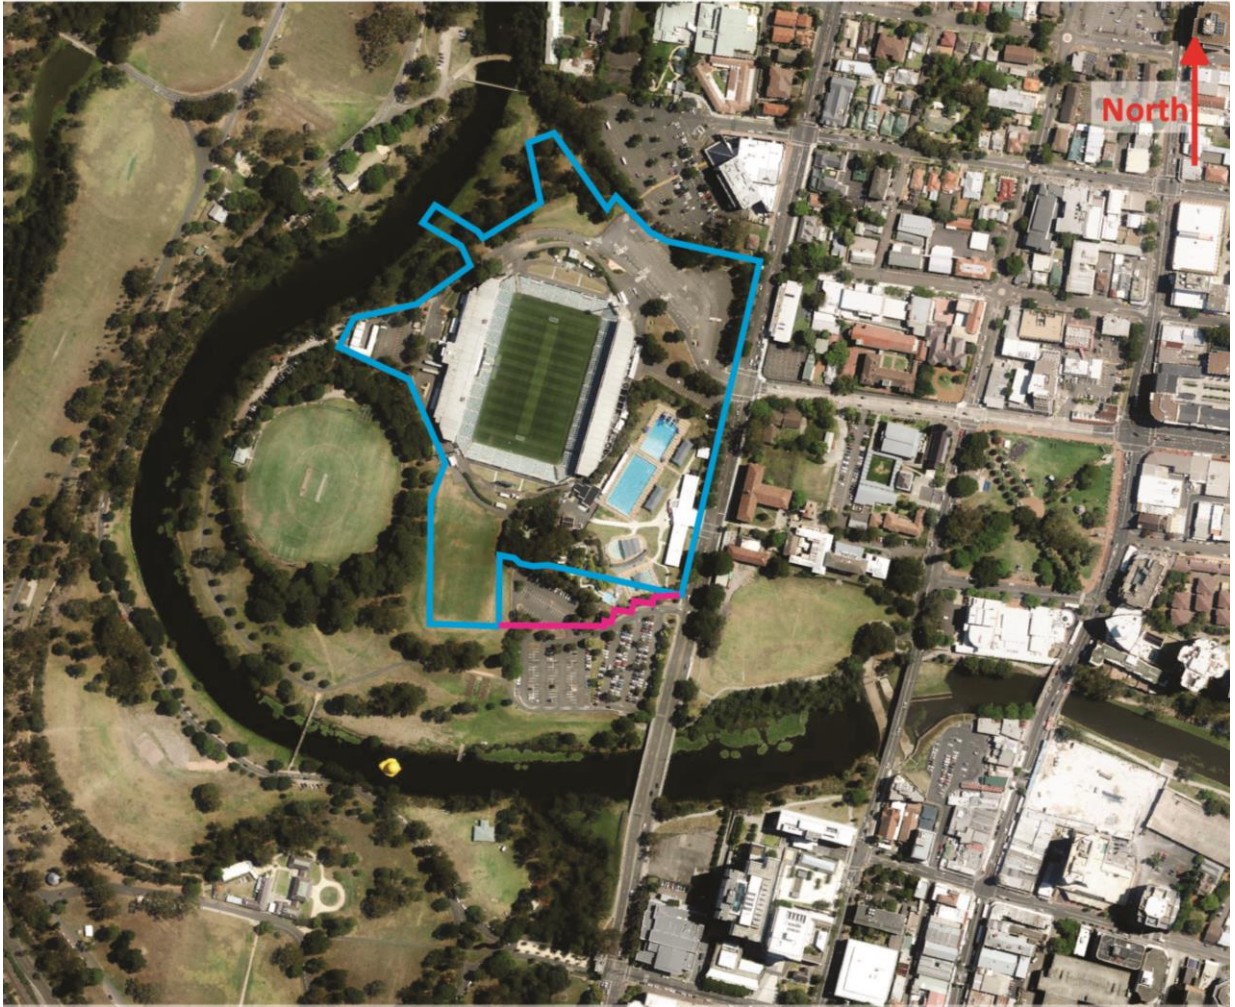
Figure 3: The southern area bounded by the pink line is the subject area. It is mostly within a Parramatta Park Trust carpark.

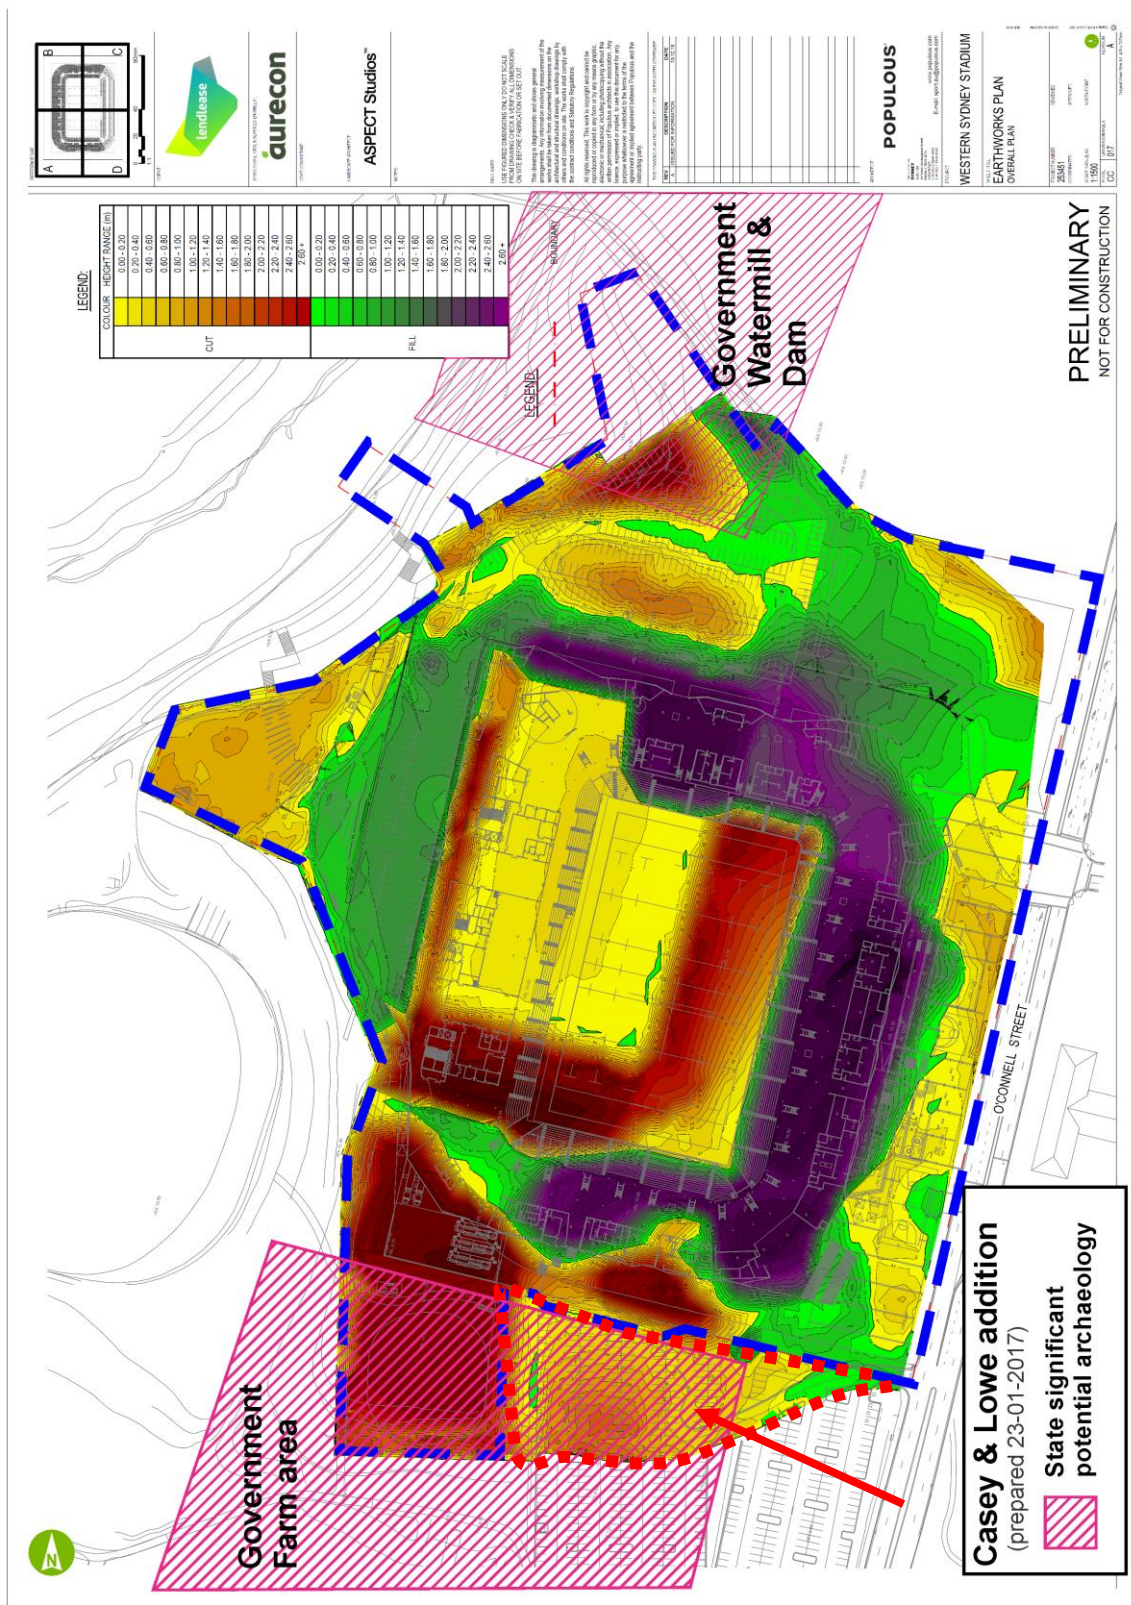
Figure 4: Bulk excavation plan showing the location of the subject area to be included in Mod 1 and the curtilage of the Government Farm.

The subject area includes part of the State-significant Government Farm which is considered to have national significance (Figure 4). The heritage values of the subject site are discussed in Section 5 of the report. The proposed impacts on Historical Archaeology by the remediation are set out in Section 10.1.1 and relate to areas containing asbestos. Understanding of the
