CONSERVATION MANAGEMENT PLAN

ROMLA AND FRELIN
86 AND 87 DARLINGTON ROAD
DARLINGTON

UNIVERSITY OF SYDNEY

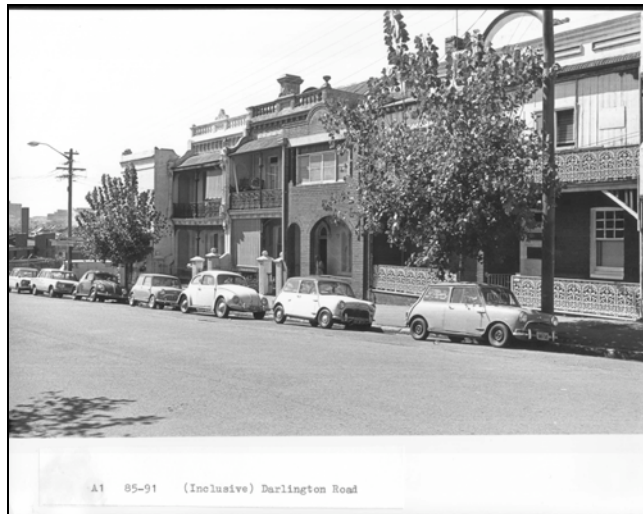
Figure 15: View of 85-90 Darlington Road, including Romla and Frelin.
(Source: University of Sydney Archives, G74/4 Buildings and Grounds Photograph Albums Item 4 - 9 Acres in Darlington, items A1, F1, F2. Undated (c 1970s).)

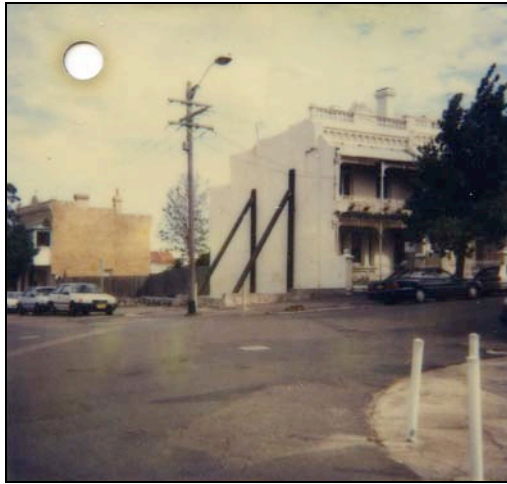
Figure 17: Photograph showing 86 Darlington Road in 1992 before alterations and additions were undertaken to the rear. (Source: University of Sydney Archives: Buildings/alterations and additions/85 Darlington Road corner Codrington Street, Ref: 062/00240087).

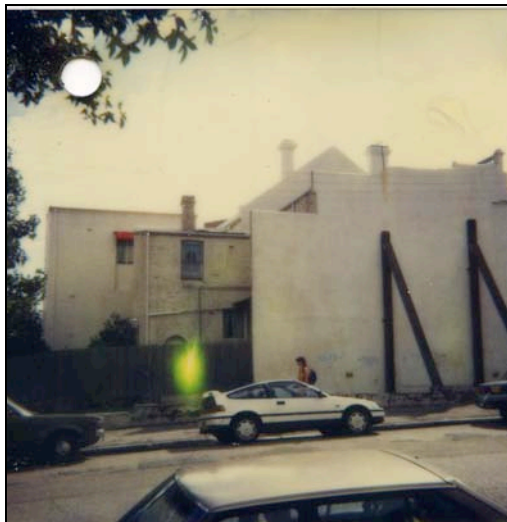
Figure 18: Photograph showing east elevation of 86 Darlington Road in 1992 before alterations and additions were undertaken to the rear. (Source: University of Sydney Archives: Buildings/alterations and additions/85 Darlington Road corner Codrington Street, Ref: 062/00240087).

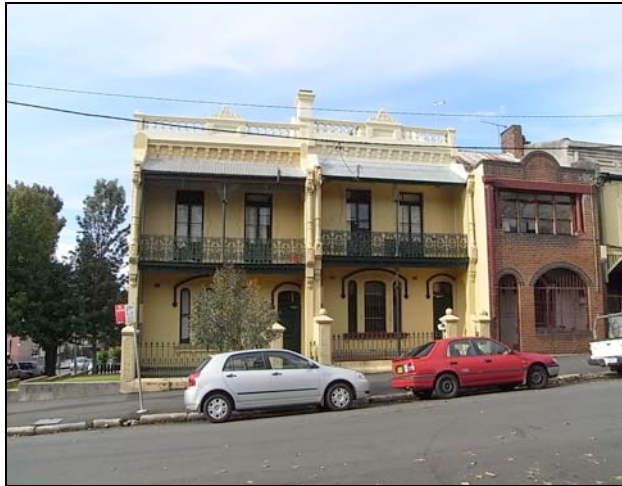
Romla and Frelin are a pair of two storey rendered masonry terrace houses, built in the Victorian Filigree style with Victorian Italianate qualities. The houses have many cast iron lacework features, including verandah posts, balustrading, brackets and valances. The terraces have elaborately decorative roof parapets and one original chimney remains above the roofline of Frelin, although it is missing its chimney pots (speculation).

Figure 19: Romla and Frelin. (Source: Heather Godfrey, April 2008.)

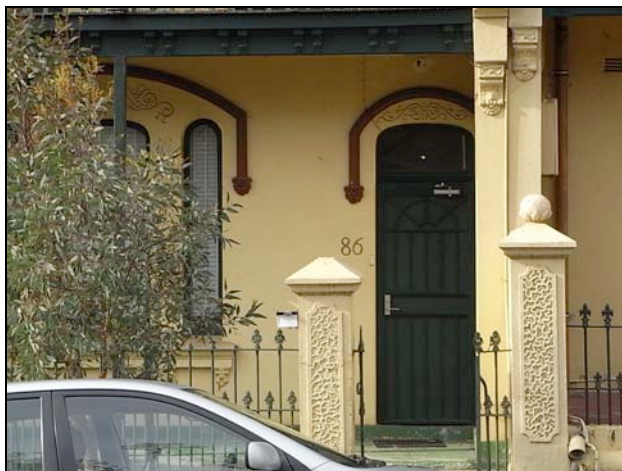
Between the moulded stuccoed front fence piers which have applied panels of vermiculation facing the street, runs a cast and wrought iron palisade fence with cast iron Fleur-de-Lys finials.

Figure 20: The front fence piers and front gate to the main entrance of Romla. Note that the orb on the left pillar is missing. (Source: Heather Godfrey, April 2008.)

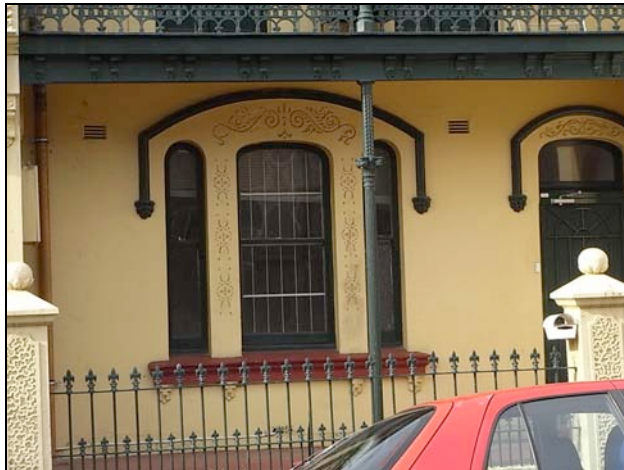
The ground floor windows comprise a double hung sash set into a shallow segmental arch with rounded corners and a flanking pair of double hung sashes to each side with semi-circular heads. The three front windows terminate on a moulded sill with decorative brackets below. The mullions between the windows and the panel above the central sash have incised decoration in the stuccoed render, sitting below a label moulding above the three windows. A label moulding enclosing a panel of incised decoration sits above the front door fanlight. Like the central window, it sits within a shallow segmentally arched opening which is rounded at the corners.

Figure 21: Detail of the ground floor windows to the front elevation of Frelin.
(Source: Heather Godfrey, April 2008.)

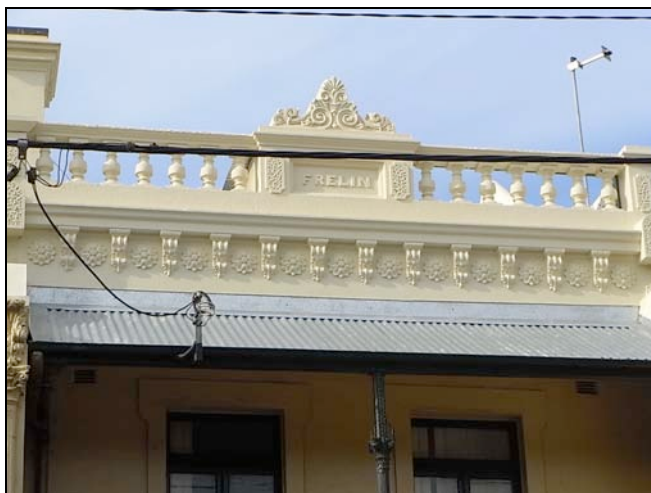
Figure 22: Detail of Frelin's roof wall parapet.
(Source: Heather Godfrey, April 2008.)

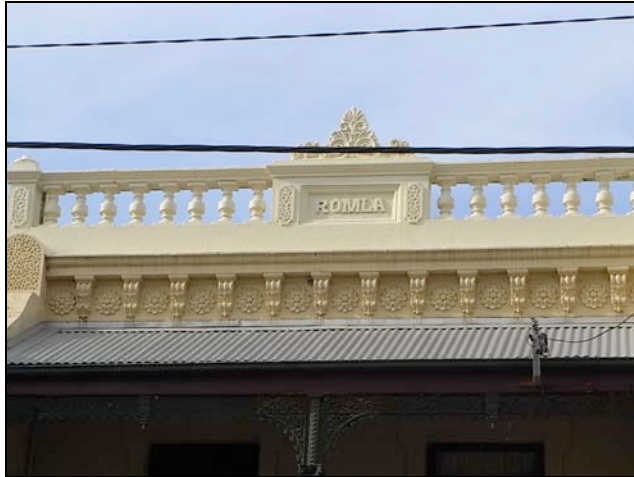
Figure 23: Detail of Romla's roof wall parapet.
(Source: Heather Godfrey, April 2008.)

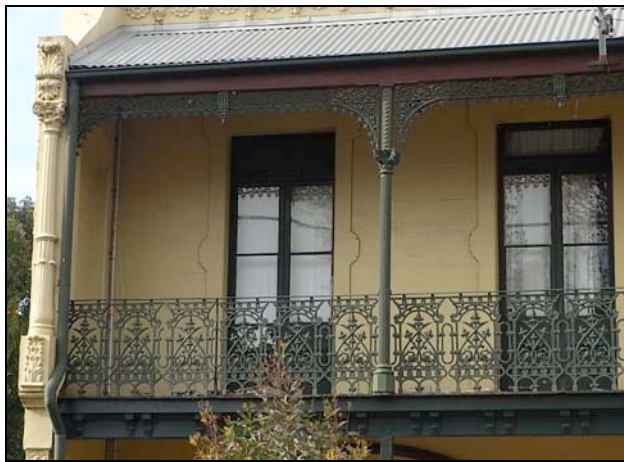
Figure 24: Detail of the first floor party wall and the decorative cast iron lacework on Romla's verandah. (Source Heather Godfrey, April 2008.)

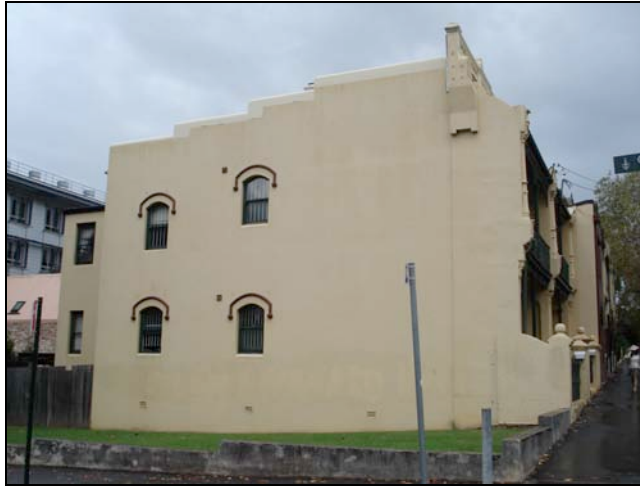
Figure 25: The eastern elevation of Romla. Note the four window openings with replica label mouldings over. (Source: Luis Abarca- Ibaceta, April 2008.)

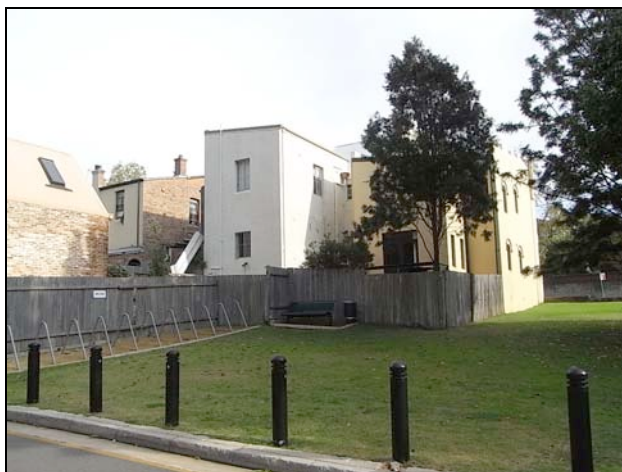
Figure 26: Rear wings to Romla and Frelin and vacant land at 19-20 Codrington Street. (Source: Heather Godfrey, April 2008.)

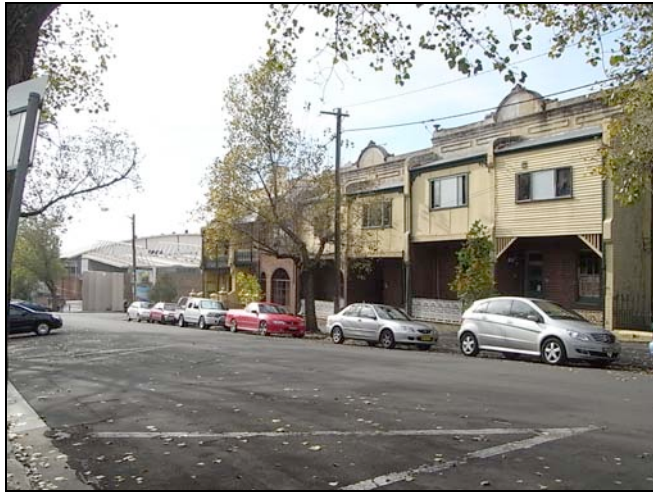
Figure 28: View of the subject site from the rear gate to the Merewether and Institute buildings on the northern side of Darlington Road. (Source: Heather Godfrey, April 2008.)

1. View of the subject from the corner of Darlington Road and Butlin Avenue (Figure 30);
2. Darlington road streetscape view;
3. View of the subject from the northern side of Darlington road (Figure 28);
4. View from the subject to the rear gate of the Merewether and Institute buildings (Figure 29);
5. View of the subject from the raised car parking area to the south of the Merewether building;
6. View from the subject to the Biochemistry and Microbiology building (Figure 31); and
7. View along Darlington Lane (Figure 32).

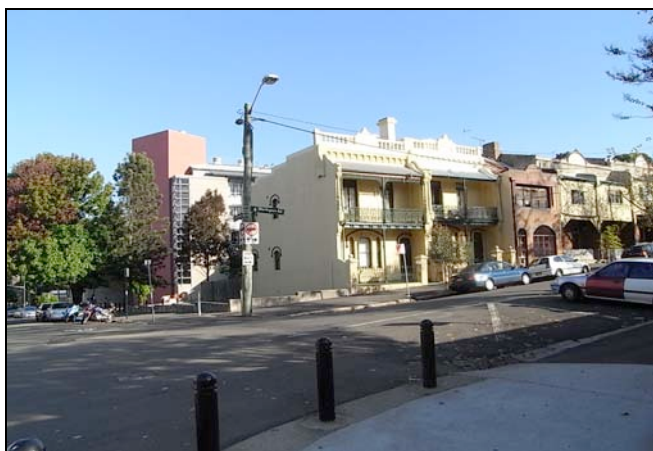
Figure 30: View of the subject site from the corner of Darlington Road and Butlin Avenue. Note the scale and bulk of the new Economics and Business Faculty building to the rear of the subject site. (Source: Heather Godfrey, April 2008.)

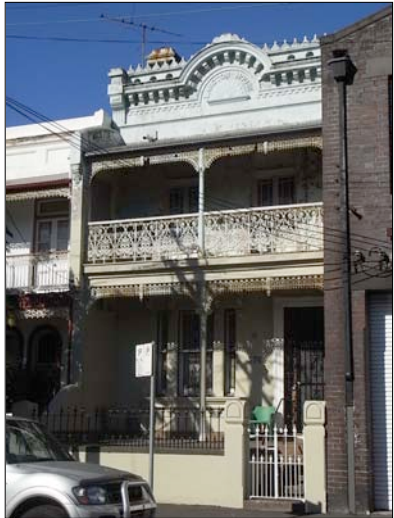
324 and 326 Wilson Street, Darlington	This pair of terraces has simpler parapet detail and smaller front verandahs. The terraces have rectangular, rather than arched windows.

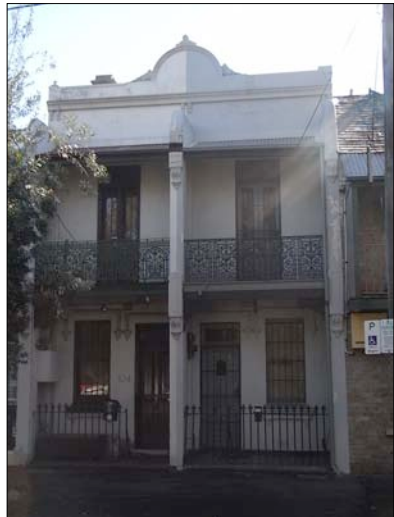
52 Lander Street, Darlington	This terrace has very simple parapet detailing and less elaborate detailing in comparison with the subject terraces. It also has rectangular, rather than arched fenestration.

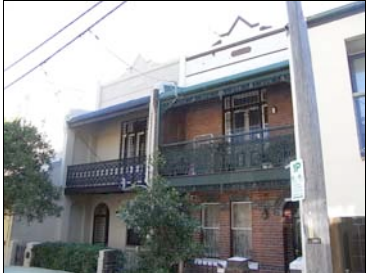
Address	Description	Photograph
14 and 16 Lander Street, Darlington.	This pair of terraces has simpler parapet detailing and No. 16 Lander Street has a face brick façade.

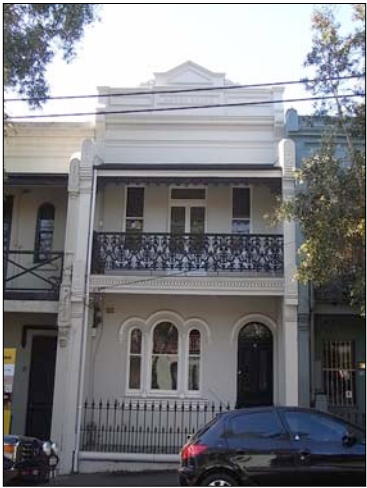
10 Ivy Street	This terrace house has similar lacework on the first floor verandah to the subject terraces. The arched fenestration with Italianate labels above the windows are also very similar to the subject terraces.

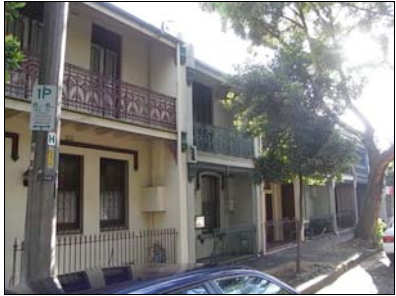
Table 12: Examples of Victorian Terrace House Streetscapes		
Address	Description	Photograph
Calder Street, Darlington	Calder Street was subdivided from Hutchinson's grant. Terraces line both sides of the street. This row has not been subject to the intrusive addition of sleep-outs. Large street trees line the pavement and contribute to the landscaped character of the streetscape.

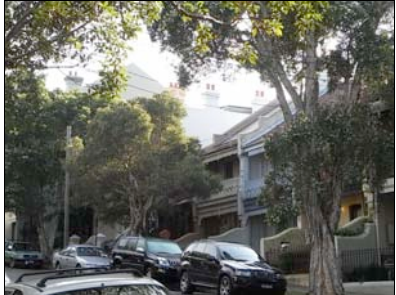
Forbes Street, Newtown	Forbes Street, Newtown was part of the Golden Grove subdivision in the 1880s. This street comprises terraces grander in scale and detailing compared to Darlington Road. They are set back further from the pavement and large street trees dominate the streetscape. They tend to have pitched corrugated iron roofs rather than flat roofs behind a parapet.

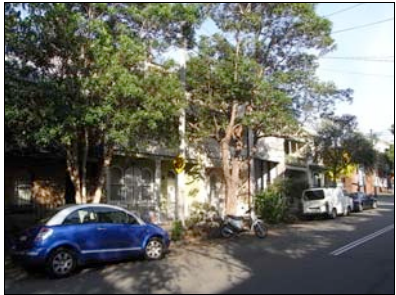
Myrtle Street, Chippendale	Myrtle Street, Chippendale was subdivided in the 1880s from Shepherd's Nursery. It is similar to Darlington Road except the terraces are built more closely to the pavement and there is a lack of landscaping to the front of the properties. Iron filigree detailing of the terraces and street trees dominate the character of this row. This row has not been affected by the intrusive addition of sleep outs to the terrace.

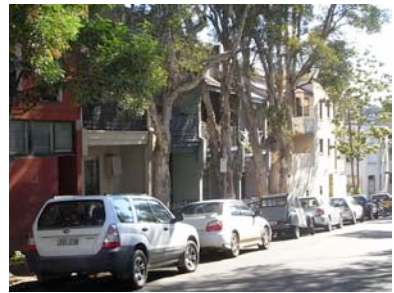
Address	Description	Photograph
Shepherd Street, Darlington	Shepherd Street, Darlington was subdivided in the 1880s from Shepherd's Nursery. It is similar to Darlington Road, except the terraces are built more closely to the pavement. There are significant street tree plantings to the front of the properties which dominate the character of the row. Cast iron filigree detailing of the terraces is a common feature of the row.

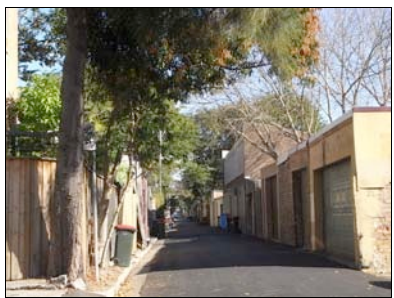
Address	Description	Photograph
Wilson Lane, Darlington	This lane is typical of rear lane development of Victorian suburbs. Garages have provided vehicle access to the terraces.

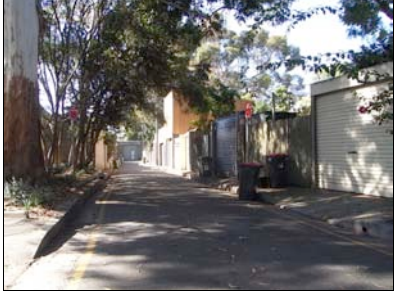
Table 13: Examples of Laneway Development in Darlington (continued)		
Address	Description	Photograph
Calder Lane, Darlington	This lane is also typical of rear lane development of Victorian suburbs.

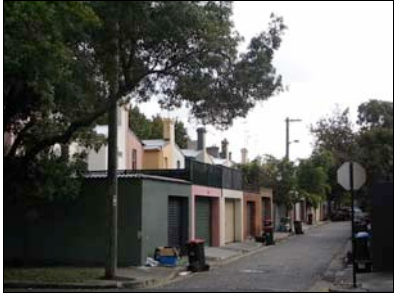
Kepos Lane, Redfern	This lane is typical of rear lanes in late Victorian suburbs and in this case, the rears of the terrace houses have retained their almost homogenous original profiles.

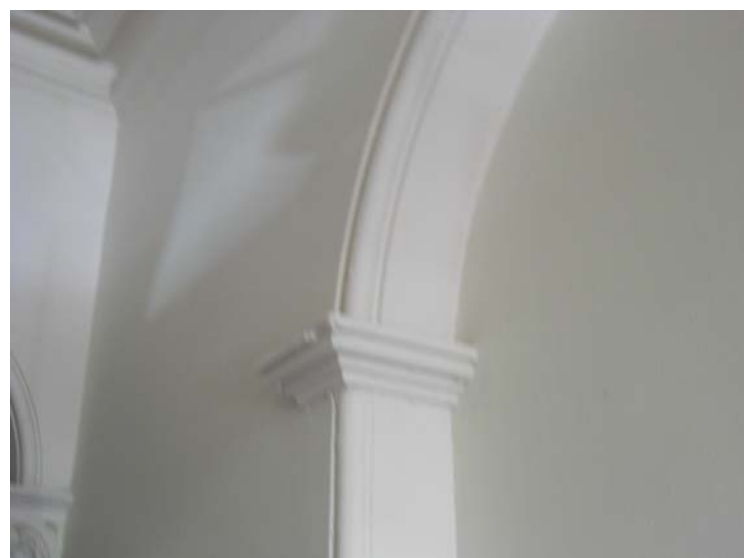
2. Arch in party wall

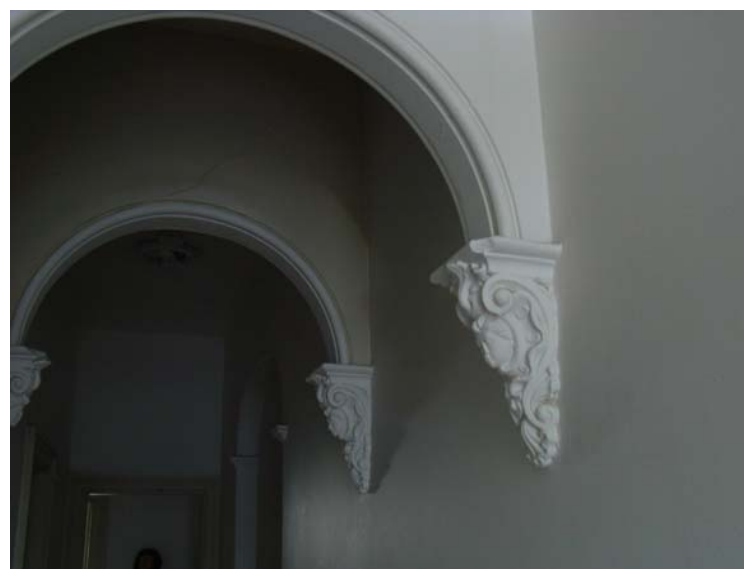
5. Hall arches

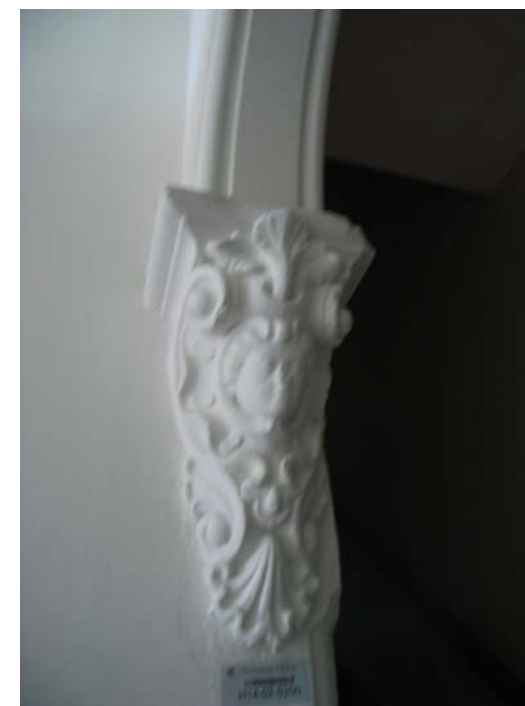
6. Corbel in hallway

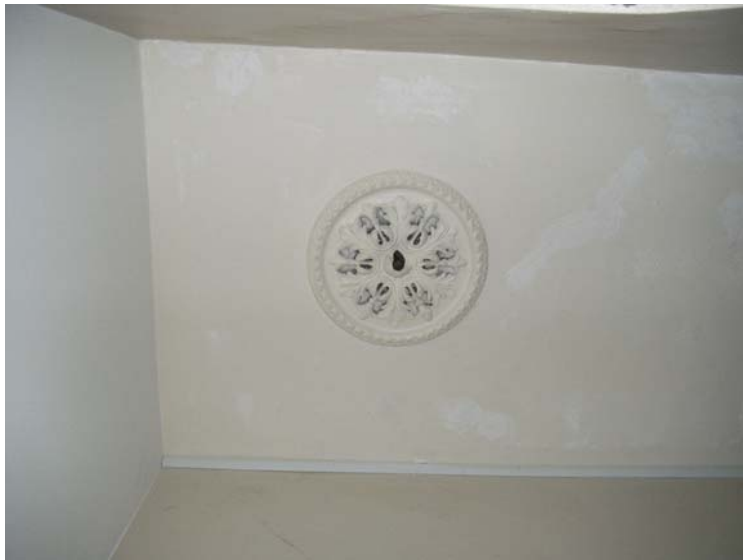
7. Small ceiling rose

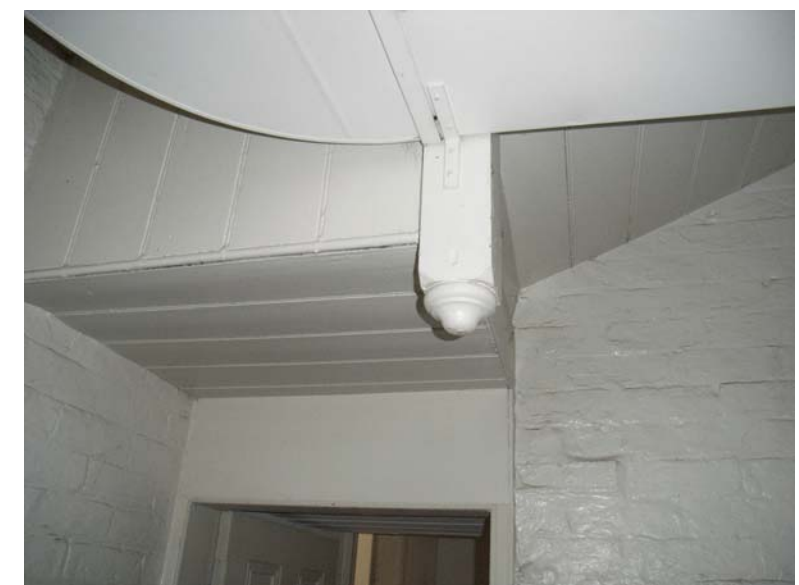
12. Under rear staircase

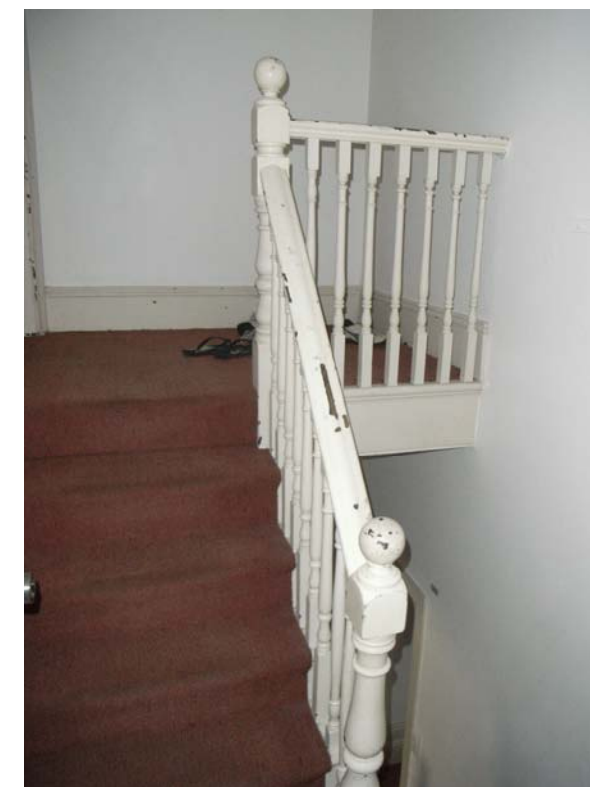
15. Rear staircase balustrade

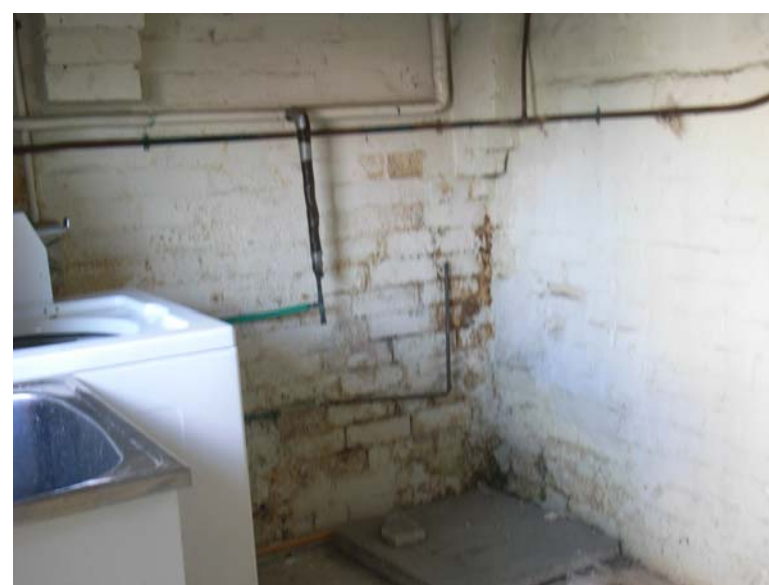
17. Rear Laundry (rising damp)

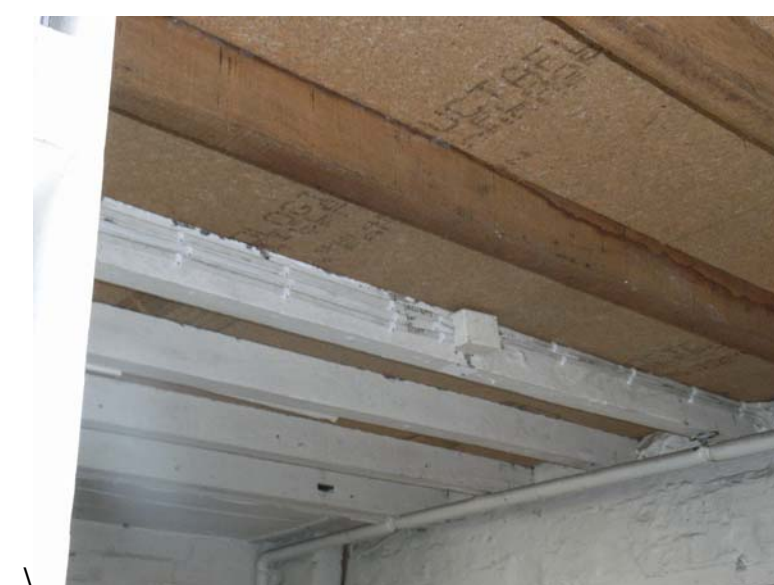
18. New ceiling to rear laundry
