Remedial Action Plan

Dooley's Catholic Club & Hotel Development,
Olympic Drive, Lidcombe NSW

29 June 2016

GEOTLCOV25554AA-AJ

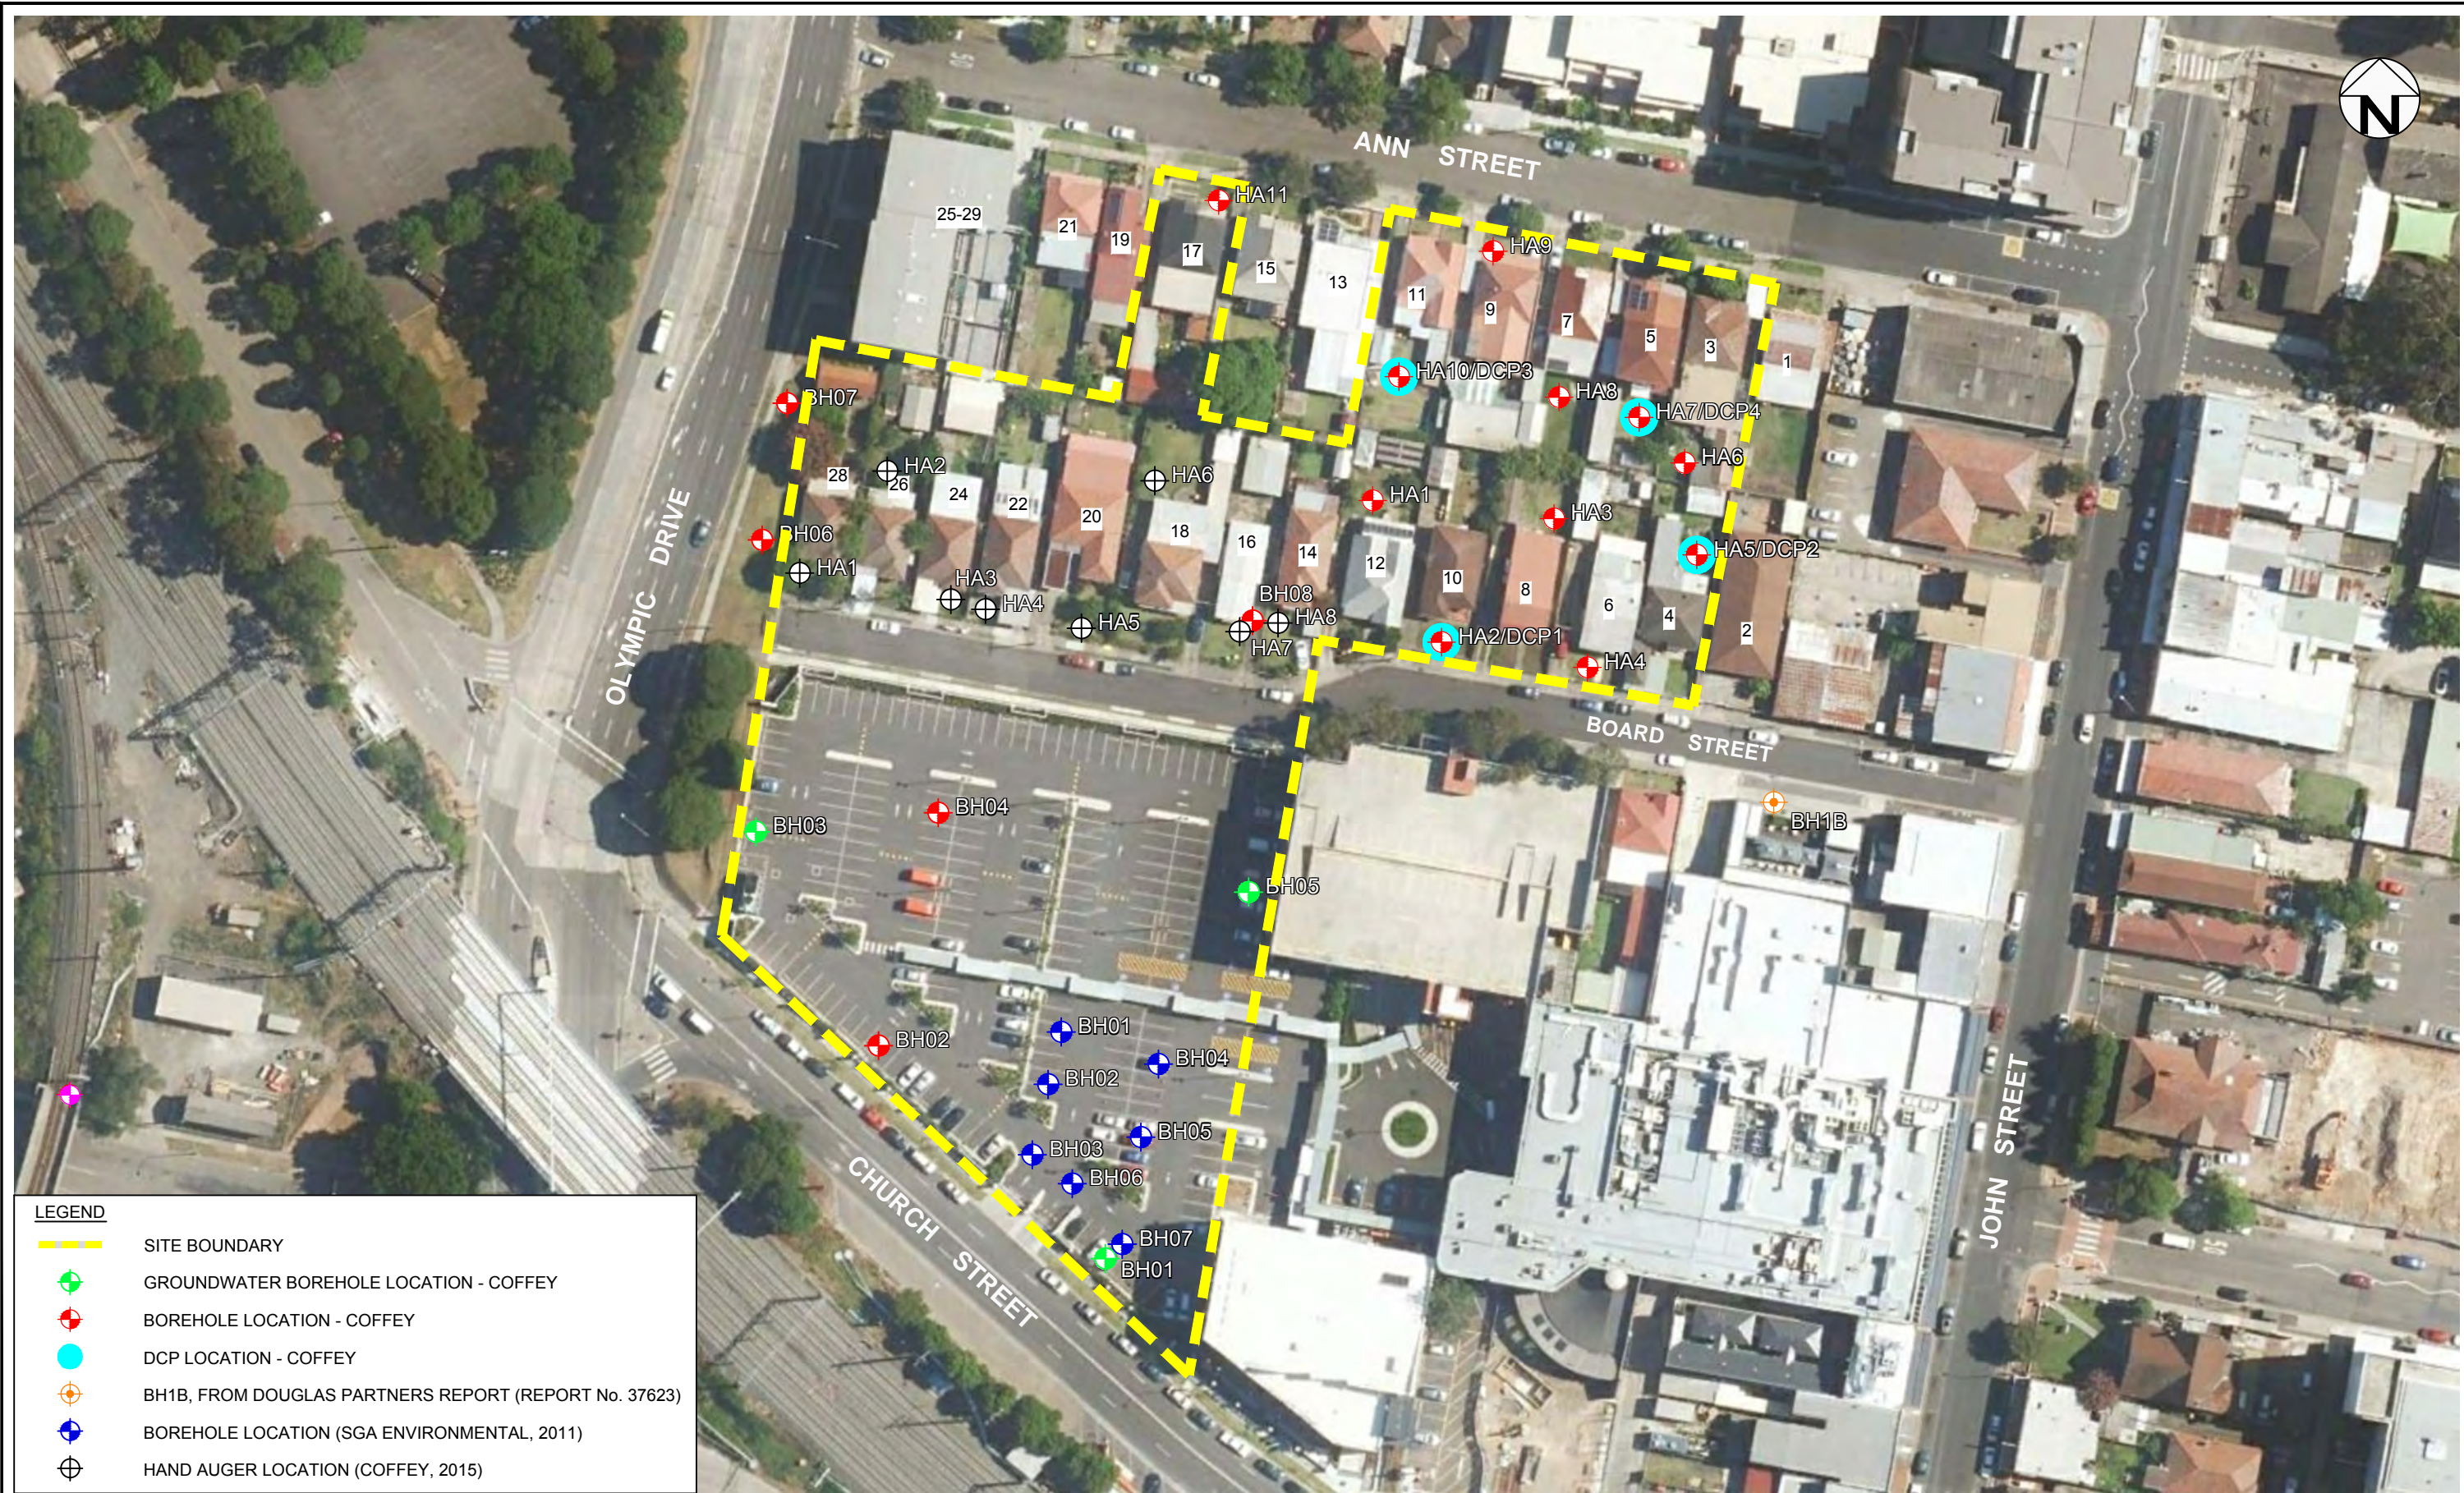
client:	BOUYGUES CONSTRUCTION AUSTRALIA		
project:	REMEDIAL ACTION PLAN DOOLEY'S LIDCOMBE CLUB & HOTEL DEVELOPMENT LIDCOMBE, SYDNEY, NSW		
title:	BOREHOLE LOCATION PLAN		
project no:	GEOTLCOV25554AA-AJ	figure no:	FIGURE 3
		rev:	A

A review of the reports prepared by SGA Environmental and Coffey indicate that the soil sampling pattern has adopted a combination of judgemental and systematic sampling patterns, which is considered consistent with the recommendations made within the Sampling Design Guidelines (NSW EPA, 1995). With regards to the former Redex workshop, SGA Environmental established 7 sampling locations on a systematic sampling grid over an area of 0.1ha, which is consistent with the minimum recommended sampling density set out within Table A of the Sampling Design Guidelines (NSW EPA, 1995) for a potential source this size. A lower sampling density was achieved across the remainder of the existing club car park.

A total of 23 sampling locations were established within the residential properties that fall within the site between Ann Street and Board Street, which cover an area of 0.8ha. The sampling density attained within this part of the site exceeds the 19 sampling positions recommended in the Sampling Design Guidelines (NSW EPA, 1995) for an area of this size, although many of these sampling locations were positioned in accessible areas of these properties that generally target areas where building materials (e.g. ACM, lead, zinc etc.) may concentrate. It is noted that restrictions have prevented access to a number of residential properties, with the distance between sampling locations increasing to 30m in this part of the site. In consideration of the age of the dwellings present on site and the suspected presence of building material in these structures containing ACM and certain

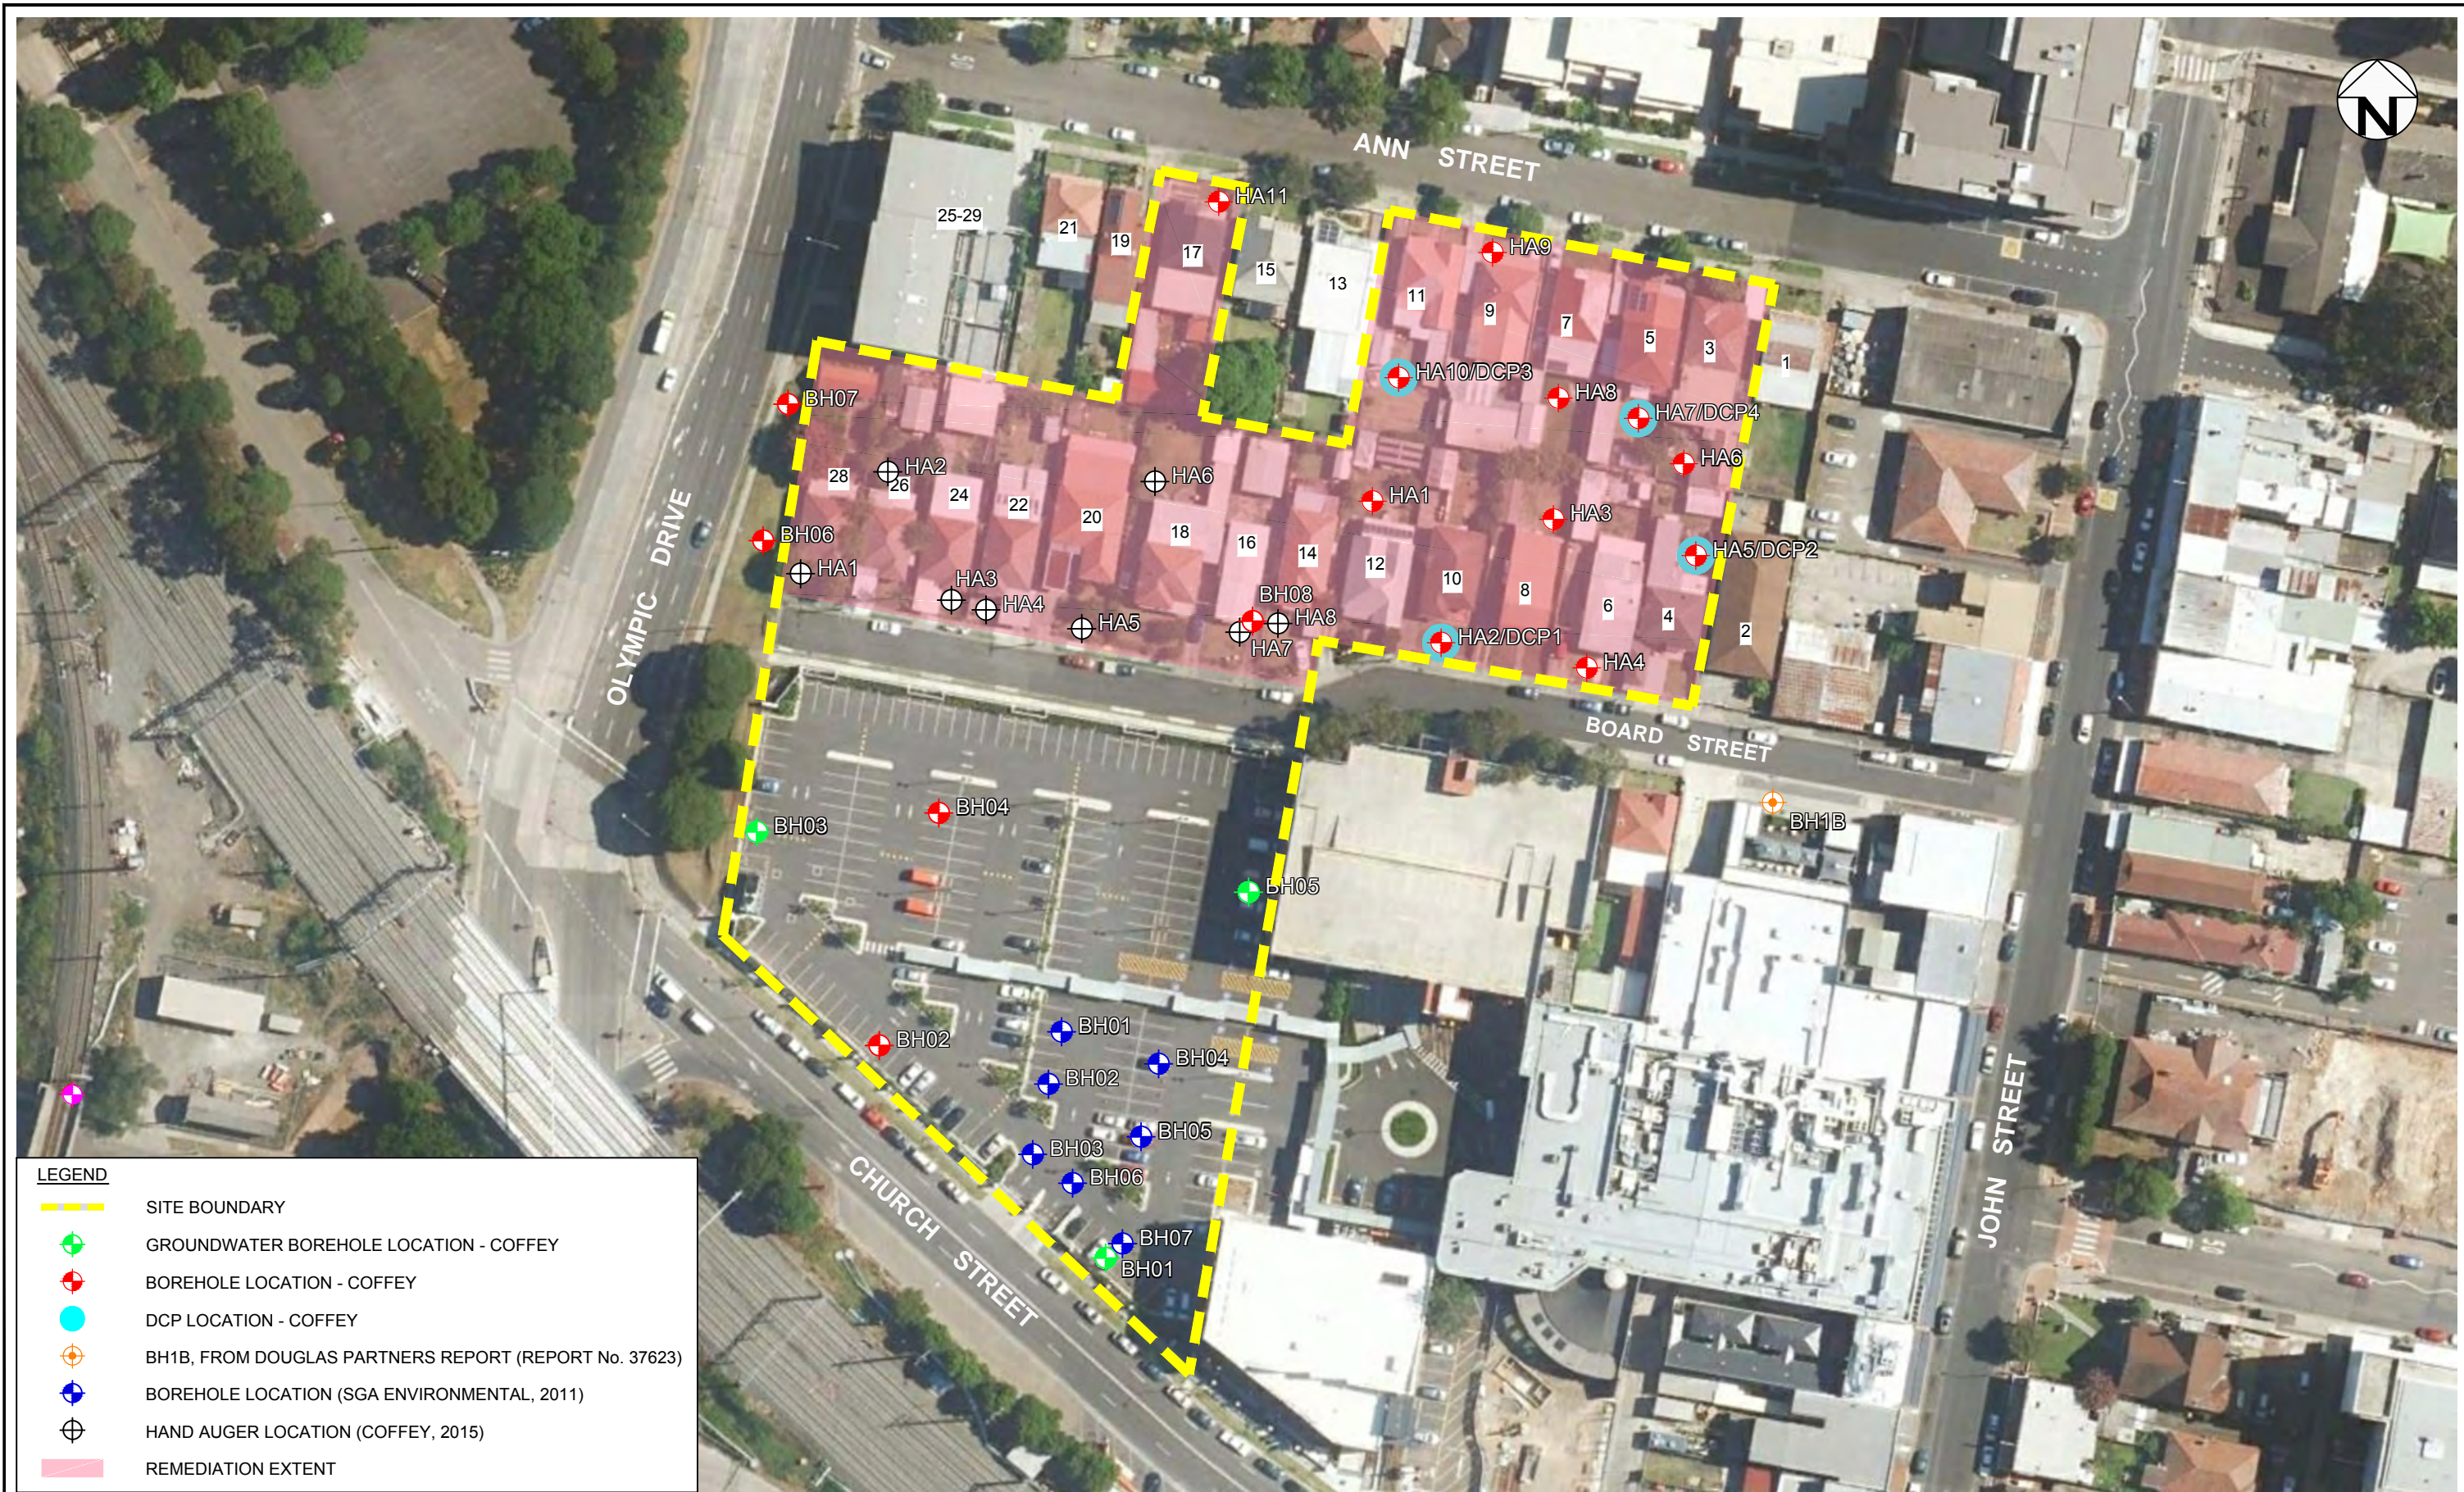
Figure 4 – Remediation Extent

The source of ACM in soil has been assessed to comprise the weathering or localised damage to ACM within existing building fabric, which typically results in ACM concentrating within shallow topsoil/fill. Investigation records also suggest asbestos fines are present within the initial 0.1m of soil, although it is noted that localised disturbance (e.g. gardening, maintenance activities etc.) may have mixed topsoil/ with deeper fill materials locally. On this basis, the vertical extent of remediation is provisionally proposed as 0.3m below ground surface (mbgs) to improve confidence in the removal of AF. The vertical extent of the excavation works shall be limited by the depth of fill.

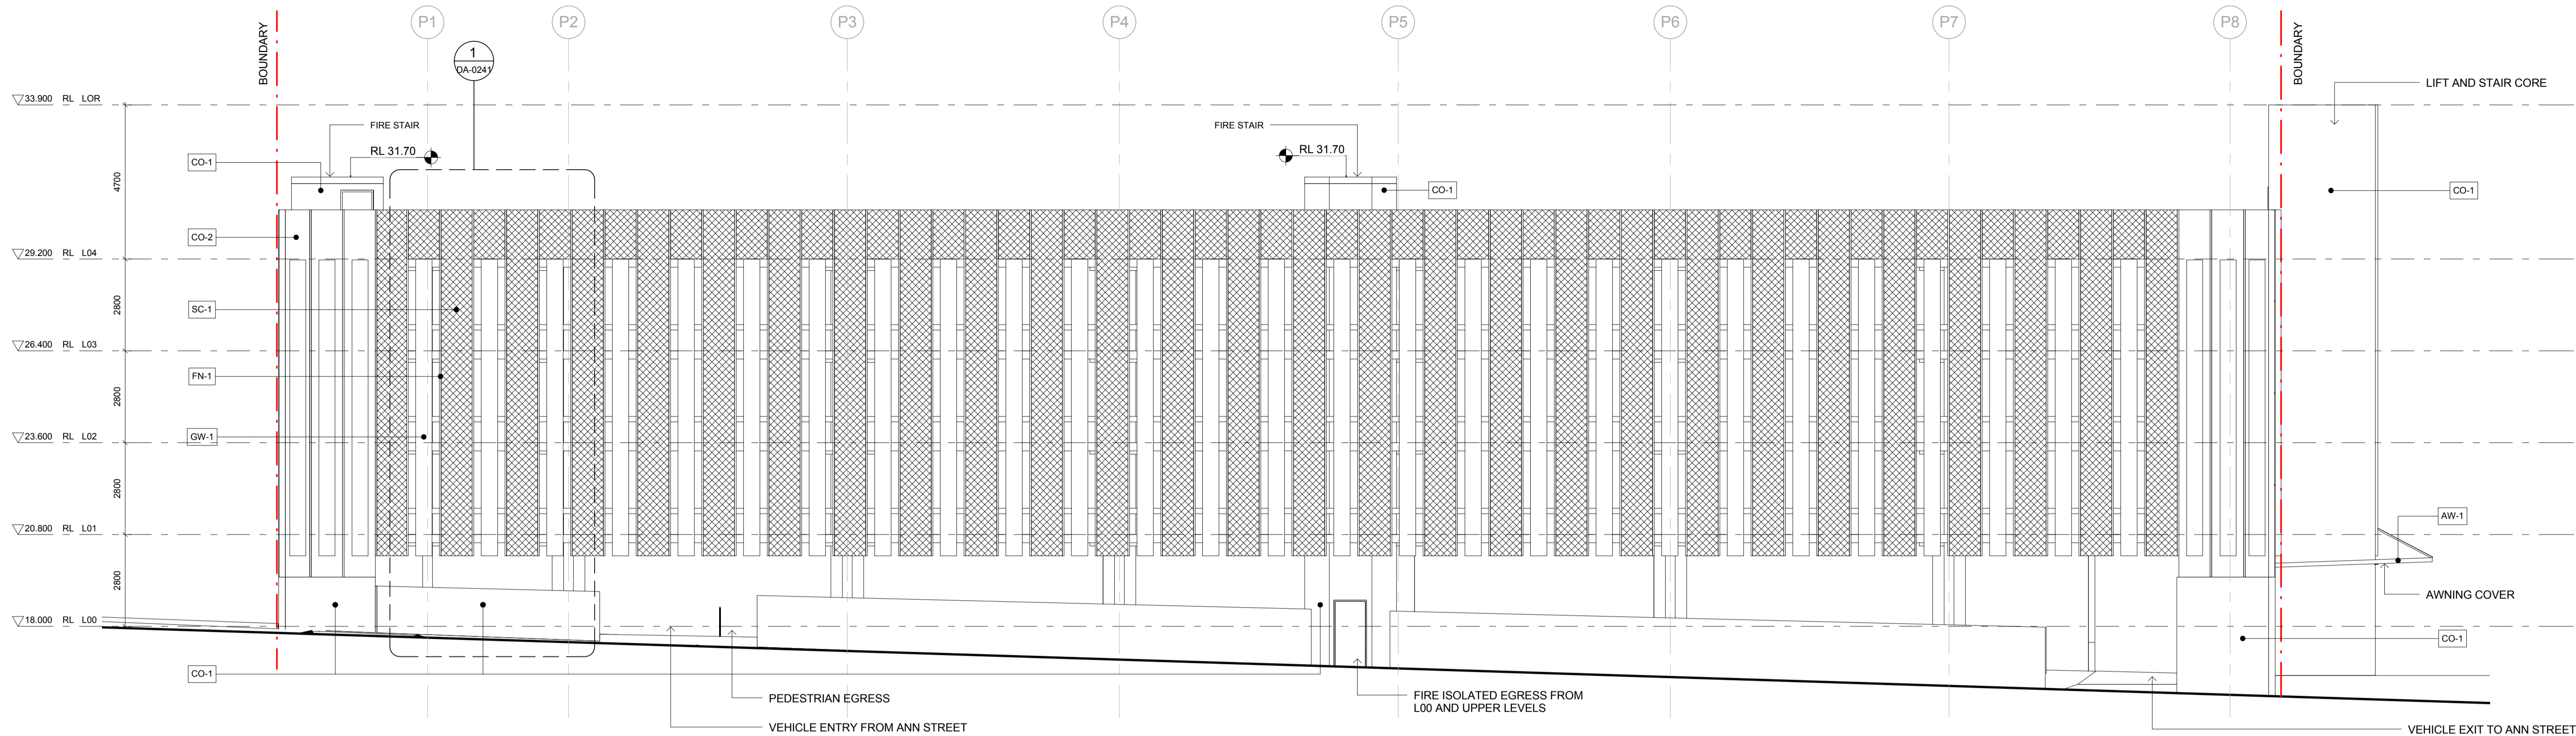
1 NORTH ELEVATION
1 : 100

CO-1	IN-SITU CONCRETE CLASS 2
CO-2	CONCRETE PRECAST PANELS, VERTICAL GROOVES @ 1000mm CENTRES
SC-1	EXPANDED ALUMINIUM MESH SCREEN
FN-1	ANODIZED ALUMINIUM FINIS, 300 X 50mm
GW-1	GREENWALL SYSTEM PANEL, 500 WIDE X 150 DEEP
AW-1	STEEL FRAME, METAL DECK AWNING, FC SHEET LINING

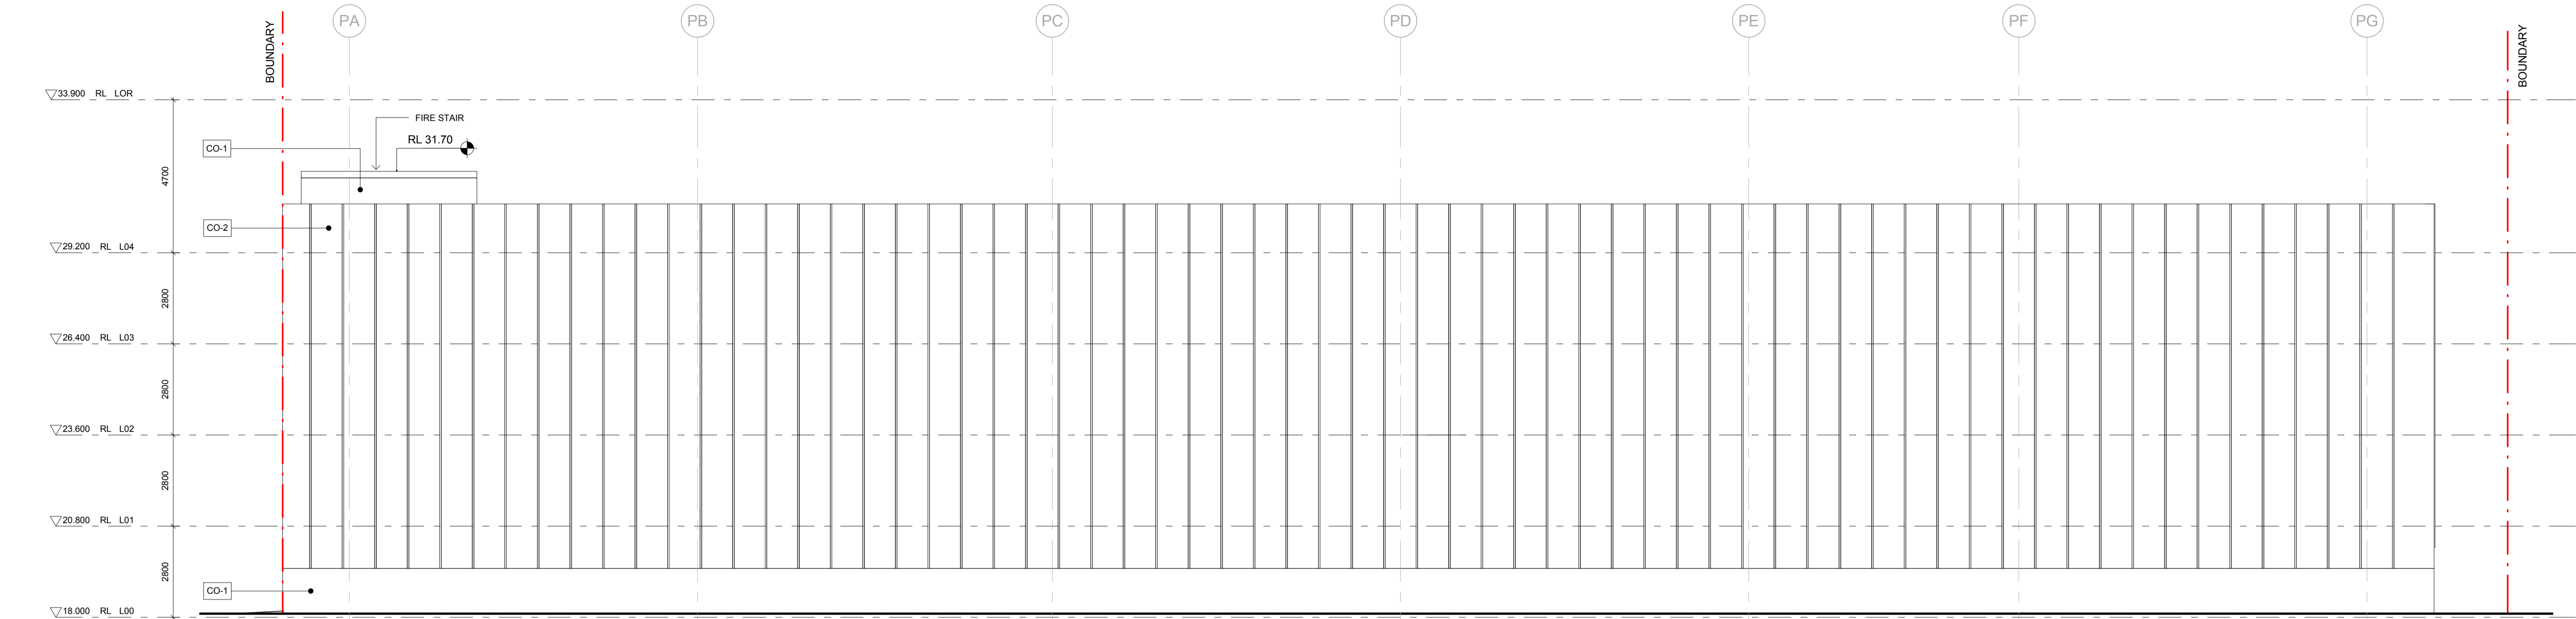
1 EAST ELEVATION
1 : 100

CO-1	IN- SITU CONCRETE CLASS 2
CO-2	CONCRETE PRECAST PANELS, VERTICAL GROOVES @ 1000mm CENTRES
SC-1	EXPANDED ALUMINIUM MESH SCREEN
FN-1	ANODIZED ALUMINIUM FINIS, 300 X 50mm
GW-1	GREENWALL SYSTEM PANEL, 500 WIDE X 150 DEEP
AW-1	STEEL FRAME, METAL DECK AWNING, FC SHEET LINING
