**Report Type:** Combined Stage 1 & 2 Environmental Site Assessment  
**Site Address:** Proposed Inner Sydney High School, Cleveland Street, Surry Hills, NSW  
**Report Number:** 2187/ER-1-1 (Revision 2)  
**Report Date:** 12<sup>th</sup> May 2017

RE: COMBINED STAGE 1 & 2 ENVIRONMENTAL SITE ASSESSMENT – PROPOSED INNER SYDNEY HIGH SCHOOL, CLEVELAND STREET, SURRY HILLS, NSW

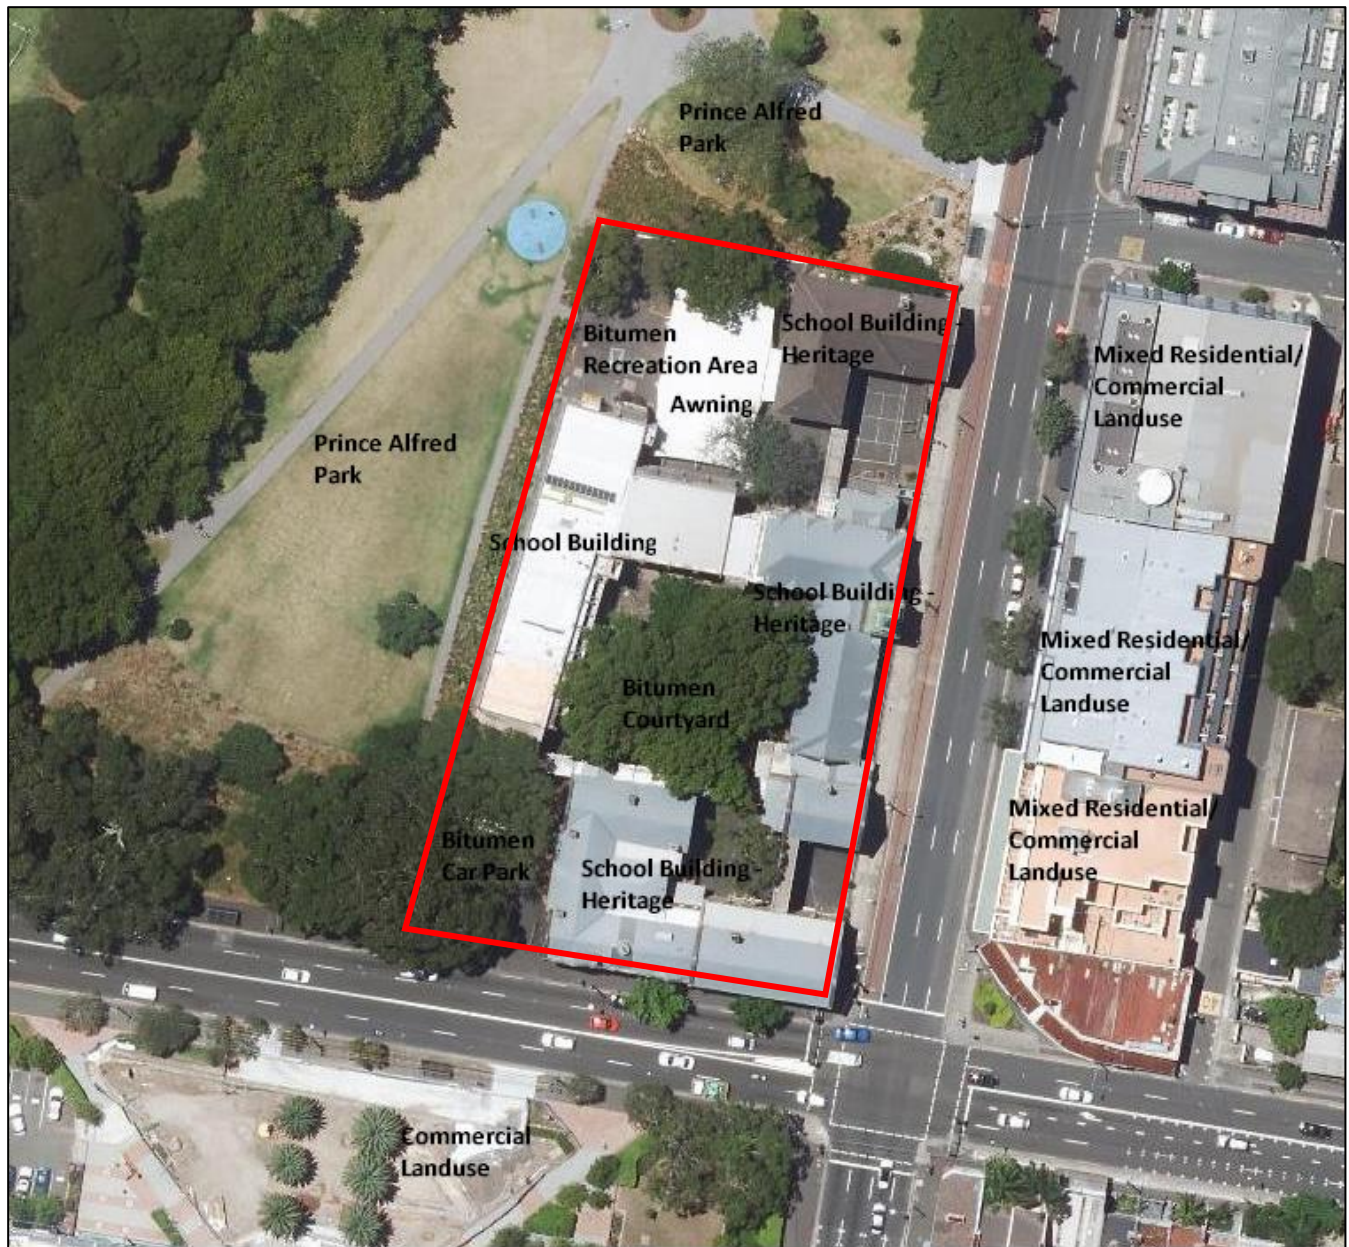
Figure 2: Site Layout and Features

The site consisted of four school buildings, a bitumen courtyard / recreation area, a bitumen car park and multiple trees. The site features are shown in **Figure 2** below and are discussed further in **Section 4**.

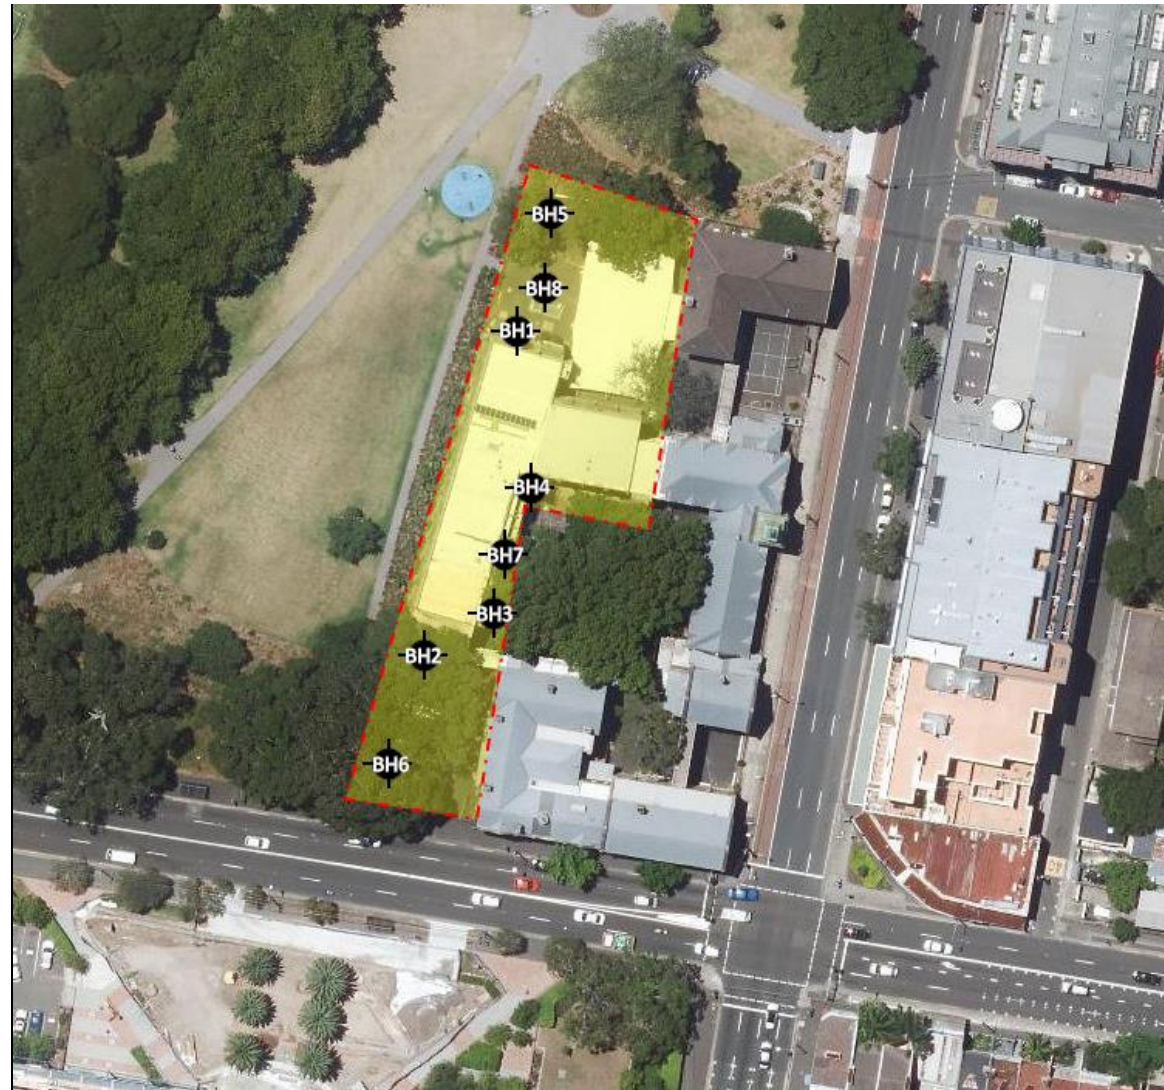
**Figure 3 – Sample Locations**

A total of eight (8) boreholes were mechanically excavated and soil samples were collected at the locations identified in **Figure 3**. Fill material was observed at all sample locations, and consisted of gravelly silty clay, gravelly silty sand and silty sand. No hydrocarbon odours were observed and no asbestos containing material (ACM) was observed. Foreign materials including gravels and minor ash and potential slag was observed in the fill material at all borehole locations. Natural soils were observed at depths generally ranging from 0.6 to 1.8 m bgs. Borehole Logs are provided in **Appendix F**.

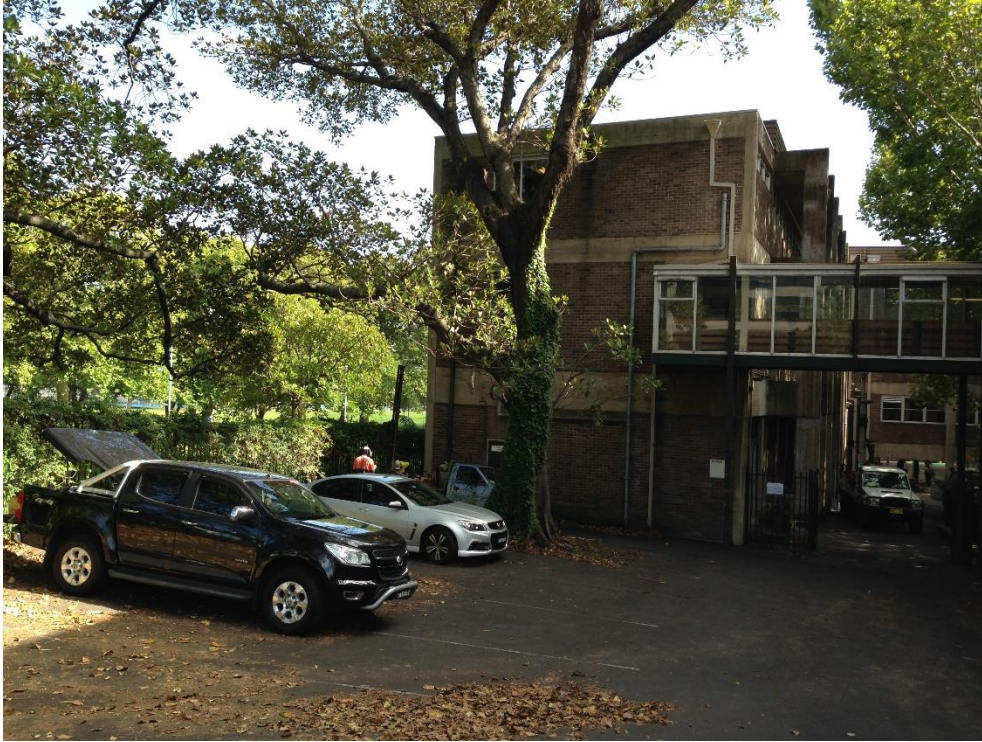
**Photograph 1:** The bitumen car park with the western building of the site, looking north. The area to the left (west) of the building was the Prince Alfred Park.

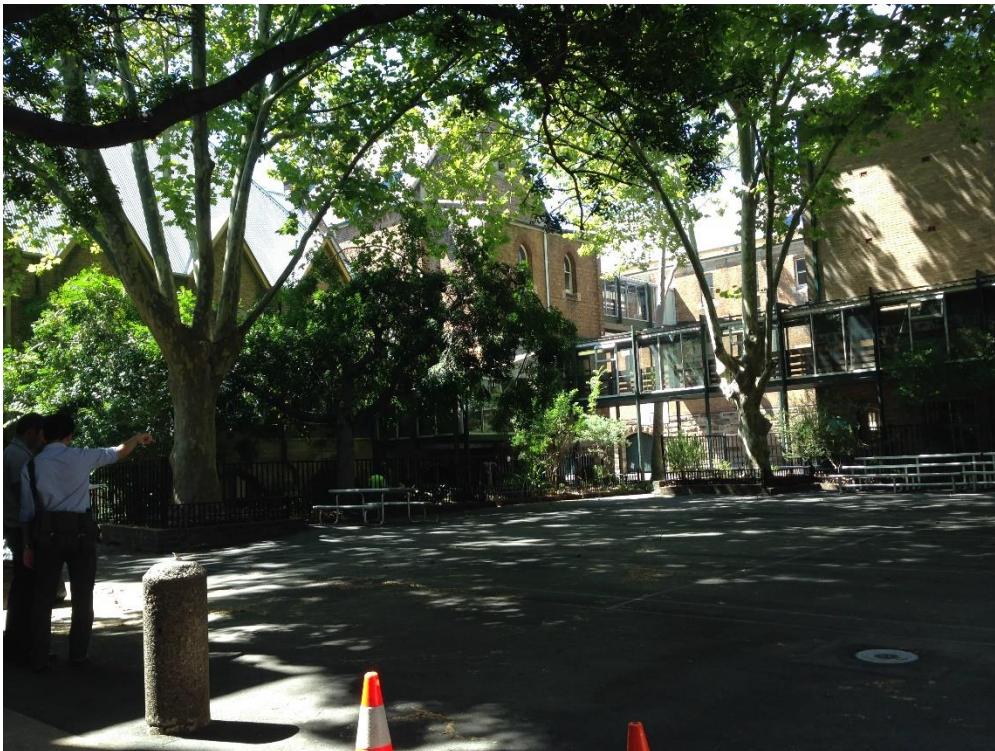
**Photograph 2:** The bitumen courtyard / recreation area in the centre of the site with the heritage buildings of the school in the background.

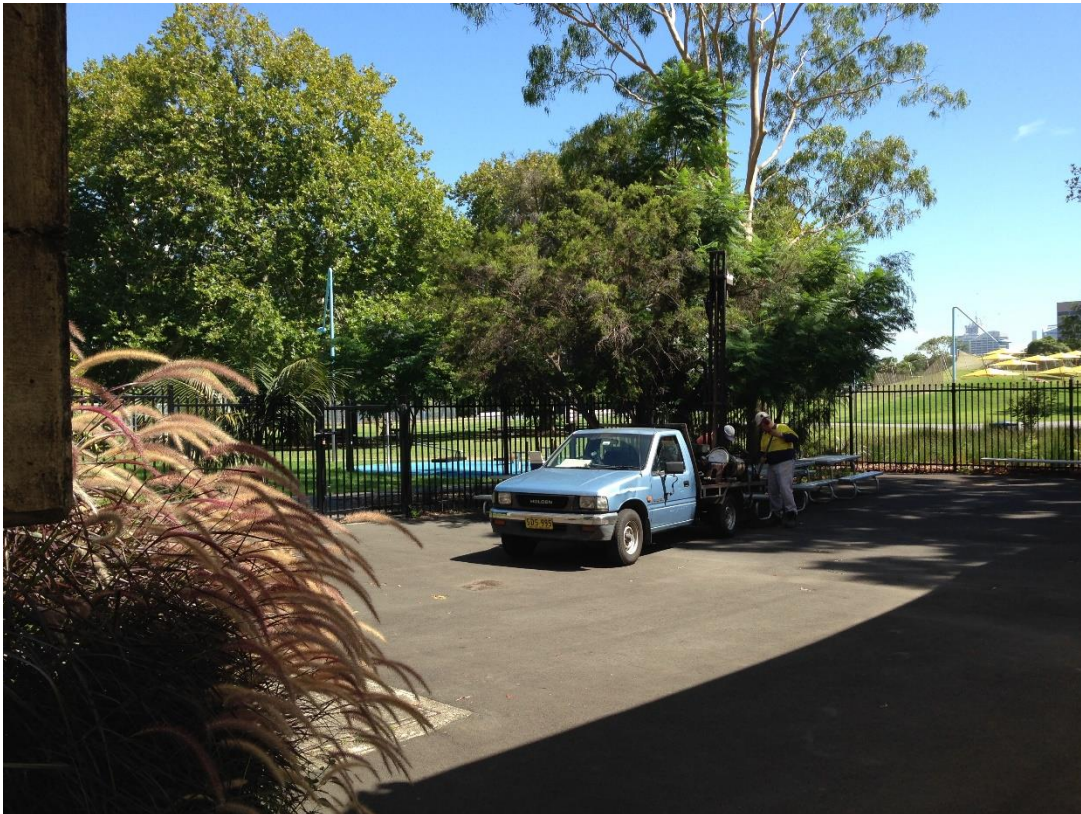
**Photograph 3:** The north-western corner of the site, looking north-west. The drill rig was in the location of borehole BH5.

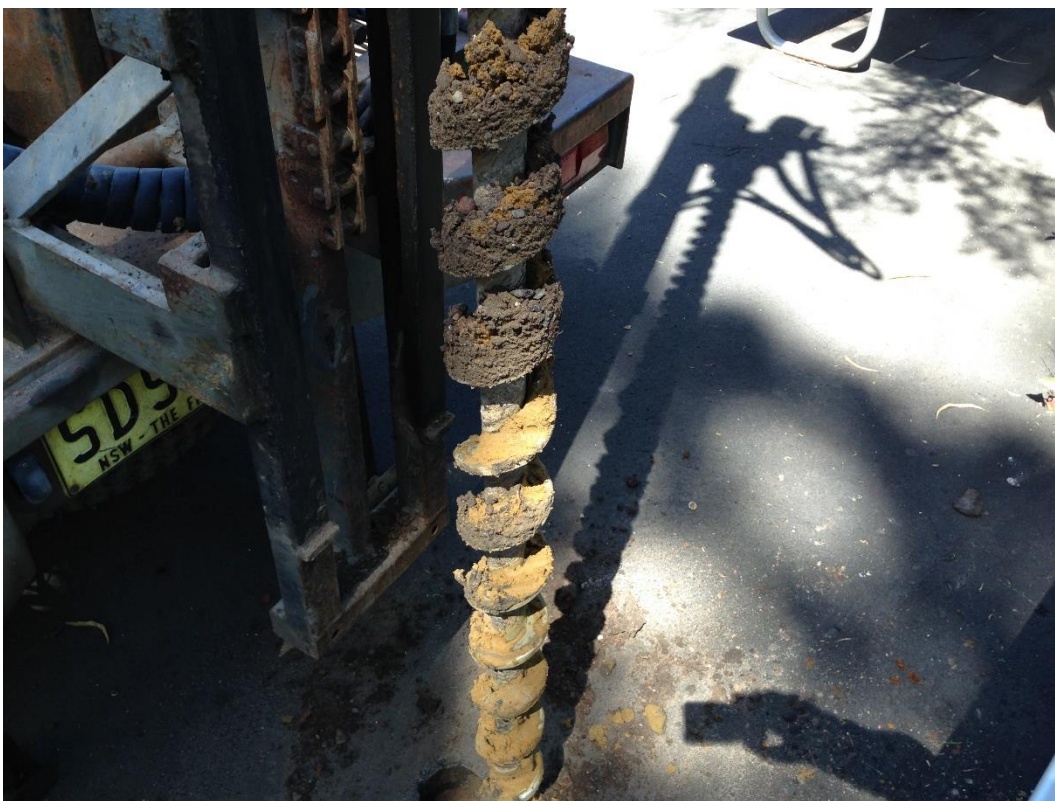
- During borehole excavation, fill material was observed at all locations at depths ranging from near surface (0.1 m bgs i.e. below the bitumen layer) to 0.6 – 1.8 m bgs. Fill material was observed to consist of gravelly silty clay, gravelly silty sand and silty sand. No hydrocarbon odours were observed and no asbestos containing material (ACM) was observed. Foreign materials including gravels and minor ash and potential slag was observed in the fill material at all borehole locations.

**Photograph 4:** A typical image of site geology, BH5.
