Moorebank Precinct West (MPW) – Stage 2 Proposal

Geotechnical Interpretive Report

Report Number. 1416224-016-R-Rev 3

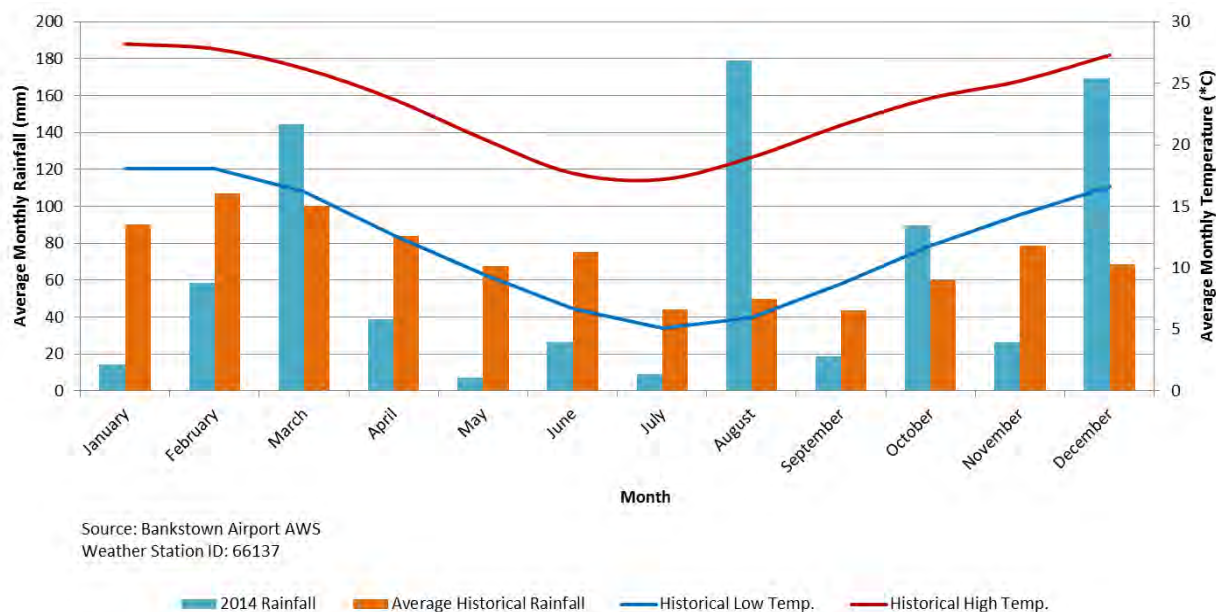
Figure 1: Monthly Rainfall and Temperature Records from Bankstown Airport (7.1 km from MPW Site)

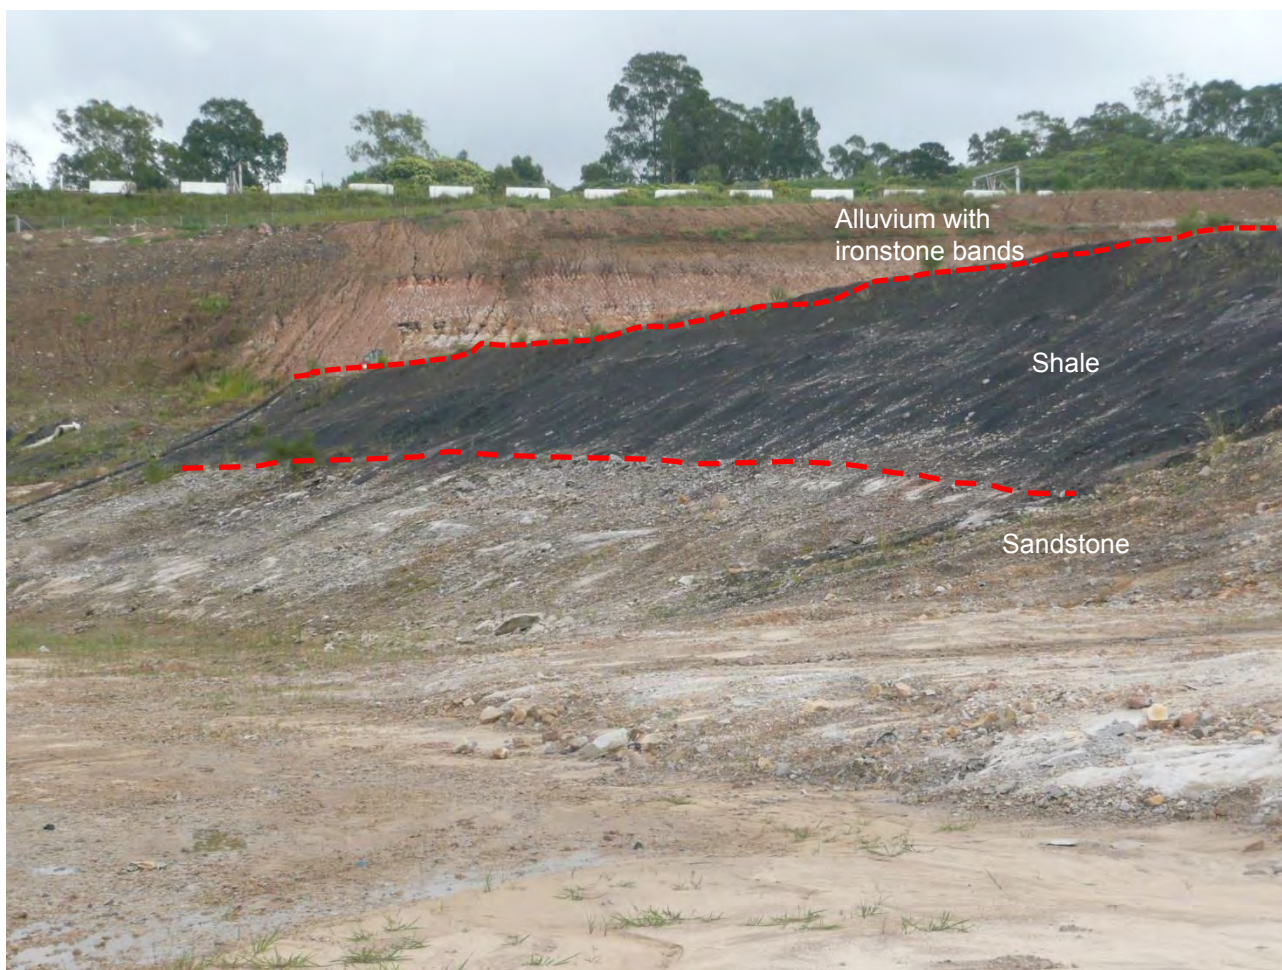
Figure 4: Photograph in Glenfield Waste Facility showing general stratigraphy looking northwest

Within the Sydney region, a relatively thin layer known as the Mittagong Formation (Rm) is sometimes present between the Hawkesbury Sandstone and Ashfield Shale units. It is not shown on the geological map in the site vicinity as being a significant near surface bedrock unit. The Mittagong Formation is typically transitional between the Hawkesbury Sandstone and the overlying Ashfield Shale with a maximum thickness of 10m. We have found what we interpret to be Mittagong Formation in borehole BHBI at the south eastern corner of the site. We found similar rock conditions in a borehole for another client at the Moorebank Avenue railway overbridge. In general, the Ashfield Shale occurs in areas of higher elevation, where it forms a cap over the Hawkesbury Sandstone or Mittagong Formations. An example close to the MP site is the western bank of the Georges River, which geological maps show to comprise shale. The general geological sequence in the area was observed during a site walkover of the Glenfield Waste Facility in December 2014. A photograph taken during this inspection shows the Ashfield Shale overlying Sandstone (with heavily eroded alluvial soils with ironstone bands in the background).

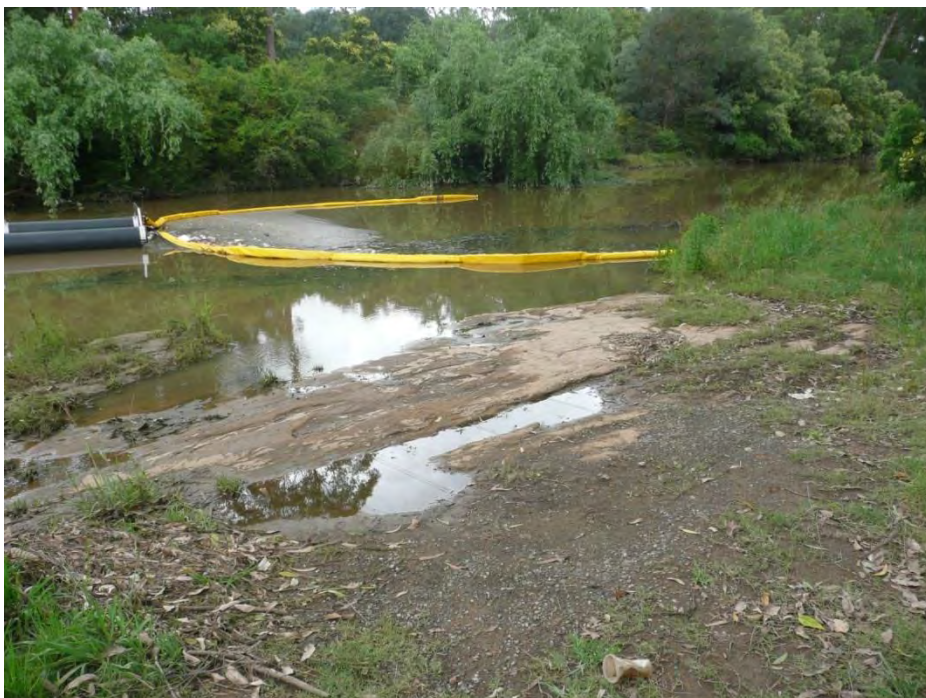
No rock outcrops were observed on the MPW site area, although some areas of the western bank of the Georges River have outcrops of sandstone close to the road bridge at Cambridge Avenue (Refer Figure 6).

Figure 6: Sandstone outcrop to the south of Cambridge Avenue road bridge

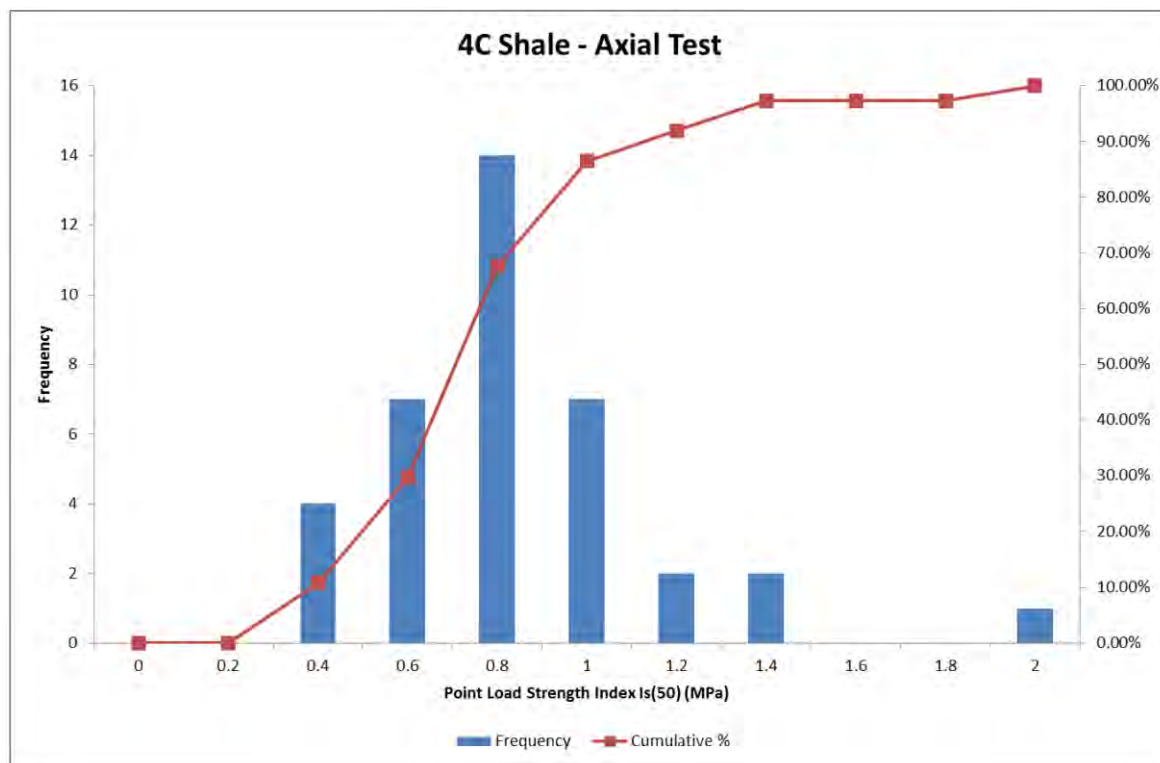
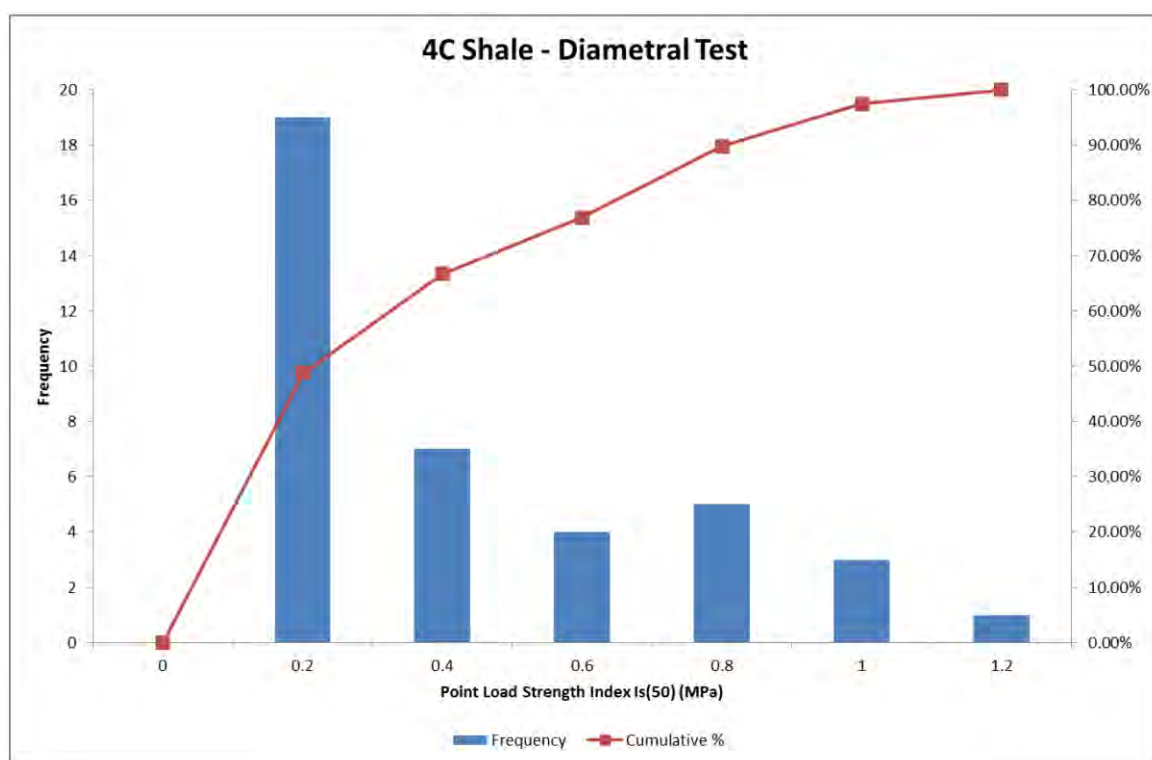
Unit 4C shale observed during the investigations was generally slightly weathered to fresh and medium to high strength. Figure 12 below gives a summary of the Is_{50} rock strength results obtained from point load testing carried out on shale samples during the investigation. As expected the data shows a strong anisotropy related to the horizontally fissile nature of the shale.

Figure 12: Point Load Test Results for Unit 4C

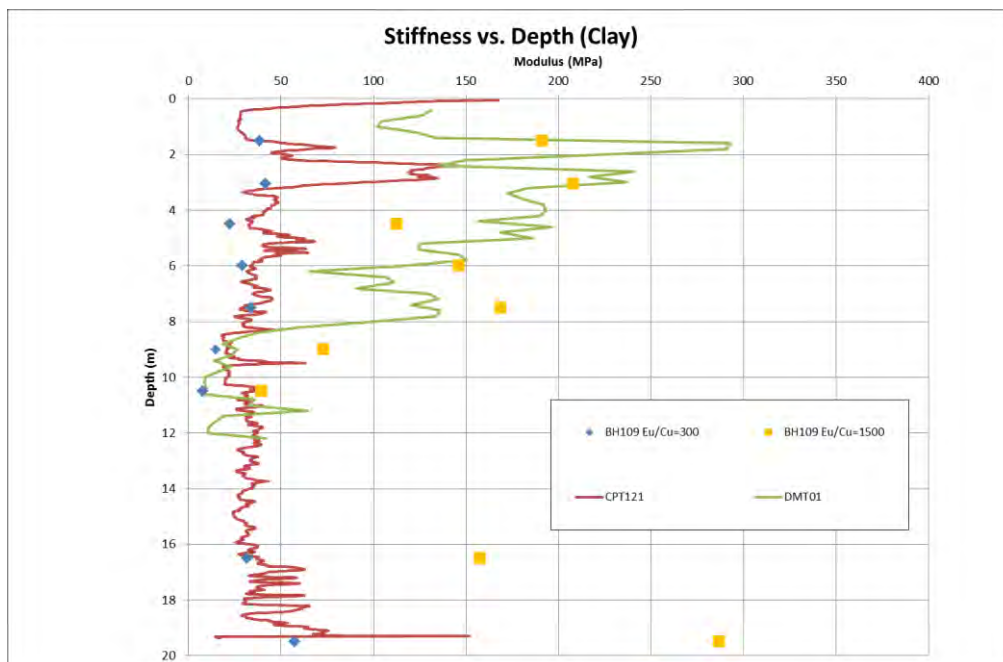
Figure 14: Stiffness vs Depth Plot for BH109 / CPT121 / DMT01 (Unit 3B Clay Profile)

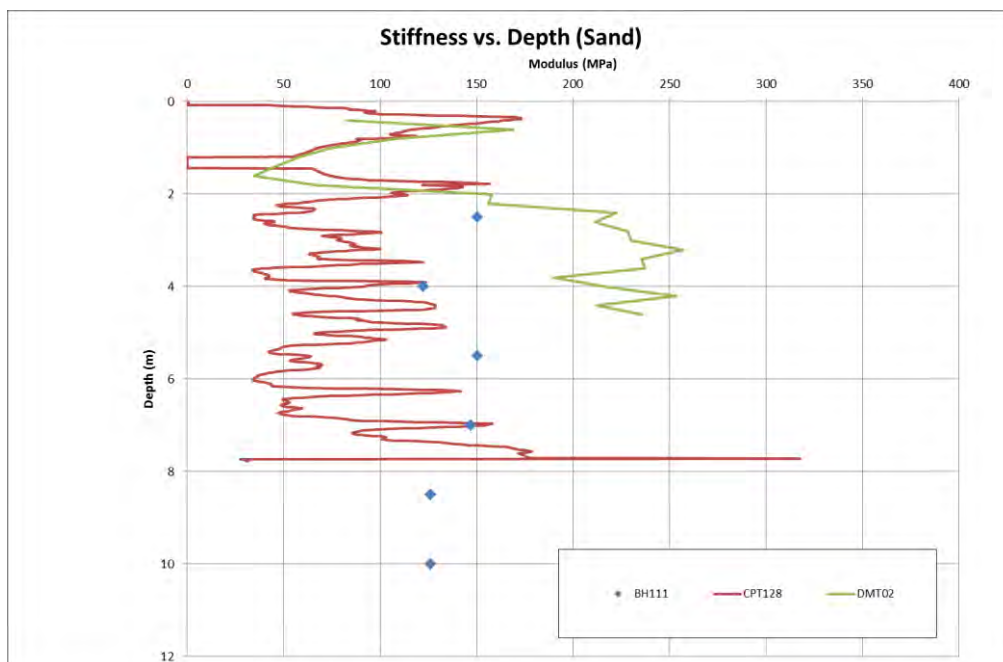
Figure 15: Stiffness vs Depth Plot for BH111 / CPT128 / DMT02 (Unit 3A Sand Profile)

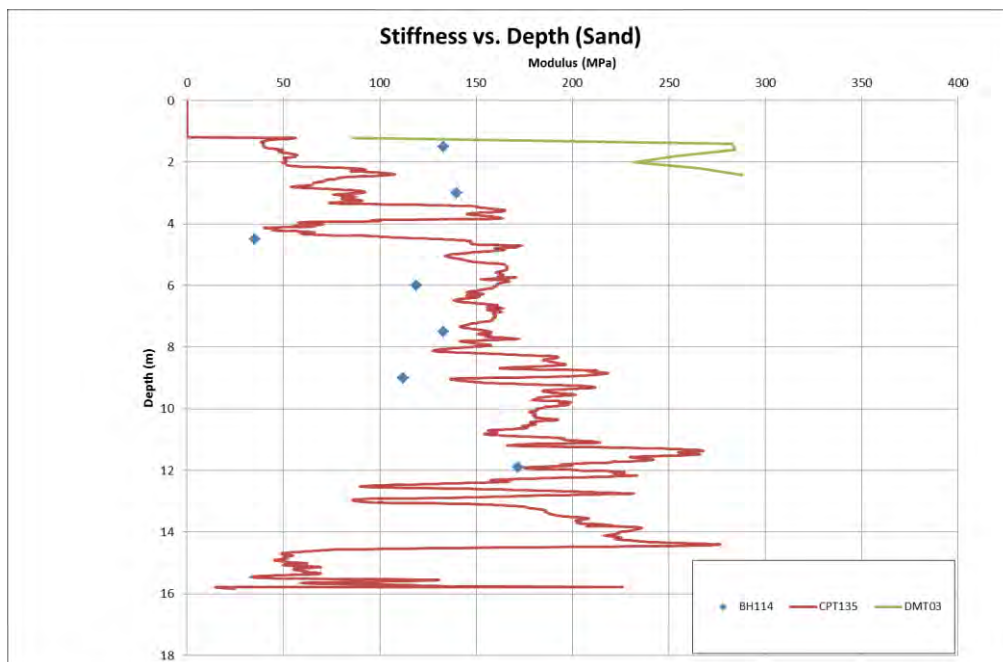
Figure 16: Stiffness vs Depth Plot for BH114 / CPT135 / DMT03 (Unit 3A Sand Profile)

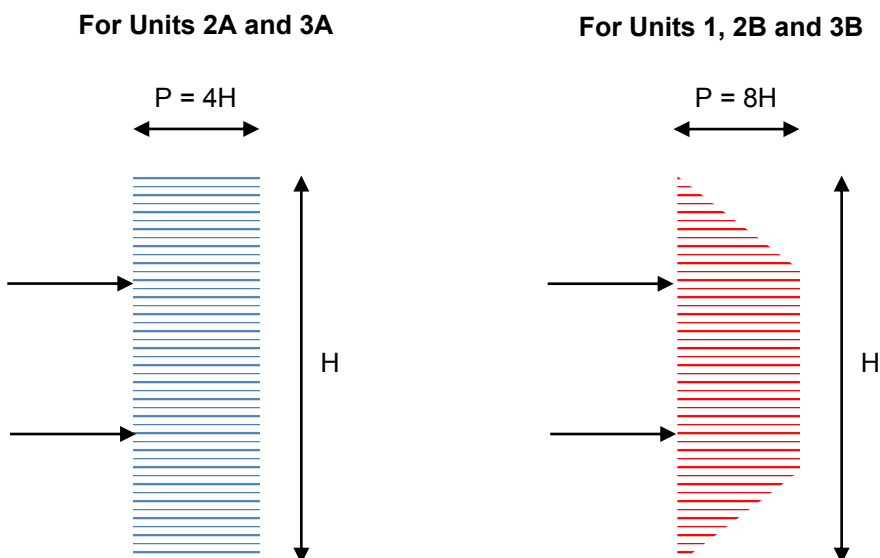
Figure 17: Alternative Earth Pressure Envelopes
