Mirvac

Preliminary Site Contamination Assessment

Harbourside Shopping Centre
Darling Drive, Darling Harbour, Sydney

14 October 2016

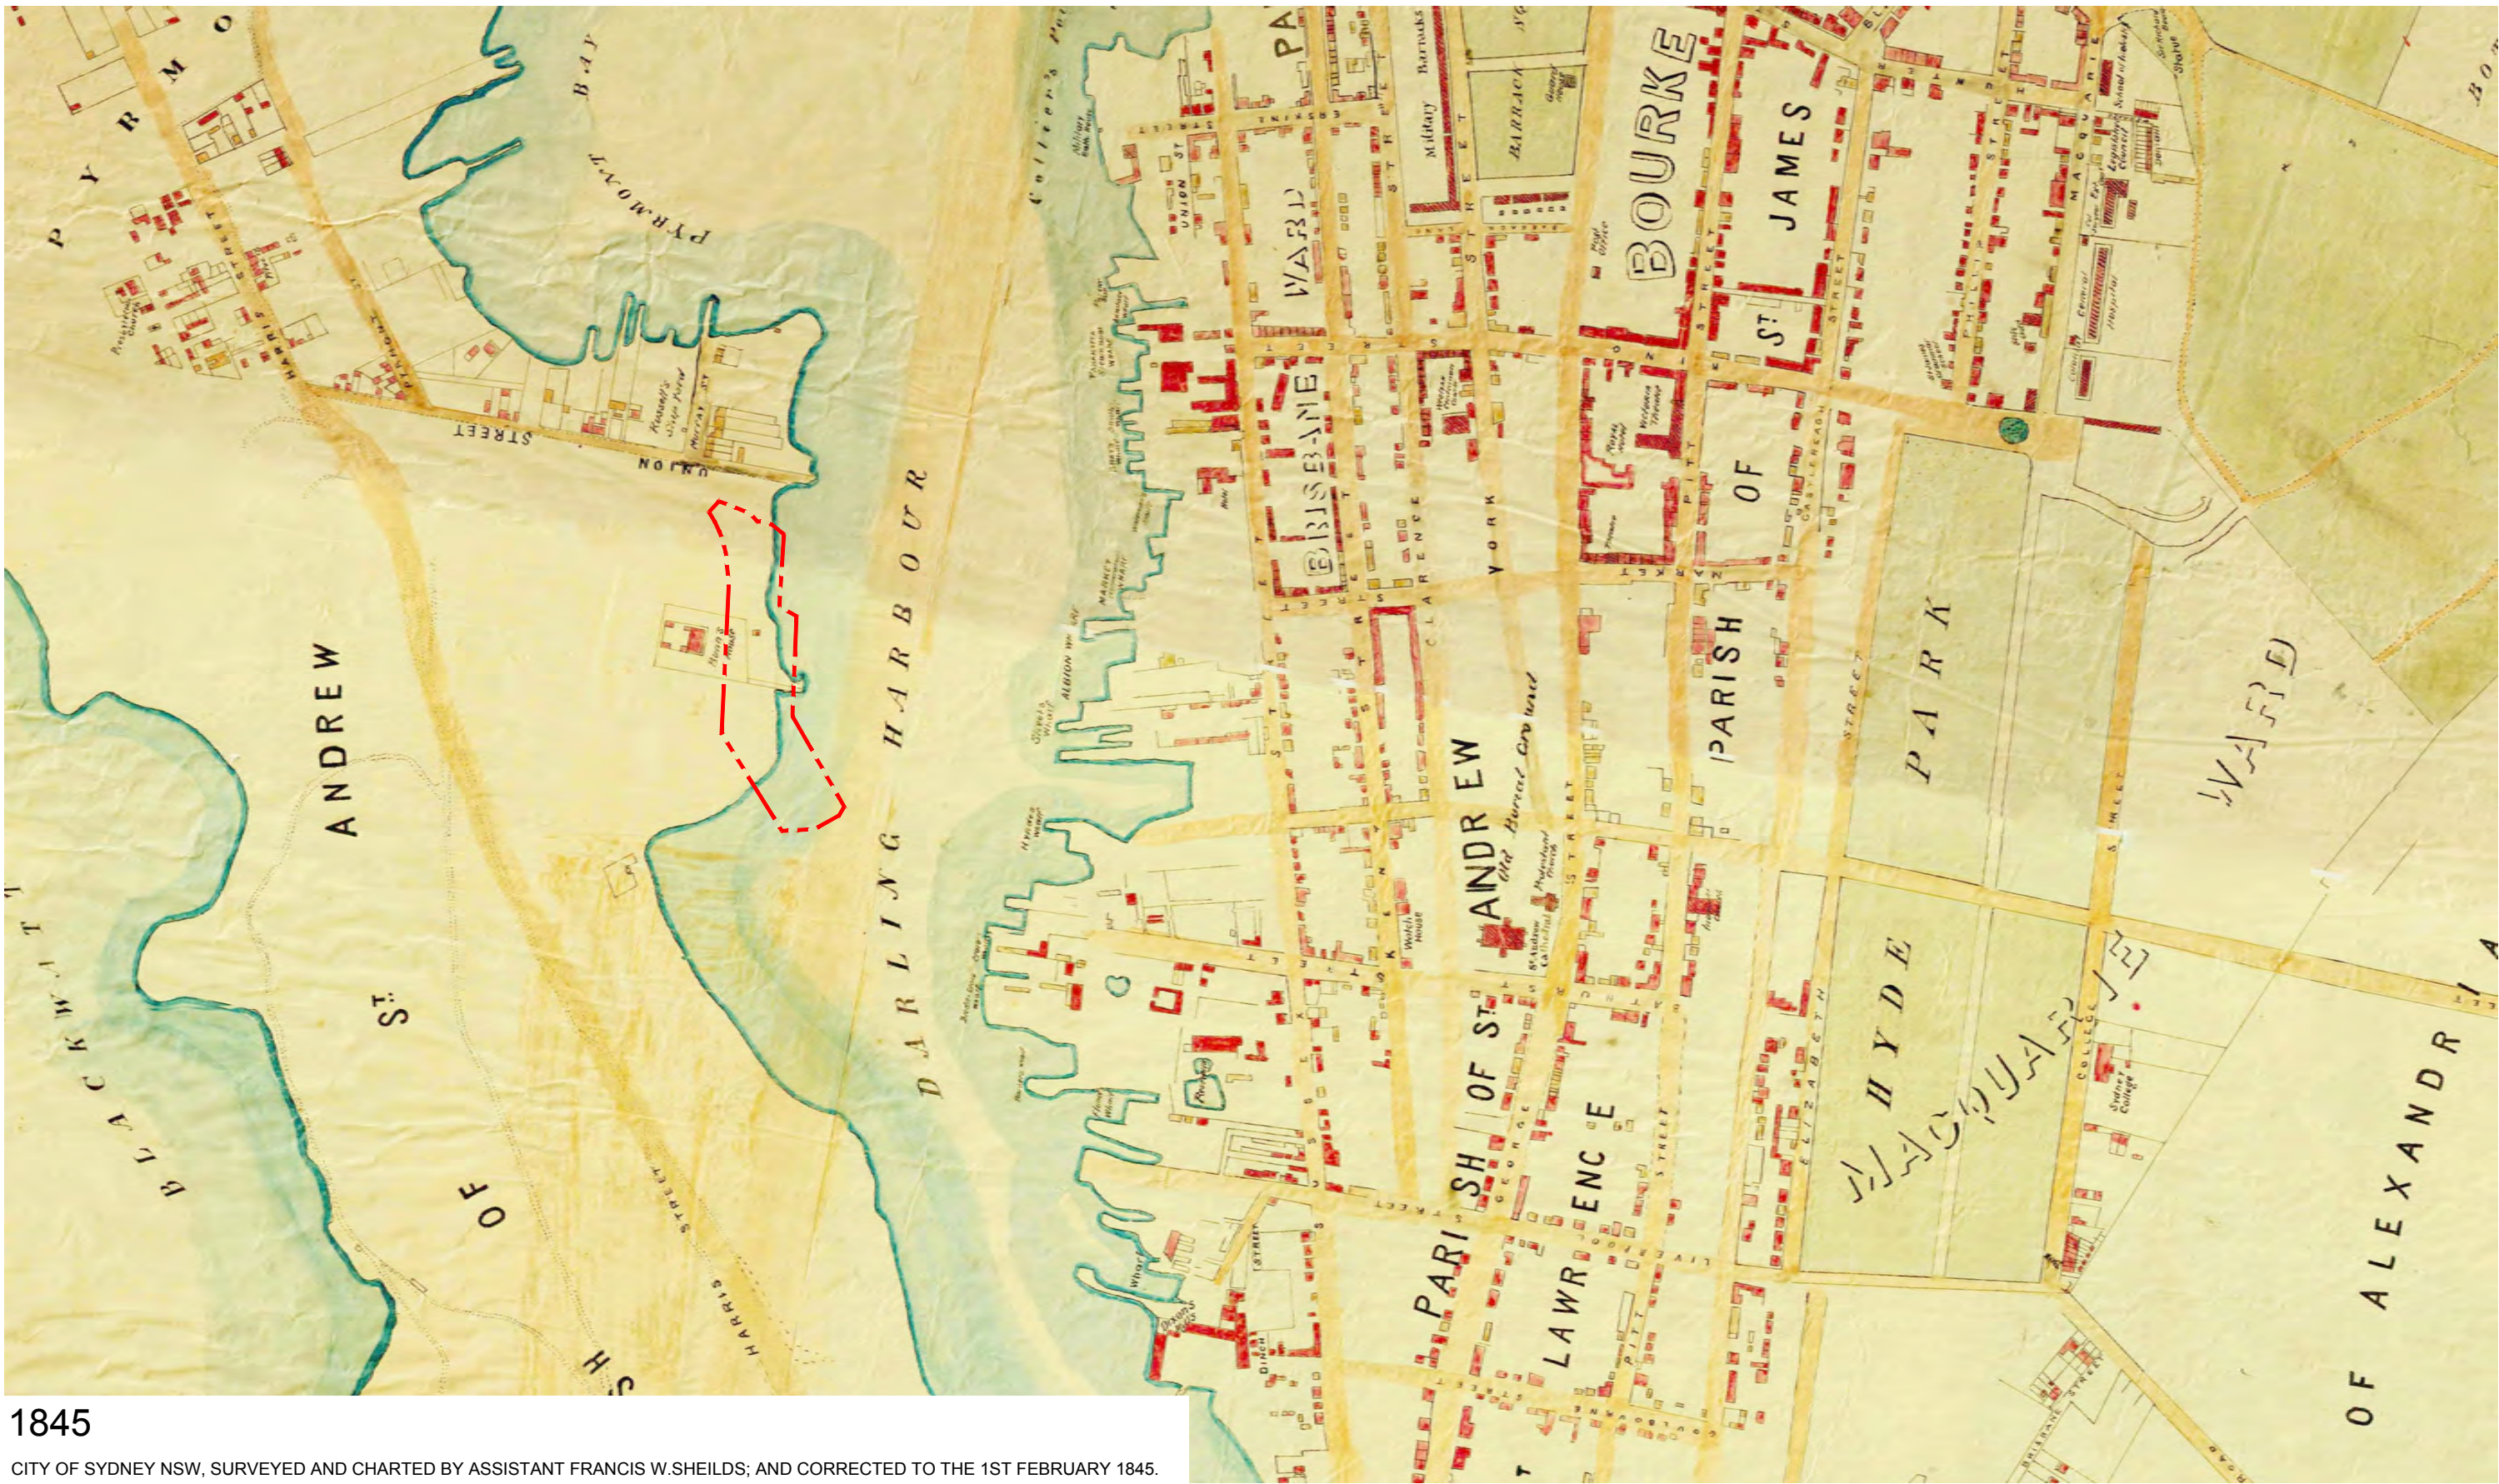
Figure 3 – Historic Map Extract – 1845

Date	Description of historic land uses
Historical Map Extracts	
1845 – Shield's Plan of Sydney (Figure 3)	The shows the site is situated along the western shoreline of Cockle Bay with the southern and eastern portions of the site submerged within the harbour. Cockle Bay appears to relatively undeveloped with the exception of Burn's House located directly west of the site. An access track leading from Burn's House to Darling harbour runs through the centre of the site.
1865 – Trigonometric Survey Plan (Figure 4)	The Trigonometric Survey Plan indicates the orientation of the foreshore within the site appears to have remained unchanged from 1845. The western foreshore of Cockle Bay to the south of the site had been developed with a rail corridor, suggesting some land reclamation had occurred to establish the rail corridor. The plan shows a number of structures established within the area although the specific land uses were not identified.

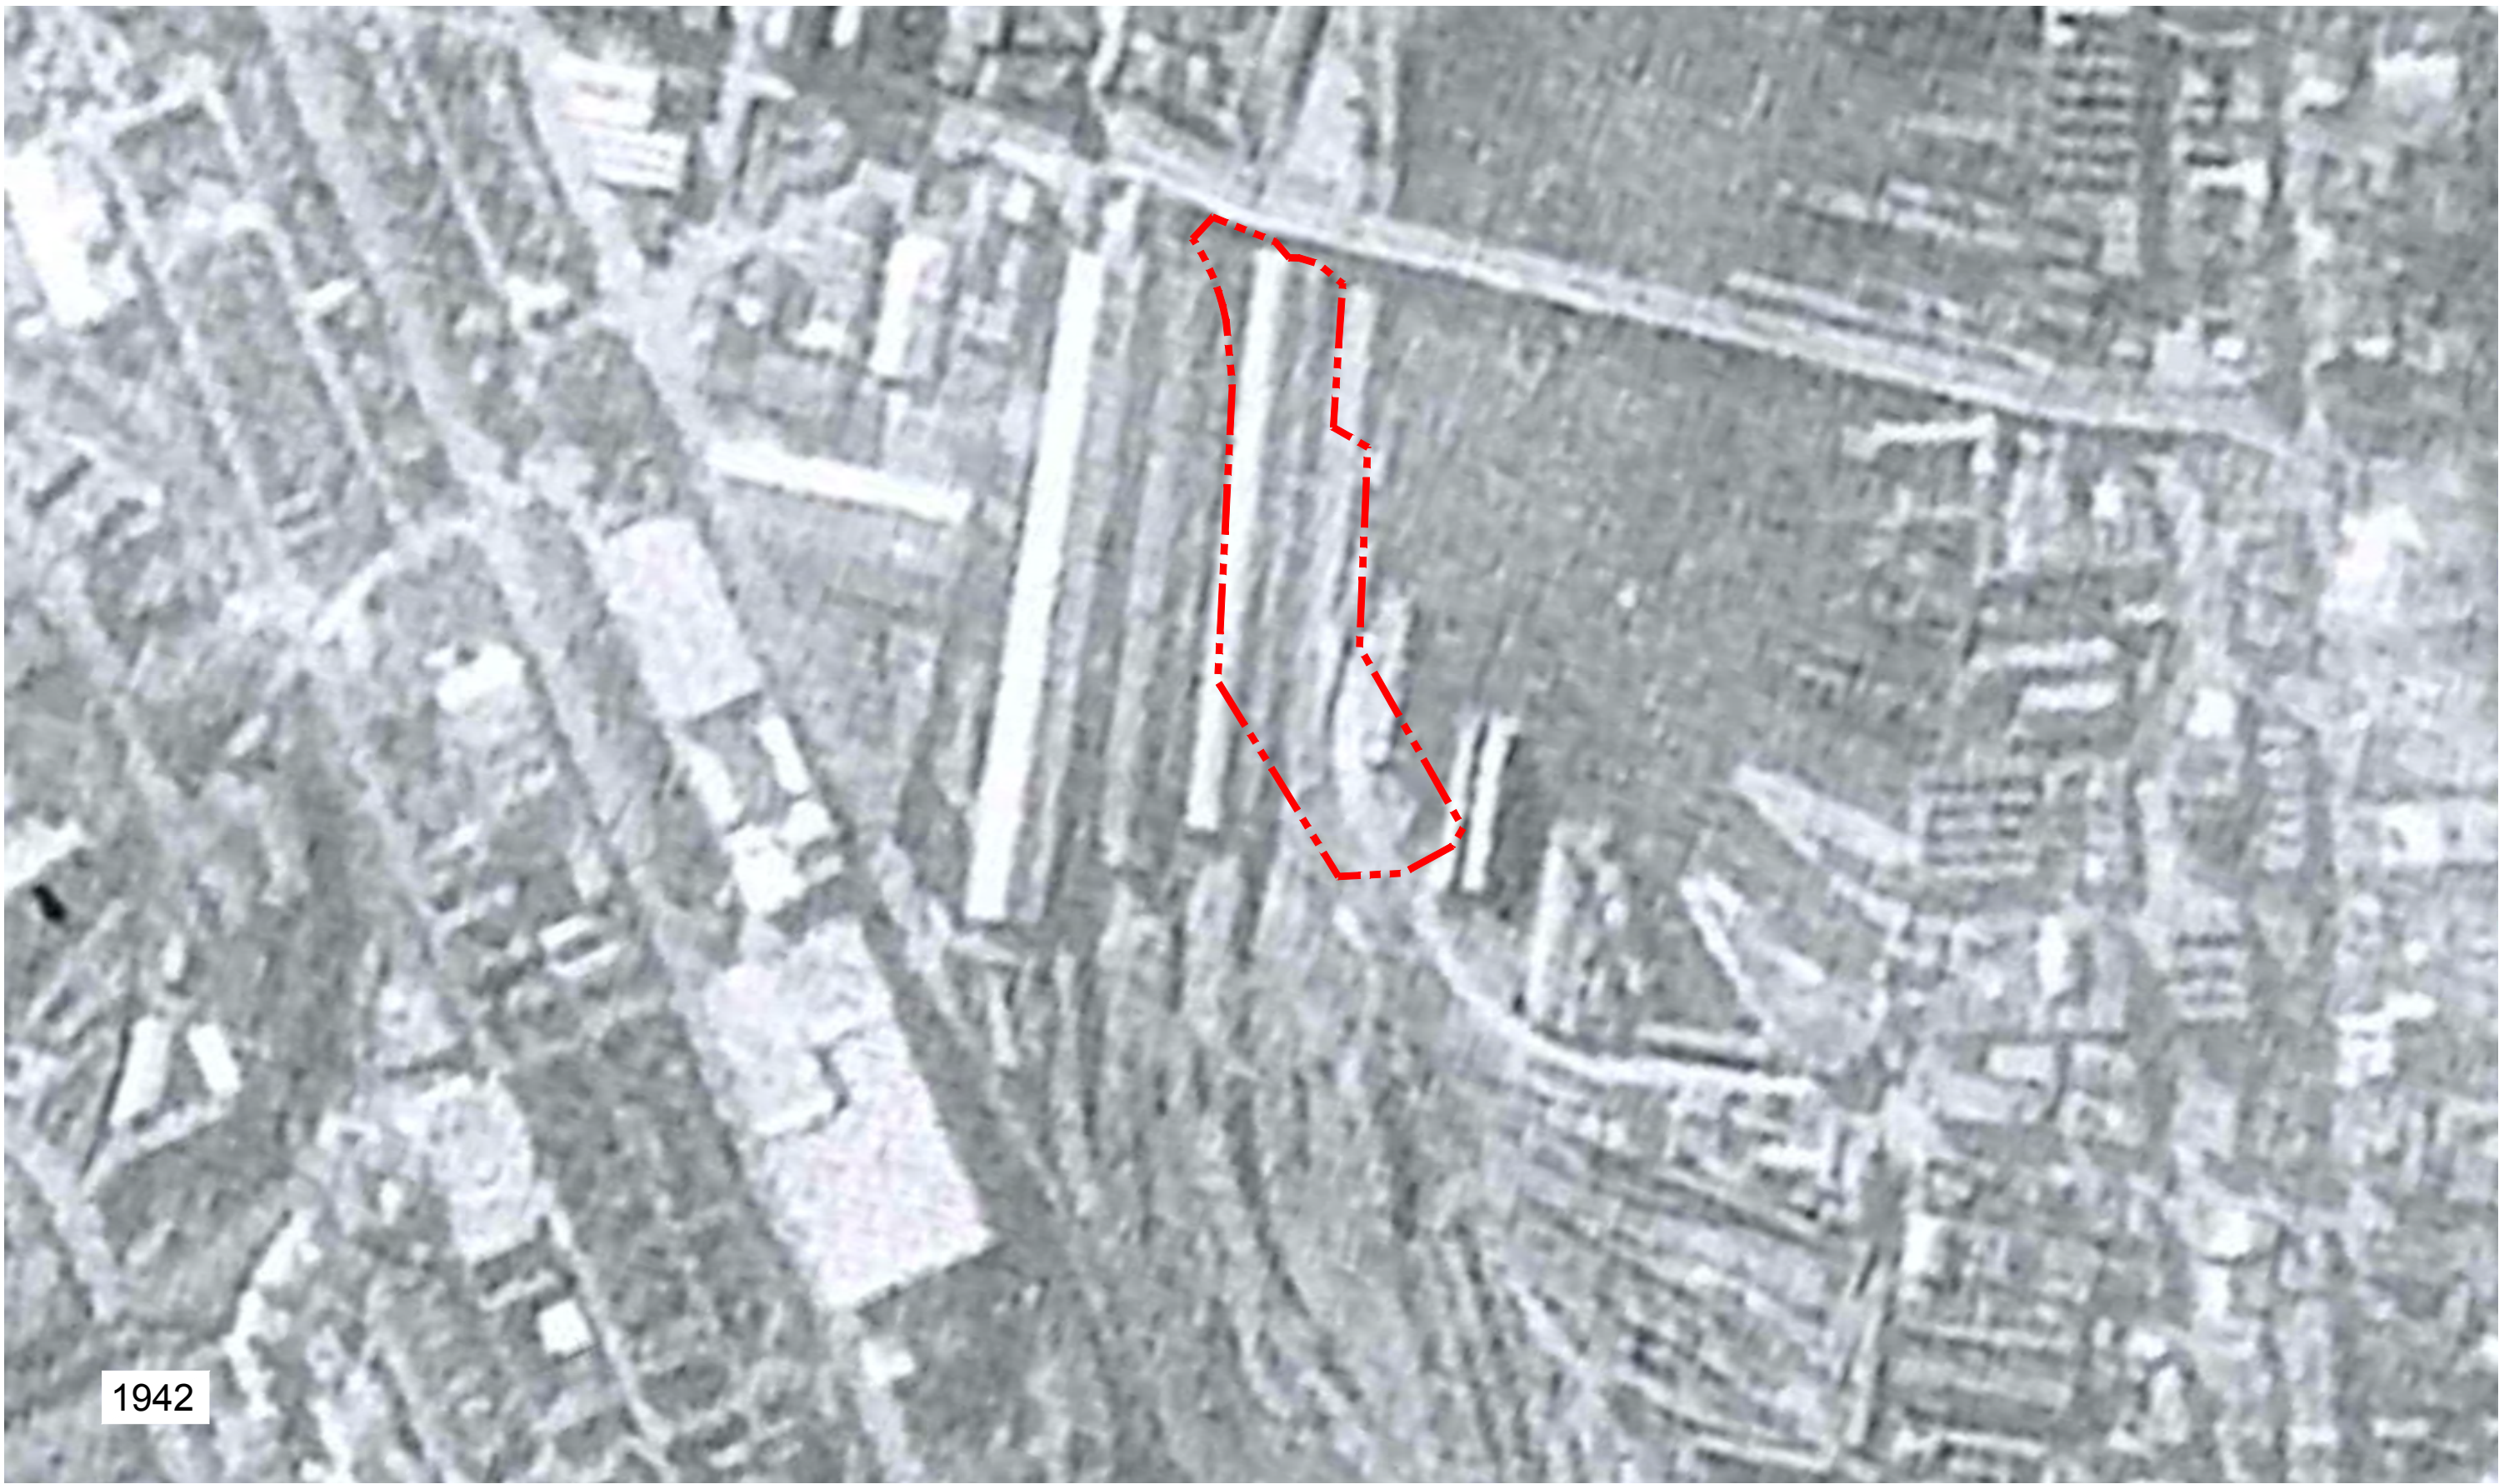
Figure 8 – Aerial Photograph – 1942

June 1942 (Figure 8)	No significant changes to the site are noted. Land located to the west of the site is further developed into a mixture of commercial and residential structures.
August 1951 (Figure 9)	No significant changes to the site are noted. Building foundations for additional structures can be seen within the rail corridor located to the south of the site.
May 1961 (Figure 10)	No significant changes to the visible portion of the site are identified. Construction of new goods yards along the rail corridor to the south of the site has commenced with an additional four elongated warehouse structures present.
August 1972 (Figure 11)	<p>No visible changes to the site are noted. The additional goods yards to the south of the site have been completed.</p> <p>High density commercial buildings have replaced many low lying buildings in the commercial district located east of Darling Harbour.</p>
