### 3.2.3 Hippopotami House (1916)

### 3.2.4 Gorilla Exhibit (1996)

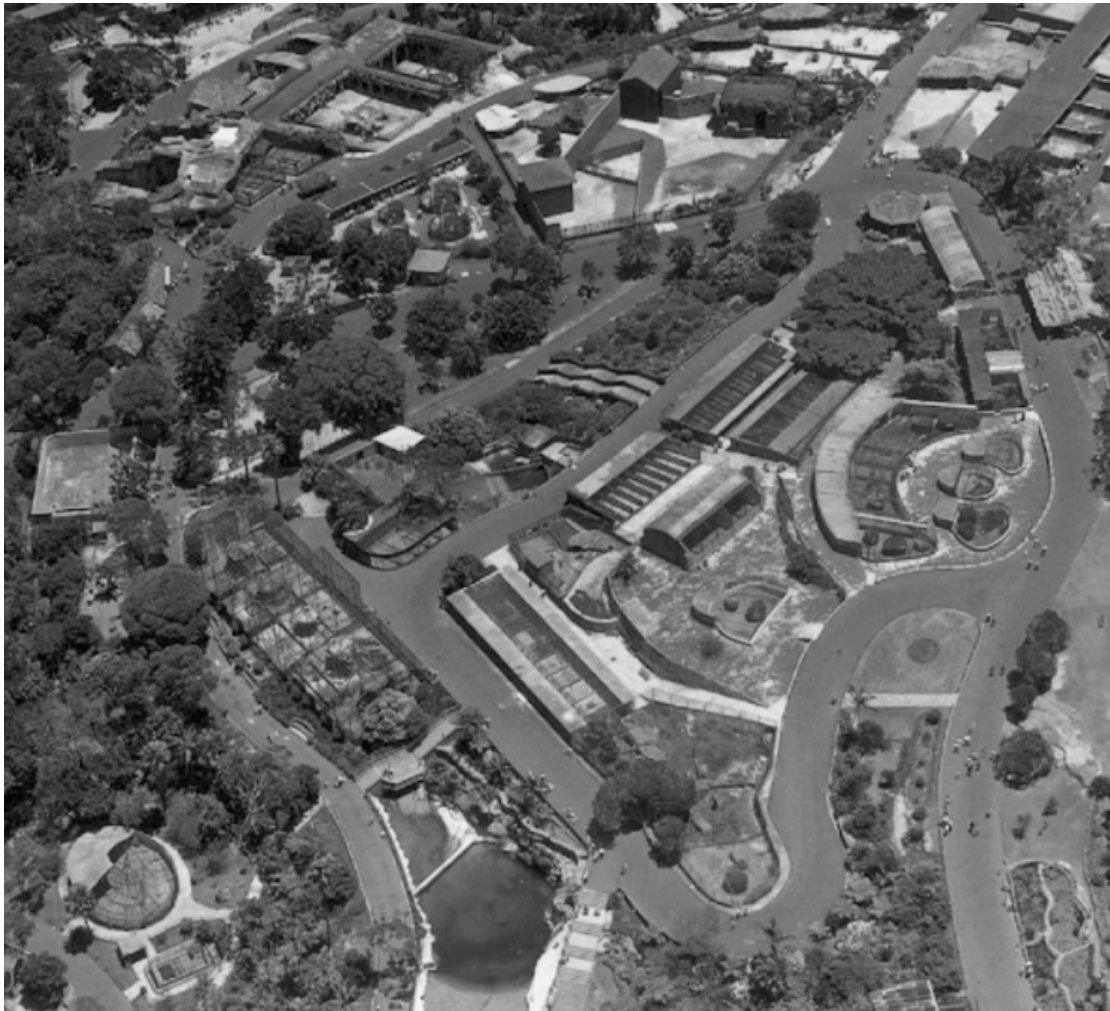
**Figure 44** Detail from an oblique aerial photograph dated 1962.

The largest of the early aviaries (now demolished) was for the birds of prey. It was designed by the GAB in late 1915,<sup>143</sup> and was described in 1917 as:

*'This aviary forms one of the prominent features of the grounds by reason of its elevated position, size and construction. It is 140 ft long, 40 ft wide, and is divided into five compartments for display of owls, vultures, condors, eagles, hawks, etc. It is constructed of water-pipe uprights and rails, and light iron roof trusses with pipe purlins. The walls and roof are covered with stout wire and mesh throughout. The central portion has a pitched roof and an average height of 35 ft, and the wings curved roofs and a height of 28ft. The artificial rock (faced) shelters are provided in each compartment, with perches for the birds, and a complete watering equipment is installed for cleansing the sloping floor'.<sup>145</sup>*

To the north of the existing gorilla exhibit and located within an elongated space between two original paths, are the remnants of one of the first major zoo exhibits. This was a prominent and substantial aviary - specifically for large birds of prey such as vultures and eagles - that was dominant in views of the central precinct of the zoo site (**Figures 44 and 45**).

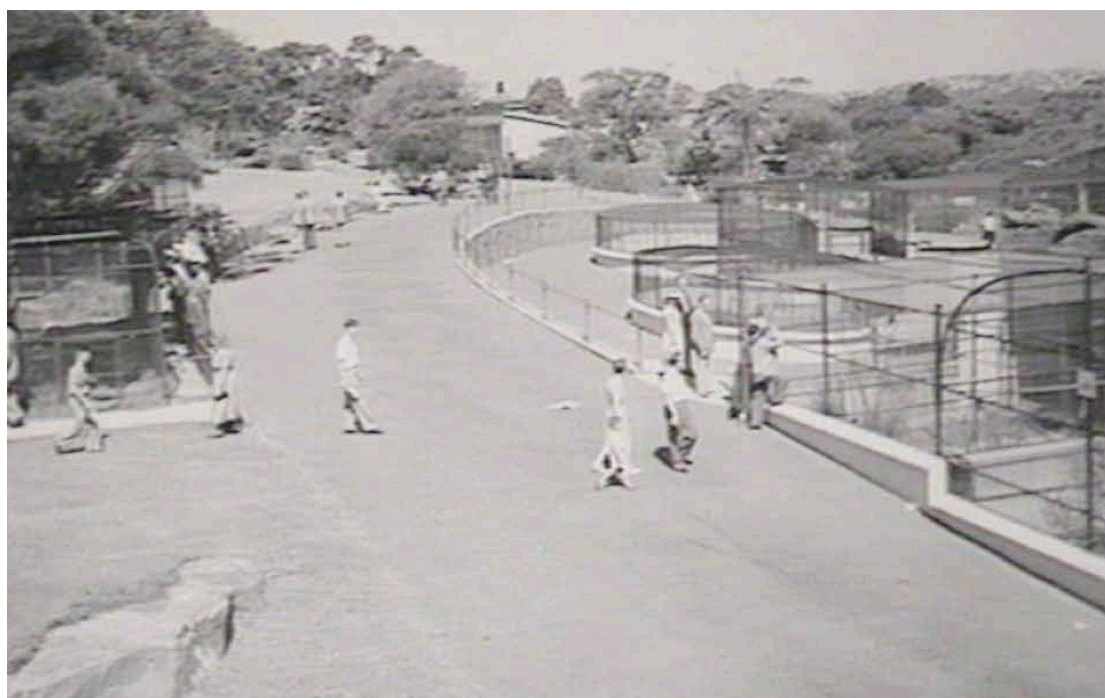
**Figure 46** The northern aviaries in 1950.

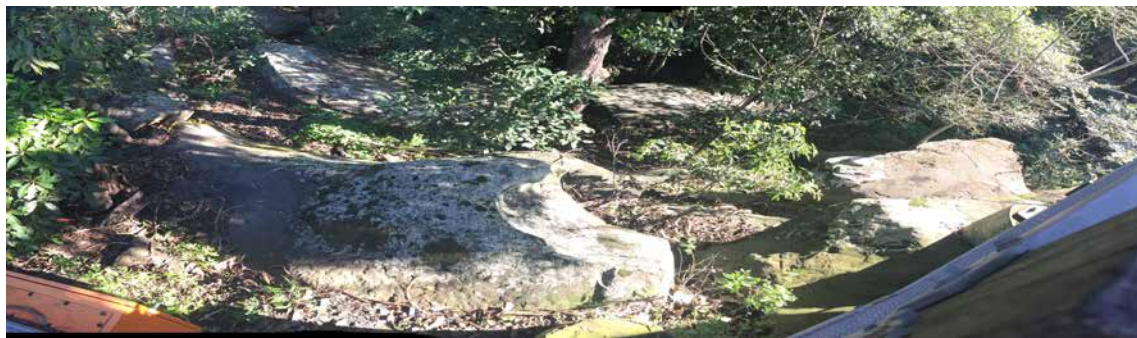
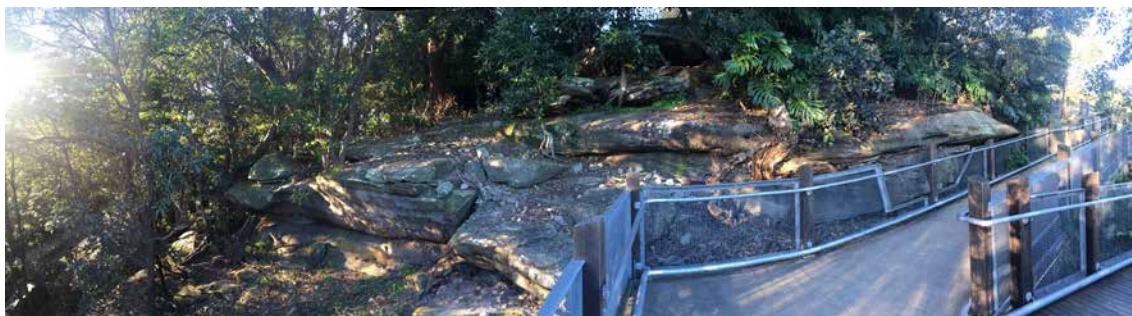
**ABOVE Figure 55** A section of remnant woodland to the immediate south of the existing western-most ramp with recruiting indigenous plant species among the retained sandstone outcrops. **BELOW Figure 56** Natural sandstone outcropping above and west of the same ramp system with a patch of remnant woodland.

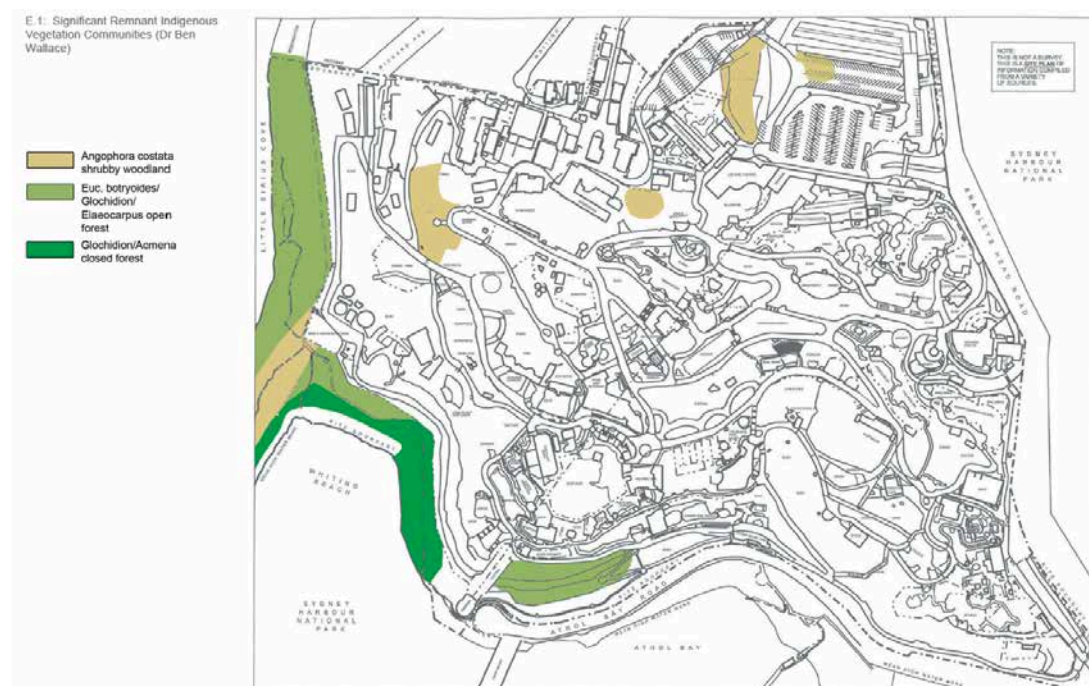
**Figure 57** Areas of significant remnant indigenous vegetation within the zoo. (Courtesy: Design 5 et al LMP, 2007)

The only substantial occurrence of locally indigenous vegetation (*Angophora costata* woodland) within the proposed African precinct relates to its western end. This coincides with where a large area is planned for a new exhibit for lions. A cursory survey in 2006<sup>165</sup> noted that there were numerous individuals of NSW Christmas Bush (*Ceratopetalum gummiferum*)(s170 Item 250L) – mainly in the southern part of this area of bushland - which is a key component of the *Angophora costata* shrubby woodland (**Figure 57**). Other species noted at that time included Waxflower (*Crowea exalata*), Bangalay (*Eucalyptus botryoides*), Hickory Wattle (*Acacia implexa*) and, further to the west, Muttonwood (*Rapanea variabilis*). The brief survey of 2006 also noted that the northern part of this remnant bushland (and the area west of the grand staircase) was affected by the parasitic fungus *Armillaria luteobubalina* which can cause tree dieback.

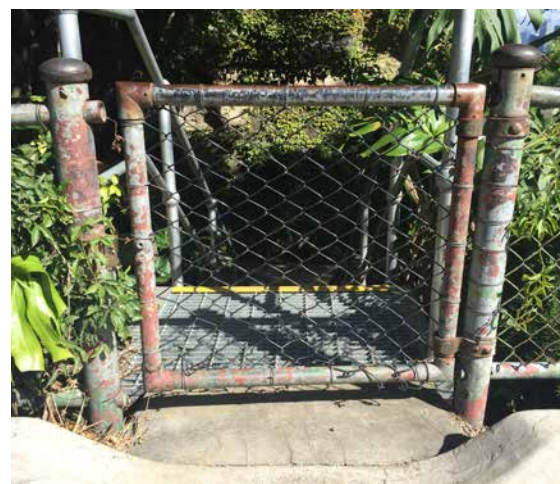
**BELOW Figure 61** An Edwardian period gate and part of the fence (Item 128L) north of the giraffe enclosure.

The structural design of the first Giraffe House utilises what appears to be steel frame at approximately 6 feet (1820mm) centres that resulted in a structure 5 structural bays long, 3 structural bays wide and 3 structural bays high. The structure includes half inch (12mm) steel bars at 12 inch (305mm) centres with steel mesh laid over and over that concrete coloured as rock. The structure has ribs or 'knees' of steel and concrete that acted as structural buttresses, as well as breaking up the rectilinear form of the structure. The roof is a curved concrete structure behind a rockwork parapet, supported in a steel-reinforced concrete bow truss frame and covered in sheets of a bituminous product known as Malthoid. **Figures 62 and 63** show the completed structure. The **Figure 16** plan includes details of the steel mesh fence structure, some part of which may remain associated with Item 128L the steel mesh fence (**Figure 61**).

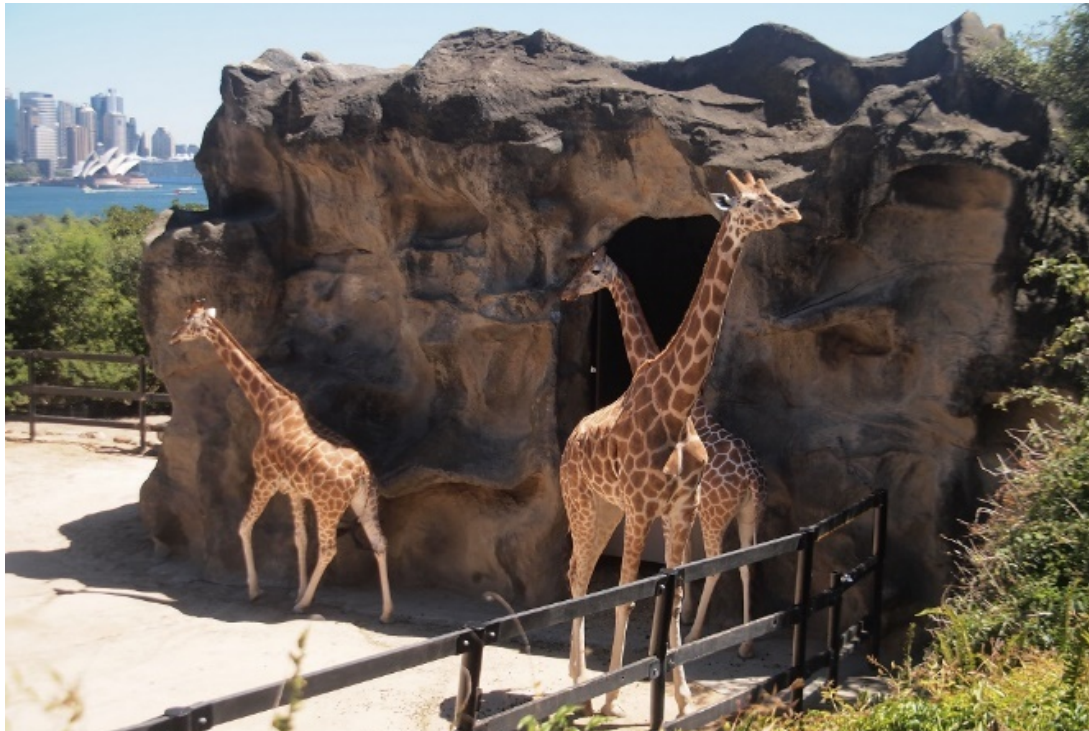
**Figure 63** A 2017 view of the 1924 giraffe house – iconic animals, an iconic shelter and an iconic public building in the background. (Courtesy: Geoff Ashley)

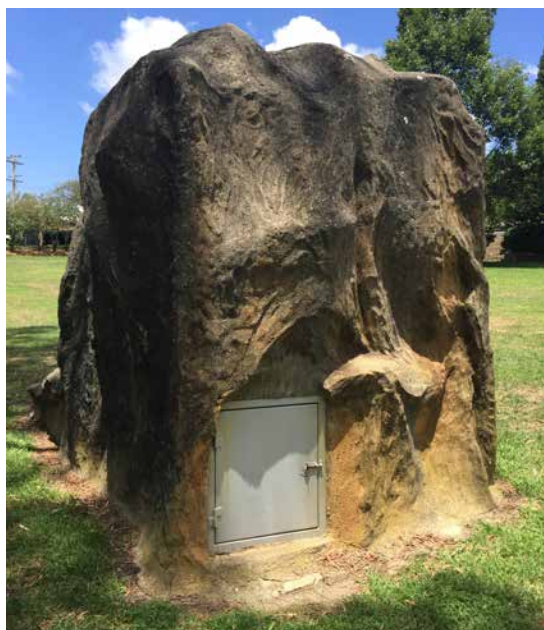
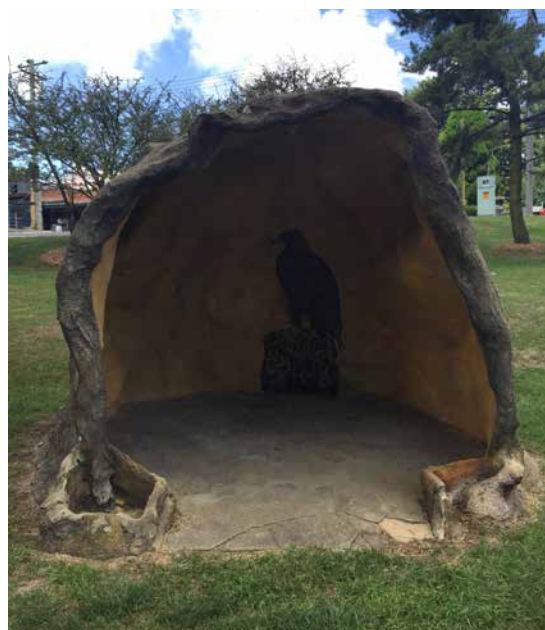
**Figures 64 and 65** Examples of the numerous small faux-rock structures within the local park at Mount Victoria in the Blue Mountains built in the 1930s under the instruction of Tom Adam who appears to have been responsible for the two giraffe shelters at Taronga Zoo.

A small park at Mount Victoria sheds some light on the people who actually built this structure as archival information held at the Mount Victoria Museum mentions that various faux-rock structures for a small zoo within the local park in the 1930s “were designed by Tom Adam[s] who had already built similar structures at Taronga Zoo”. Those at Mount Victoria were “made from cement-rendered steel and wire mesh and were likely to have been created by Adam[s] either with his assistants from the zoo or by local men employed under the Depression

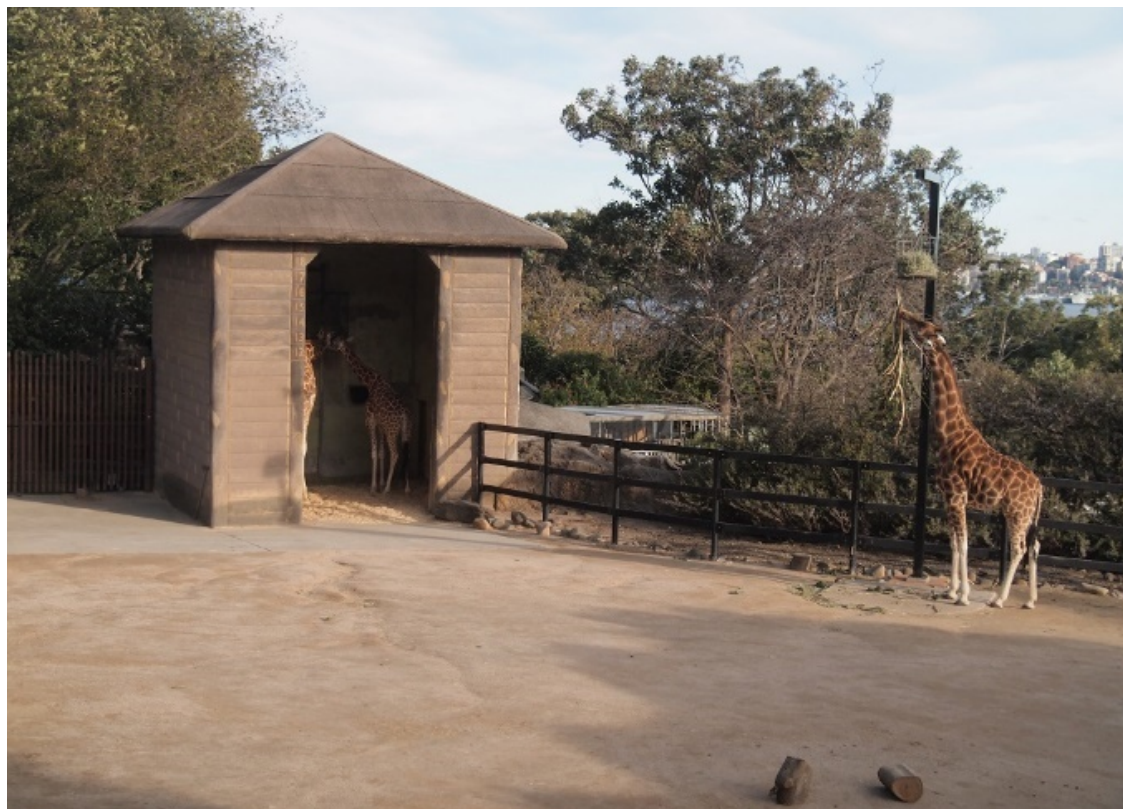
**Figure 68** A 2017 view of the 1940s giraffe shelter showing more of its contextual setting. (Courtesy: Geoff Ashley)

The new Giraffe House was built with in-situ reinforced concrete walls with a surface treatment that imitates horizontally laid logs between 'posts' at corners and the openings. A similar structure was built for the African Elephant House (now demolished). The new Giraffe House is approximately 6m square and is of a similar height to the eaves. The structure has an opening facing north and has framing inside to contain feed. The structure is topped with a pyramidal hip roof that, while constructed of concrete, has the appearance of layered thatch sheeting (**Figure 67**). To the west of the structure is a small imitation rock enclosure probably used for storage. Cast into one of the posts at the entrance to the cabin are figures showing heights in feet of the animals. With the recent removal of the former koala shelter/kiosk near the Upper Entrance area, this giraffe structure is now the only surviving 'log cabin' type construction left within Taronga Zoo.

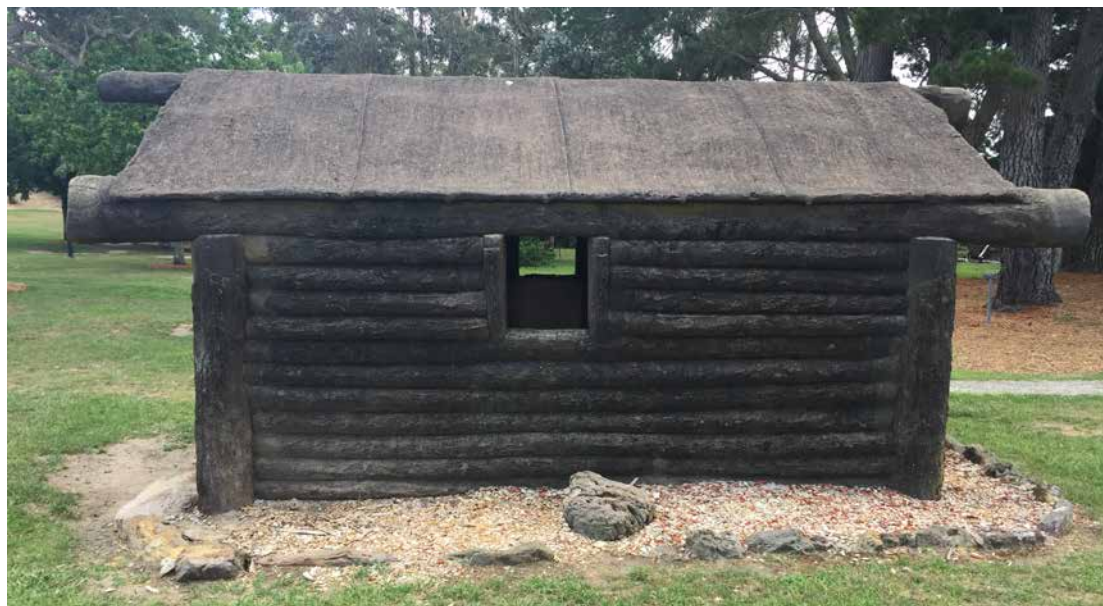
**Figure 69** The concrete faux-timber log shelter at Mount Victoria in the Blue Mountains also showing its parallel-scored roof cladding to imitate traditional thatch. Both this structure and the 1940s giraffe house at Taronga Zoo share in common the technical expertise and creative authorship of Tom Adam.

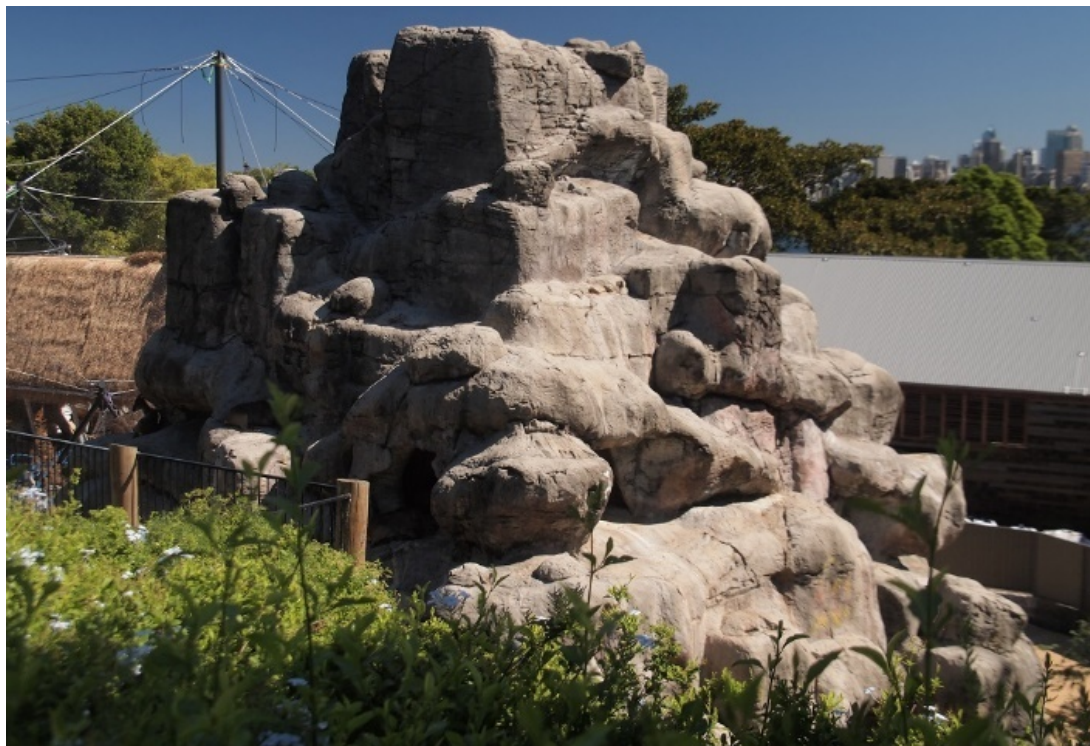
**Figure 70** A 2017 view of the 1932 Tahr Mountain, though now showing within its traditional setting visually intrusive structures associated with the new Sumatran Tiger precinct to the south. Also note the current 'blocky' form of the structure after modifications to its original 'angular' form (**Figure 11**) – ostensibly to assist with regular cleaning and maintenance though, in practice, this has not been convincingly successful. (Courtesy: Geoff Ashley)

Although the s170 inventory noted Tahr Mountain as in good condition, an inspection in July 2016 undertaken for this project by the heritage specialists, the design team and structural engineers revealed that water ingress into the structure through the imitation rock cladding has resulted in significant corrosion and deterioration most particularly to the imitation rock cladding layer but also to the supporting concrete frame. In some areas light was visible through the cladding layer indicating areas of water ingress. A report from that inspection by Woollacott Consulting Engineers noted that at some places the internal surface profile of the imitation rock cladding appears to have been reinstated by spraying shotcrete onto the surface, particularly at the southwest corner and along the northern side.<sup>173</sup> The report also noted some damage to the structural concrete frame by way of corroding reinforcement and spalling concrete, mostly where the framing was in contact with the external imitation rock cladding that was allowing water ingress.

The report concluded that the extent of spalling damage observed to the structural framing of the mountain has not yet severely compromised the structural integrity. However, if the damage is left untreated and allowed to continue, it will eventually result in localised beam/column failures, which could compromise the stability of the structure and necessitate extensive remedial works or demolition. The report identifies action to repair the reinforced concrete frame. In relation to the ferro-concrete cladding the report states that it is generally in very poor condition, and localised failures could occur at any time where, dependent on their extent, could result in the injury/death of animals on the mountain. The report recommends that internal repair of the cladding be undertaken, using temporary propping of cladding panels between supporting columns to allow for drummy material and heavily corroded reinforcement to be cut back and removed, prior to installing new reinforcement and reinstating the original surface profile by spraying with shotcrete.

This HIA report recommends that as a mitigative measure in relation to this DA that a detailed investigation and documentation project be instigated (with reference to the structural engineering report made for this project) and that a conservation program be implemented so that Tahr Mountain is capable of future use.

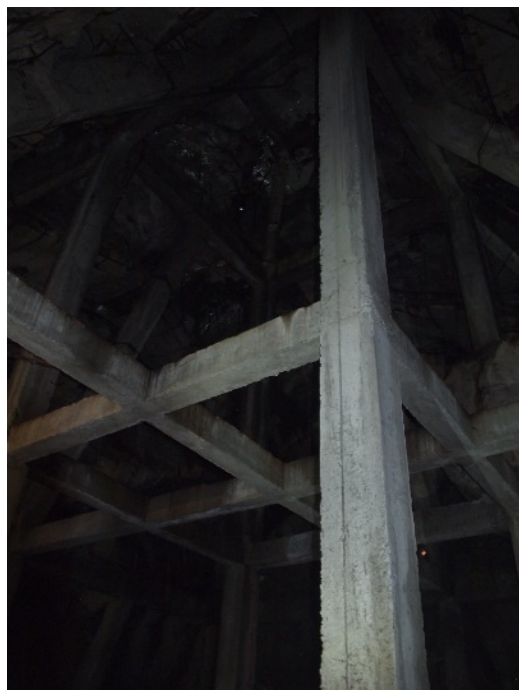
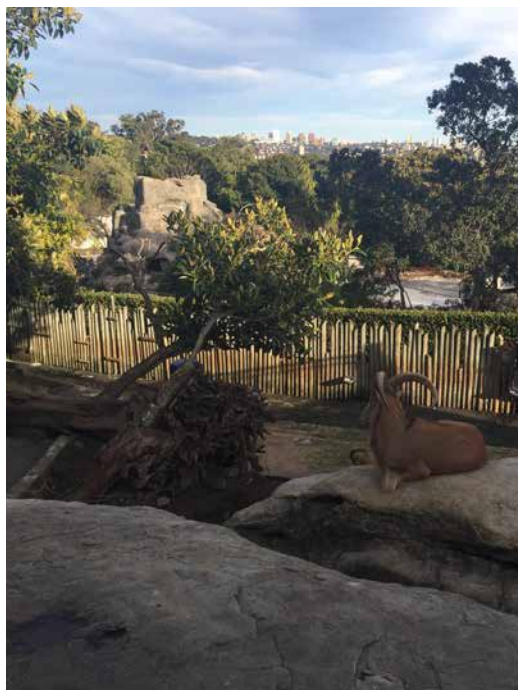
**LEFT Figure 71** A recent view of Tahr Mountain's interior structural members. (Courtesy: Geoff Ashley)  
**RIGHT Figure 72** A view of across the Barbary sheep enclosure with Tahr Mountain in the background. Note effective blending of faux-rockwork and natural sandstone to assist in visually unifying the Taronga Zoo site.

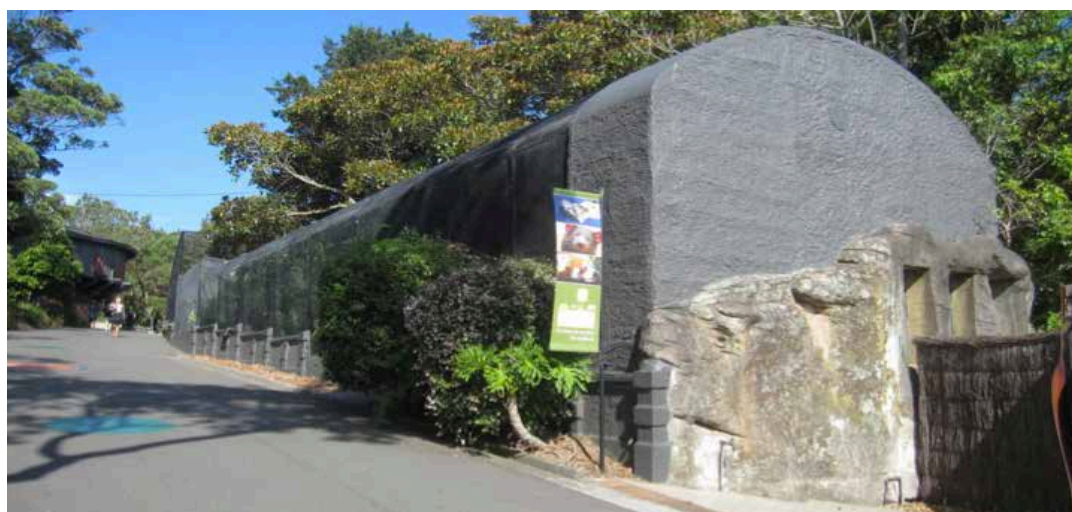
**ABOVE Figure 78** A recent view of the former Finch Aviaries (s170 Item 60B) with the former Python enclosure (in faux-rock) to the right. (Courtesy: Jean Rice) **BELOW Figure 79** An April 2017 view of the new lawn over the site of most of the former Finch Aviaries with the retained former Python enclosure to the right. Also evident in the view are the two mature trees – a Brown Pine (s170 Item 168L) and the large Moreton Bay fig tree (Item 160L) beyond the lawn. Between the two trees is a change of level indicating the location of an Interwar period stone retaining wall.

The former Finch Aviaries (60B)(**Figure 78**) along the main public thoroughfare were built progressively with the first group completed adjacent the roundhouse at the western end (now partly demolished) in the first decade of Taronga Zoo's development (evident in the 1943 to 1950 photography – see **Figures 19** and **20**). They were originally built as a python exhibit but soon changed to an aviary. A second group was added in the 1930s with a gap in between where a path emerged from around the back of the 'U-shaped' aviary. The much later infilling of this gap resulted in the aviaries being 'read' as a long line of meshed enclosures. The former Finch Aviaries were partly demolished by early 2017 with the original python structure retained.

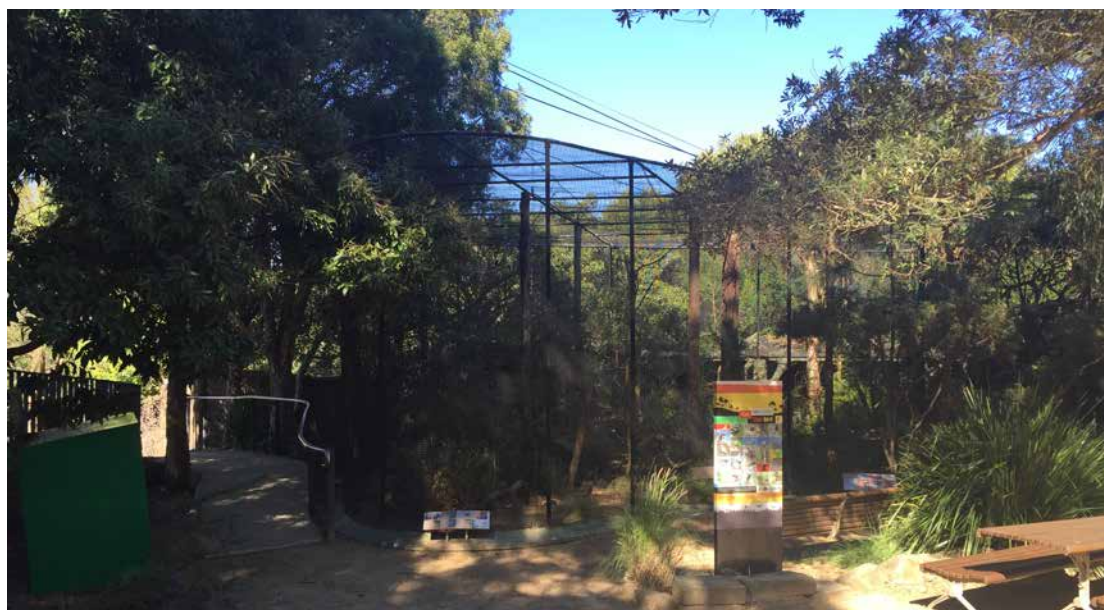
**Figure 81** A 2016 view of the eastern end of the Bush Birds of Australia exhibit where the unique 'U-shaped' form of the aviary enables an unusually close engagement with the birds. Sympathetic landscaping within and outside the aviary provides a convincing sense of 'immersion' with the exhibit.

The largest of the remaining early aviaries is the 'U-shaped' Bush Birds of Australia exhibit (Item 97B)(**Figure 81**) featuring birds of Cumberland Plains Woodland and Ironbark-Turpentine Forest vegetation communities. The basic structure of the 'U-shaped' aviary was in place by 1934 and has been modified more recently to extend its height and increase flying space and volume for internal vegetation.

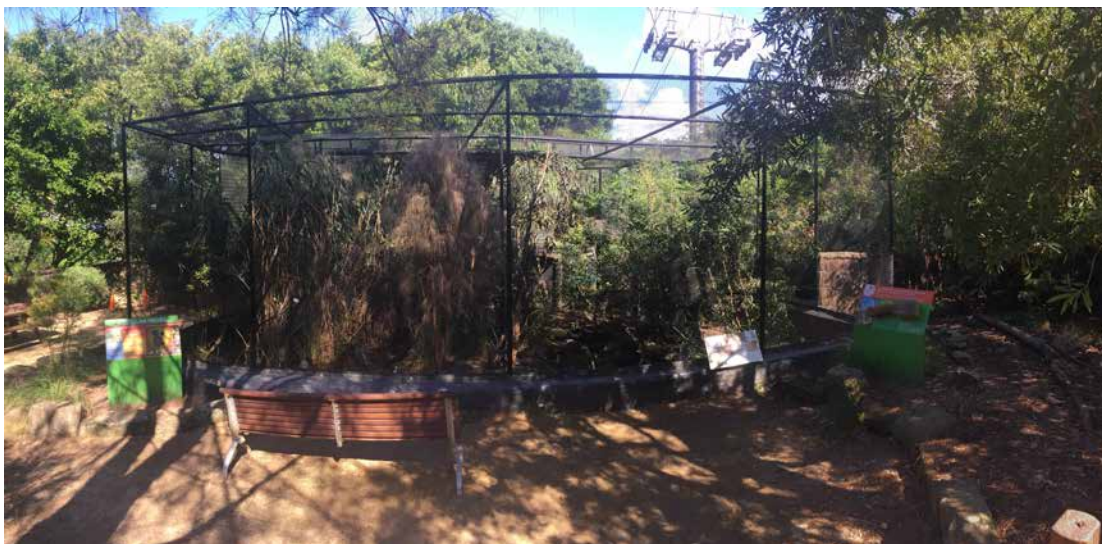
**Figure 82** The eastern aviary (Item 159B) currently with various Australian finches and kingfishers.

A third, much smaller aviary (159B)(**Figure 82**) was built to the southeast of the 'U-shaped' aviary in the 1930s (shown as being for snakes in the late 1930s guide plans). As with the latter, this small structure offers a more intimate, reflective area in which to engage with the birds away from the noisy main thoroughfare. While wire divides the birds from visitors, it could be argued that it is more likely visitors would experience small birds very close than within the large walk-through aviaries that are now the preferred exhibit option.

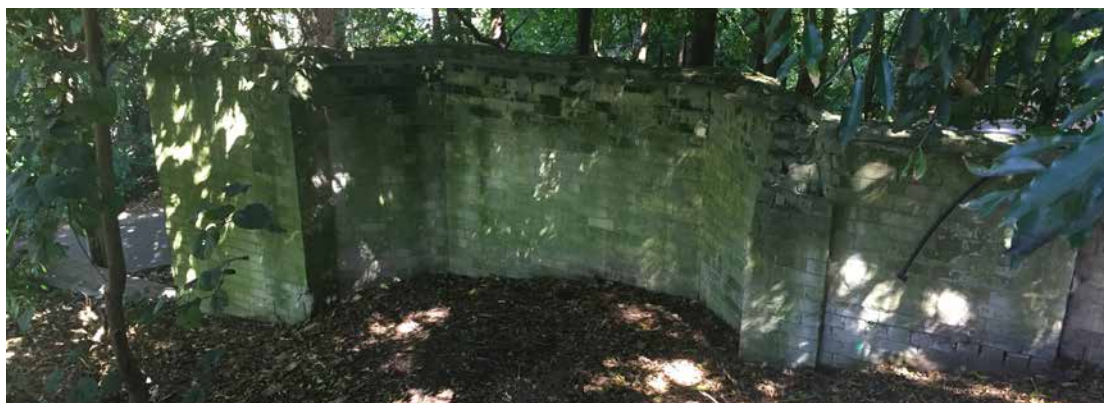
**Figure 83** The remnant apse of the former Bird of Prey aviary.

What remains of the structure is the northern roughcast masonry base wall indicating part of its outline and extent. At the southwestern end is a surviving apsidal enclosing wall though at the northeastern end a rustic stone wall (next to steps leading to the existing Lemur exhibit area) survived until recently<sup>180</sup>. Use of the aviary for its original purpose (keeping large birds of prey accustomed to flying considerable distances) understandably waned such that its pipe and mesh superstructure was removed about the 1970s.

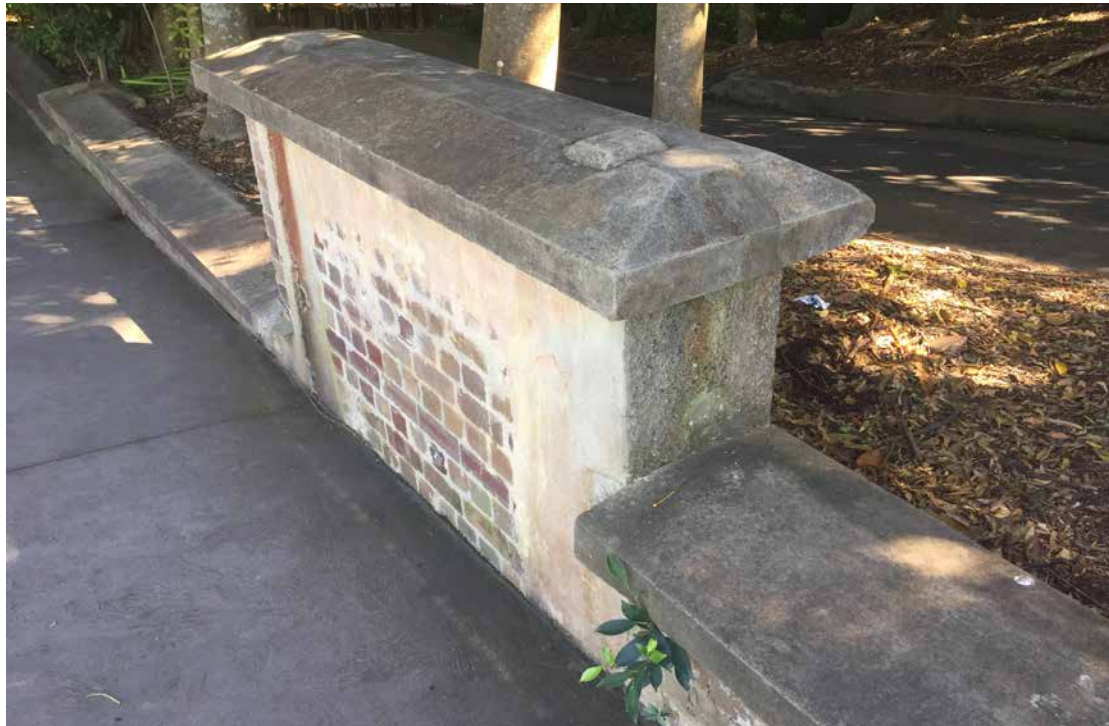
**ABOVE Figure 84** Part of the upper boundary wall of the former Birds of Prey aviary showing its generous concrete coping and an upstand section with exposed English Bond brickwork. **BELOW LEFT Figure 85** An intact corner section of the former aviary boundary wall. **BELOW RIGHT Figure 86** *Callitris rhomboidea* at the end of the former Birds of Prey aviary – and potentially contemporary with it.

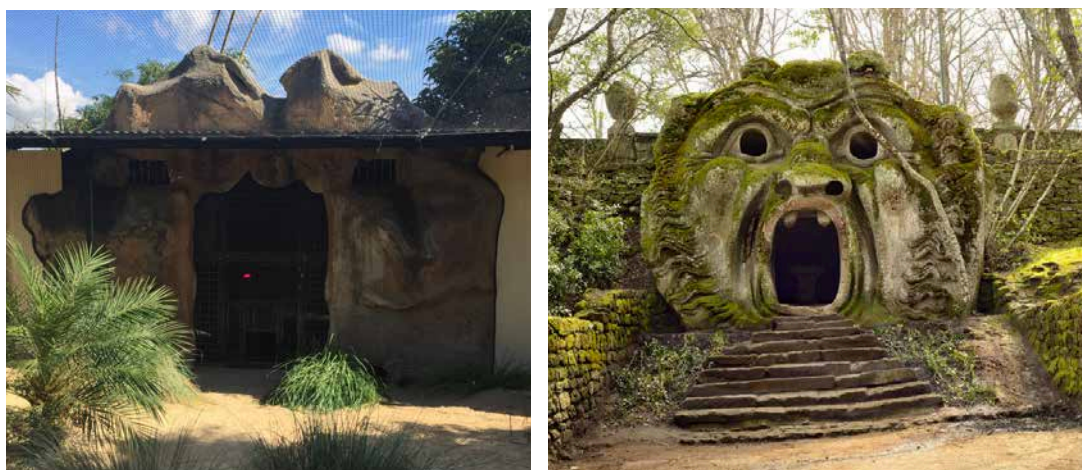
**LEFT Figure 87** Item 98B (currently the Fennec Fox shelter) appears to be a light-hearted stylised reference to the famous 16<sup>th</sup> century Mannerist monster face of Pier Francesco Orsini's Bomarzo villa garden. (**Figure 88 RIGHT**)(Source unknown)

Little is documented about the history of this structure. While featuring imitation rock, its proportions and openings suggest a grotesquely anthropomorphic face with a central mouth opening, two small 'eye' windows and ear like side projections. It was originally adjacent a prominent public path which continued to elevated walkways above and around the lion and tiger pits. In the current arrangement visitors only see the front façade of the structure and the wire mesh enclosure in front of the structure significantly limits views to it (**Figure 87**). The structure is roughly square or rectangular in plan and has a curved roof like the 1924 Giraffe House with concrete imitation rock appearing to continue down the sides.

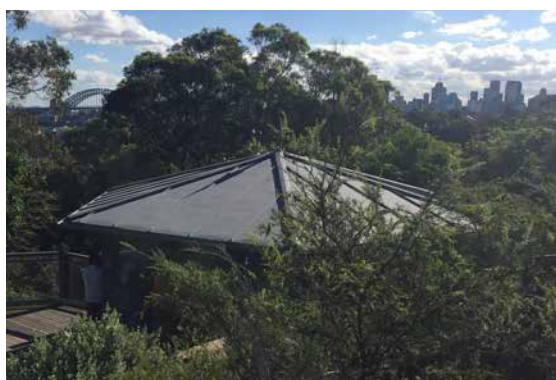
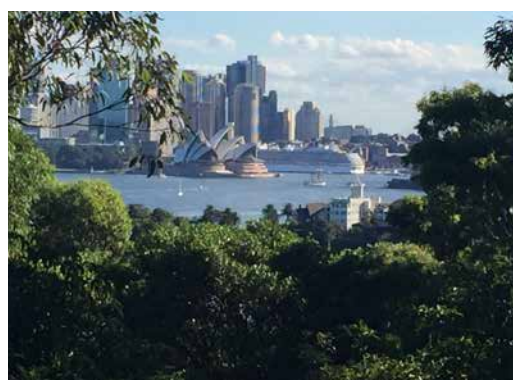
**LEFT Figure 89** An April 2017 view of the 1932 octagonal shelter (with a more recent roof) showing a glimpse of the vistas to the Sydney Harbour Bridge and North Sydney that would have been possible in previous years from within the structure. **RIGHT Figure 90** A current vista from the shelter to the harbour, opera house and CBD. **BELOW Figure 91** Inside the octagonal shelter showing the apertures with views of the harbour and CBD. The photograph also reveals the more recent wall plates and superstructure over the original 1932 walls. (Courtesy: Geoff Ashley)

The Shelter is octagonal in plan and has a structure of single skin brickwork. The Shelter now has textured cement rendered walls, but it appears (from lost joinery) that it was originally of a (glazed) face brick construction. Openings that are facing the path have arched openings. Openings that face the view have wider rectangular openings. A timber seat is built along inside walls.

The Conservation Strategy stated that the Shelter was in poor condition with the roof shingles decayed (presumably timber) and not watertight. **Figure 37** shows a low sheet metal roof with traditional raised seam upstands. The s170 inventory states that the Shelter was restored/refurbished in 2012 and it appears that the roof has been reconstructed to its original form. The roof soffit appears to have been changed to plywood during the reconstruction.

An important part the reason for, and history of, the Shelter are the views available from it and the Stevens Lookout. An undated but most likely 1930s photo (**Figure 37**) shows the Shelter with good views to the Harbour Bridge. While views to the Harbour Bridge may now be limited from vegetation growth, there remain very good views of the Opera House from this Shelter (**Figure 90**).

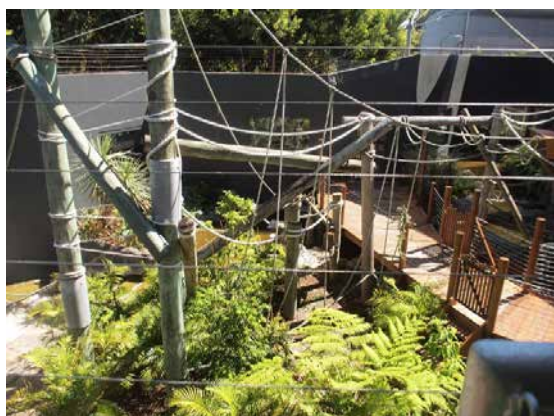
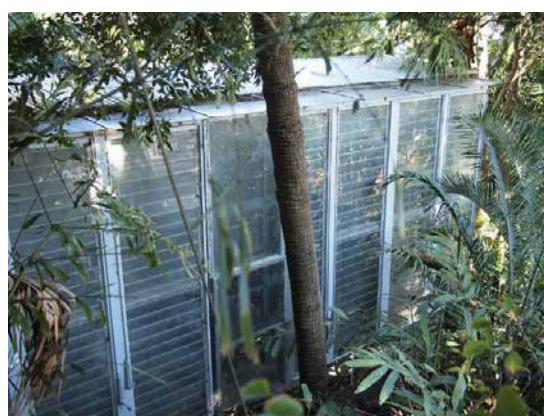
The enclosure is in many respects deliberately 'non-architecture' where the animals are generally viewed in a rainforest like landscape space enclosed by walls but open to the sky (**Figure 92**). The open space area was shown as Exhibit on construction drawings and is constructed with a high reinforced concrete block wall with a steel wire and fabric canopy over parts of the space. A watercourse ran through the Exhibit and it had extensive planting and a timber climbing structure.

**LEFT Figure 92** Orang-utan enclosure (103B). **RIGHT Figure 93** Louvred glazing next to the Orang-utan exercise yard. (Both photographs courtesy: Geoff Ashley)

The Enclosure building had 8 animal dens, 2 exercise yards, an internal viewing yard (visitors could view in), a keeper office and circulation and a food preparation area. The Enclosure has two curved steel roofs and a louvre-glazed wall standing in front of the exercise yard but also providing light but protection from weather (**Figure 93**).

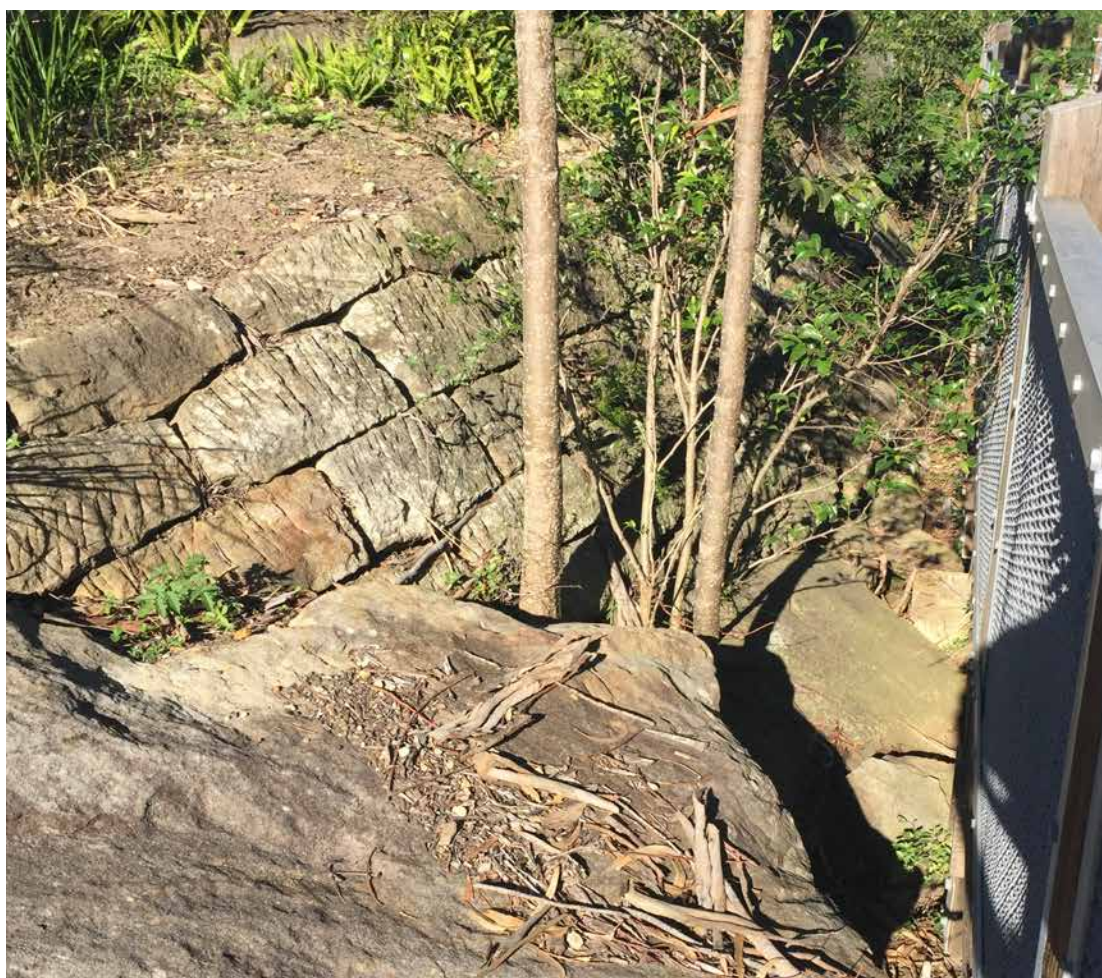
**Figure 96** A section of battered drystone retaining wall of worked (sparrowpecked) sandstone above the existing ramp (at right) and south of the Barbary sheep enclosure. Note too, part of a large rock outcrop in the foreground that characterises the remnant natural landscape in this western part of the Waterhole precinct.

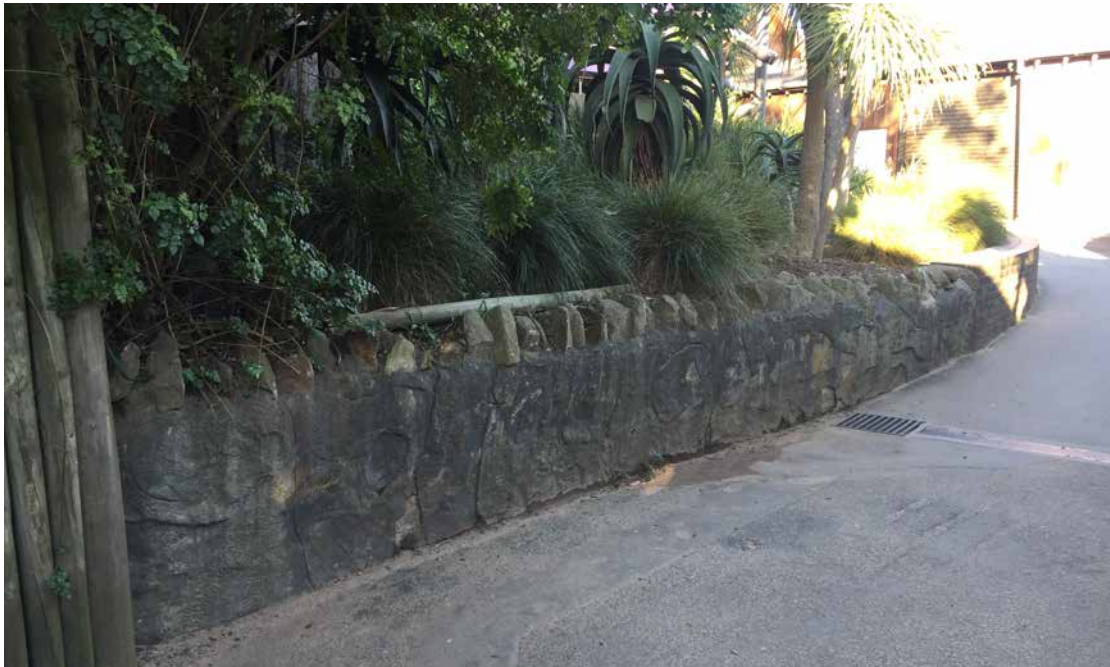
**Figure 97** Item I32L, near the eastern end of the Waterhole precinct, features faux-rockwork render to the body of the wall with stone cresting reminiscent of that used for the one-off rustic stone exedra and bridge within the eastern gully of the zoo. Its character and position defining an early path, suggest the wall section was part of the early phase of zoo development.

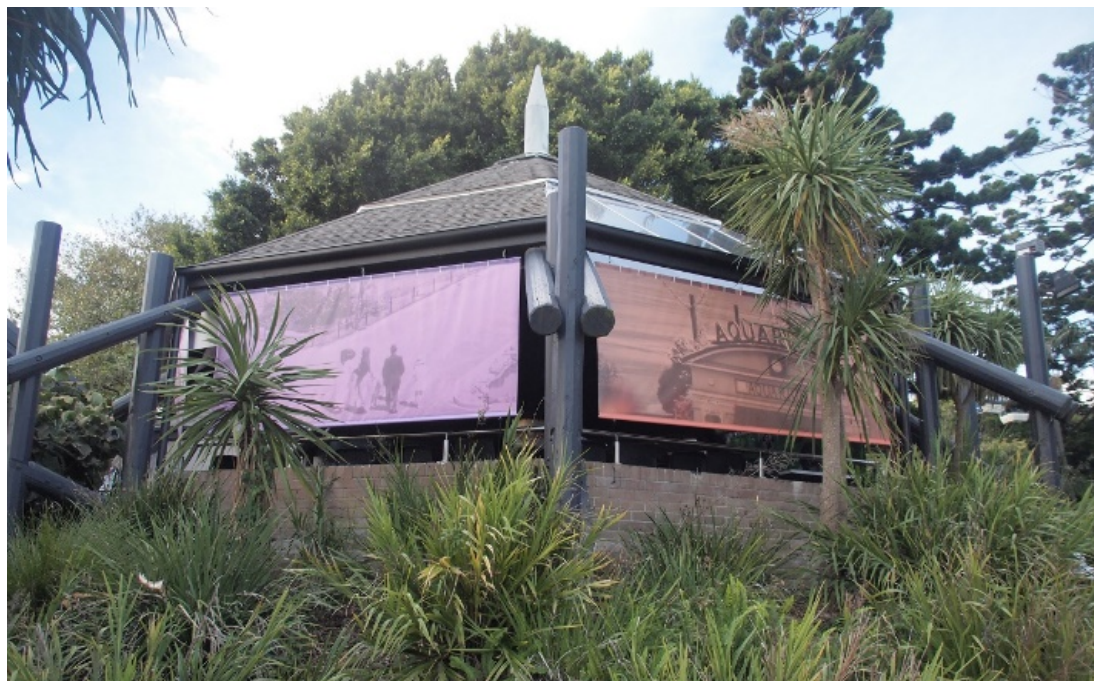
**Figure 102** The 1987 Safari Lodge with its earth-toned base walls and substantial structural poles provides a sensitive and thematically appropriate focus for the original African Waterhole precinct. (Courtesy: Geoff Ashley)

The structure itself is interesting, being comprised of two parallel roughly hewn c150mm timbers forming the roof structure and continuing to the ground as bracing for the corner poles. Similar timbers span from central posts of each of the three octagonal 'pods' to the roofing structure. The roof cladding is a modern bitumen-based shingle material to replicate the sense of timber shingles. The structure is surrounded by dense landscape plantings of similar theme to the structure.

The Safari Lodge Kiosk is comprised of three linked and similar sized octagonal shaped timber frame structures (**Figures 33, 34 and 102**). Two of the octagonal structures are open as visitor eating areas and the third has operable walls with a glazed toplight. There is an additional gable-roofed structure of three segments housing visitor toilets surrounding the northern octagonal structure.

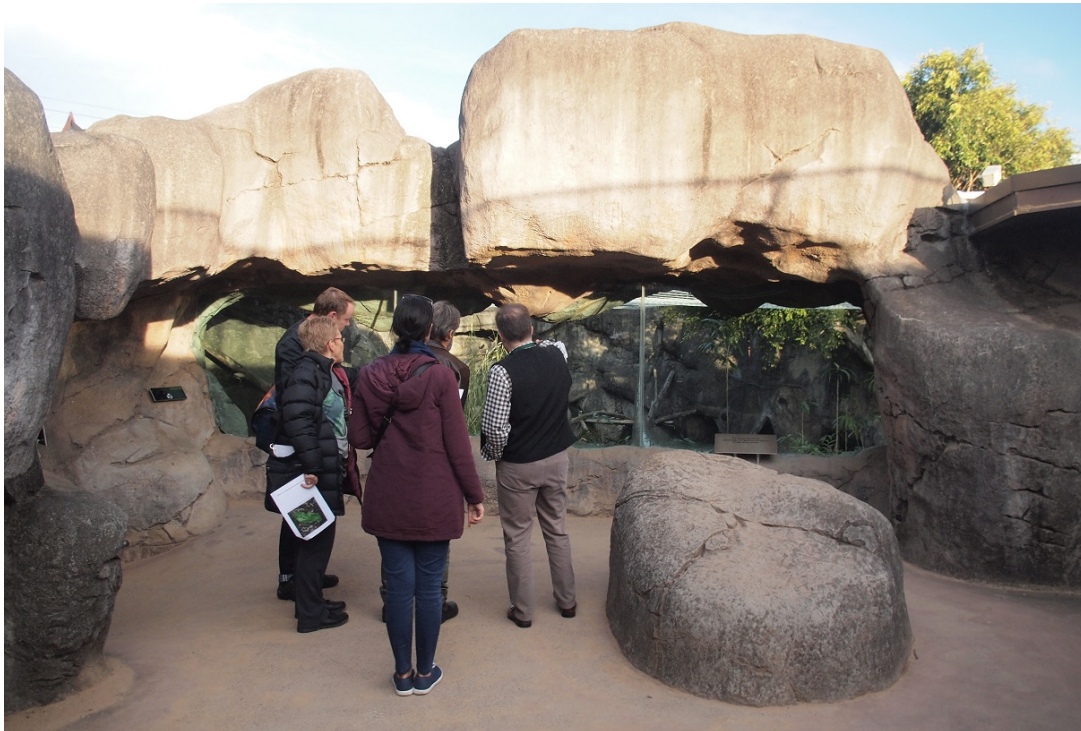
**Figure 103** The upper Sun Bear exhibit forecourt enclosed by massive faux-rockwork 'boulders'. It lies to the immediate south of the proposed new African Waterhole precinct. (Courtesy: Geoff Ashley)

Opposite the current meerkat exhibit is the former 'Lion Caves' area, with an enclosure currently used for a Sun Bear and featuring a considerable amount of faux-rockwork of generally high quality. It was opened in 1996 by then NSW Minister for the Environment Hon Pam Allen MP. At the enclosed superior viewing space (typical of older exhibits) much use has been made of broad plate glass 'walls' though with massive faux-rockwork sections (appearing to be disconcertingly unsupported) above (**Figure 103**).

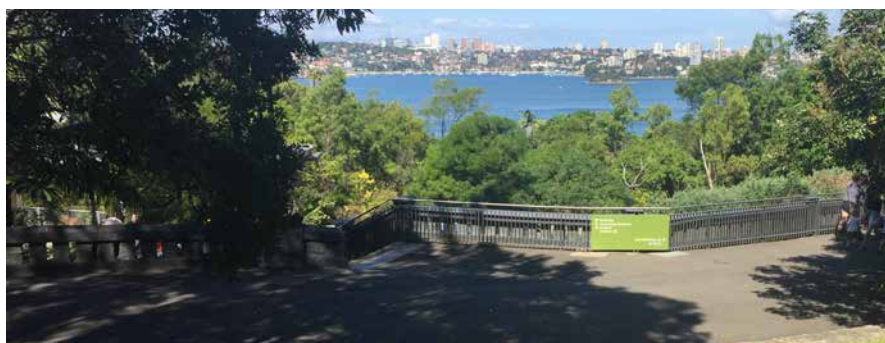
**Figure 104** A famous view from the Serpentine path en route to the former seal pools. Note the early balustrading defining the path.

The basic network of roads and paths from the original and early zoo plans serves to maintain a continuity and legibility across the visually complex site. It is likely that this layout would hold social value (through 'mind-mapping' of reference points or 'place memory') as much as historical value. Often the sequence of paths and publicly accessible access roads forms part of a serial visual experience featuring animal exhibits as well as broader intermittent views and panoramas out across the zoo to the harbour (Figure 104) and city skyline beyond.
