### 3.2.3 Hippopotami House (1916)

### 3.2.4 Gorilla Exhibit (1996)

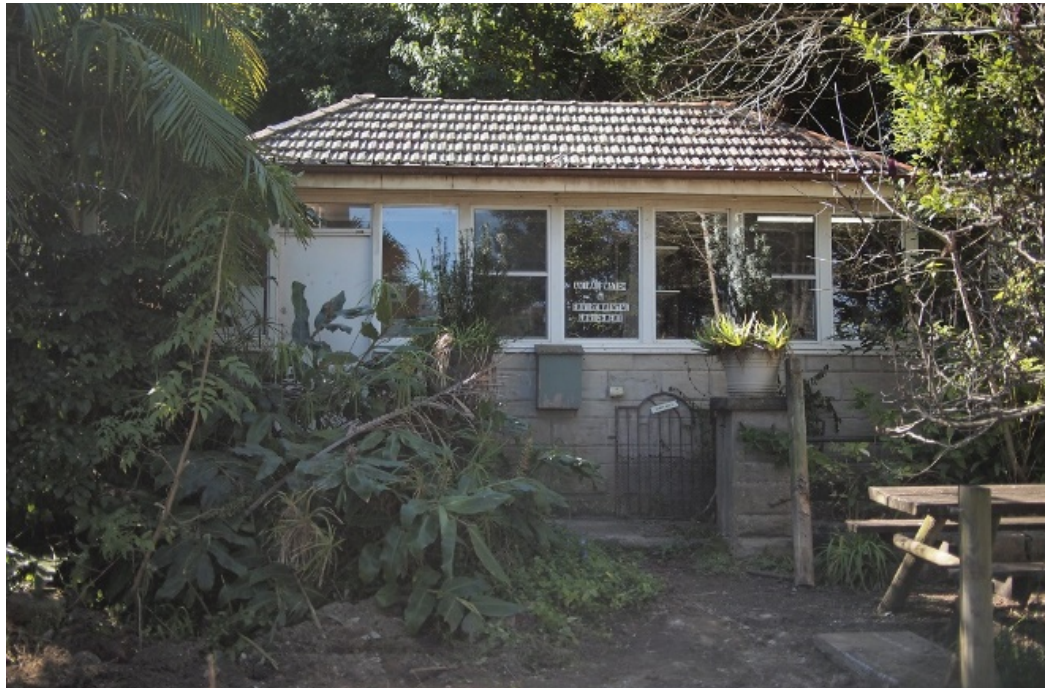
The building itself is designed to appear as a classic Federation period 'Mosman style' sandstone cottage with a terracotta tiled roof, heavy timber brackets and joinery and an open (now infilled) verandah. The course ashlar 'sandstone' blockwork is actually very well constructed cement render over brickwork. While the faux fabric makes it difficult to date, the interior details of tiles and window joinery suggest a late 1930s to mid-1940s construction. Turner House demonstrates a sophisticated level of design with very high quality faux sandstone block render over brickwork, as well as fine timber joinery detailing. It still retains interesting elements of its landscape surrounds, including symmetrical circular planters and a broad curved step onto (originally) an open verandah (later built in)(**Figure 105**). Turner House is in a good condition with largely intact internal spaces and finishes although the grounds around it are not currently actively used or well maintained.

**Figure 105** The front elevation of Turner House showing its infilled verandah with the existing entry to the left as well as the original front boundary wall, piers and entry gates on axis centrally. This main house axis also seems to relate to two of the large Hoop Pines nearby suggesting a deliberate siting concern for the building within this precinct. Well-executed faux-sandstone blockwork walling is extended to the boundary walls and piers within the grounds. (Courtesy: Geoff Ashley)

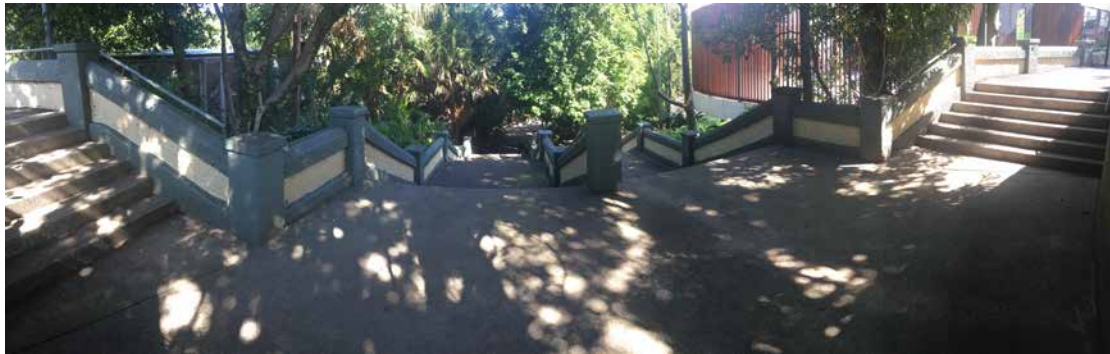
**Figure 106** View looking down the Grand Staircase with the modified 'wings' and additional steps that were introduced with the construction of the adjacent Orang-utan exhibit.

Three polychrome-painted roughcast stucco balustrades (walls and piers) frame two lines of broad concrete steps each of three flights – the same as Park Guell. Since the 1990s the staircase linked the Hallstrom Square public open area with the Orang-utan exhibit. The upper curved flights were added in association with the Orang-utan exhibit. The lower entry to the staircase is framed by remnants of rustic stone seating (see **Section 4.5.6** below) that originally extended further to the east. Substantial sections of the original zoo path network survives in the vicinity of the stairs.

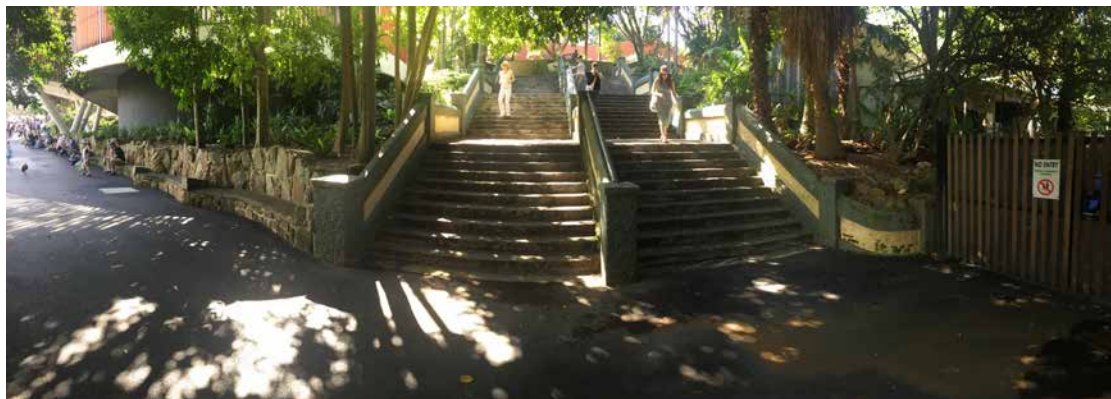
**Figure 107** View across the lower entry to the stairs showing their integral connexion with the rustic scalloped seating to the left (extending under the new Centenary Theatre) and to the right (currently concealed behind the timber fencing).

The series of concave rustic stone seats with masonry arms (Item 58L)(**Figures 106, 107, 108, 114 and 115**) are closely associated with, and frame, the lower end of the grand double staircase (Item 59L). More of the original seats have survived on the western side of the staircase with most being demolished on the eastern side when the Orang-utan exhibit was built in the 1990s (only three remain). Like the grand staircase, the seats closely associated with it have a clear inspirational precedence in similar features at Park Guell, Barcelona. When viewed from along the straight path they address, the seat sequence has an obvious scalloped rhythm that emulates in a subtle way that of the famous mosaic serpentine bench over the Market Hall at Park Guell. The original full compliment of seats was a bold landscape element within the zoo but even the reduced version of today is still impressive and, together with the grand staircase, continues to form a substantial early landscape feature.

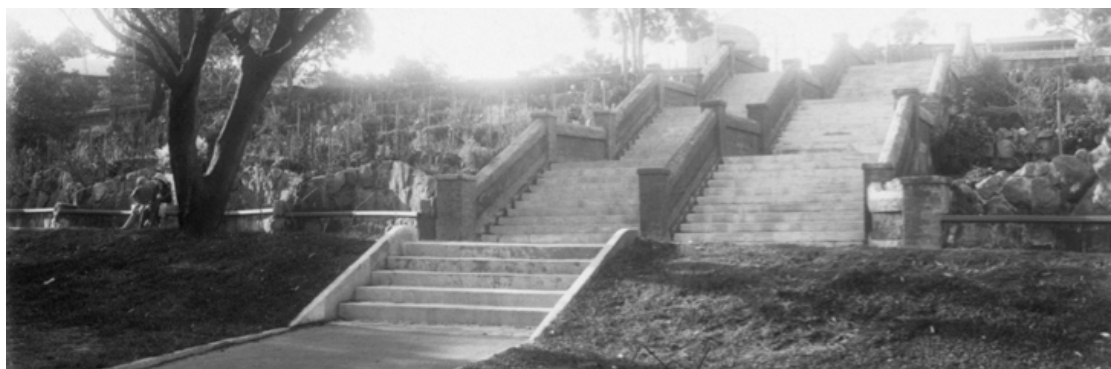
**Figure 108** A 1925 view of the stairs and rustic seats with much less shade. (Source: ML GPO 1/15362)

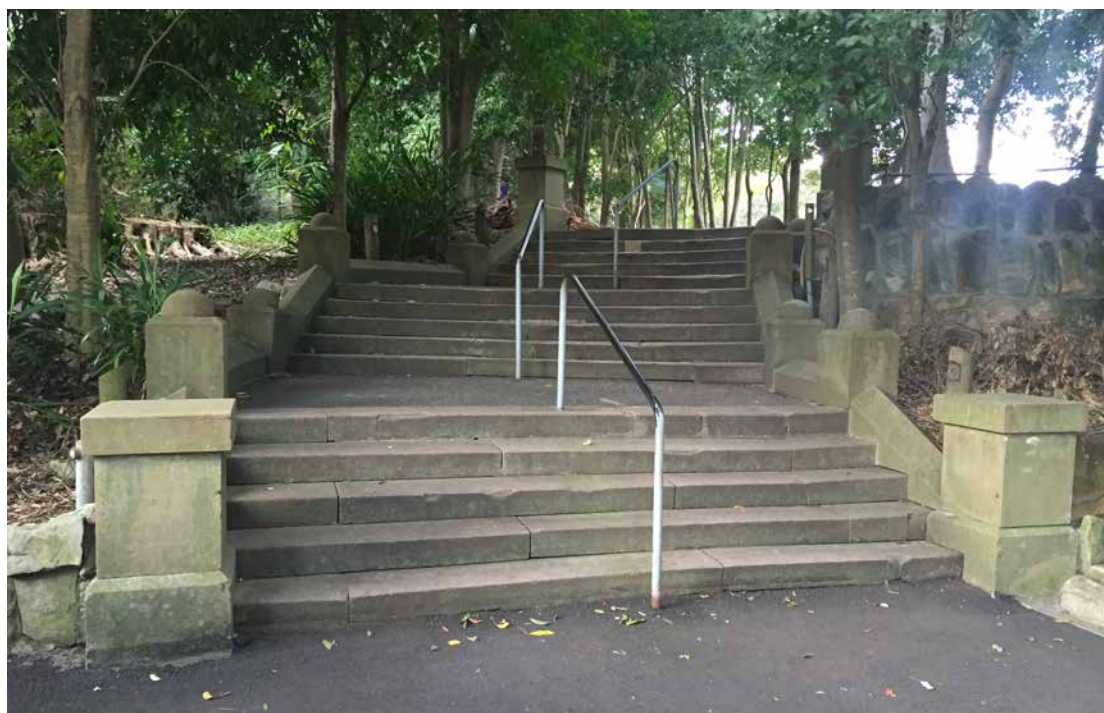
**Figure 110** Ensemble of curving sandstone steps and associated detailing. Note the internal piers with balled surmounts as a contrast to the plainer, principal piers with flat coping suggesting the intended addition of features as part of the original design.

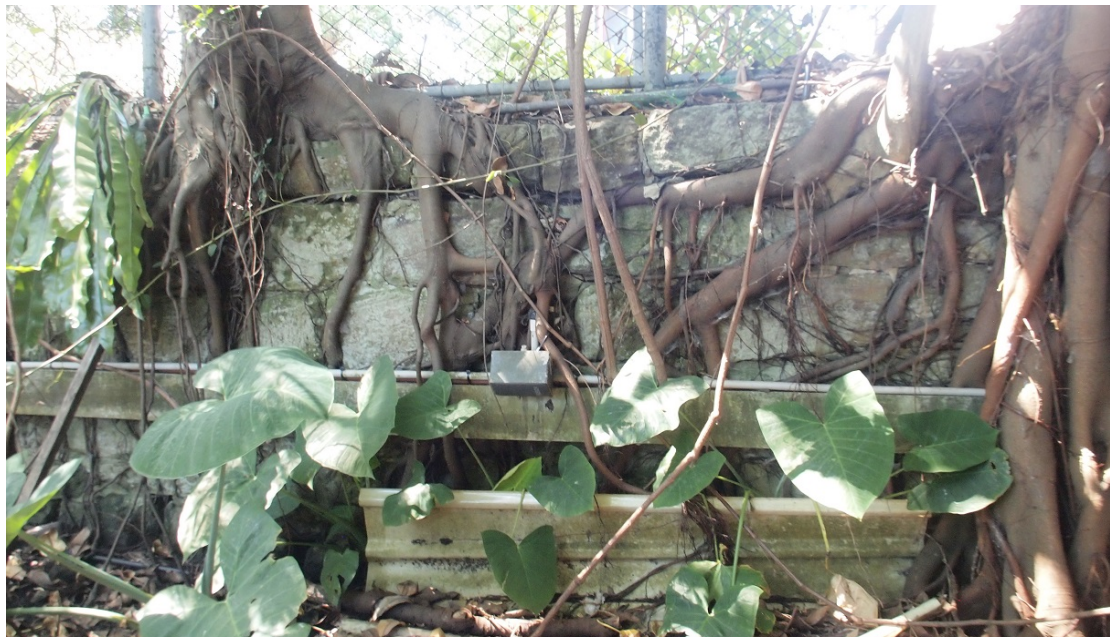
**Figure 111** Between the former Finch Aviaries and the large fig tree (Item 160L) is a meandering retaining wall of mixed construction though mainly sandstone ashlar blockwork along the western half. It is presently enshrouded in a combination of fig tree seedlings, foliage and sundry services.

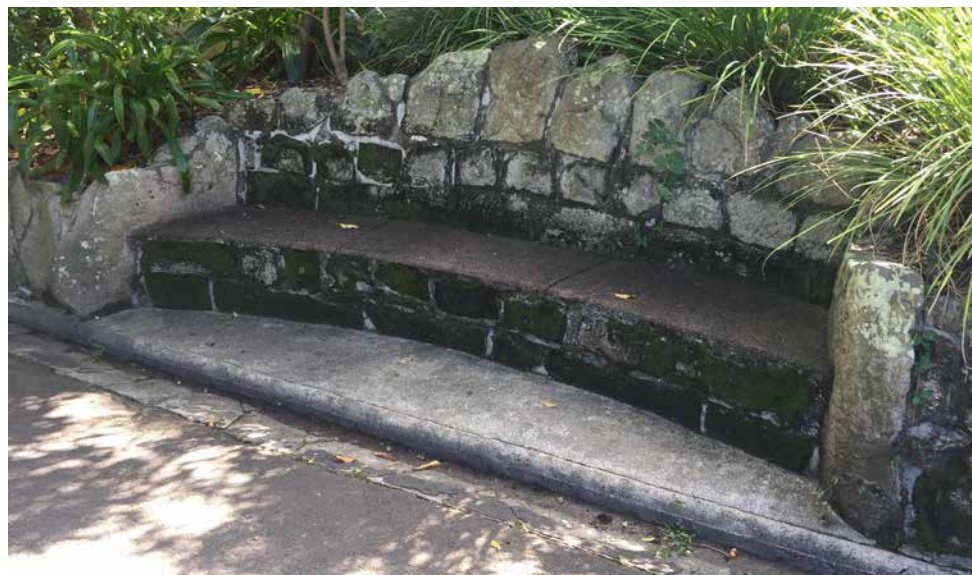
**Figure 112** One of the three rustic seats (Item 55L) below the ramp in the proposed Congo precinct.

Closely associated with both Waterhole and Congo precincts are distinctive rustic seats built from stone and/or faux-rockwork. The small curving set (Item 76L)(**Figure 113**) north of the Barbary sheep and the series (Item 55L)(**Figure 112**) below the former Bird of Prey aviary site, are of a similar vintage and character with the coloured concrete seats probably replacing the original timber slats in the 1940s. The 76L set have been carefully built to the site conditions such that it follows a convex corner while ascending the upper road junction.

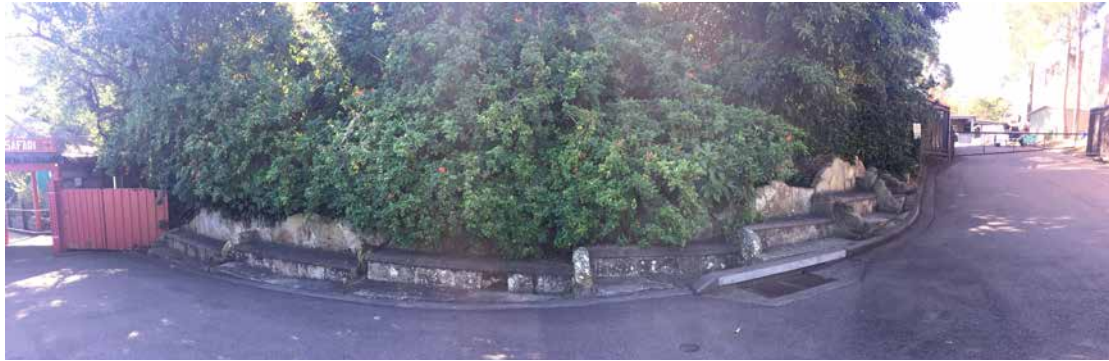
**Figure 113** The ascending, convex series of rustic stone seats (Item 76L) are now a rare feature within the zoo site. They are currently opposite the Chimpanzee Park and the Barbary sheep enclosure but are within a proposed construction zone for the new lion yards. The *Tecomaria capensis* behind the seats appears to be from a former hedge.

Associated with the intended changes to the circulation system (including site levels), it is proposed to remove and relocate the rustic seating ensemble (Item 76L) north of the Barbary sheep enclosure (even though these have been conserved as recently as 2013 through extensive repairs) and those (Item 55L) southwest of the lemur enclosure although alternative sites for the relocation of both of these items have not, as yet, been indicated.

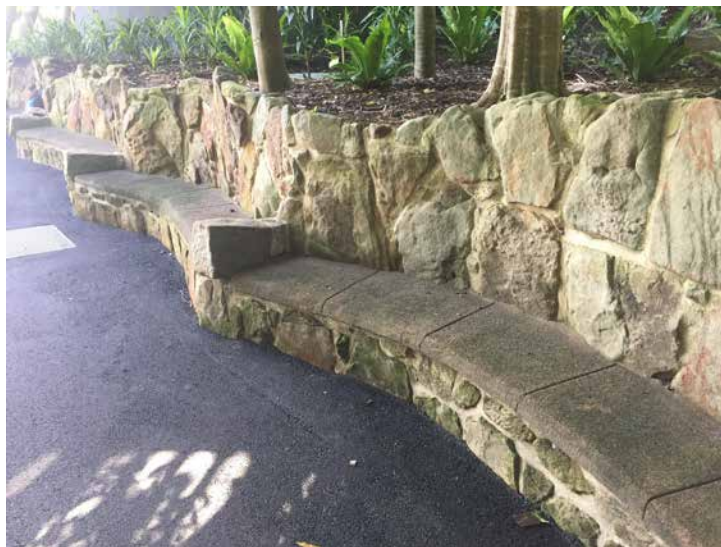
**LEFT Figure 114** Part of the long sequence of scalloped rustic stone seating to the west of the Grand Staircase.

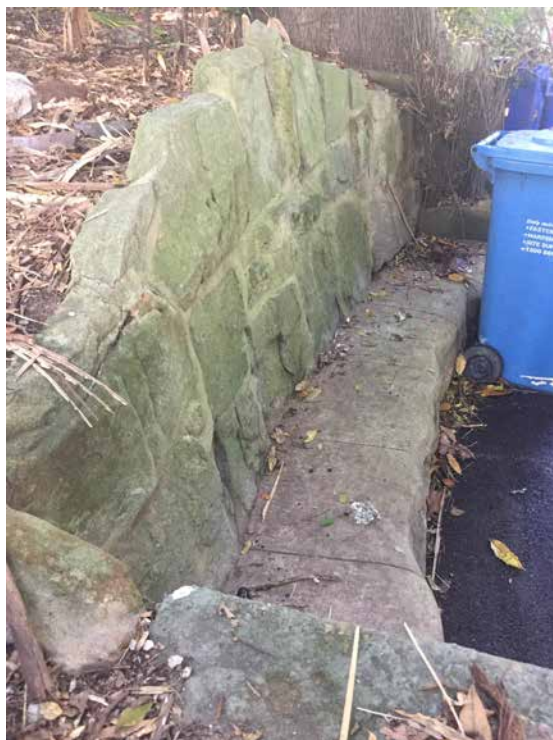
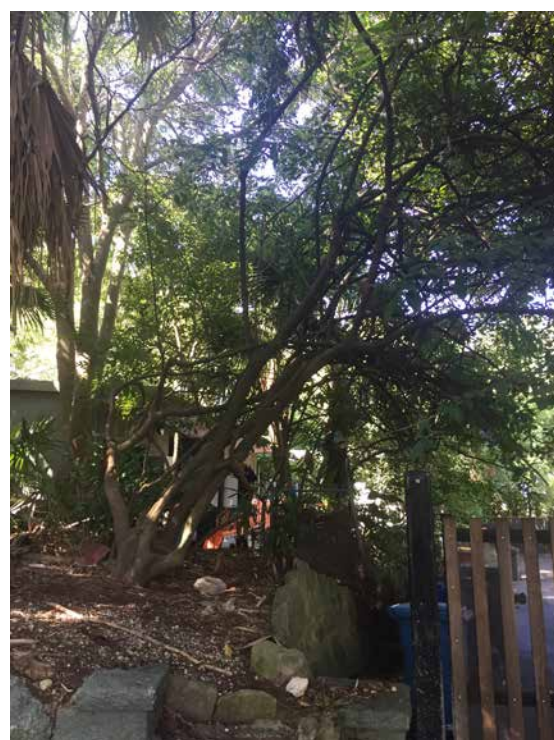
**BELOW LEFT Figure 115** To the east of the Grand Staircase is a remnant group of three rustic seats though now fenced off.

**BELOW RIGHT Figure 116** A view of the same seat with the old *Elaeagnus triflora* behind – now struggling with heavy shade.

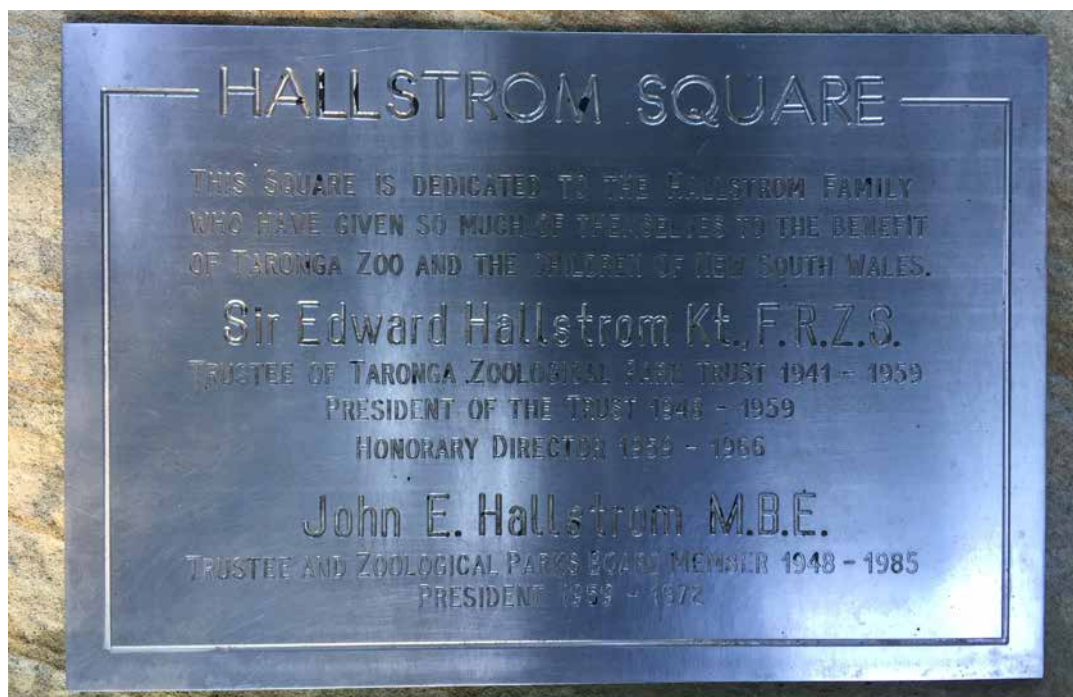
**Figure 117** The information plate on top of the sandstone plinth memorialising Sir Edward Hallstrom and John E Hallstrom at the current Hallstrom Square.

Several memorials are located within the proposed new Congo precinct (refer to **Appendix D**), the largest of which is the sandstone plinth at Hallstrom Square in memory of two members of the Hallstrom family with a long connexion to the zoo. The memorial features a metal plate at the top and a large metal bas-relief sculpture to the front of Sir Edward Hallstrom made by his daughter Jean Hill (**Figures 117 and 118**). The upper plate mentions both Sir Edward Hallstrom and his brother John E Hallstrom.

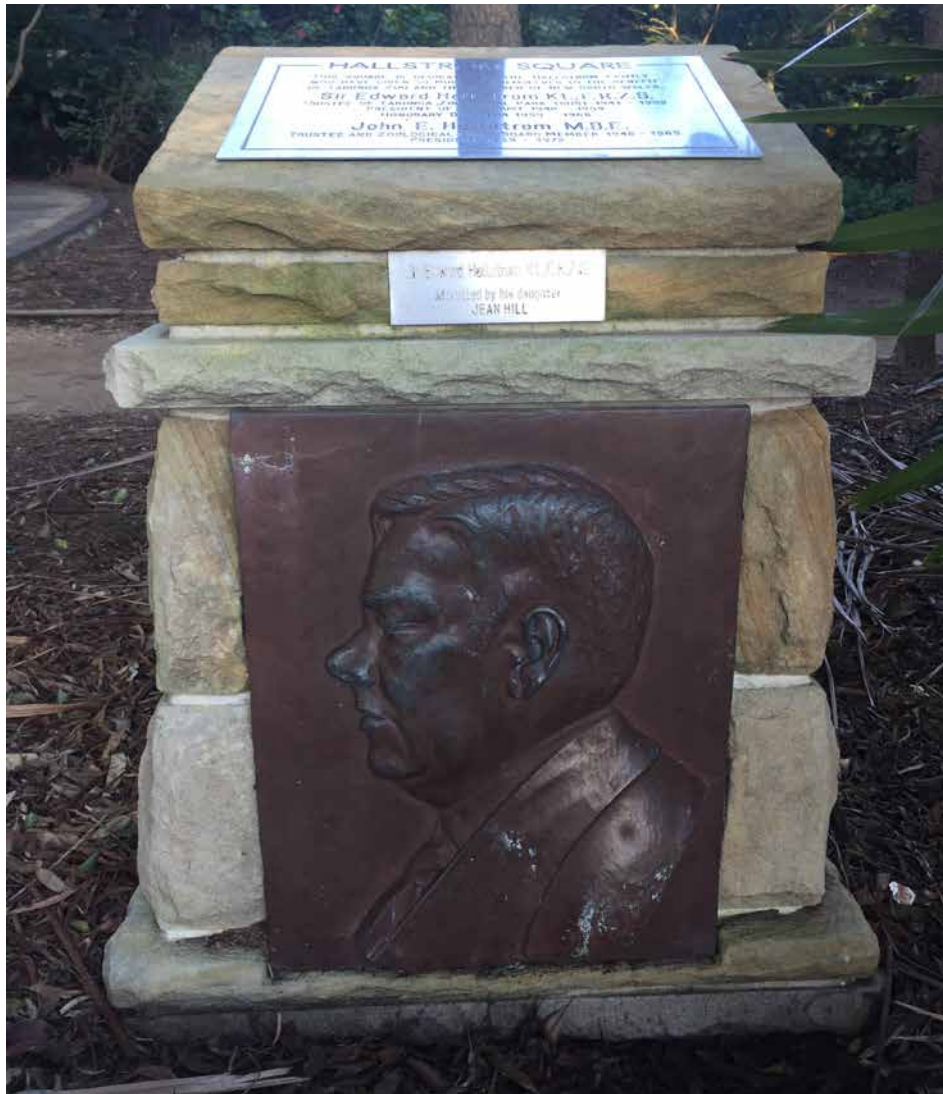
Figure I I 8 The Hallstrom memorial with the bas-relief panel of Sir Edward Hallstrom.

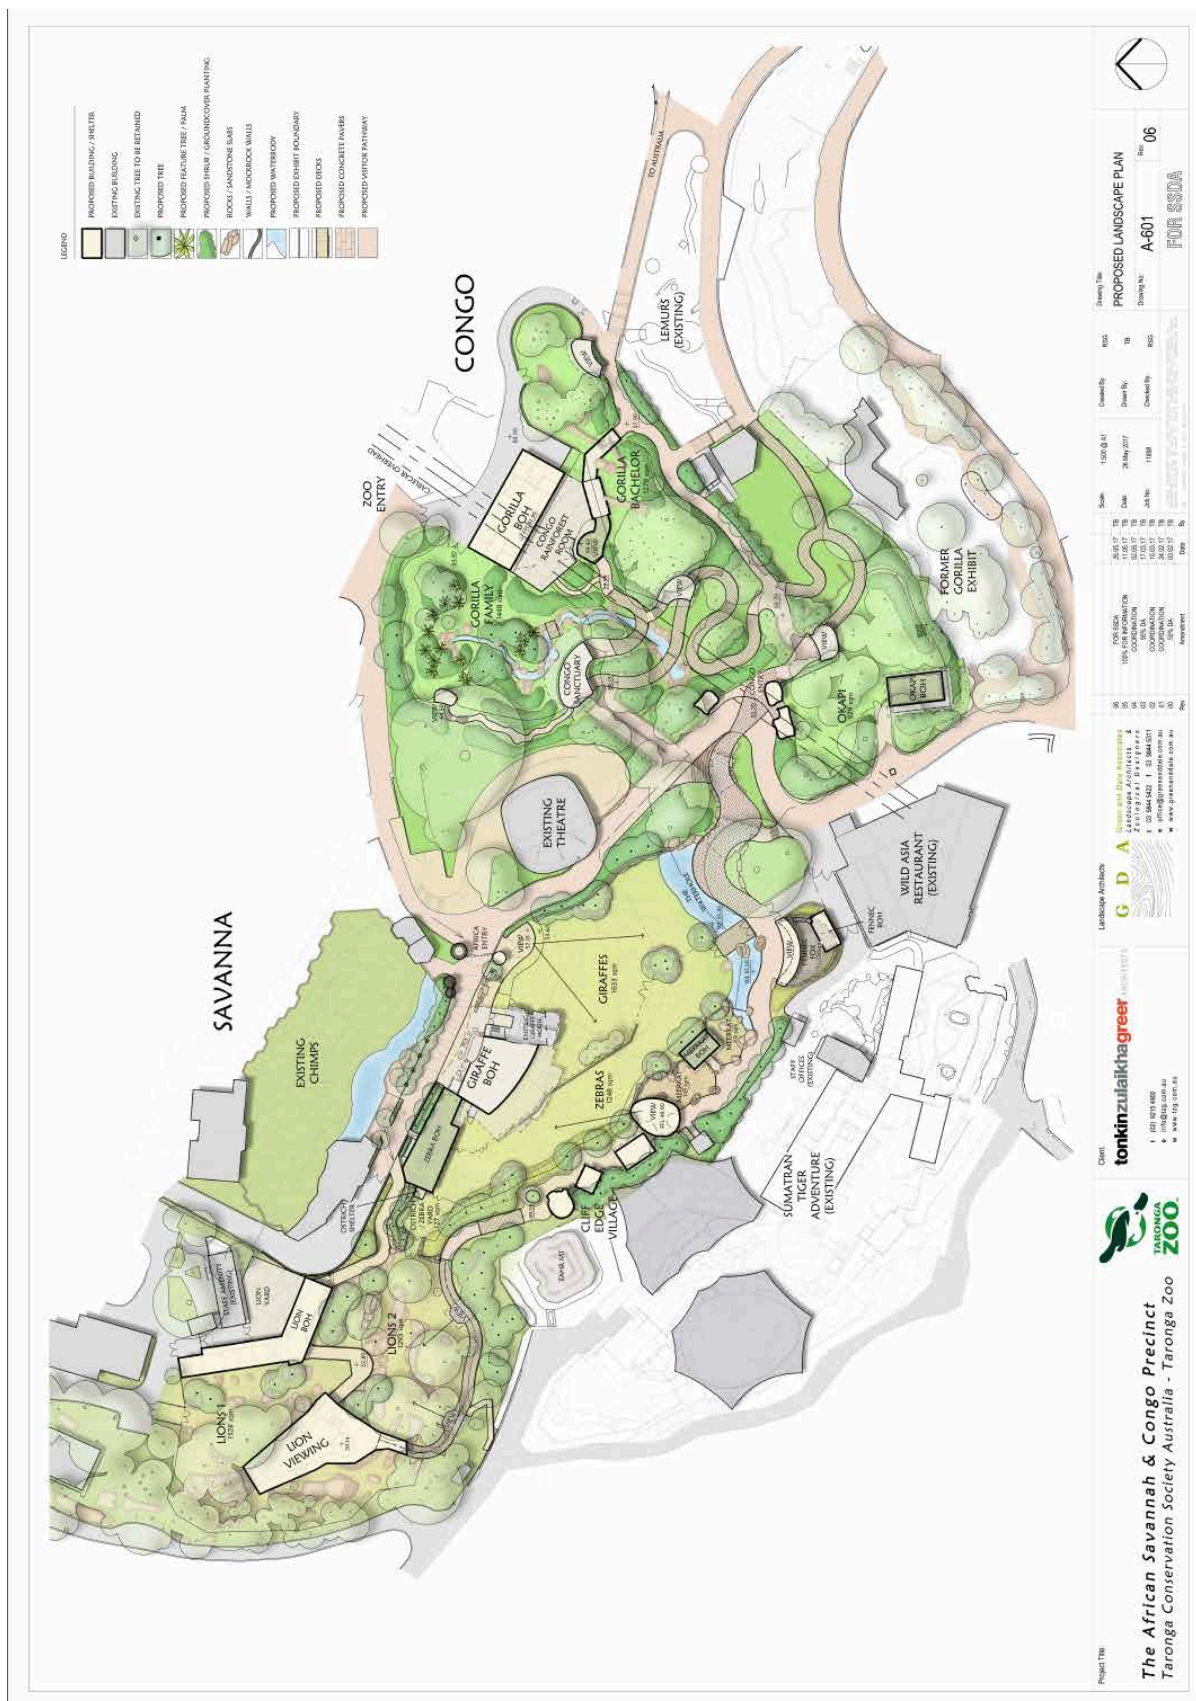
Figure 121 Proposed Landscape Plan A-601 (Courtesy Green and Dale Associates)  
Overall site plan indicating the extent and character of the proposed works for the new Waterhole and Congo precincts at Taronga Zoo.
