# PRELIMINARY STAGE 2 ENVIRONMENTAL SITE ASSESSMENT

# PROPOSED LINDFIELD LEARNING VILLAGE DEVELOPMENT

# **ETON ROAD, LINDFIELD**

16 OCTOBER 2017 REF: E30259KMrpt2

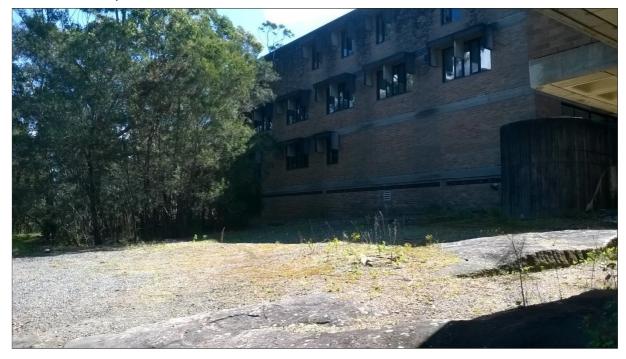
A walkover inspection of the proposed development areas was undertaken by EIS on 8 September 2017. The area where the COLA is proposed (see Plate 1 below) was located to the south of a 3-4 storey brick building, and was generally covered with grass, trees and other vegetation, gravel or sandstone outcrops.

**Plate 1:** the area in the south of the site where a Covered Outdoor Learning Area (COLA) is proposed.

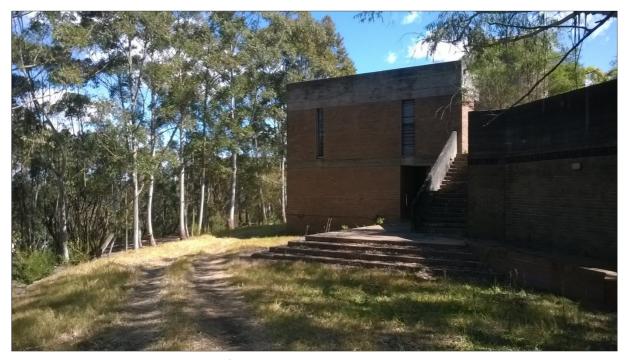
The area where the new external stairway is proposed (see Plate 2 below) was located to the southeast of a 2-3 storey brick building and concrete stairway, and was generally grass-covered.

Plate 2: the area in the south-east of the site where a new external stairway is proposed.
