**RE: UNSW CLIFFBROOK CAMPUS REDEVELOPMENT  
GEOTECHNICAL INVESTIGATION**

**CLIFFBROOK CAMPUS REDEVELOPMENT  
GEOTECHNICAL INVESTIGATION**

**PSM3029-006R Rev1      AUGUST 2016**

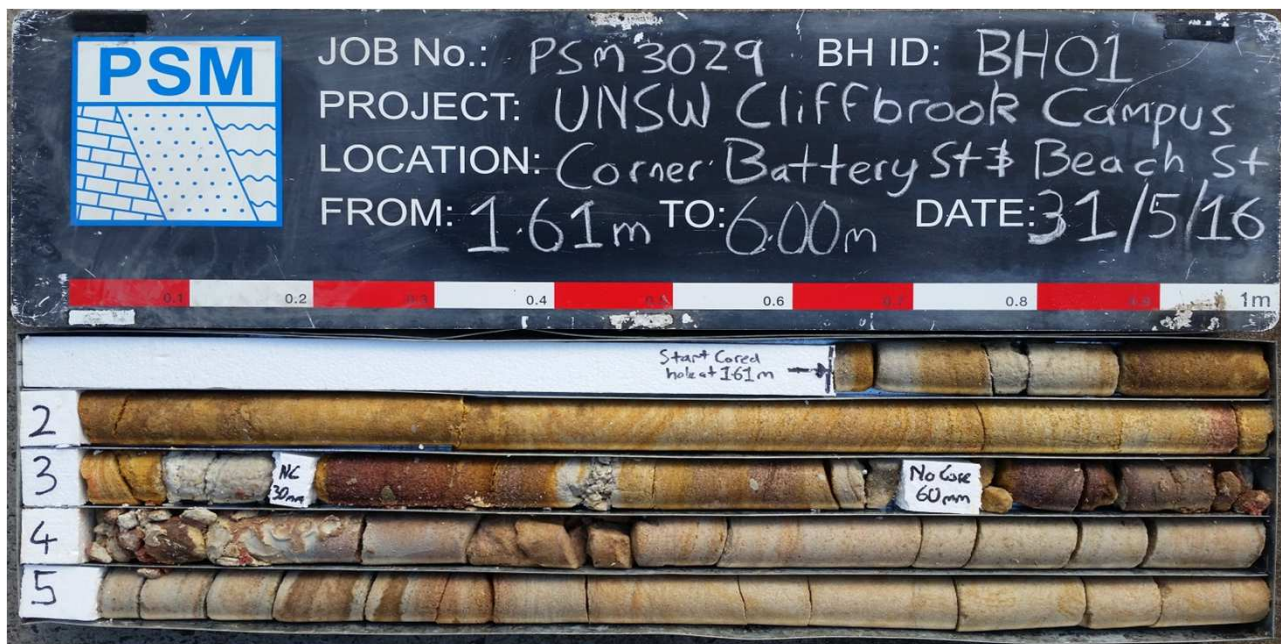
UNSW  
UNSW Cliffbrook Campus  
Coogee, NSW  
CORE PHOTOGRAPHY - BH01

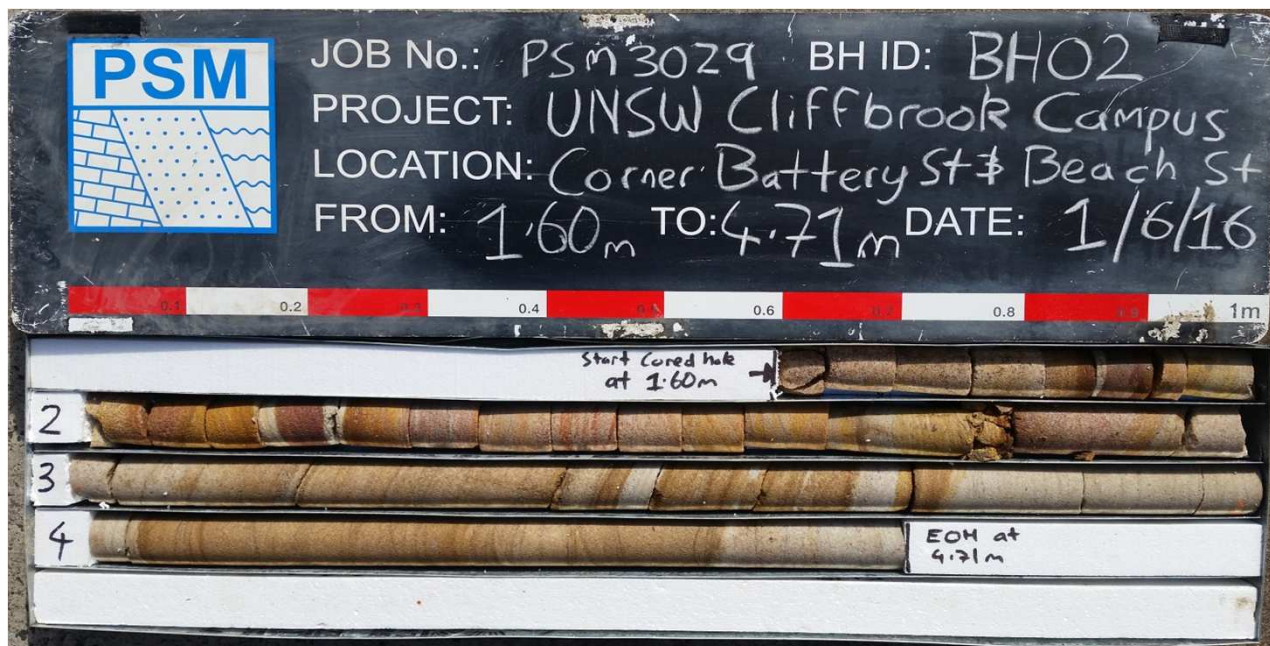
UNSW  
UNSW Cliffbrook Campus  
Coogee, NSW  
CORE PHOTOGRAPHY - BH02

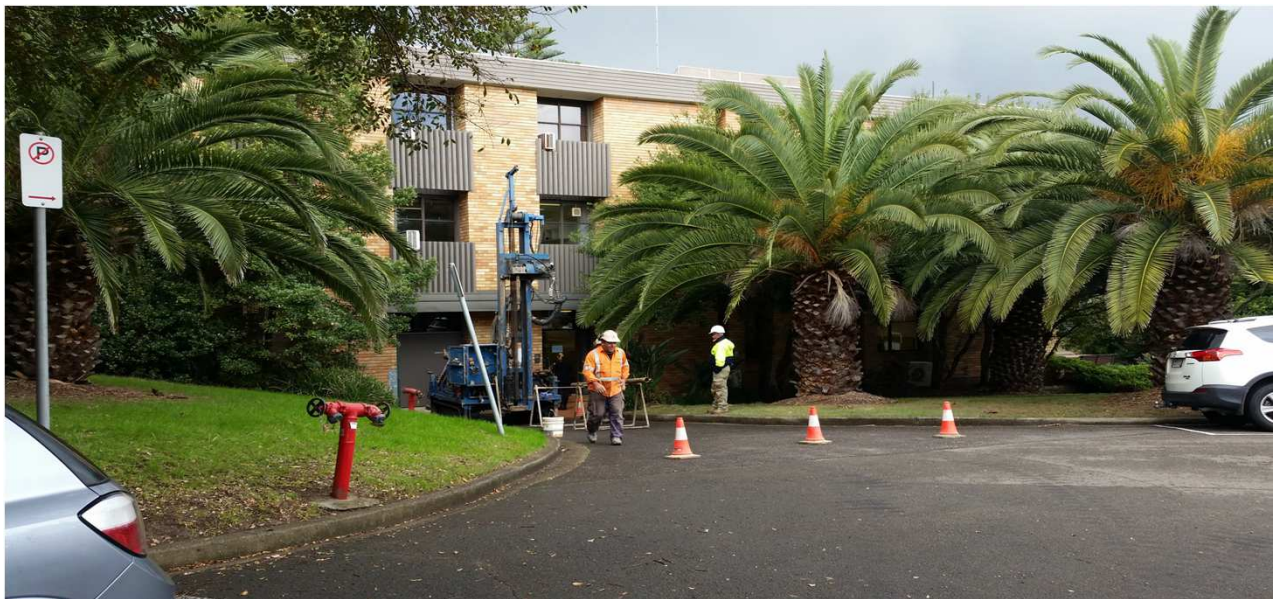
Photo 1 - Looking south east at JK300 drill rig set up at BH01

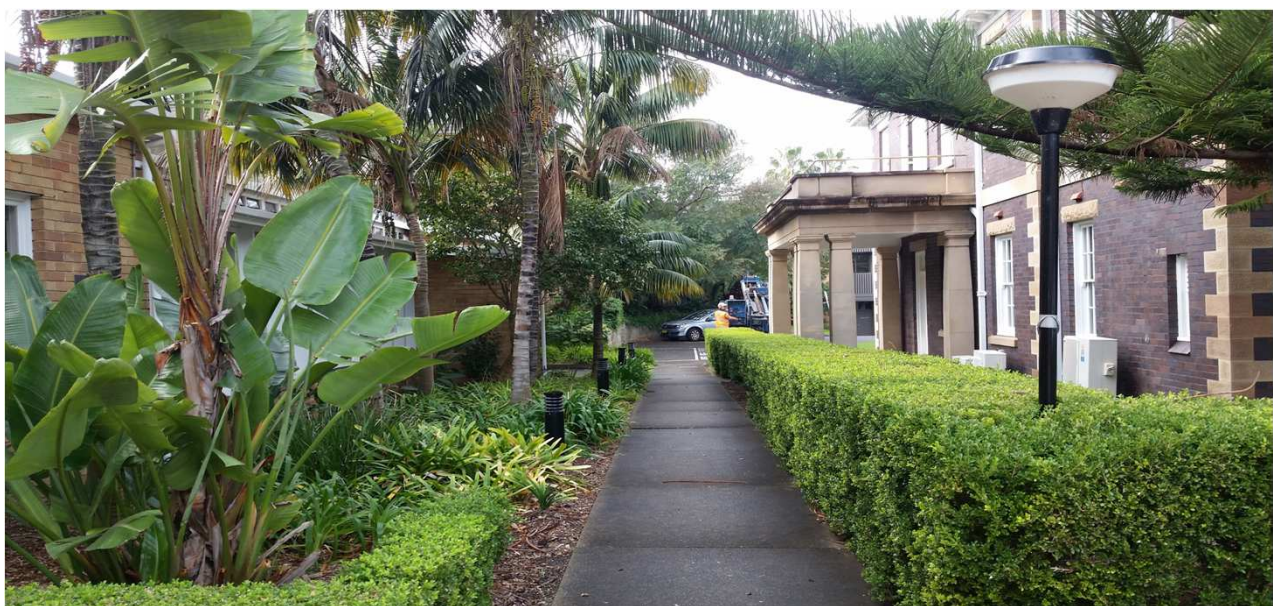
Photo 2 - Looking east towards BH08 (Drill rig setting up at BH08)
