# HERITAGE IMPACT STATEMENT

## Redevelopment of UNSW Cliffbrook Campus

45-51 Beach Street, Coogee, NSW

State Significant Development Submission (SSD 8126)

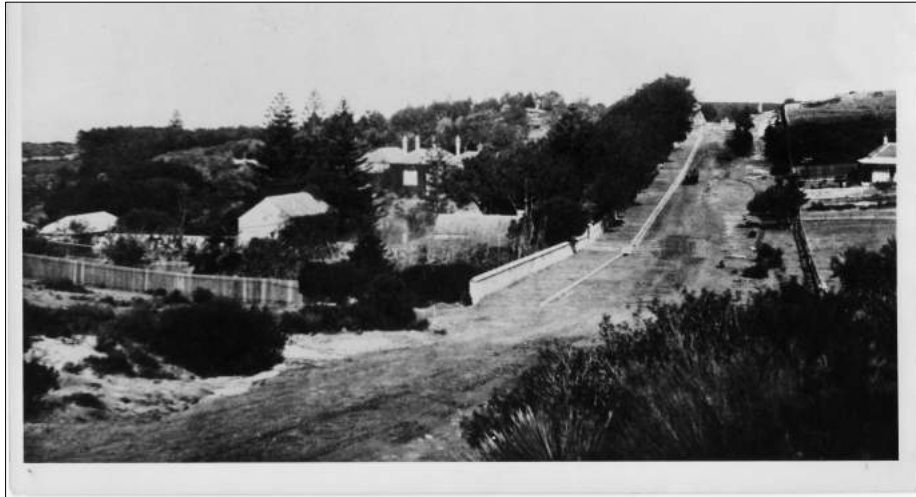
Figure 4 shows the stone boundary wall along Beach Street, with the stable complex behind, in the early 1880s.

**Figure 4: Looking south along Beach Street, showing Cliffbrook, c.1883.**  
Randwick and District Historical Society.

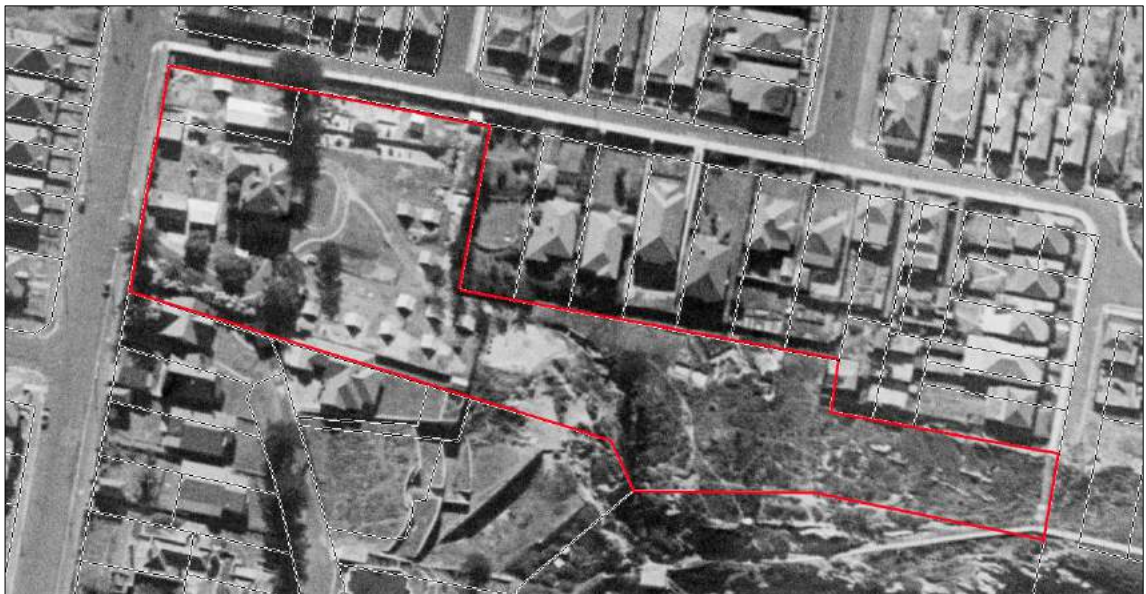
Figure 6, an aerial photograph dated 1943, shows tents/small huts set up in the grounds of *Cliffbrook* in an orderly fashion, indicative of a military use. This photograph also shows the pattern of pathways and vegetation patterns on the site at this time. There is a building in the location of the building marked 'CC2' in Figure 3. This building is not 'CC2' but a building long since demolished. The only structures still standing from this period are the boundary walls, *Cliffbrook* ('CC1' in Figure 3) and the garage ('CC3' in Figure 3).

**Figure 6: NSW Lands Department, 1943.**  
NSW Lands Department.

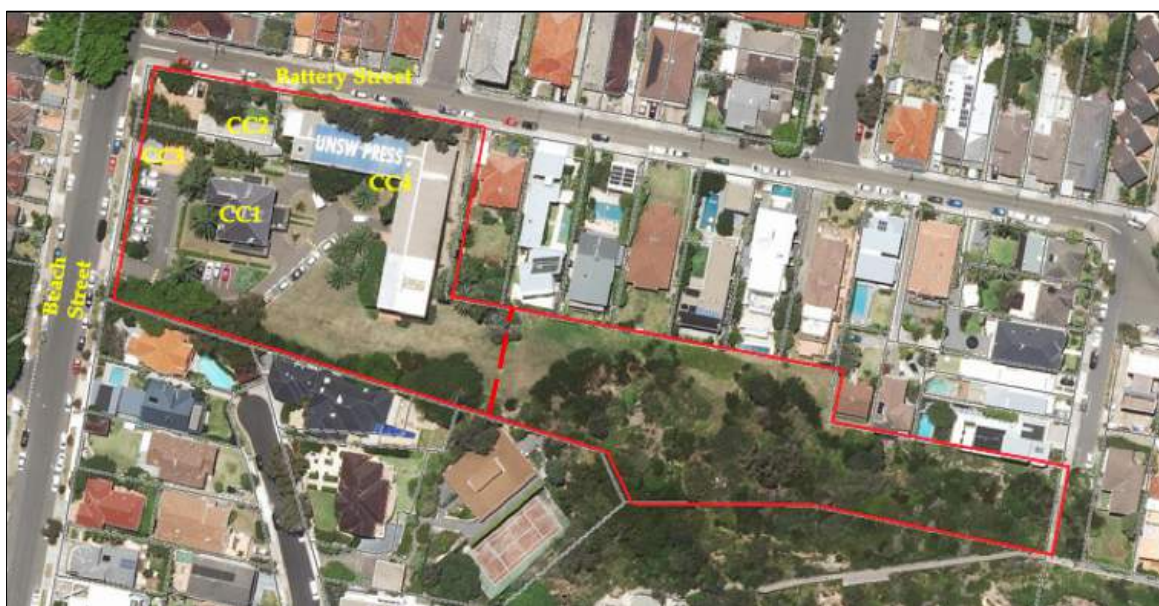
For the following, refer to Figure 8, an aerial photograph over the site, and to the survey that accompanies this application. The red line identifies the site boundaries. The area to the left of the broken red line comprises the Study Area identified in the *CMP 2017*. This is the part of the site with which this statement is concerned.

**Figure 8: Aerial photograph over the site.**

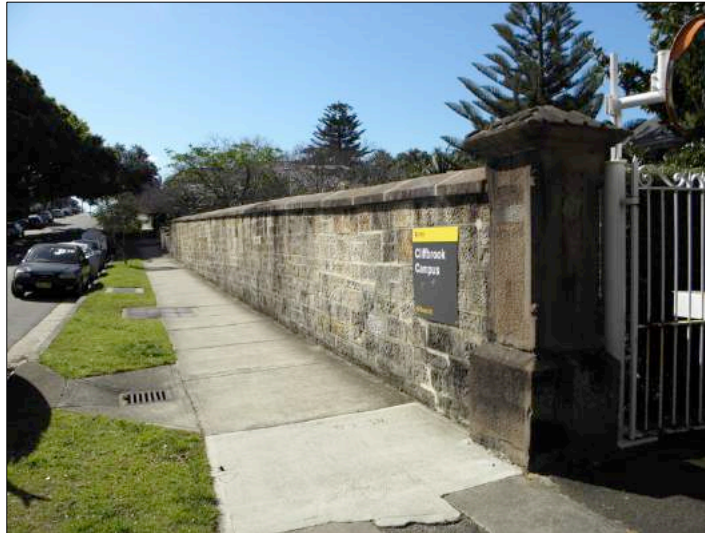
**Figure 9:**  
The Beach Street stone wall.

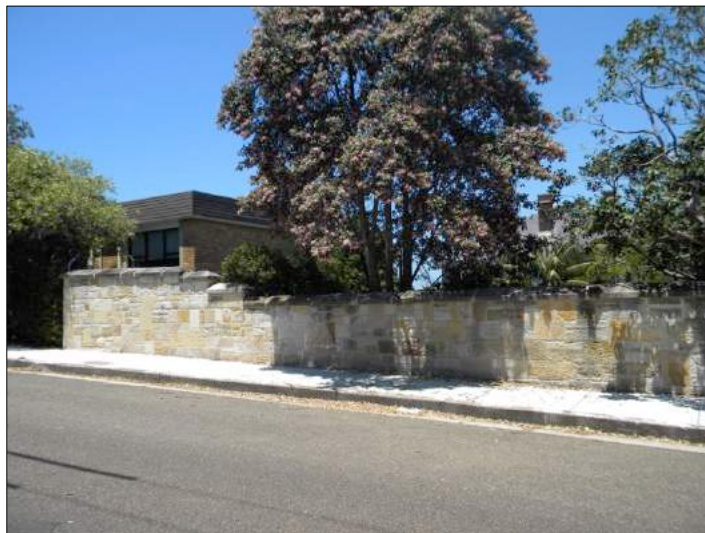
**Figure 10:**  
The Battery Street stone wall.

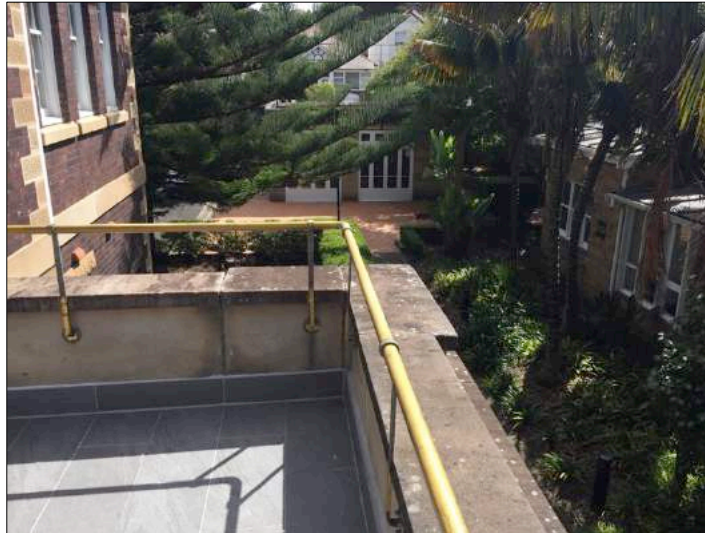
**Figure 22:**  
Showing the pipe  
railing and modern  
tiling on the northern  
porch at first floor  
level.

- The tiles on the porte-cochere roof and on the northern and southern porches were added in 1993.
- The existing railings on the porte-cochere roof and on the northern and southern porches appear to have been added (or repaired) in 1993.

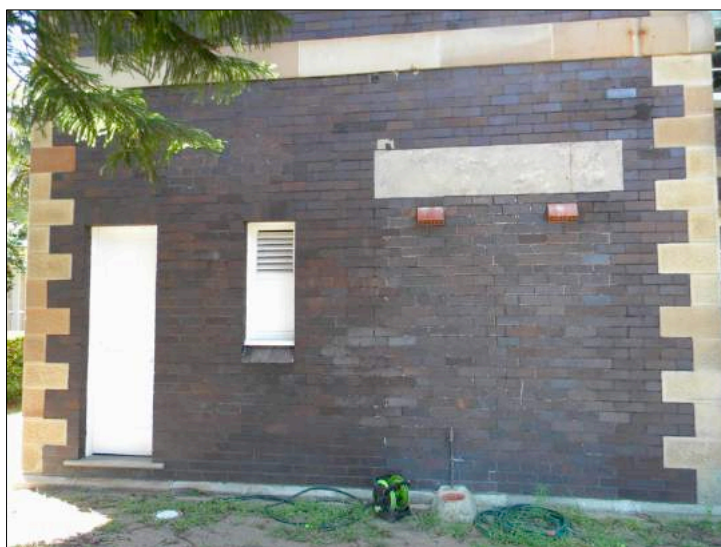
**Figure 26:**  
Detail of the western elevation of the rear wing showing the blocked in porch and existing openings.

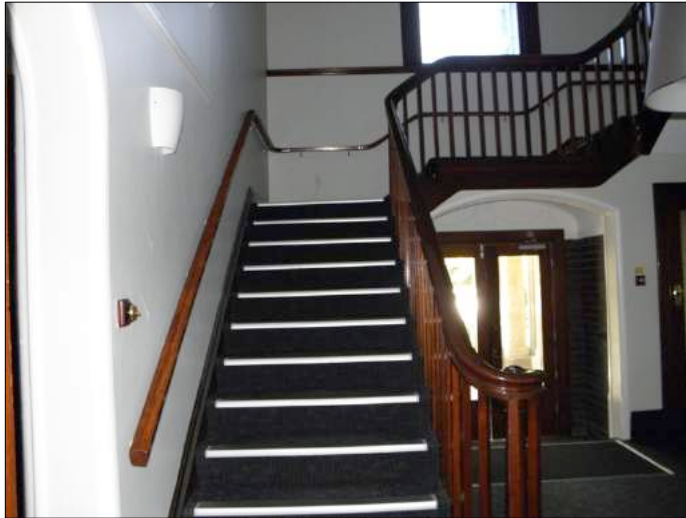
**Figure 30:**  
Main entrance hall (Room G11 in the *CMP 2017*) showing the staircase.

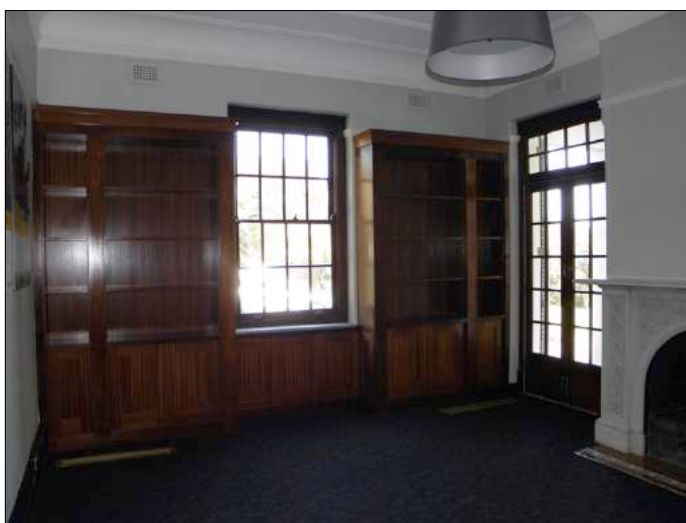
**Figure 32:**  
Ground Floor. Room GO1, marked Syndicate Dinning on the accompanying FJMT plans, showing the later bookcases fitted to either side of the window in the eastern wall. It is proposed to remove these bookcases.

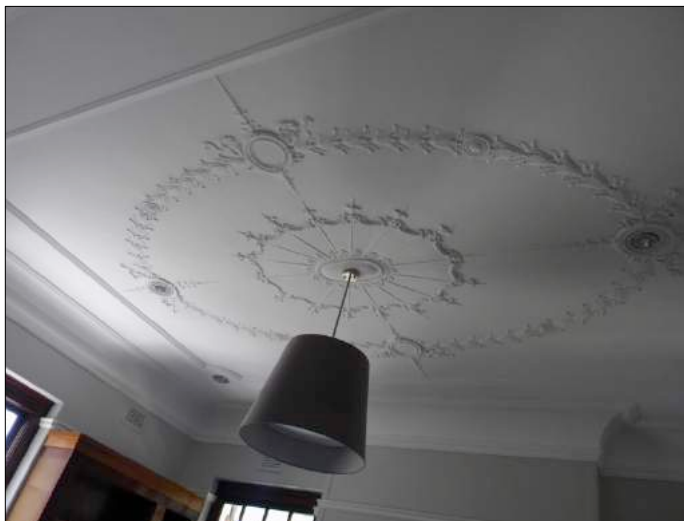
**Figure 34:**  
Ceiling in Room G01.  
This ceiling is typical of the ceilings within the principal rooms at ground and first floor level.

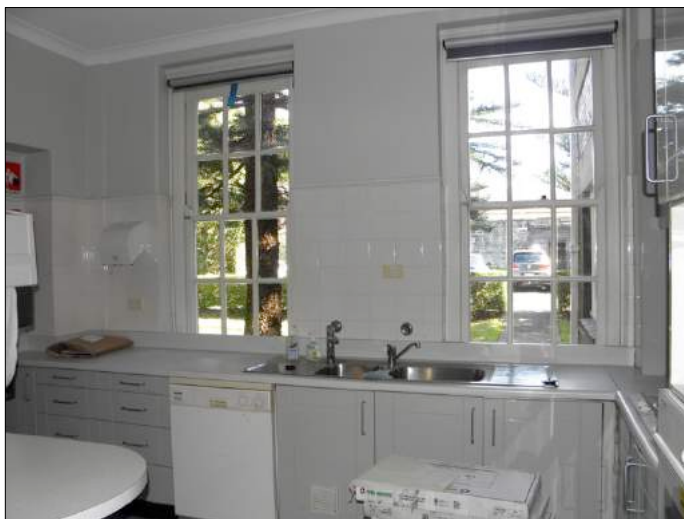
**Figure 35:**  
Room G03. Western wall.  
Kitchen fitted out in 1993.  
It is proposed to remove this fitout and install a lift within this room.

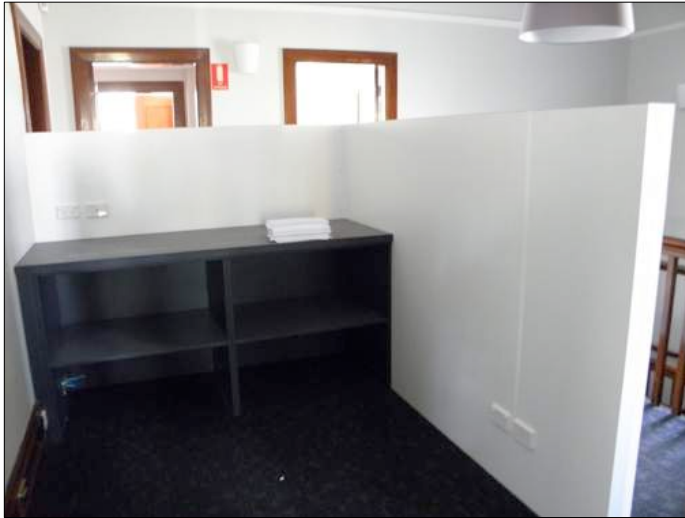
**Figure 47:**  
Room 104. Later partitioning, which it is proposed to remove.

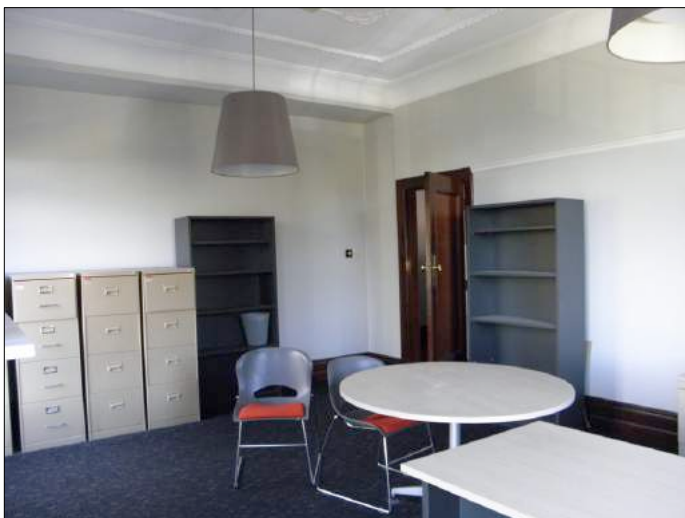
**Figure 49:**  
Room 101. It is proposed to remove the plasterboard wall that divides this room from Room 102.

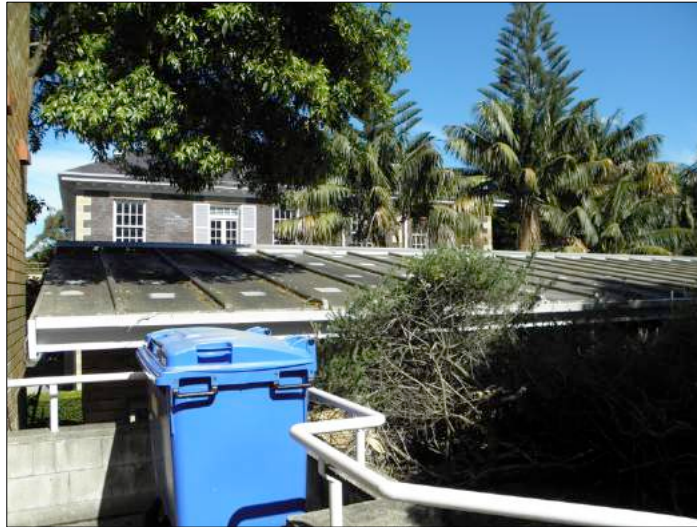
**Figure 60:**  
Roof of CC2.
