Remedial Action Plan

Western Sydney Stadium Redevelopment
Confidential Privileged Communication

2 February 2017

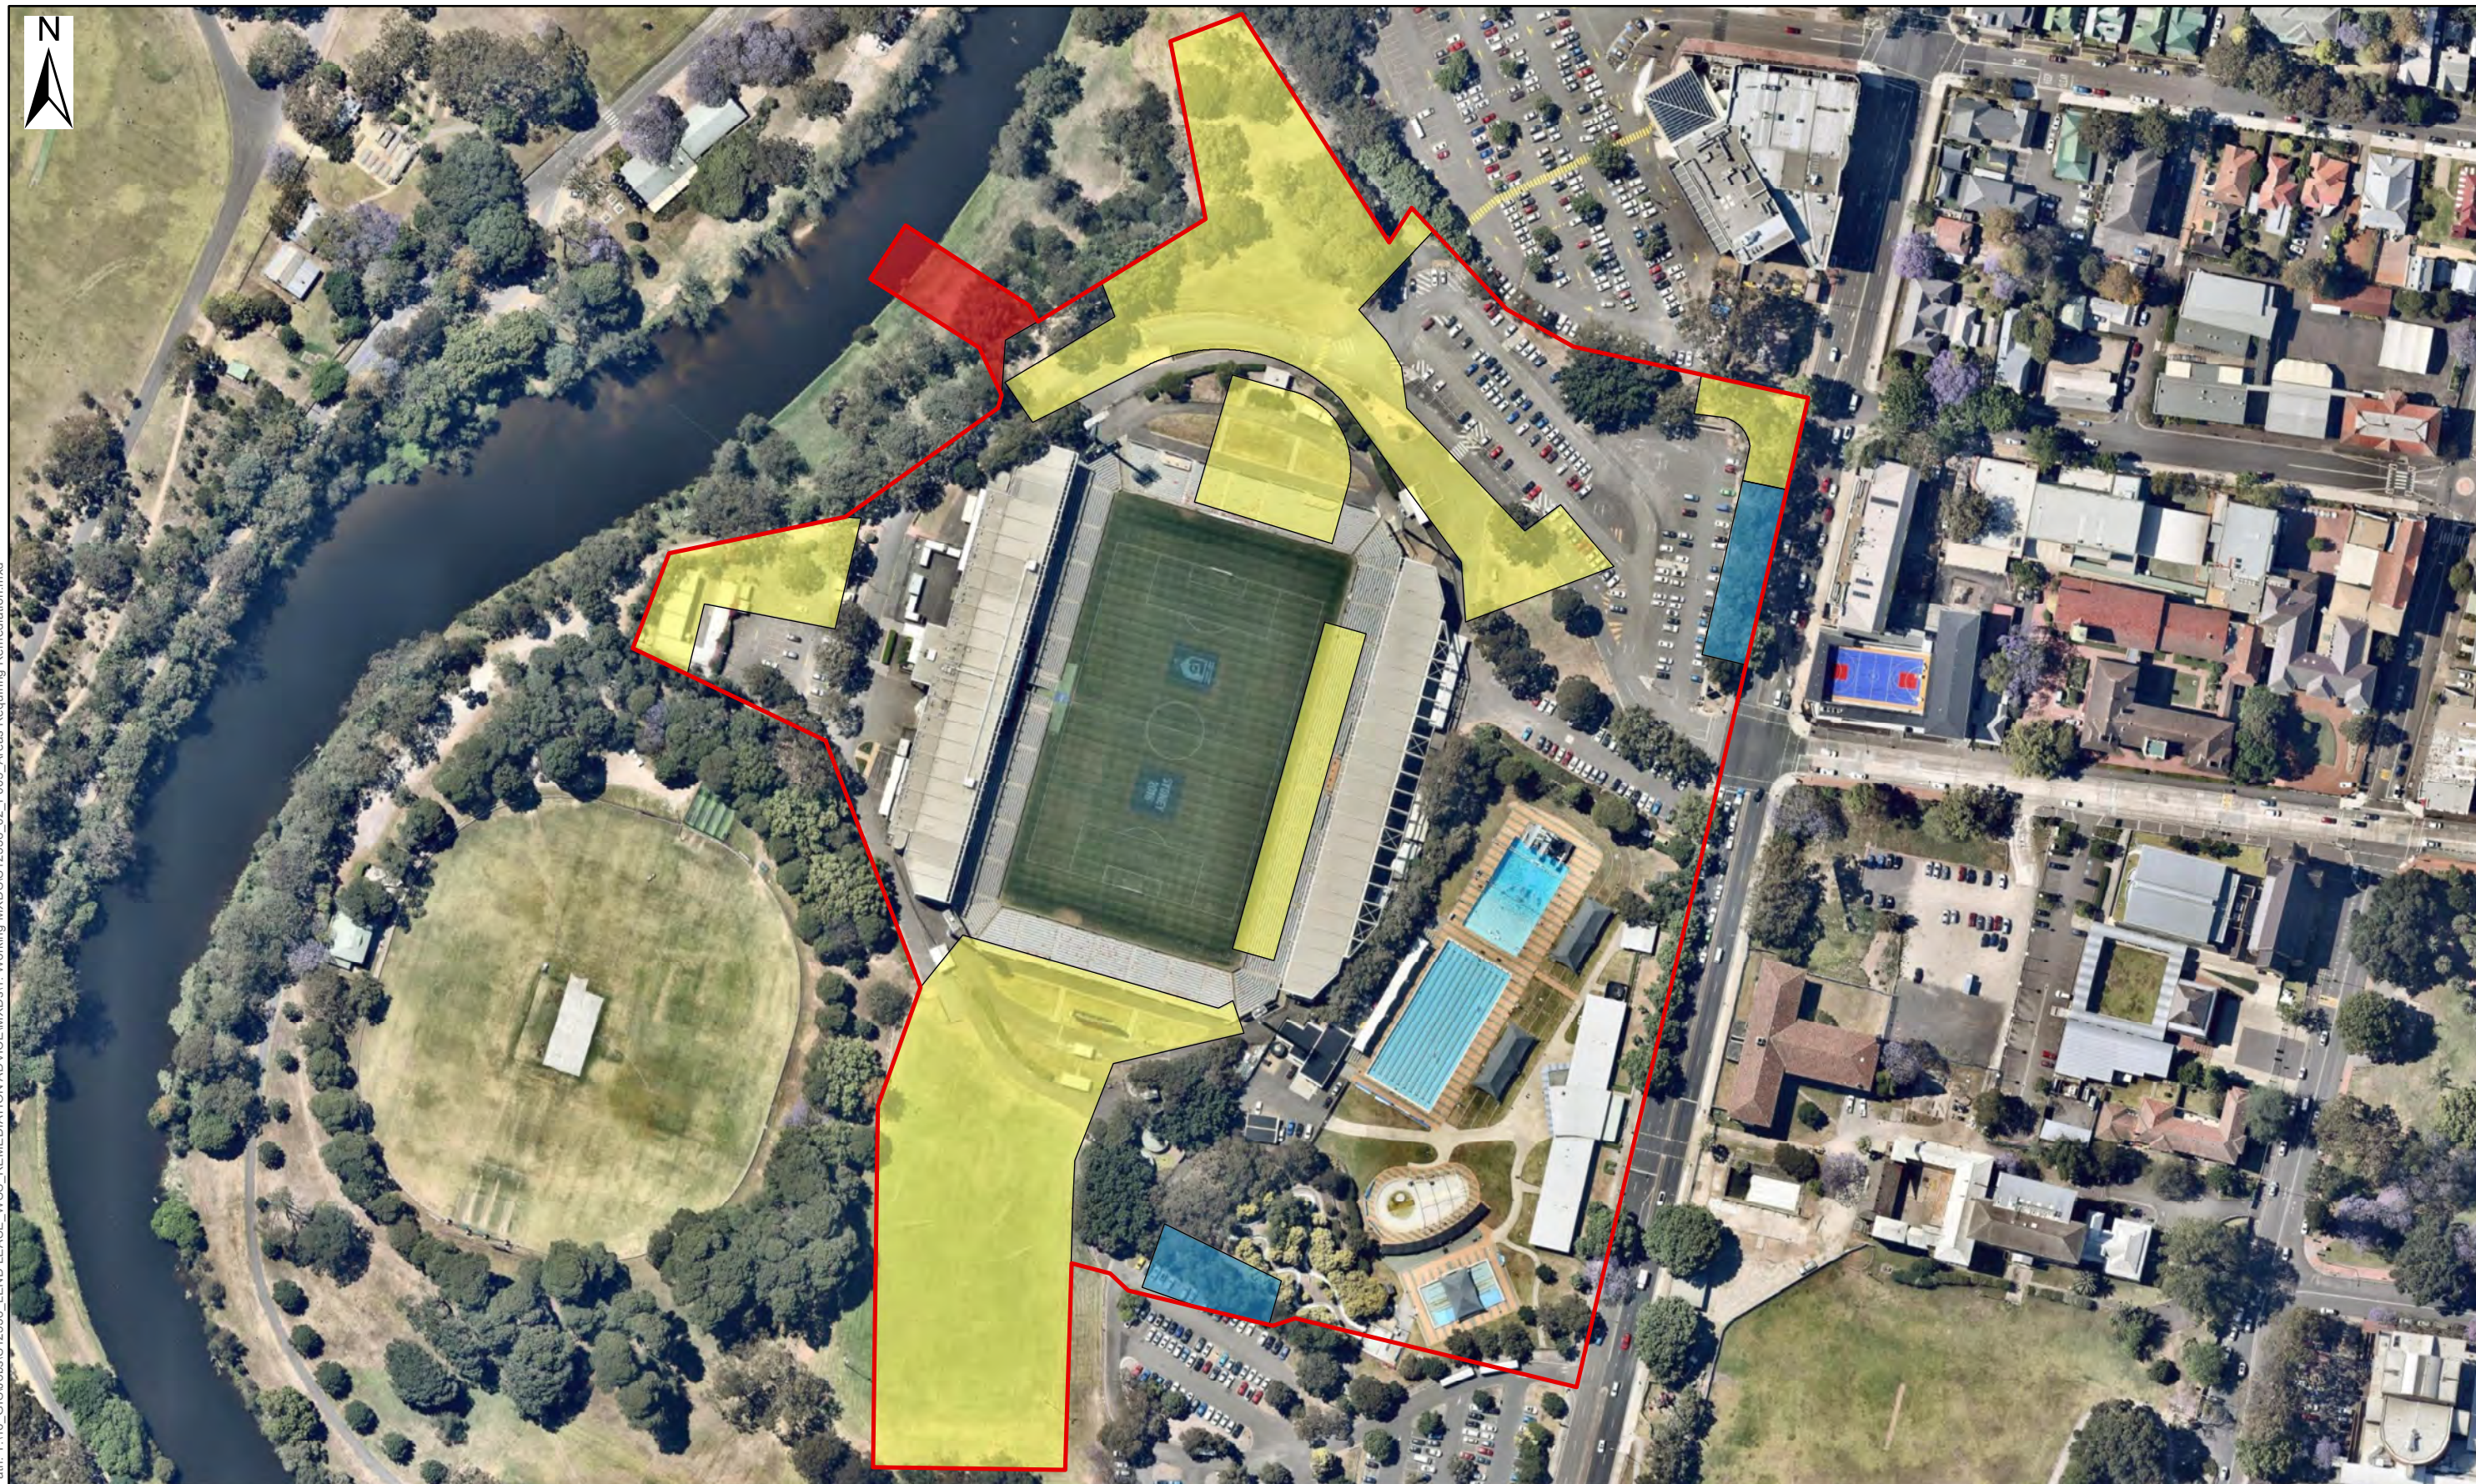
Figure 5: Areas Requiring Remediation

- Site Boundary
 Additional Investigation Area
 Remediation Area A Asbestos in Soil Remediation Extent
 Remediation Area B Chemical CoPC Remediation Extent

The location of these areas is illustrated within **Figure 5**.
