## **NSW Department of Education**

### North Kellyville New Primary School Dam Dewatering Report

August 2017

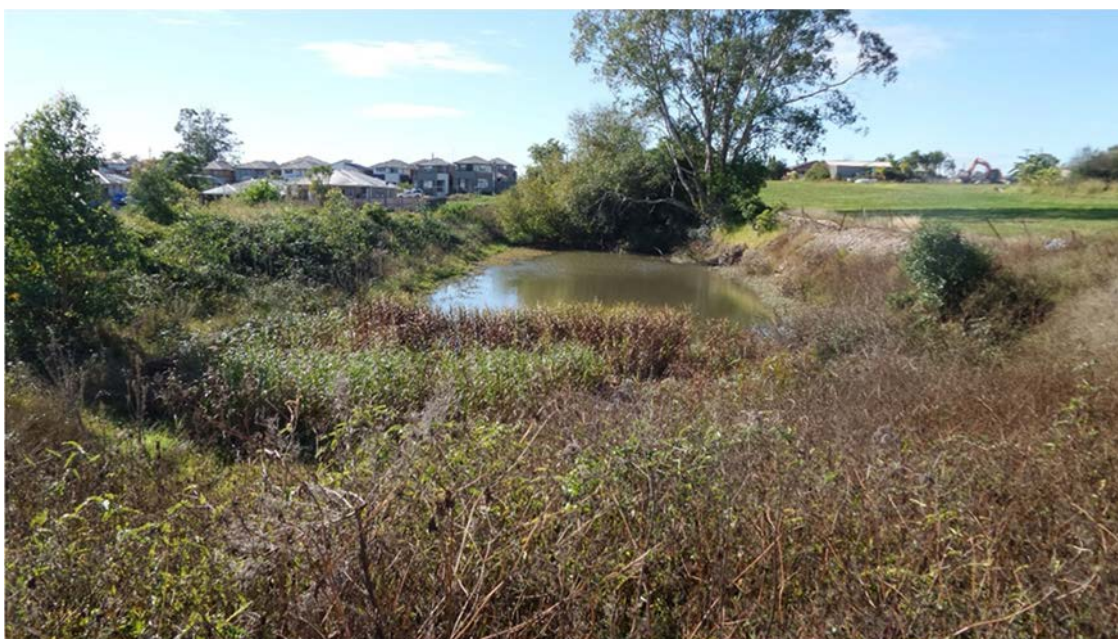
**Photograph 1 Onsite Dam**

The dam is of moderate size and approximately 40m by 20m of open water was present at the time of the survey (Photograph 1). The dam contains sloped banks comprising a shale and fill substrate.

The banks are heavily vegetated with exotic weeds and was dominated by Blackberry (*Rubus fruticosus* subsp. *aggregate*) particularly on the dams' northern edge. Small numbers of native flora line the dam including a large Forest Red Gum (*Eucalyptus tereticornis*) on the dam's eastern bank. Native fringing aquatic vegetation within the dam itself is restricted to a small narrow band of *Persicaria* sp, Water Primrose (*Ludwigia peploides* subsp. *montevidensis*) and Duckweed (*Wolffia* sp.). A small patch of emergent sedges is present on the western edge of the dam, where a man-made drainage line has been constructed. Submerged debris and small snags occur in the periphery of the northern edge of the dam in open water.

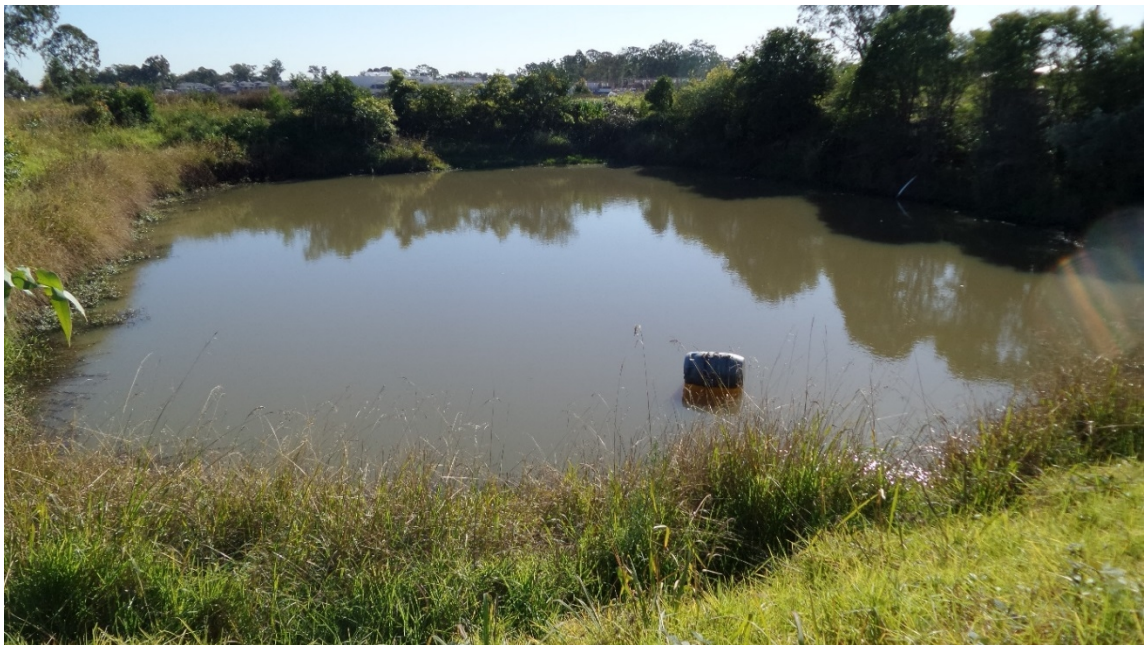
Photograph 2 Offsite dam with fringing exotic vegetation (Offsite Dam 1)

The Offsite Dam 1, is of a moderate size and with approximately 50 m by 40 m of open water present at the time of the survey. This dam is shown in (Photograph 2) below. The dam contained deeply incised banks > 5m and comprising a shale and fill substrate and appeared to contain relatively deep water. The banks were heavily vegetated with exotic weeds and contained Kikuyu (*Pennisetum clandestinum*) and Blackberry (*Rubus fruticosus* subsp. *aggregate*) on its upper banks. A limited amount of native vegetation lined the dam including emergent eucalypts with Sweet Pittosporum (*Pittosporum undulatum*) present on the western and northern edges. Native fringing aquatic vegetation within the dam itself was restricted to small scattered patches of *Persicaria* sp. There were no submerged debris or stags to provide basking habitat for frogs/turtles or waterbirds.

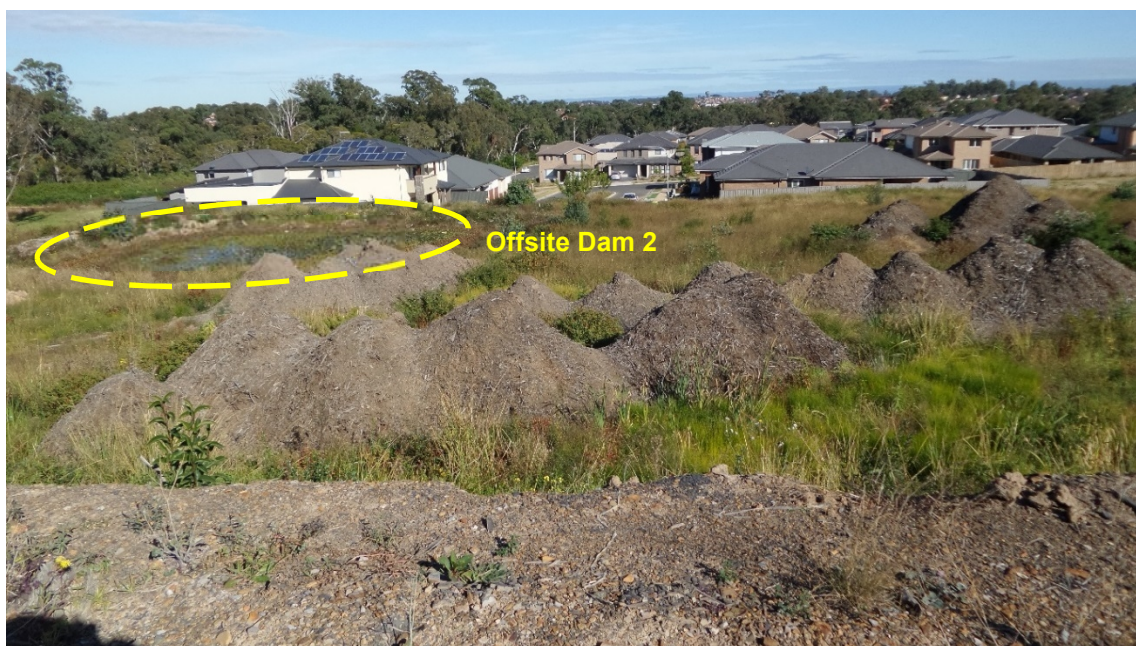
Photograph 3 Recently cleared vegetation mapped as Cumberland Plain Woodland adjacent to property (showing location of Offsite Dam 2)

The western edge of the dam lies adjacent to a property comprising vegetation mapped as Cumberland Plain Woodland (THSC 2008). However, this vegetation has recently been cleared and only large piles of mulch remain. Another dam, Offsite Dam 2, is located on the neighbouring property (refer Photograph 3 below).

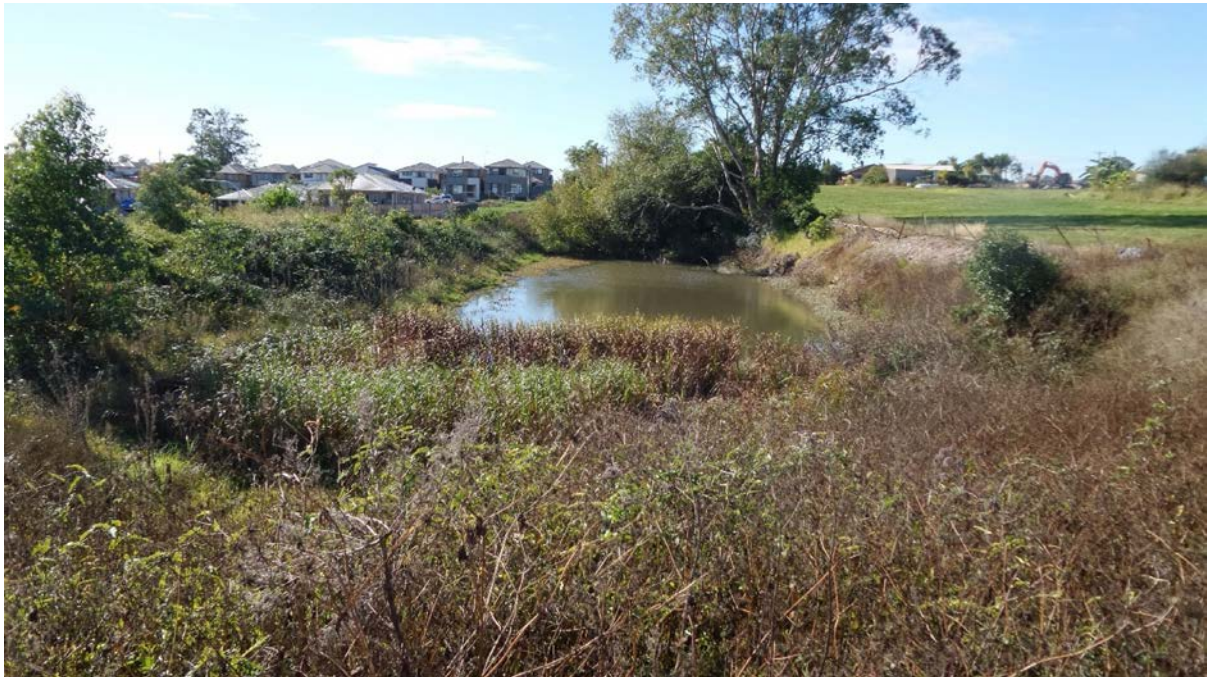
**Photograph A: Onsite dam**

The dam is of moderate size and approximately 40m by 20m of open water was present at the time of the survey (Photograph A). The dam contains sloped banks comprising a shale and fill substrate.

The banks are heavily vegetated with exotic weeds and was dominated by Blackberry (*Rubus fruticosus* subsp. *aggregate*) particularly on the dams' northern edge. Small numbers of native flora line the dam including a large Forest Red Gum (*Eucalyptus tereticornis*) on the dam's eastern bank. Native fringing aquatic vegetation within the dam itself is restricted to a small narrow band of *Persicaria* sp, Water Primrose (*Ludwigia peploides* subsp. *montevidensis*) and Duckweed (*Wolffia* sp.). A small patch of emergent sedges is present on the western edge of the dam, where a man-made drainage line has been constructed. Submerged debris and small snags occur in the periphery of the northern edge of the dam in open water.
