Alexandria Park Community School, 7-11 Park Road Alexandria

PRELIMINARY ABORIGINAL ARCHAEOLOGICAL
ASSESSMENT

Tanner Kibble Denton Architects Pty Ltd

December 2017

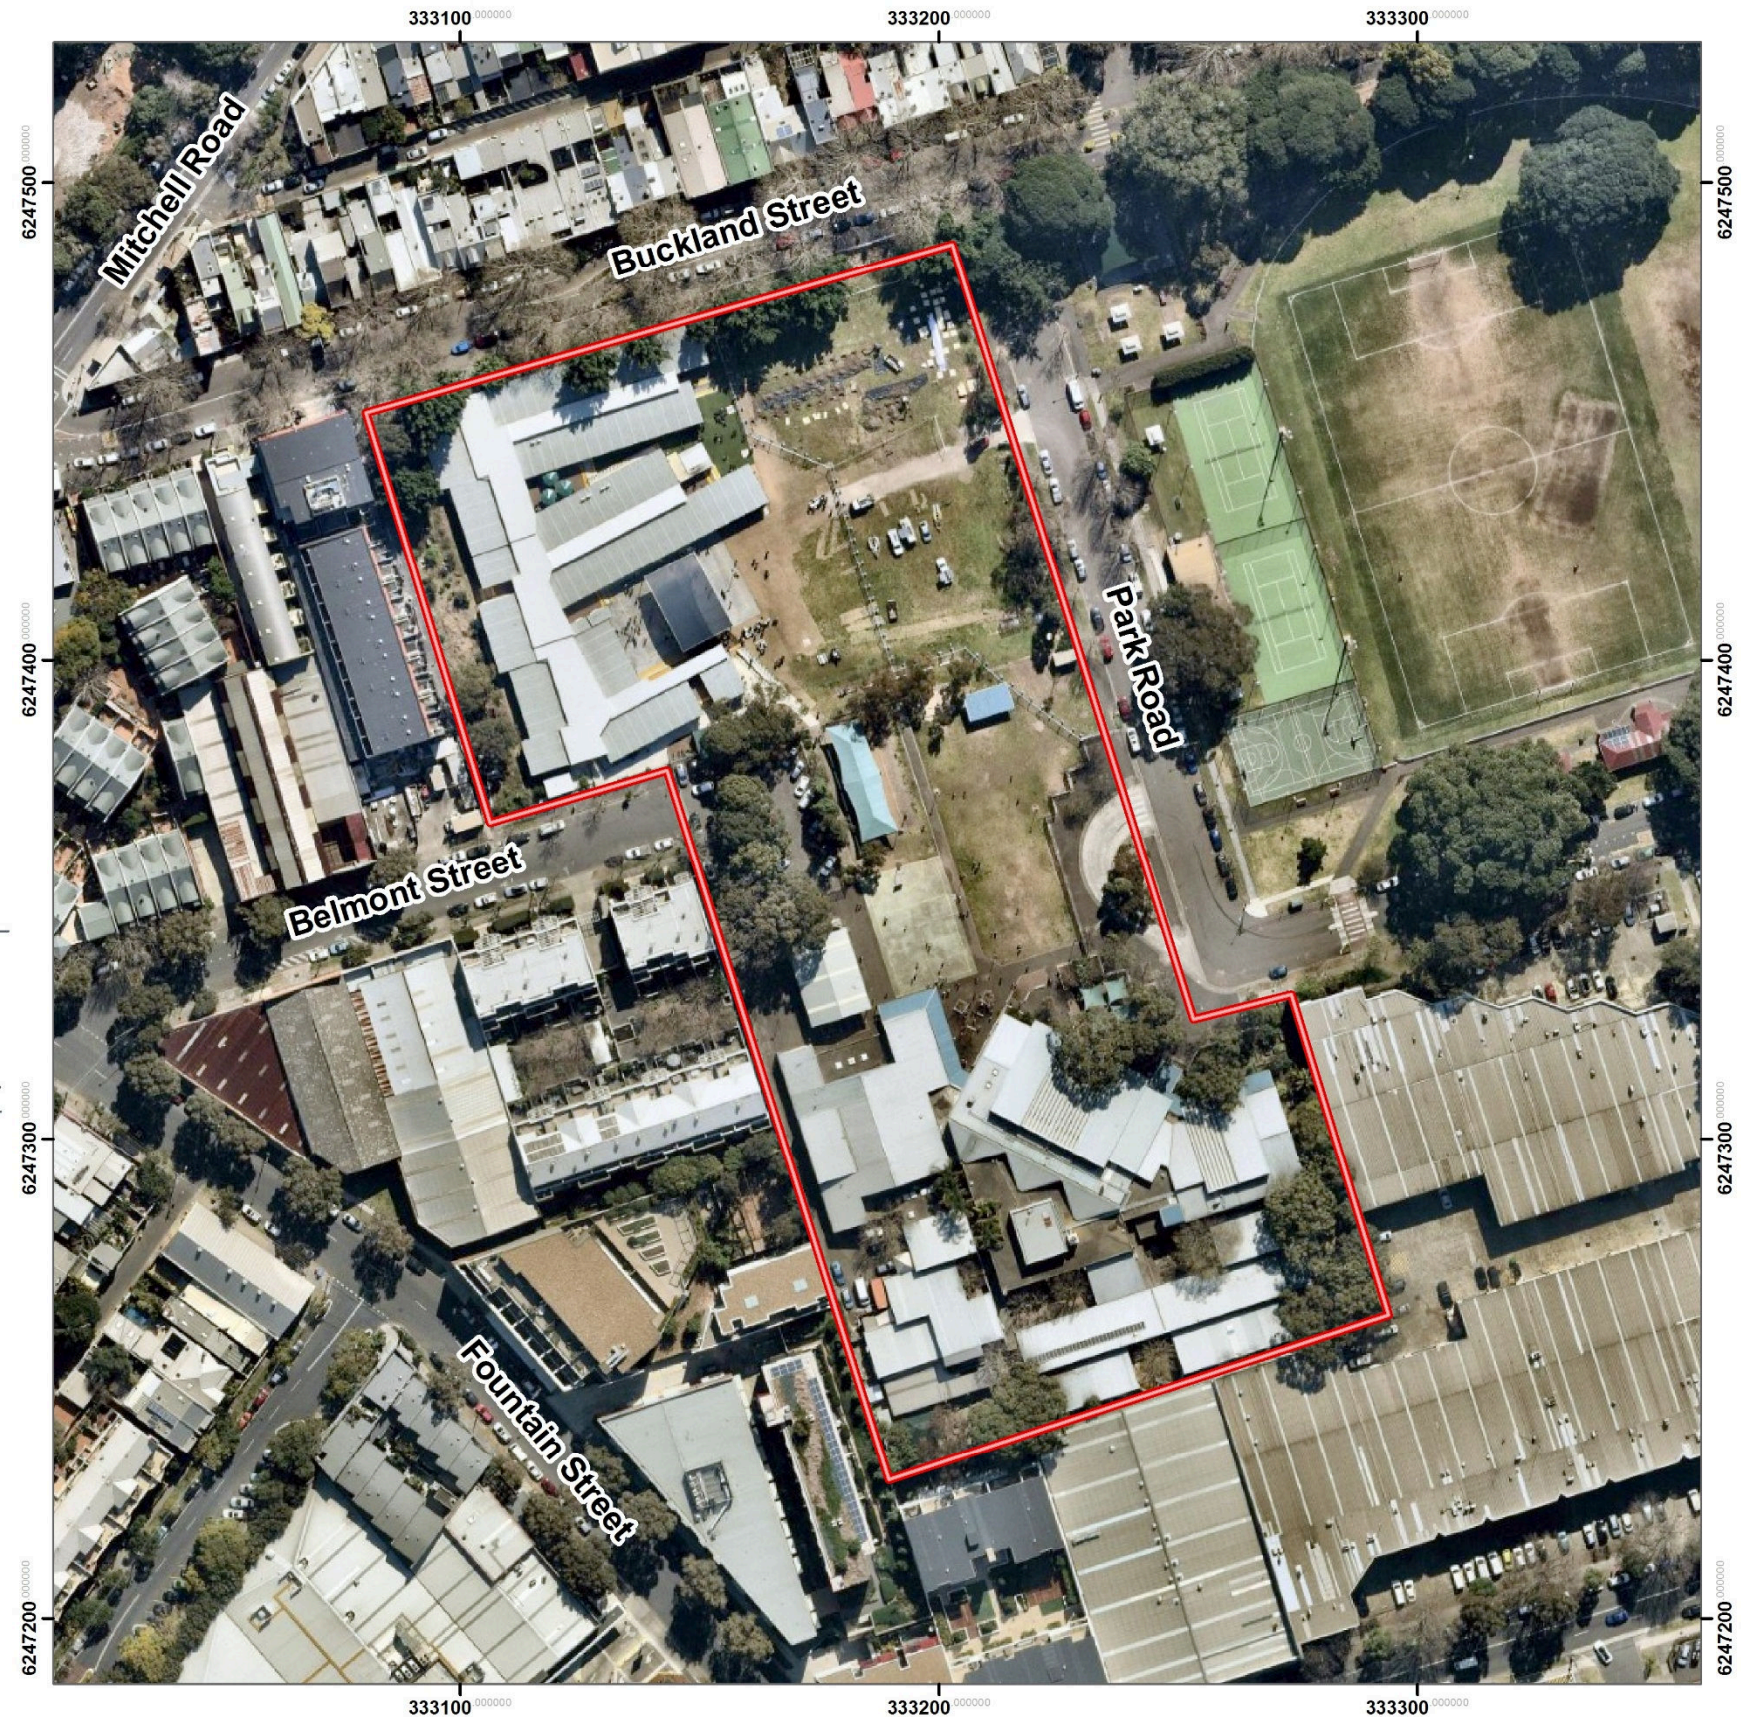
Figure 1. Alexandria Park Community School Site.

The Alexandria Park Community School is a NSW Department of Education owned and managed property comprising approximately 3 ha within the City of Sydney Local Government Area. It is located 5 km southwest of the Sydney CBD and is bound to the north by Buckland Street, to the east by Alexandria Park and Loveridge Street, to the south by McEvoy Street and to the west by Belmont Street and properties that front onto Fountain Street (**Figure 1**).
