Detailed Site Investigation

Alexandria Park Community School, Park road,
Alexandria NSW

26 October 2017

SYDEN199382-R01-Rev2

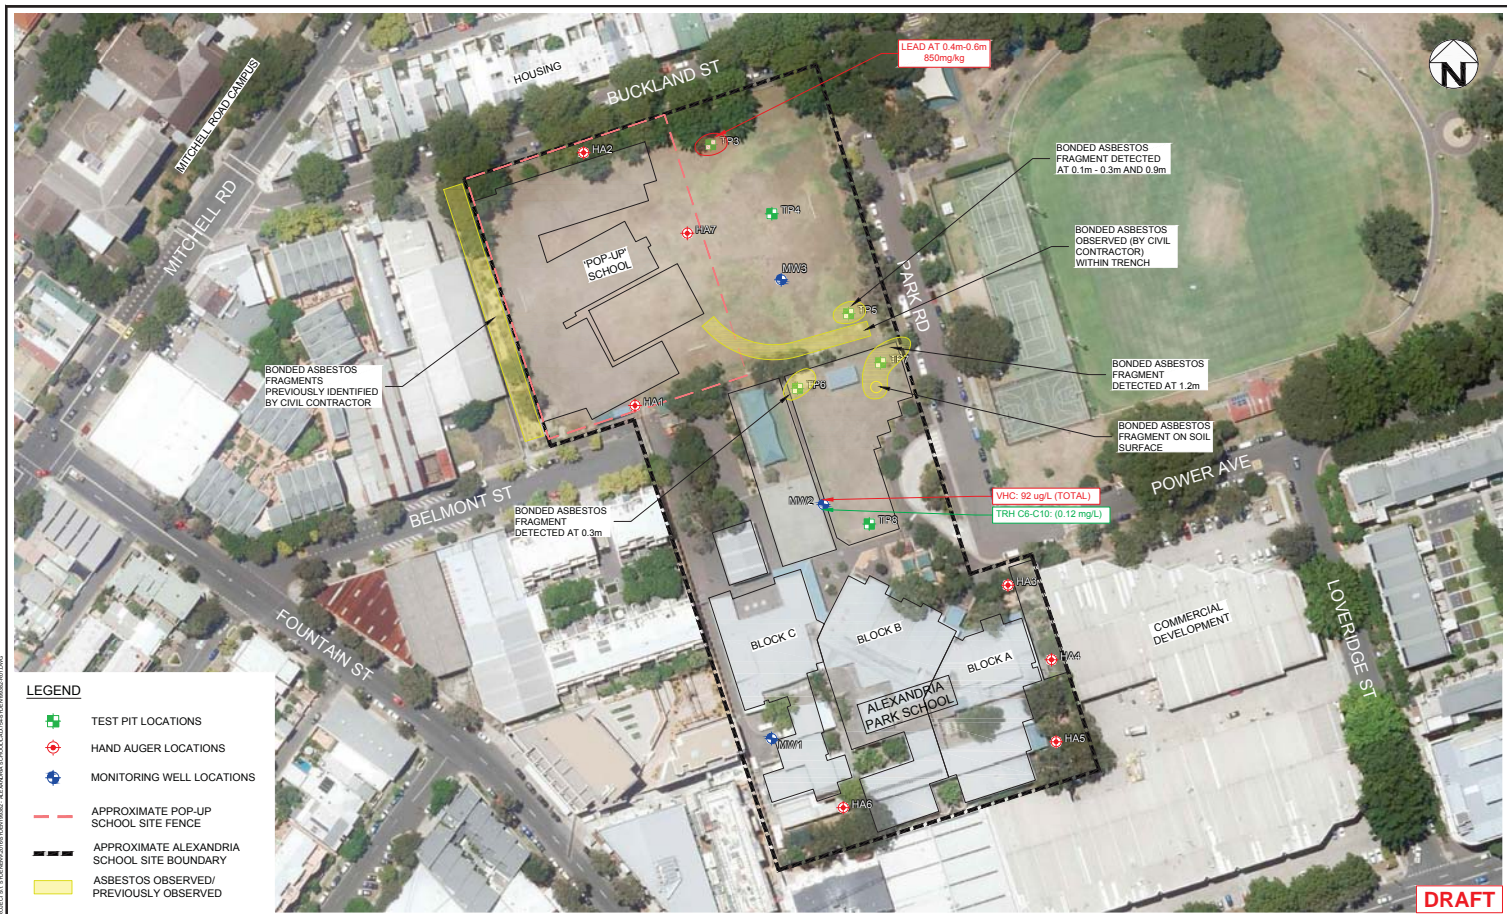
client:	TKD ARCHITECTS PTY LTD		
project:	ALEXANDRIA PARK COMMUNITY SCHOOL PARK ROAD, ALEXANDRIA, NSW		
title:	HUMAN HEALTH INVESTIGATION CRITERIA EXCEEDANCES		
project no:	754-SYDEN199382-R01	figure no:	FIGURE 3
		rev:	A

- Anecdotal evidence from the manager coordinating the pop-up school construction works indicated that bonded asbestos cement fragments had been encountered within the northern half of the site during service excavations. During the site walkover, a fragment of bonded asbestos cement was also noted on grassed playground adjoining the Park Street entrance. The fragment was triangular shaped and approximately 4cm in length. The fragment edges were sub-angular and it did not crumble with moderate hand pressure. Figure 3 illustrates the locations where bonded asbestos has been identified.

Bonded asbestos cement fragments were observed at the following locations during the investigation:

- TP5: Three bonded asbestos cement fragments (approximately 3cm x 3cm), angular to sub-angular. The asbestos fragments were in relatively strong condition and did not crumble with moderate hand pressure.
- TP6: Bonded asbestos cement fragment (4cm x 4cm), angular. The asbestos fragment was in relatively strong condition and did not crumble with moderate hand pressure.
- TP7: Bonded asbestos cement fragment (4cm x 4cm), sub-angular. The asbestos fragment was in relatively strong condition and did not crumble with moderate hand pressure.
- Soil surface adjacent TP7 (APS): Bonded asbestos cement fragment (3cm x 2cm), sub-angular. The asbestos fragments were in relatively strong condition and did not crumble with moderate hand pressure.

- Observations made of fill materials exposed along service trench excavations measuring between 65m and 90m, as illustrated on Figure 3.
- Table A of the Sampling Design Guidelines (NSW EPA, 1995) recommends 40 sampling positions for a 3.0 ha site. With regard to assessing fill materials, the investigation density was lower than the minimum investigation density recommended by the Sampling Design Guidelines (NSW EPA, 1995). The Sampling Design Guidelines recommend a systematic sampling programme where the distribution of contamination is expected to be random. Given the access restrictions present within the site, it was not possible to establish a systematic sampling grid, and therefore the distance between sampling locations in certain areas of the site is more than that recommended by the Sampling Design Guidelines. As such, the degree of uncertainty associated with unexpected contamination associated with fill materials present in these areas is assessed to be greater. Conversely, in other areas of the site where the distance between sampling locations is less, the degree of encountering unexpected contamination is assessed to be proportionally less.
